NEW JERSEY DIVISION OF FIRE SAFETY

Firefighter Fatality and Serious Injury Report Series

Two Chief Officers and a Firefighter Killed in a Collapse During a Structural Fire

**Gloucester City, New Jersey
July 4, 2002**

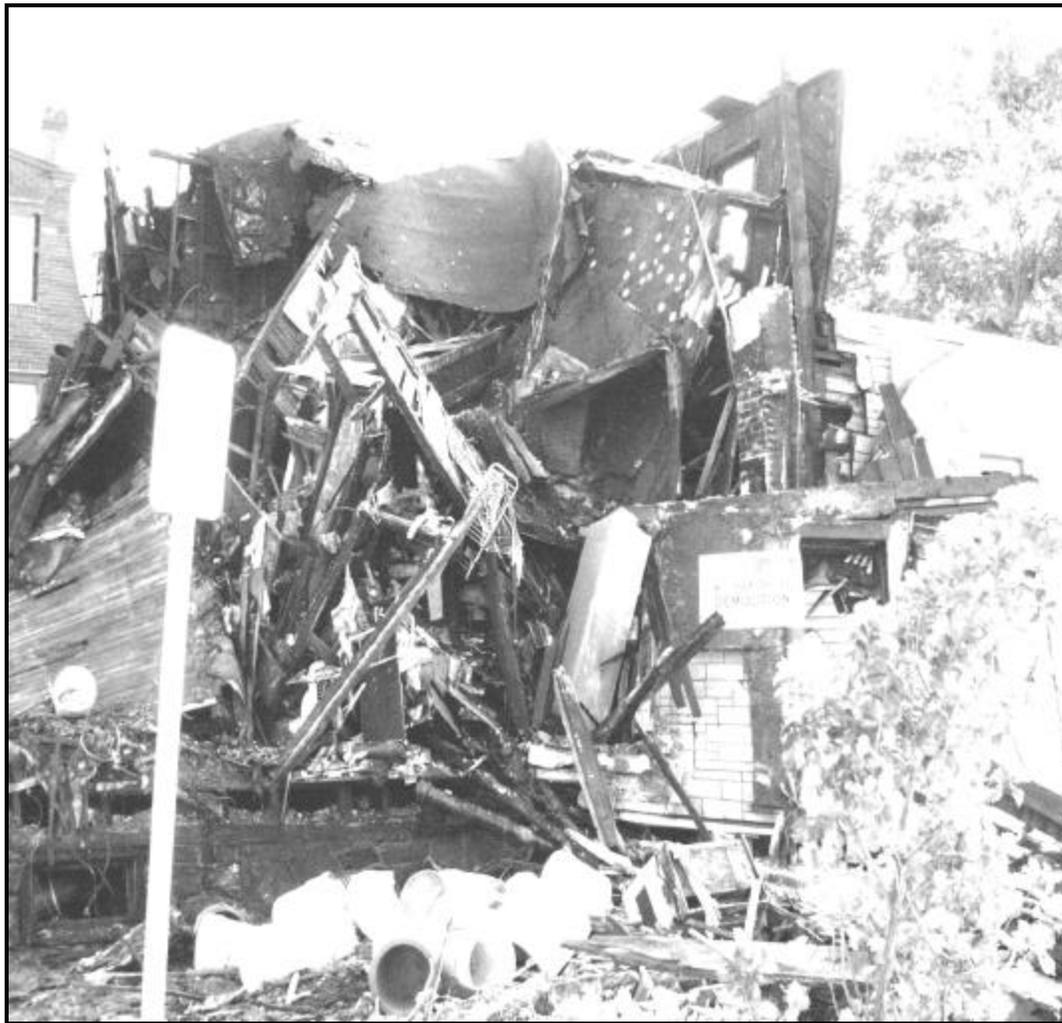
View of collapse from the “A” – “D” corner.

- Cracks or bulges in walls – Photos and videos showed significant bowing of the Division D wall during defensive operations prior to the collapse.
- Obvious movement of floors, walls, or roofs – FF's on the interior of unit 202 reported that the floor, walls and ceiling were dropping. This also was confirmed by FF's on the exterior that reported seeing debris falling from within unit 200.
- Unusual noises – FF's on the interior of unit 202 reported hearing sounds of debris falling from within unit 200.

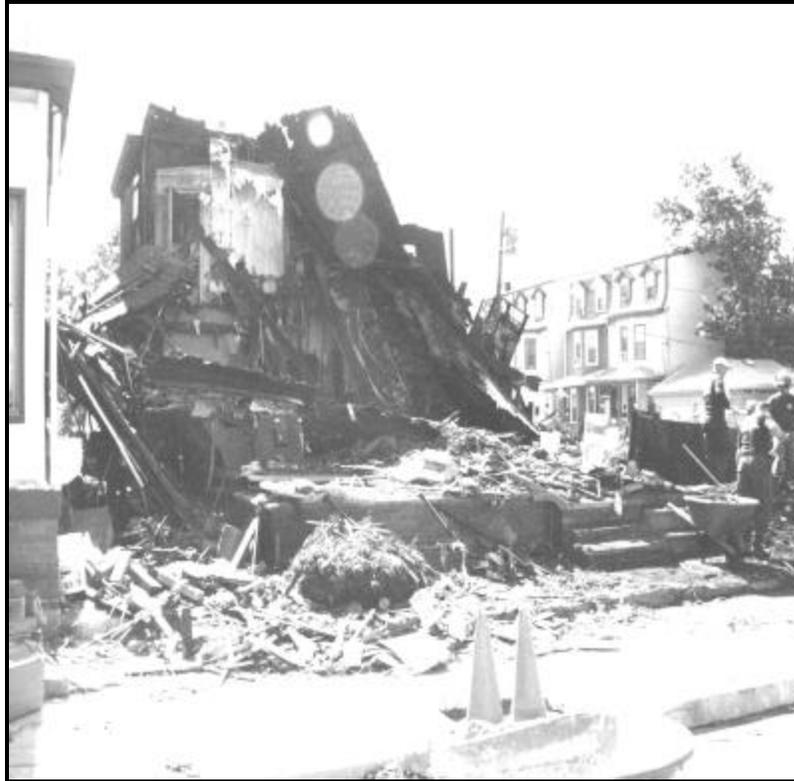
View of collapse from “A” – “B” corner.
