NEW JERSEY DIVISION OF FIRE SAFETY

Firefighter Fatality and Serious Injury Report Series

Career Firefighter Killed While Operating at a Structure Fire

**Union City, New Jersey
September 9, 2006**

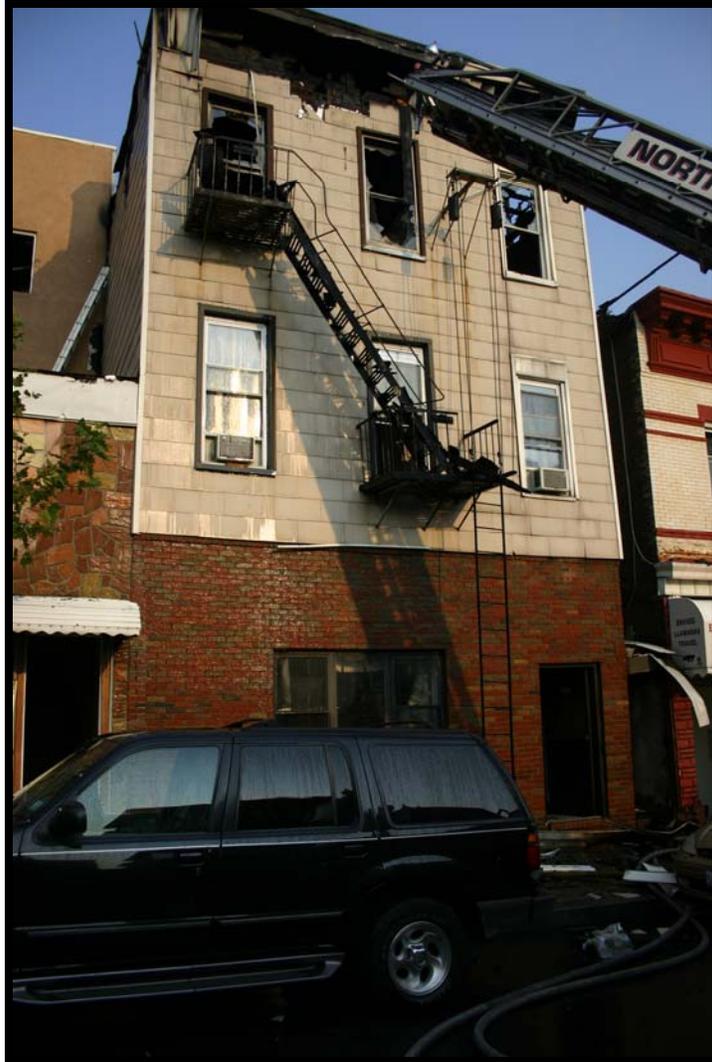
Figure 1 - Division A side of 1813 Bergenline Avenue - Note the adjoining structure on the Division B side and the alleyway on the Division D side.

- *Obstructed 360° view* – Initial arriving personnel had a limited view of the entire structure to observe conditions due to similar size and type minimal-clearance exposures on both sides of this structure. This is a common problem in urban communities and in this case, the Div. B-1 exposure was directly abutting this structure, and the Div. D-1 exposure was separated from this structure by a narrow alleyway. This alleyway was the only means of directly accessing the Div. C side of this structure / property.

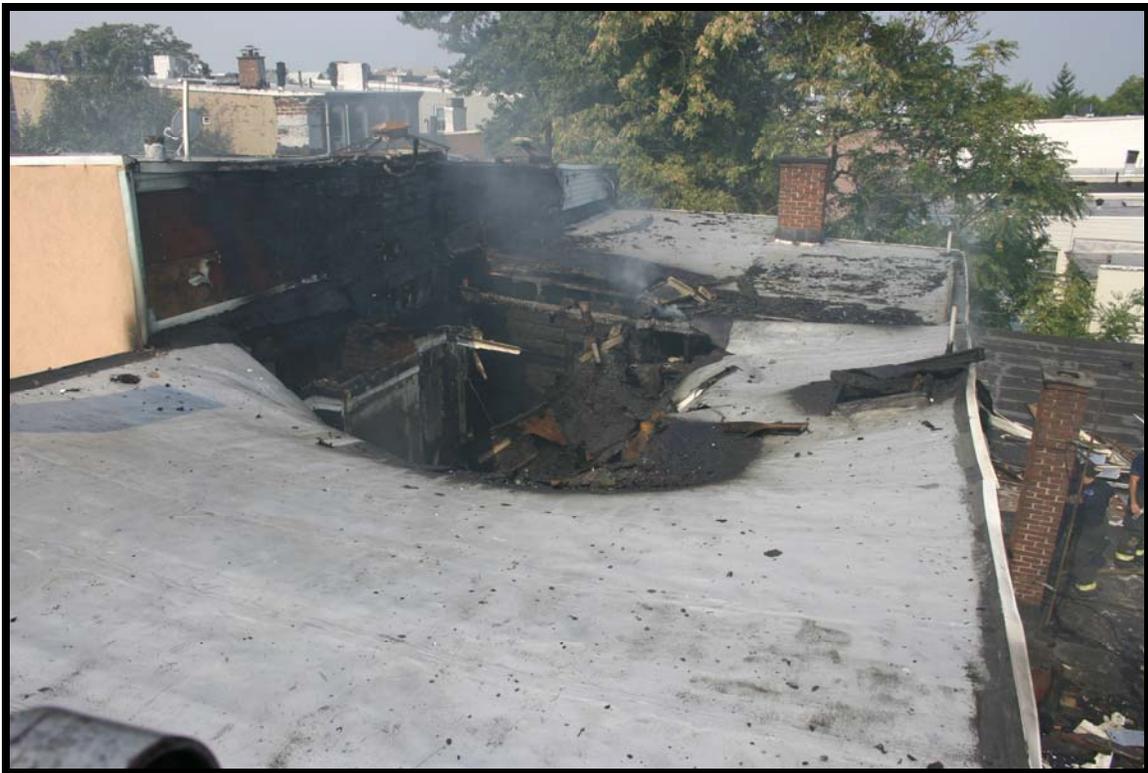
What was learned later through investigation but not immediately known at the time was that this fire was burning uncontrolled inside a large, open ventilation shaft on the interior of the structure. Inside the apartments, there were windows into the shaft for ventilation and light; it was through these windows that the fire was extending into all levels of the structure. It is believed that a failure of these shaft windows resulted in the sudden eruption of fire into the apartment, trapping FF Neglia.

Figure 2 - Rooftop view of 1813 Bergenline Avenue and adjoining exposure building - The vertical shaft is located at the center of the burned out area against the abutting structure

- *Open vertical shaft* – This structure contained a large (approx. 10’ x 12’) open vertical shaft, which is where this fire originated. These shafts are commonly found toward the center area between these types of abutting structures, and provide for light and ventilation to the interior rooms along the abutting “exterior” walls. These shafts frequently contain accumulations of combustible trash, as was the case in this incident. Personnel must be cognizant for the existence of these shafts, especially when the source of smoke can not be immediately identified because the fire can be burning within the shaft, hidden from the direct view of FFs. These shafts also pose a fall risk to personnel, as the windows that lead into shafts can have low sill heights, or be mistaken for an emergency means of egress.
[Prior to this incident, the NHRFR experienced another incident where a fall into a similar open shaft resulted in the injury to a veteran FF. The NHRFR conducted their own internal investigation of this incident, and developed a list of recommendations for FF operations at similar structures containing shafts.]

- *Combustible construction* – This structure, as well as the exposure structures were traditional wood-framed construction, which pose an obvious threat for rapid fire spread. Additionally, the interior portion of the aforementioned vertical shaft was of combustible wooden construction, believed to be sheathed with asphalt siding, which is a known hazard to FFs, as it has been called “gasoline siding” due to the rapid rate at which it will burn. This could also explain why the conditions went from only minor smoke to sudden, extreme fire and heat throughout all three building levels, and through the roof.

To this end, it is recommended that inspectors check these shafts at regular intervals to ensure that there is no accumulation of combustible debris within the shaft, and also that the tops of these shafts remain open, or are capped in an approved manner. Further, violations should be issued to the building(s) owner(s) if any of these “common area” issues are discovered.

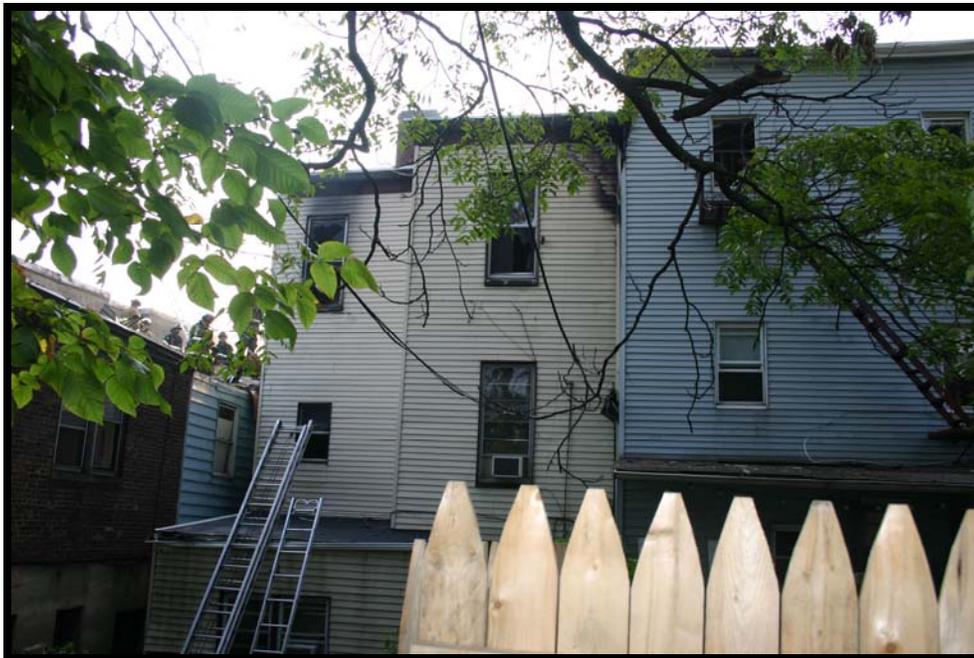
Figure 3 - Division C side of 1813 Bergenline Avenue where FF Neglia was removed from the third floor window of the structure - Note that the building to the right is the abutting structure
