# ***NEW JERSEY DIVISION OF FIRE SAFETY***

## ***OFFICE OF THE STATE FIRE MARSHAL***

### **Analysis of Fire Department Emergency Operations During Two Responses to the Same Residence**

**Teaneck, New Jersey  
March 21 and 22, 2005**

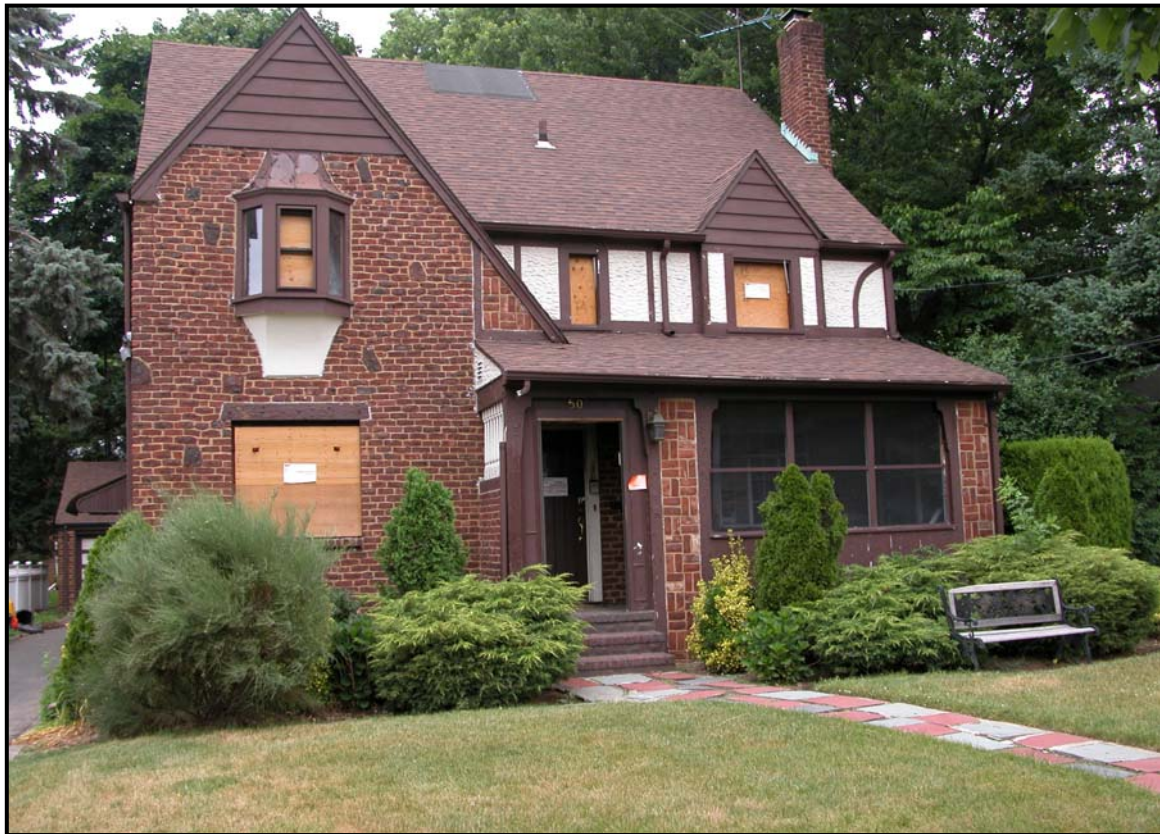
Figure 1 – The home at 501 Rutland Avenue.

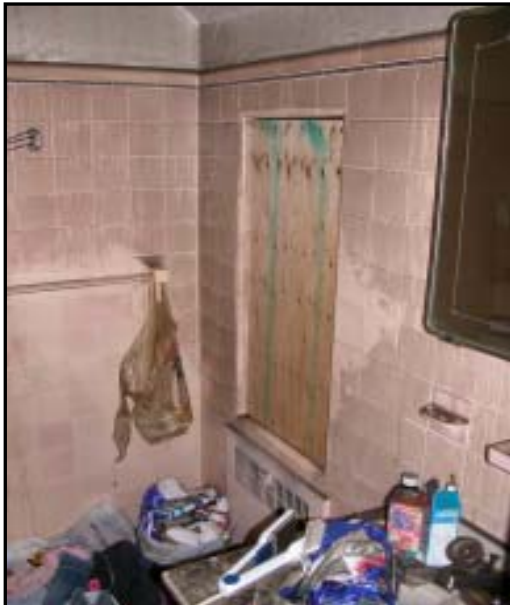
**Figure 3 – An inside view of the second floor bathroom window where two children and their mother were removed from the home.**

The windows in the house generally were steel casement type with center steel partitions. The windows were substantially smaller than what are required in new construction. This made egress and rescue efforts of the occupants much more difficult and time consuming. It was noted that the woman who was rescued from the second floor bathroom window had become wedged and necessitated the forcible removal of the steel window frame to allow her rescue. Additionally, it must be noted that many of the other windows in the home were outfitted with window mounted air conditioning units. Many other windows were partially blocked by large pieces of furniture, such as the bed in the master bedroom that further slowed rescue personnel entering the structure.

A common theme of fire prevention programs offered by fire departments and state and national fire organizations is the concept of establishing and maintaining multiple exit routes for occupants of dwellings. Occupants are instructed to have at least two ways out of their home in and the event that normal egress ways such as doors may not be usable if they are blocked by fire. For this reason, windows must be considered as alternate escape routes and homeowners are advised to keep windows clear of obstructions as much as possible.

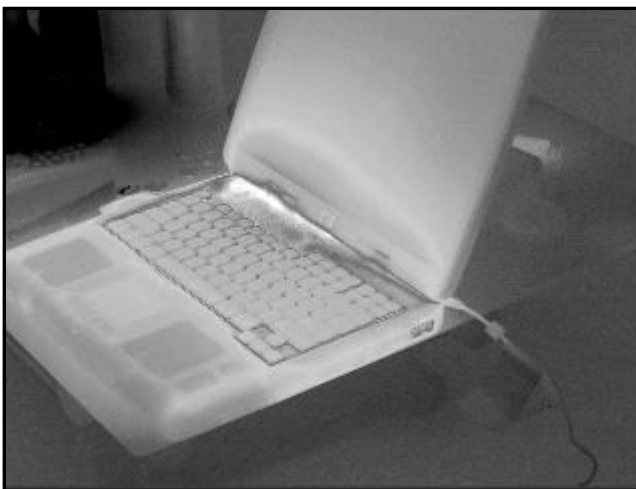
As previously explained in this section and specifically relating to the inability of TICs to "see" through insulated objects, the TIC would not have been an effective tool in locating this overheated fan motor, if it was in fact overheating at the time of the first incident. This is due to the heavy insulation that surrounds the unit. Additionally, the TIC would show the normal heat that is given-off by a properly operating electrical appliance such, would not indicate a problem.

**Figure 5 – An image of a normally operating electrical device, in this case a laptop computer, as viewed by a thermal imaging camera. This illustrates how even normally functioning equipment emits heat energy that is observed by a thermal imaging camera. Note the warmer areas are represented by whiter shades indicating warmer temperatures. Cooler areas are represented by darker shades.**

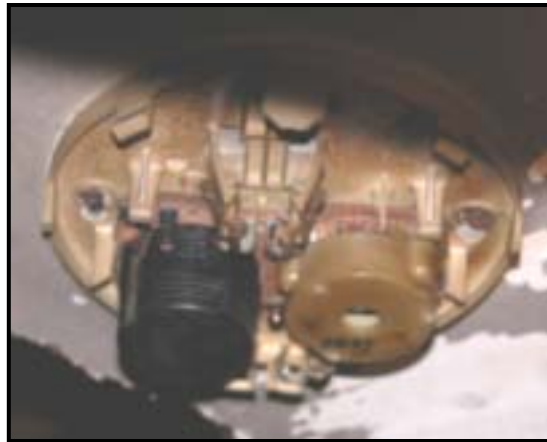
On the early morning of March 22, 2005 only two working smoke detectors were found. These detectors were located on the first and third floors of the home. Other detectors in the home were found to be missing batteries or had been removed completely prior to this incident.

The NJ Uniform Fire Code requires that all one and two family dwellings be equipped with a minimum of one smoke detector on each level of the home. Therefore, this home would have required at least four detectors. The code does not require routine inspection of smoke detectors by code enforcement officials, but rather only when a new home is constructed or upon resale of an existing home. Records obtained during the course of this investigation revealed that at the time of the sale 501 Rutland Avenue in 1998 to the owners/occupants at the time of the fire, working smoke detectors were present and in compliance with the requirements of the NJ Uniform Fire Code.

**Figure 6 – This photograph shows the smoke detector that was located in the basement. It shows that the battery was missing at the time of the fire. This is evidenced by the uniform discoloration of the unit caused by the fire.**

Since the time of these incidents, the TFD has instituted a policy where if firefighters observe deficiencies with regard to smoke detectors in homes that they have responded to, the Fire Prevention Bureau is contacted and personnel will visit the home. They will inspect smoke detectors and install batteries and/or replace the detectors, free of charge. Additionally, the fire department mailed fire safety brochures to all residents and provides voluntary fire safety inspections if requested to do so.
