PRE-REHABILITATION: LEAD-BASED PAINT RISK ASSESSMENT

**EMERGENCY OPERATIONS CENTER AND
COAST GUARD STATION
420 PELHAM AVENUE
BEACH HAVEN, NEW JERSEY 08008**

PARS PROJECT NO. 710-18

DECEMBER 2014

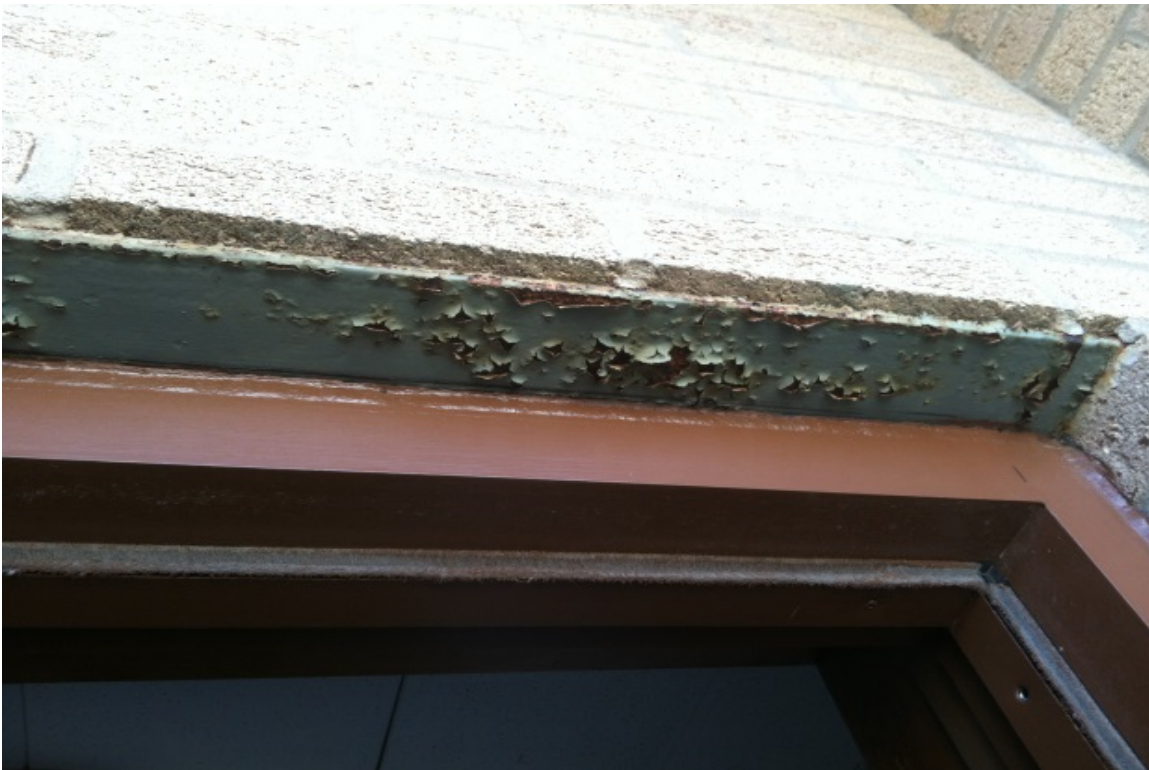
Photo 2: Four (4) LBP Door Lintels on Municipal Court Section

HAZARD 2: Scraping LBP on the door lintels and columns

1. **INTERIM CONTROLS - STABILIZATION:** A lead hazard could be created if the door lintels and columns are prepared for repainting (scraped) during the upcoming renovations. Any work that will disturb these surfaces must be carried out by properly trained lead workers, following lead-safe work practices. Following preparation work, the LBP coatings on the door lintels and columns may be addressed by stabilizing the surfaces with new paint. This activity has the potential to create a high volume of lead-contaminated dust, and extra care must be taken by the contractor to limit and contain the dust generated.

2. **ABATEMENT - REPLACEMENT:** Replacement of the door lintels and columns is another possible remediation option. This involves removing paint removal by a heat gun, chemical or contained abrasive, and/or removal and replacement of LBP building components, if possible, and installing new building materials. This remediation option has the potential to generate extremely high amounts of lead contaminated dust and would require appropriate containment.

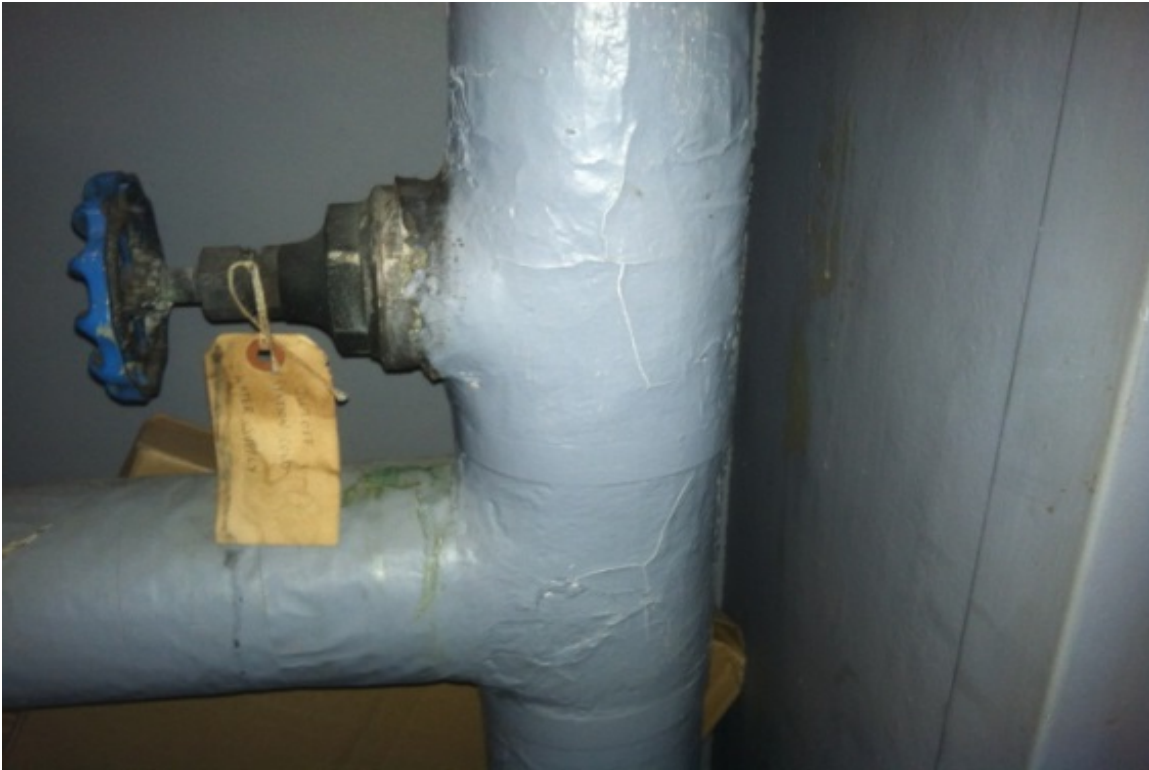
Photo 3: LBP Pipe Insulation

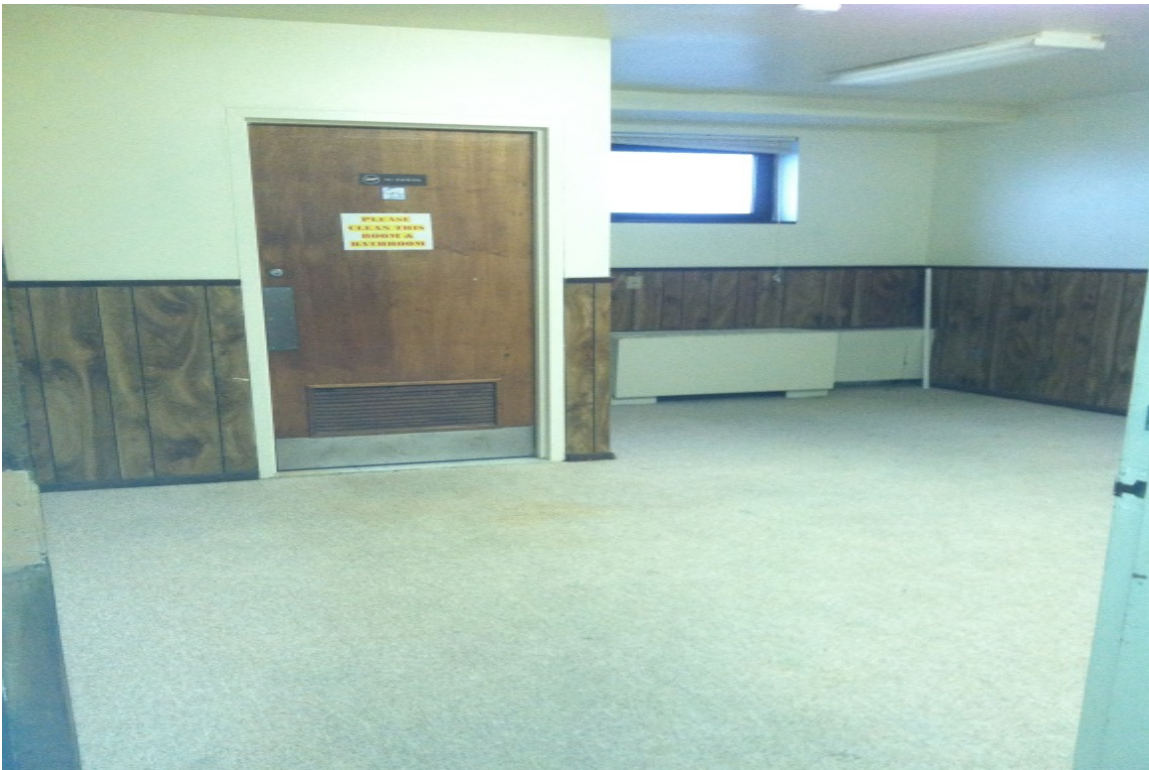
Photo 4: Room W106 – Lead Dust Hazard Location

HAZARD 1: Removal of floor dust-lead hazard

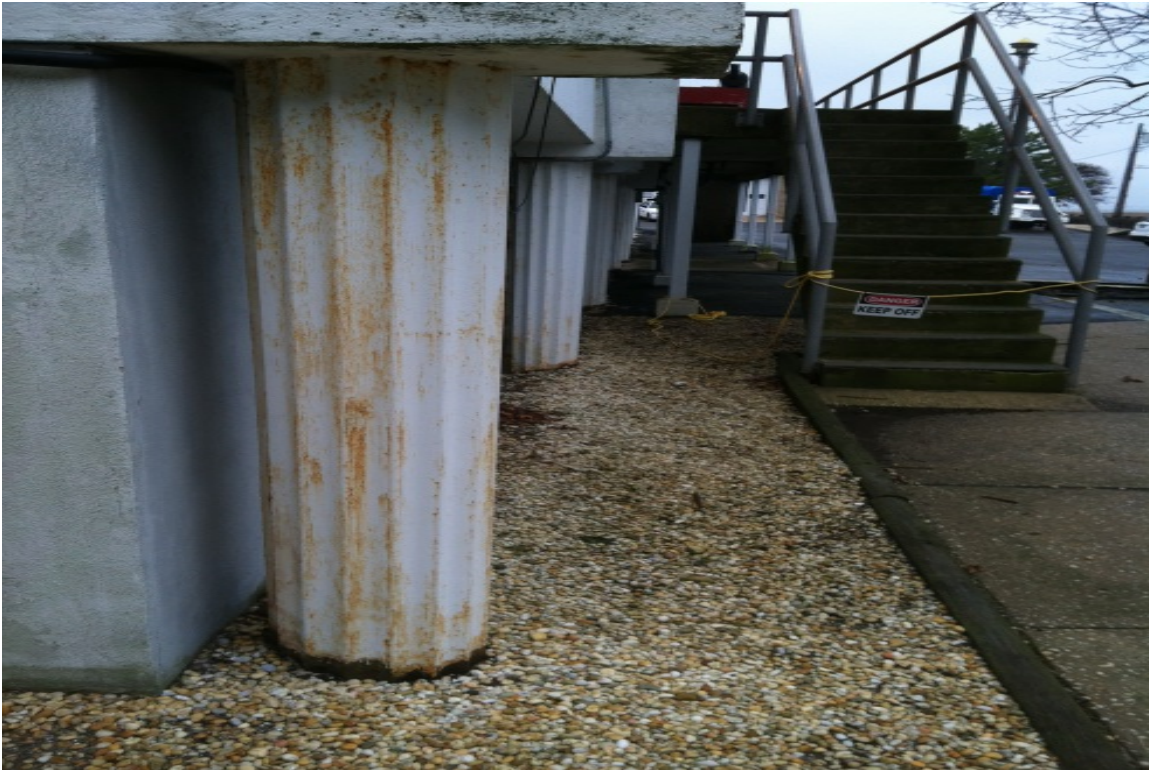
Photo 5: Representative Exterior Column at Municipal Court Section

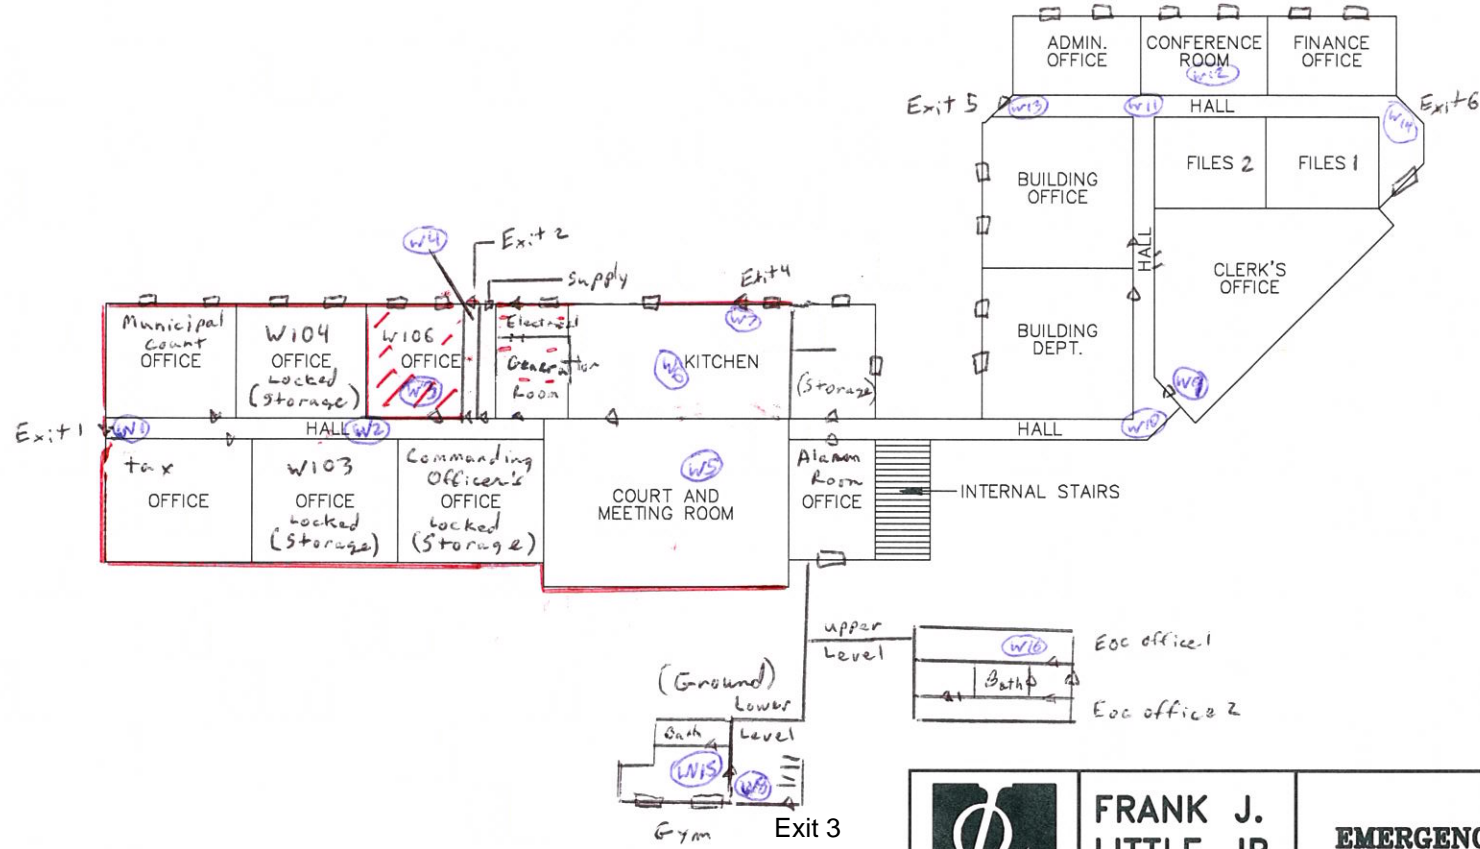
- WF LAP Wipe Locations
- LAP on Door Lintels & Columns & pipe insulation (Elbows & tees)
- LAP Dust Hazard
