Field Assessment Form

New Jersey Community Development-Disaster Recovery Block Grant (CDBG-DR)
Hurricane Sandy Disaster Recovery Program

Applicant ID: NCR40029a	
PAMS Pin:	DCA Grant Number: B-13-DS-34-0001
Applicant Name: Borough of Carlstadt	Inspection Date: 11/13/2014
Damage Address: Kero Road, Carlstadt Boro	Inspector: Brian Rodriguez
Program Type: NCR	Project Description: Reconstruction In Existing Footprint
Location Verified By: Neighboring houses	Parcel Status: Public Right of Way

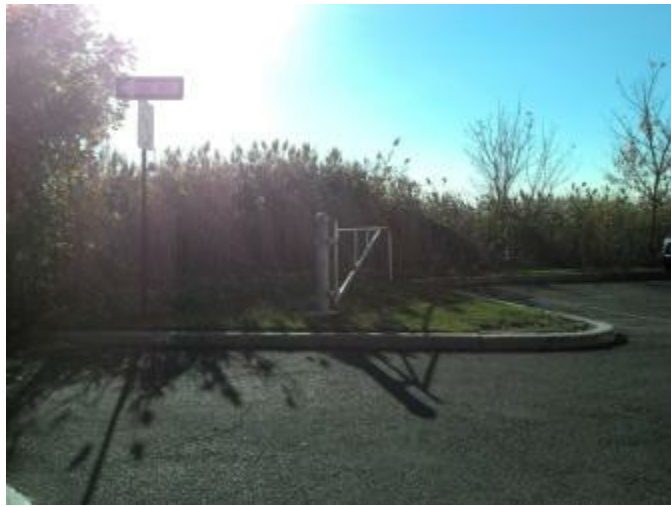
NCR40029b_EA_Wetland_1

Comments: Wetland observed immediately southeast of site.

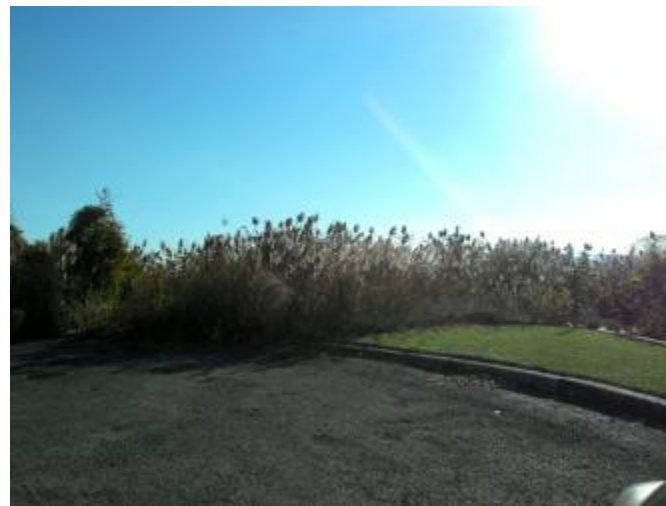
NCR40029c_EA_Wetland_1

Comments: Wetland observed immediately east of site.

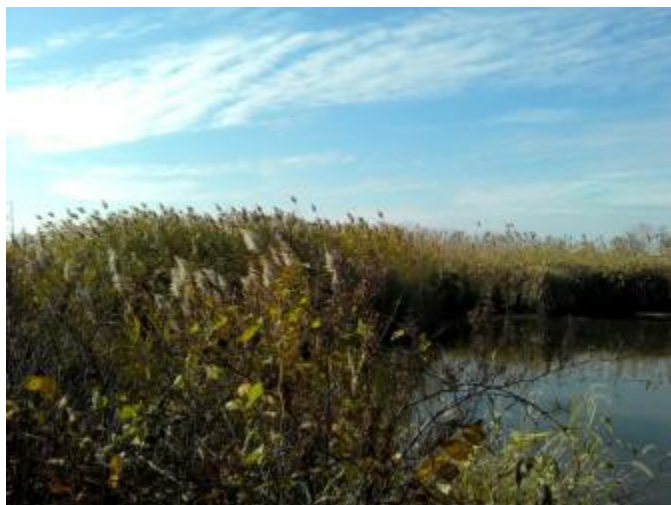
NCR40029e_EA_Wetland_1

Comments: Wetland observed immediately west of site.

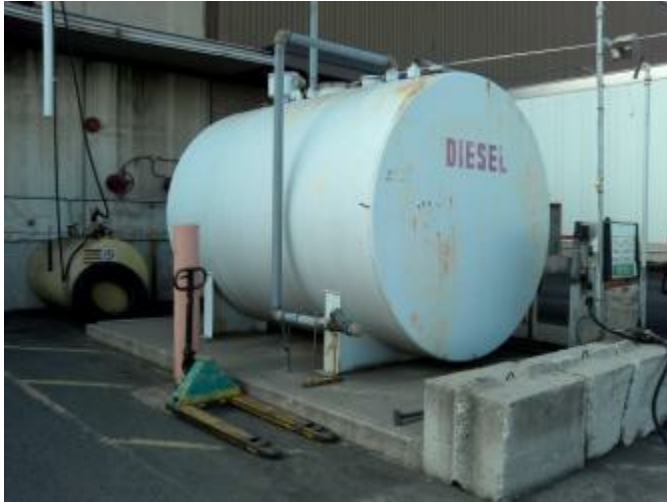
NCR40029f_EA_AST_1

Comments: Two ASTs observed along north face of building.

AST ID	AST Name	Lat Lon	Size	Contents	Pressure	Is Diked
AST_0205_92_1-1	unknown	40.83414 -74.08042	500	flammable liquid	Unpressurized	No
AST_0205_92_1-2	diesel	40.83420 -74.08053	5000	diesel	Unpressurized	No

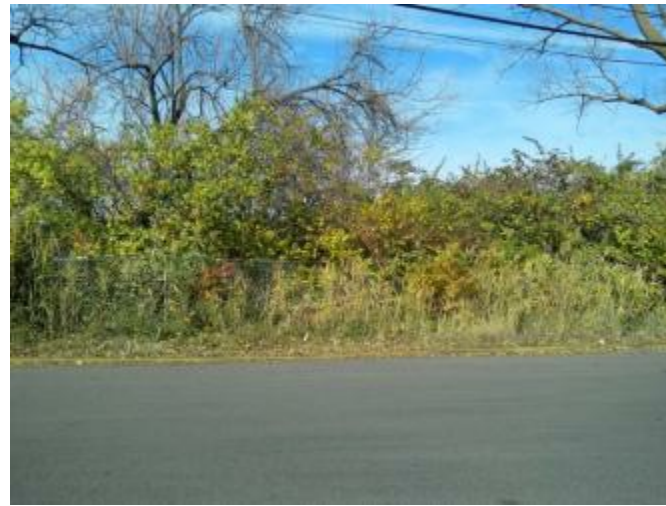
NCR40029f_EA_Wetland_1

Comments: Wetland observed west and north of property.
