Estimated Cost of Repair - Work in Place

Insured: William Ryan
Property: 2 S Montgomery Avenue Apt 1
Atlantic City, NJ 08401

Type of Loss: Hurricane

Estimate: 06556_RYAN_WIP

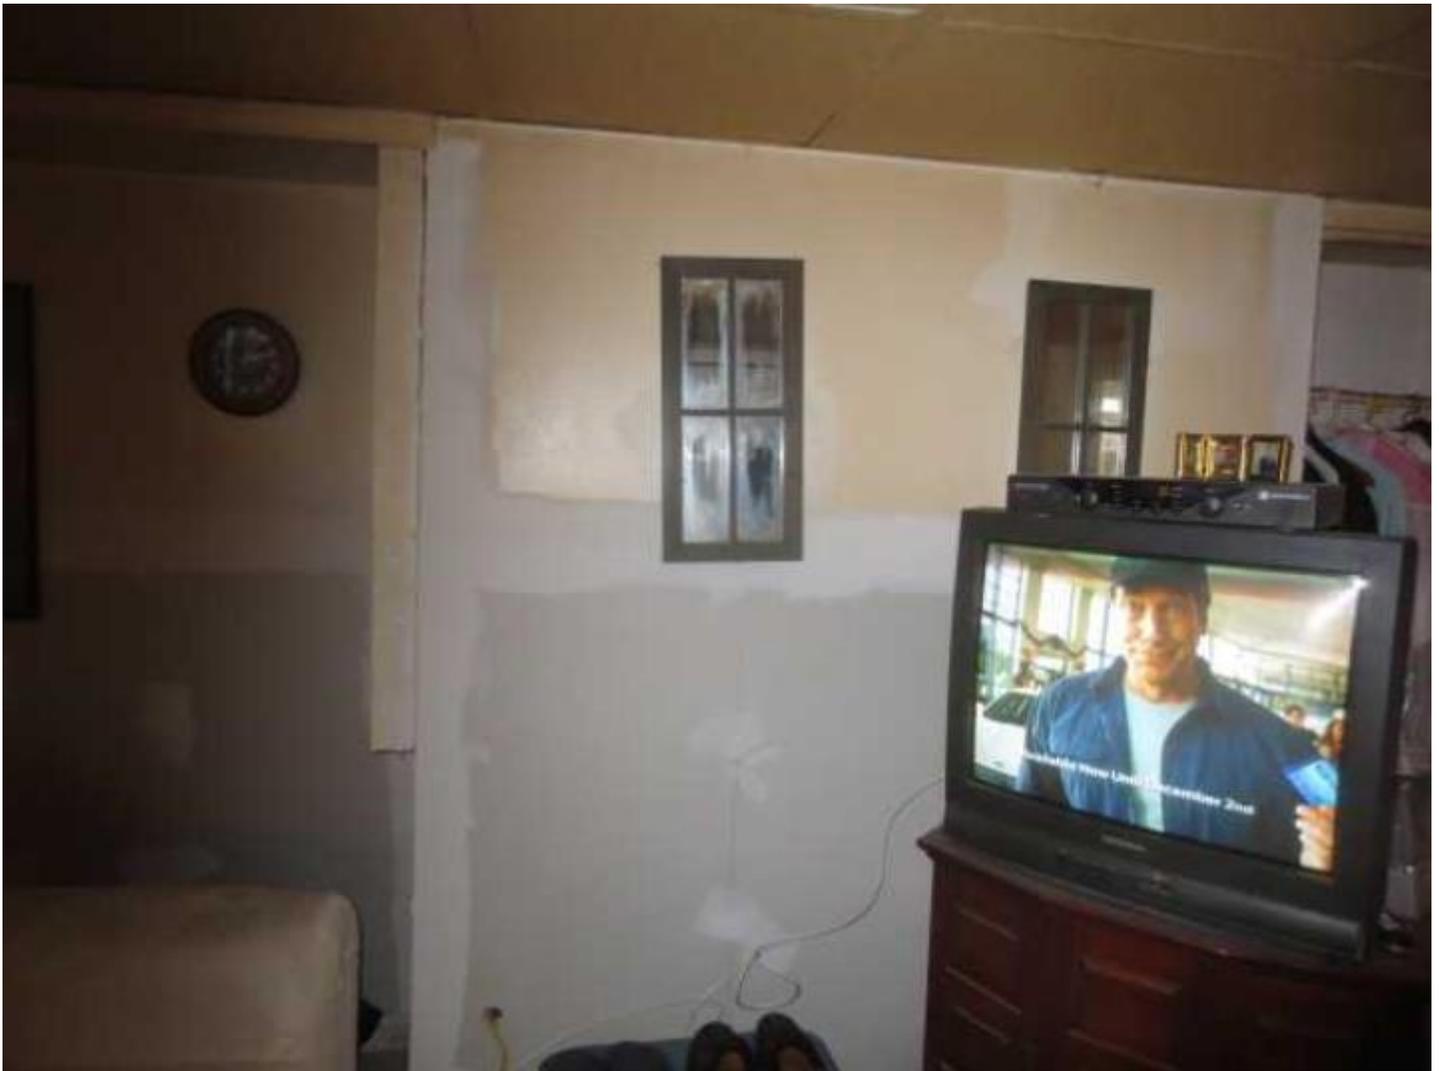
6 Living Room

DESCRIPTION	QTY	UNIT PRICE	TOTAL
-----GENERAL ITEMS-----			
1. Final cleaning - construction - Residential	111.86 SF @	0.30 =	33.56
-----WALLS & CEILINGS-----			
2. Apply anti-microbial agent	88.33 SF @	0.27 =	23.85
3. Seal framing members for odor/mold control (white pigmented shellac)	88.33 SF @	0.75 =	66.25
4a. Remove 1/2" drywall - hung, taped, floated, ready for paint	88.33 SF @	0.51 =	45.05
4b. 1/2" drywall - hung, taped, floated, ready for paint	88.33 SF @	2.10 =	185.49
5. Remove Baseboard - 3 1/4"	22.08 LF @	0.54 =	11.92
6. Remove Base shoe	22.08 LF @	0.20 =	4.42
-----FLOORING-----			
7. Remove Vinyl floor covering (sheet goods)	111.86 SF @	1.09 =	121.93
-----HVAC-----			
8. Remove Baseboard electric heater - 6'	1.00 EA @	14.76 =	14.76

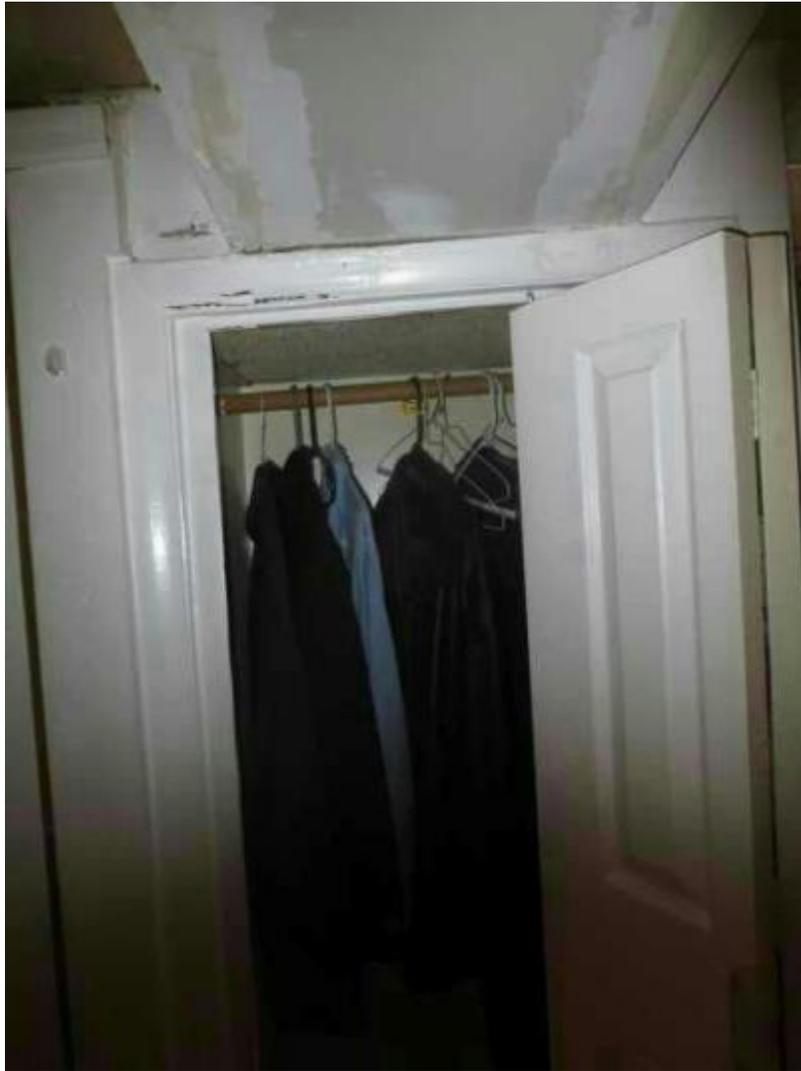
7 Closet 1

DESCRIPTION	QTY	UNIT PRICE	TOTAL
-----GENERAL ITEMS-----			
9. Final cleaning - construction - Residential	6.50 SF @	0.30 =	1.95
-----WALLS & CEILINGS-----			
10. Remove Baseboard - 3 1/4"	10.50 LF @	0.54 =	5.67
11. Remove Base shoe	10.50 LF @	0.20 =	2.10
-----FLOORING-----			
12. Remove Vinyl floor covering (sheet goods)	6.50 SF @	1.09 =	7.09

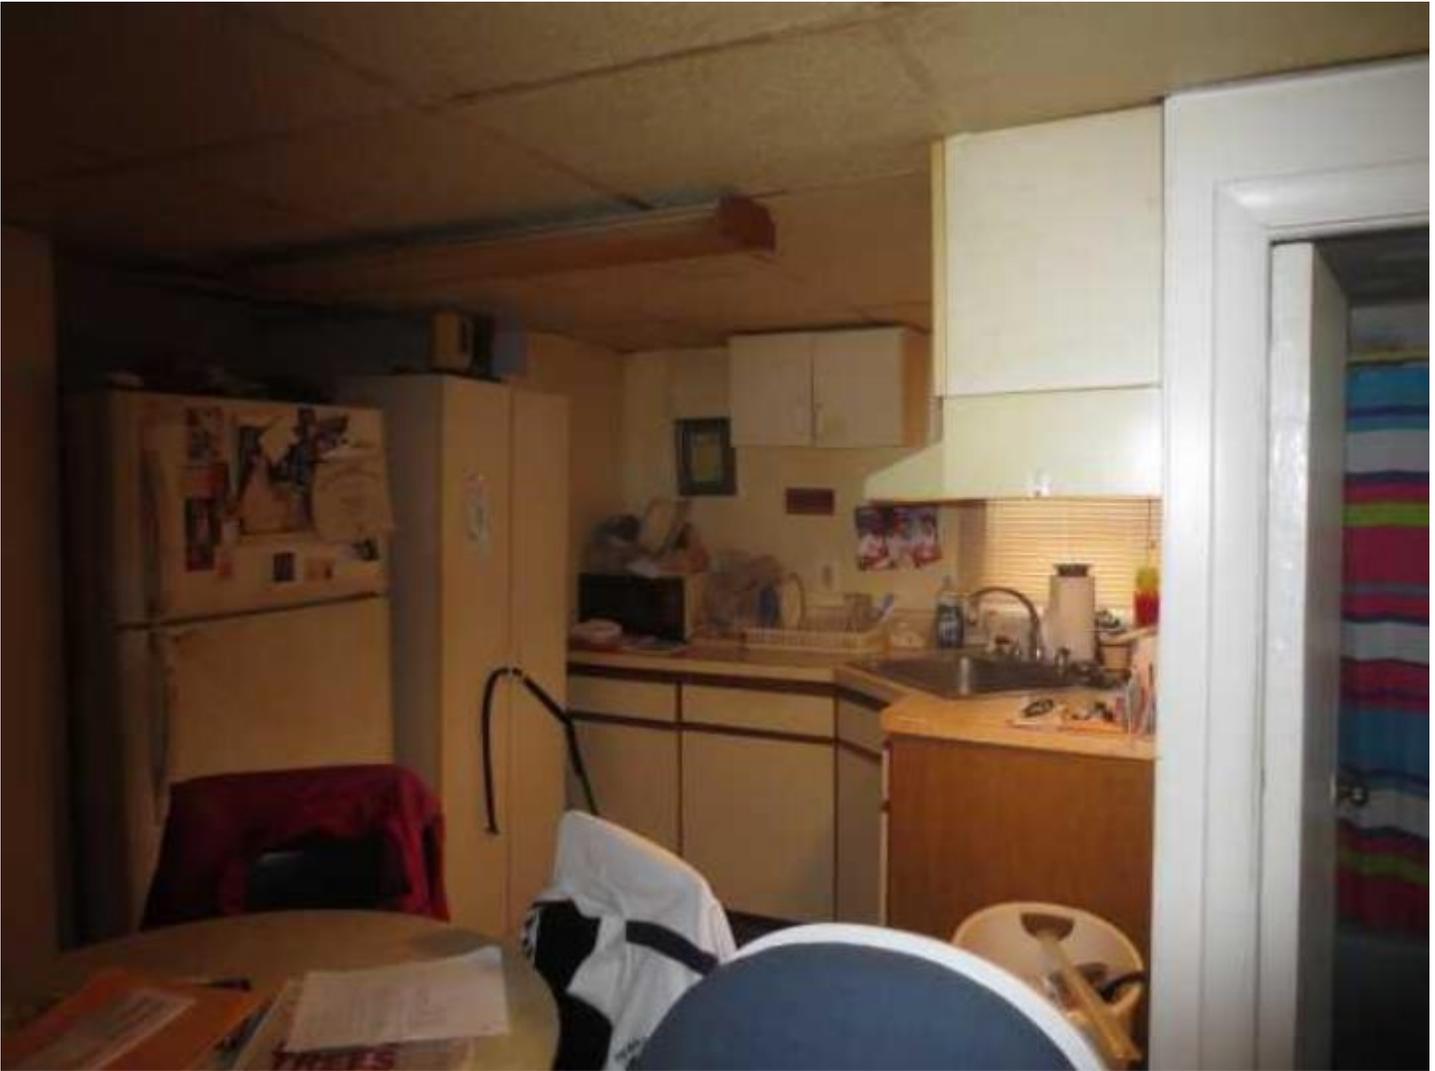
8 Kitchen

DESCRIPTION	QTY	UNIT PRICE	TOTAL
-----FLOORING-----			
13. Remove Vinyl floor covering (sheet goods)	63.68 SF @	1.09 =	69.41
-----APPLIANCES-----

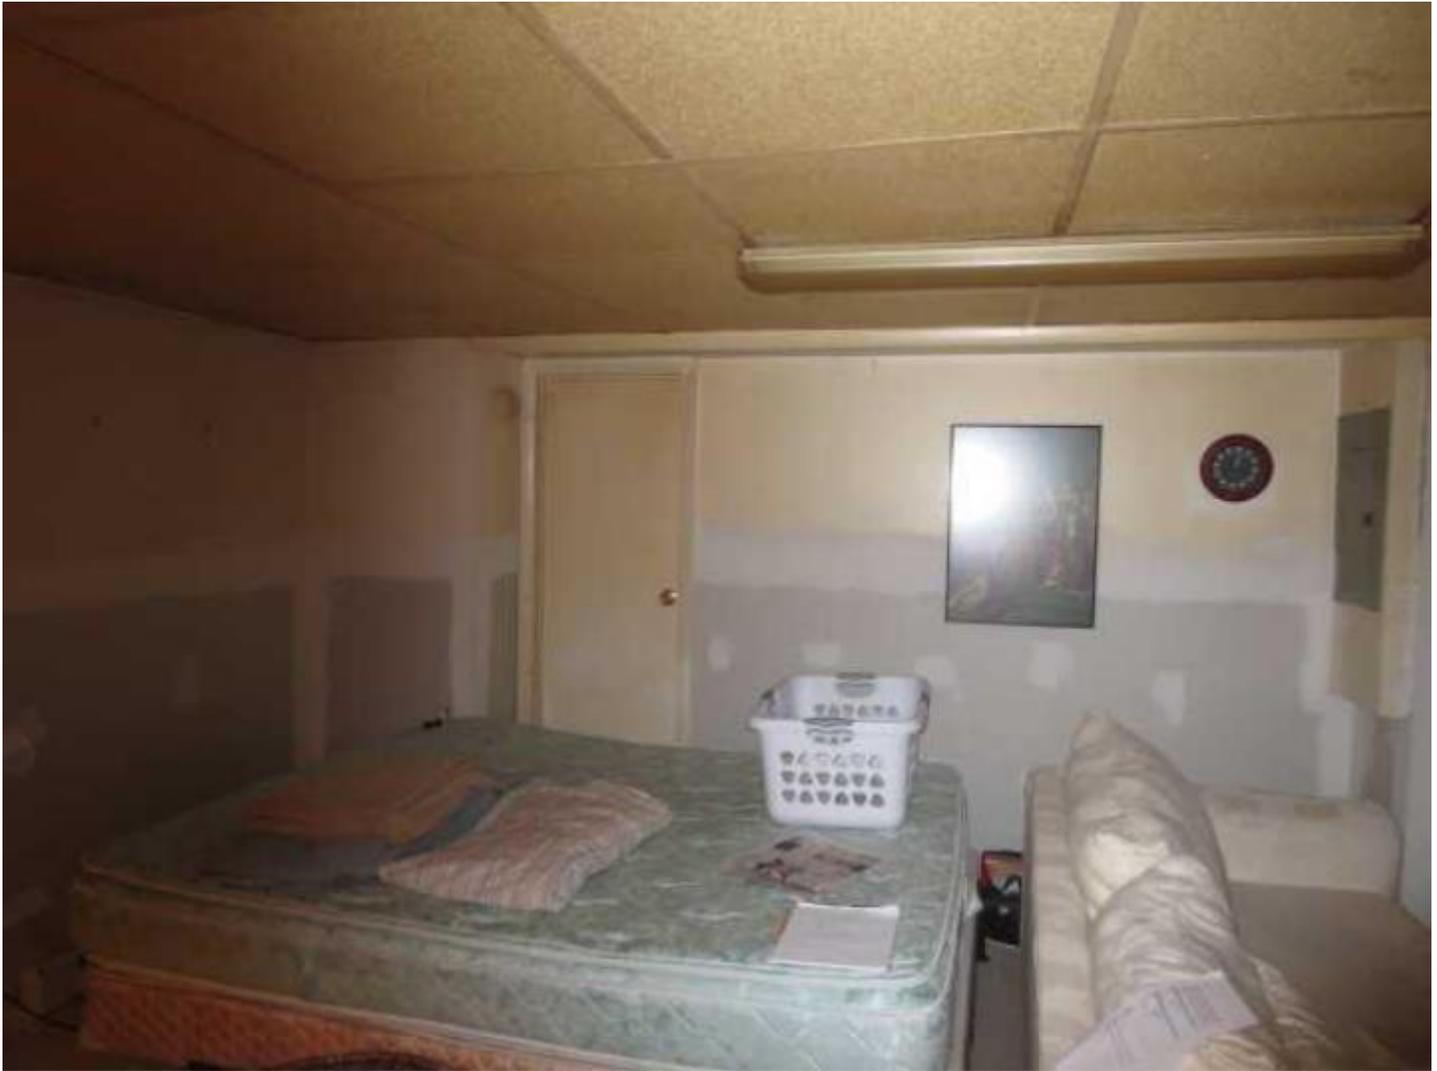
12 Bedroom

DESCRIPTION	QTY	UNIT PRICE	TOTAL
28b. Exterior batt insulation - 4" - R13 -----FLOORING-----	98.40 SF @	0.98 =	96.43
29. Remove Vinyl floor covering (sheet goods) -----HVAC-----	165.13 SF @	1.09 =	179.99
30. Remove Baseboard electric heater - 10'	1.00 EA @	17.71 =	17.71

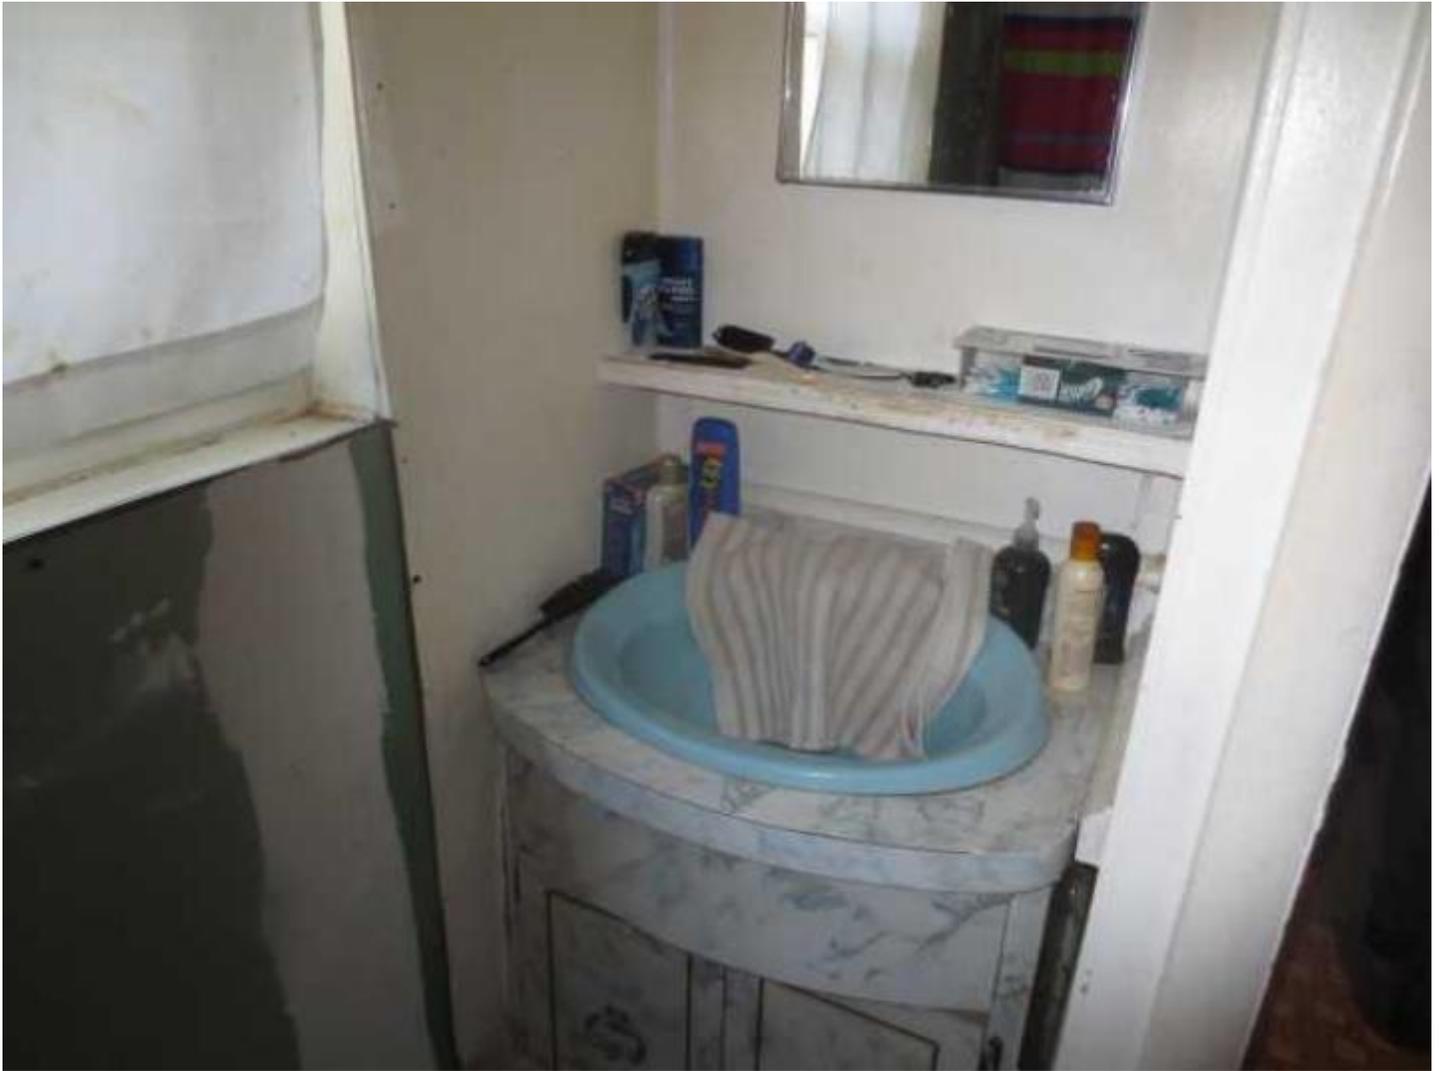
14 Bathroom

DESCRIPTION	QTY	UNIT PRICE	TOTAL
-----GENERAL ITEMS-----			
31. Final cleaning - construction - Residential -----WALLS & CEILINGS-----	30.92 SF @	0.30 =	9.28
32. Apply anti-microbial agent	30.92 SF @	0.27 =	8.35
33. Seal framing members for odor/mold control (white pigmented shellac)	30.92 SF @	0.75 =	23.19
34a. Remove 1/2" water rock (greenboard) hung, taped ready for texture	30.92 SF @	0.51 =	15.77
34b. 1/2" water rock (greenboard) hung, taped ready for texture -----HVAC-----	30.92 SF @	2.00 =	61.84
35. Remove Baseboard electric heater - 3' -----ELECTRICAL-----	1.00 EA @	12.64 =	12.64
36a. Remove Light fixture	1.00 EA @	9.84 =	9.84
36b. Light fixture	1.00 EA @	88.97 =	88.97
