Wilson Avenue School

Presentation of Remedial
Action Response

NJDEP

August 2010

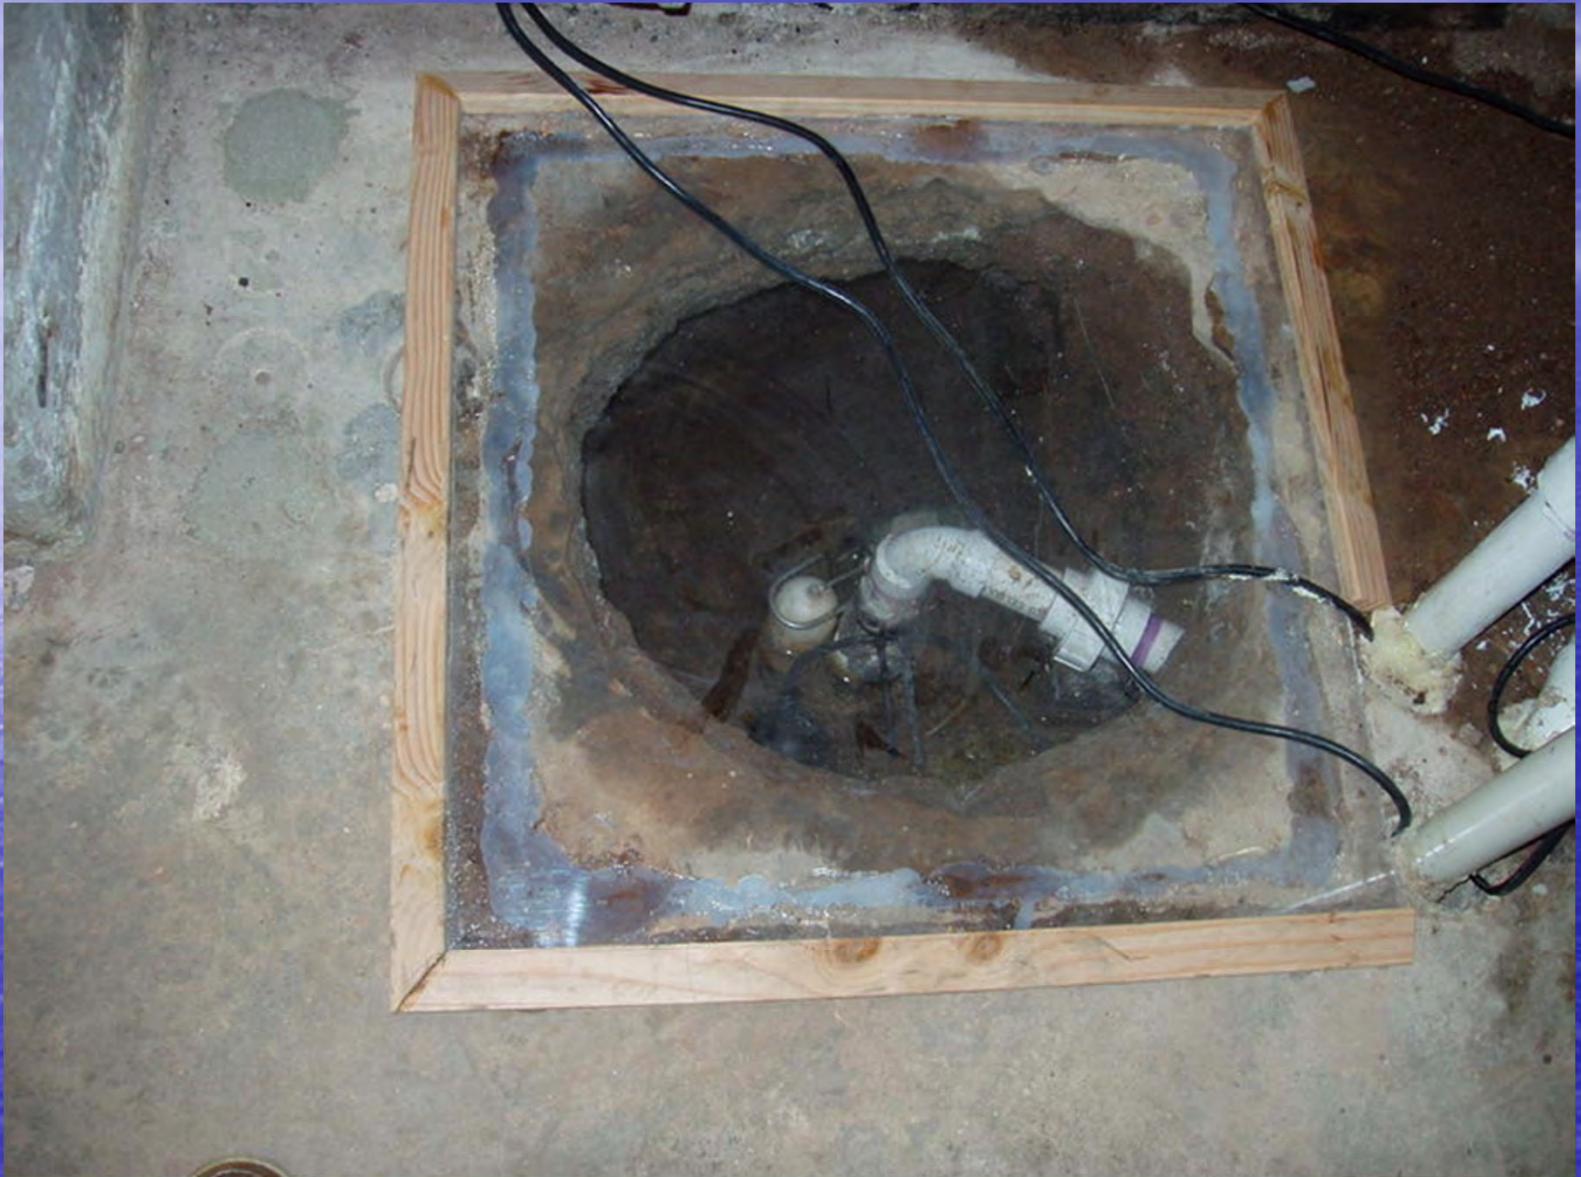
- Groundwater under the school building was apparently contaminated with gasoline from an unknown source.
- Melting snow and heavy rain in March raised the level of the contaminated groundwater up to the gym floor.
- A sump pump clogged and the gym floor flooded.

- Vapors from the contaminated ground water entered the school through the sump pits, causing a Vapor Intrusion problem.
- The air samples showed elevated levels of Benzene; 1,4, Dichlorobenzene; and Perchloroethylene.
- Only Benzene was also found in the water at that time.

- Made improvements to the sump pits by covering the sump pits and adding second pump in case one fails
- Installed vent pipes to the roof where it's treated and vented to the air.
- Tests of the INDOOR AIR in the school showed ALL levels BELOW action levels

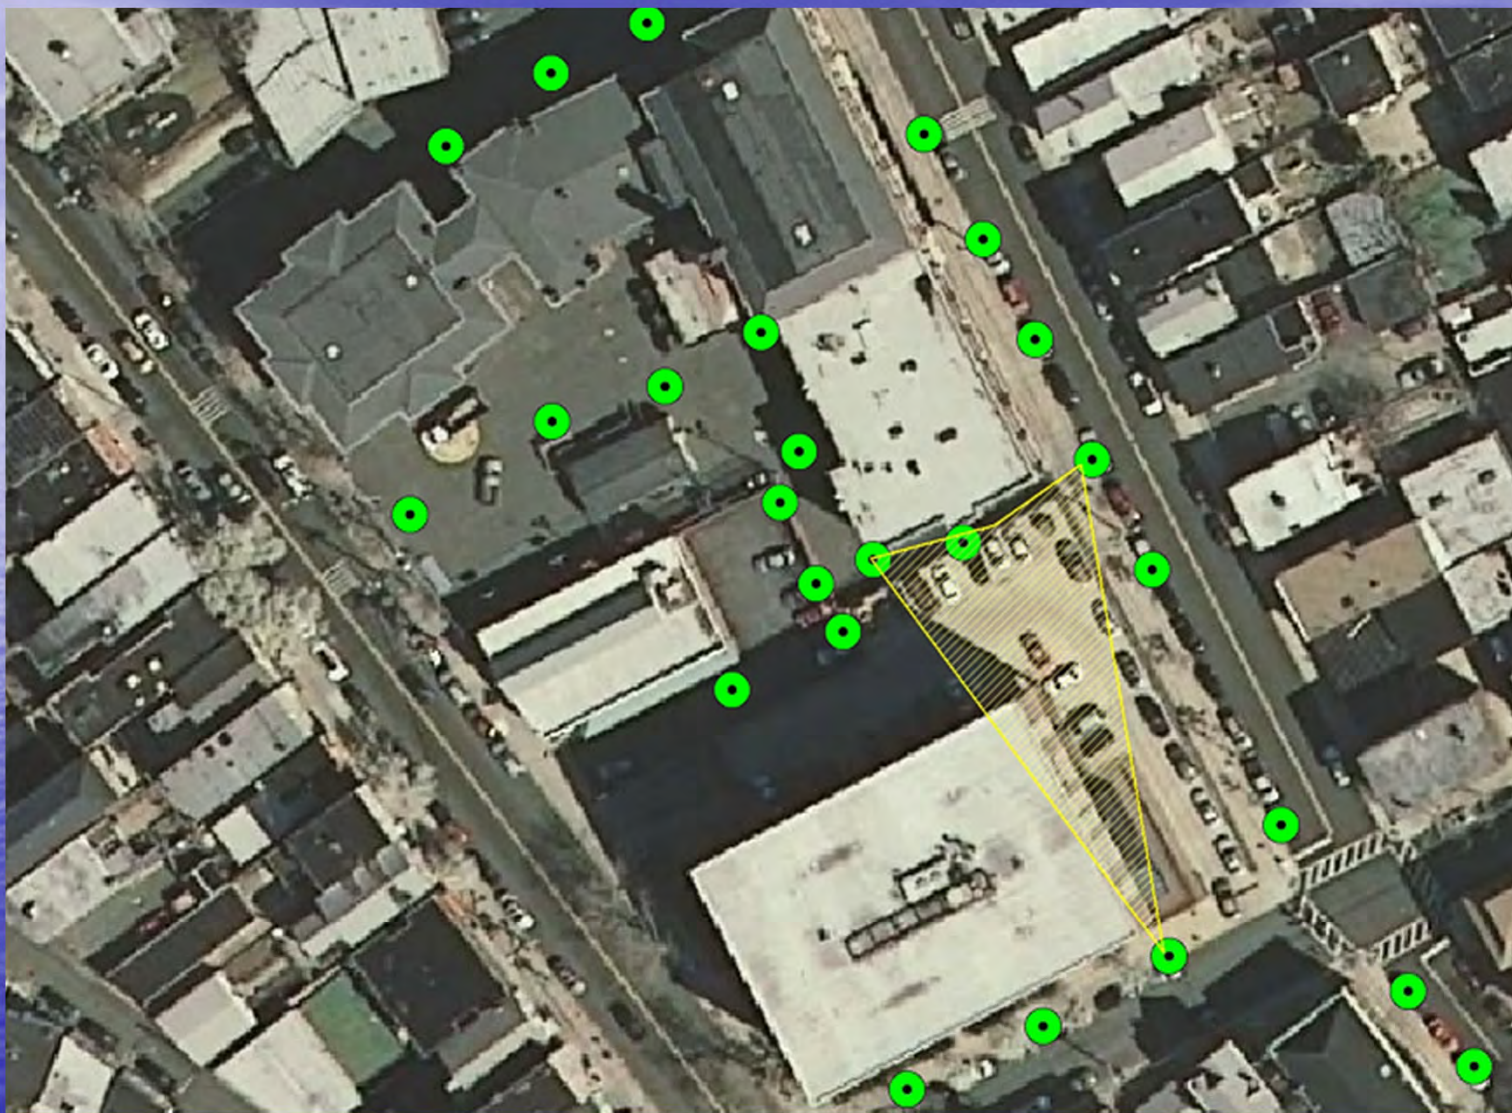
- Sampled the ground water around the school using a "geoprobe".
- Approximately 60 samples were taken from 30 locations.
- The investigation failed to find the source and no further investigations are planned.
- A relatively small area of gasoline related contamination was found.
