# NJ FACE INVESTIGATION REPORT

FACE 03-NJ-021

February 20, 2004

## **Hispanic Quarry Supervisor Struck by Machine Part During Maintenance**

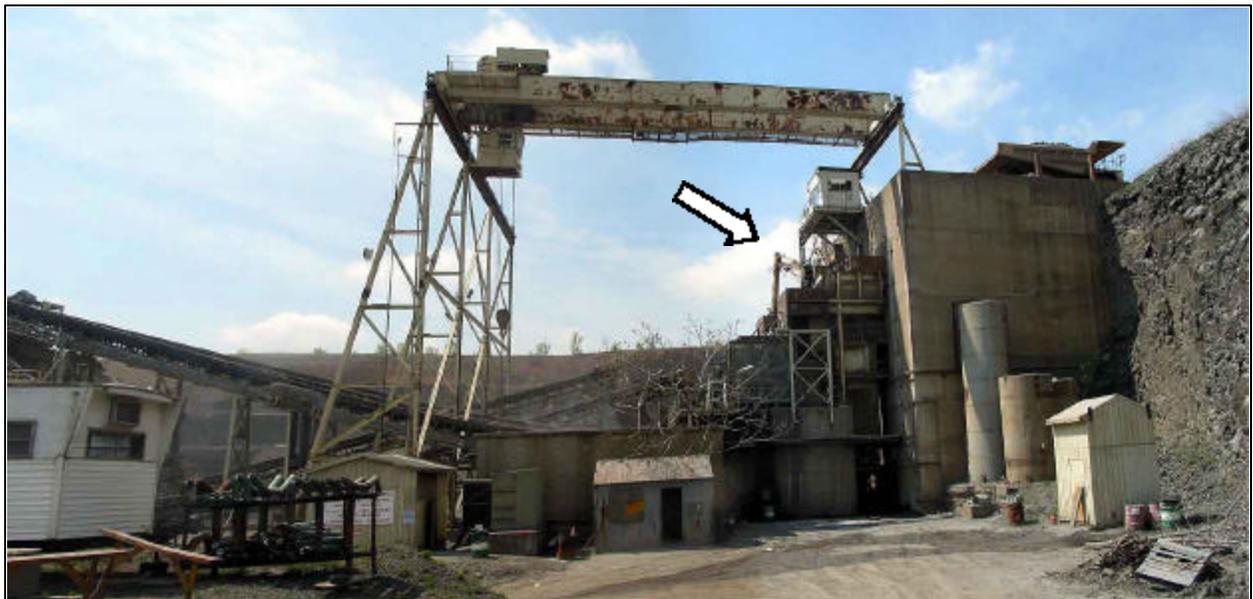
**Photo 1**  
**Primary Crusher**  
**Arrow points to area where the incident occurred**

The crew of three met on the morning of the incident and went to the crusher at 7:00 a.m. The jaw crusher was located in a large concrete building built into the side of the quarry rock face (see Photo 1). The crew included a supervisor (the victim) and two Spanish-speaking quarry workers. They climbed

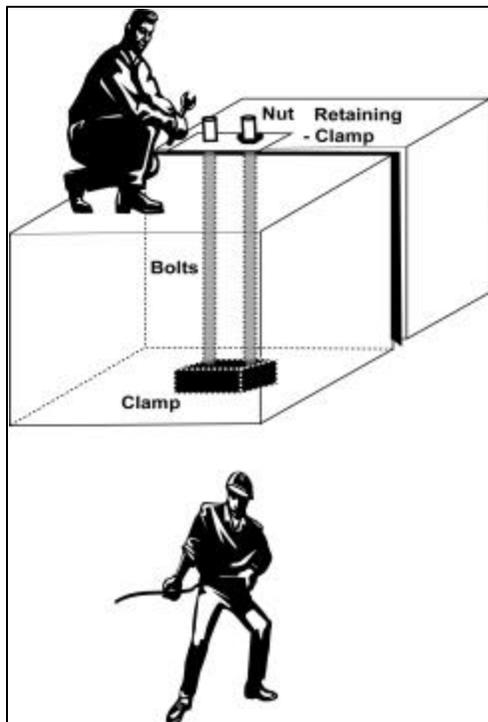
**Graphic 1**  
**Diagram of Jaw Crusher**  
**Assembly (simplified)**

The first worker started to remove the second nut but felt that something was wrong. He told the victim this and asked if he should continue, and the victim said to go ahead. When he removed the last nut, the two unrestrained bolts attached to the clamp slipped through the machine and out the bottom. The victim, who was wearing a hard hat, was standing directly under the clamp preparing a hand-held drop light when he was struck on the head by the 1,000 pound metal clamp and bolt assembly (see Graphic 1) and killed instantly. His co-workers immediately called

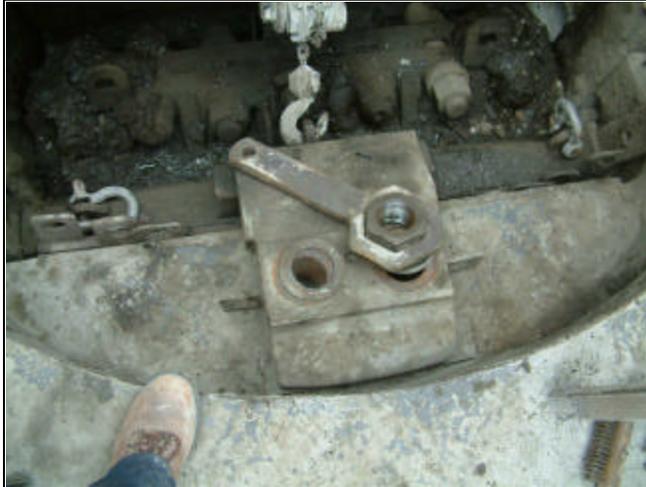
**Photo 2**  
Top of Jaw Crusher Showing Toggle Block Retaining Clamp, Nut, and Wrench

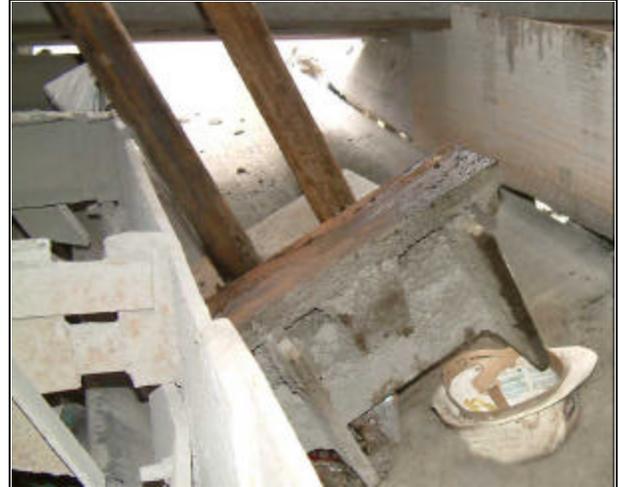
**Photo 3**  
Retaining Clamp Assembly Showing Bolts Projecting From Top

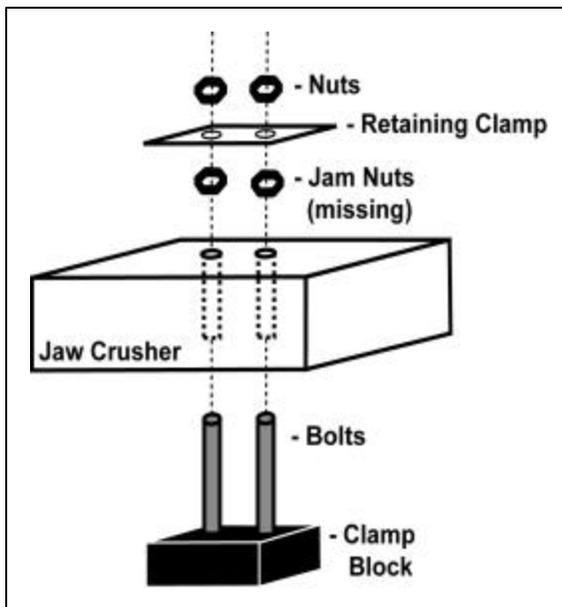
**Graphic 2**  
Exploded Diagram of Clamp Block Assembly (simplified)

During the FACE investigation, the employer’s safety supervisor explained that the retaining clamp bolts were usually held with two sets of nuts: one set that secured the retaining clamp and a second set of “jam” nuts under the clamp that served to hold the whole retaining clamp assembly in place (see Graphic 2). In 2002, the victim supervised a repair of the machine to replace the 3-inch-diameter bolts. When the retaining clamp was reassembled, the second set of jam nuts was not installed. Only one set of nuts was used to fasten the retaining clamp, and these nuts were placed over the retaining clamp. As the nuts were removed, the weight of the assembly pulled the bolts down as the last nut was loosened. This is likely what the co-worker noticed and

asked the victim about as he loosened the nuts. The victim may have thought that the jam nuts were in place and told him to go ahead with removal of the last retaining clamp nut.

The employer stated during the FACE investigation that, after the incident, they designed and welded a permanent metal brace to the assembly to prevent its falling through the machine.
