**SUBSURFACE INVESTIGATION OF
RECHARGE BASINS**

**EDWARD DUBLE SENIOR CENTER
WINSLOW TOWNSHIP
AND
CHESILHURST PUBLIC WORKS BUILDING
CHESILHURST BOROUGH**

**RFP-05-006
Camden County, New Jersey**

Princeton Hydro, LLC Project No. 0579.001

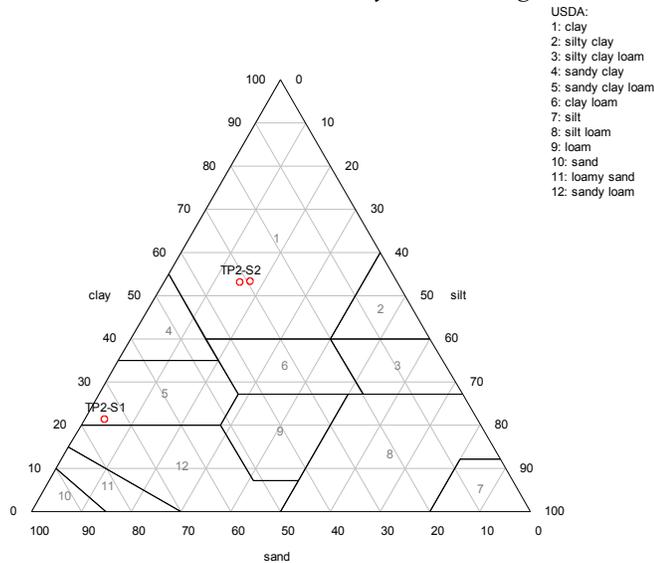
Illustration 1 - Basin No. 1 USDA Soil Plot

Samples were collected from each test pit within the footprint of the basin (i.e. From TP2, TP3, & TP4). The tube permeameter samples were collected from the surface of the basin, Stratum II (hydraulically restrictive layer) and Stratum III (proposed infiltrative layer). Test result sheets are included in Appendix E, the results are summarized in the tables and charts below:

Test Pit	Sample	Depth	K-Class	
			Preliminary	Replicate
TP-2,3,4	S1	1.5'	K-3	K-3
TP-2,3,4	S2	4.0'	K-0	K-0

Table 5 - Basin No. 1 Permeability Class Ratings

Test Pit	Sample	Depth	Permeability (in/hr)			
			Preliminary	Replicate	Replicate	Replicate
TP-2,3,4	S-3	7.0'	14.7	16.3	15.5	-
			11.4	14.5	14.5	-
			14.2	14.0	15.0	-
TP-2	S-2	4.0'	0.0130	0.0040	0.0760	0.0030
TP-3	S-1	4.0'	0.0030	0.0030	0.0090	-
TP-3	PZ-3	9.97'	21.47	23.04	-	-
TP-4	PZ-4	9.81'	18.17	18.63	18.33	-

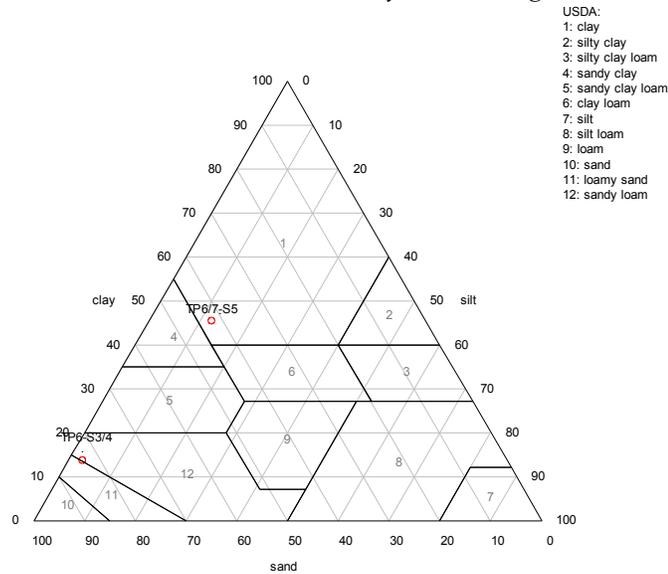
Illustration 2 - Basin No. 2 USDA Soil Plot

Samples were collected from each test pit located in the footprint of the basin (i.e. From TP6 & TP7). The tube permeameter samples were collected from the surface of the basin, Stratum III (hydraulically restrictive layer) and Stratum IIA (proposed infiltrative layer). Test result sheets are included in Appendix E, the results are summarized in the tables and charts below:

Test Pit	Sample	Depth	K-Class	
			Preliminary	Replicate
TP-6,7	S-3,S-4	5.0'	K-4	K-4
TP-6,7	S-5	8.0'	K-0	K-0

Table 7 - Basin No. 2 Permeability Class Rating

Test Pit	Sample	Depth	Permeability (in/hr)			
			Preliminary	Replicate	Replicate	Replicate
TP-5	S-1	4.0'	0.0039	0.0090	0.5280	0.1200
TP-6	S-1	0.5'	0.0120	0.0080	0.0150	-
TP-6	S-2	3.0'	0.0050	0.0040	0.0100	-
TP-6	S-3	6.0'	2.2000	3.6000	5.2000	-
			1.6000	3.3000	5.2000	-
			1.3000	3.2000	4.7000	-
