Southern Pinelands Natural Heritage Trail Scenic Byway Corridor Management Plan

Task 10: Transportation Safety and Accident Record Study

August 2008

Howard/Stein-Hudson Associates, Inc.

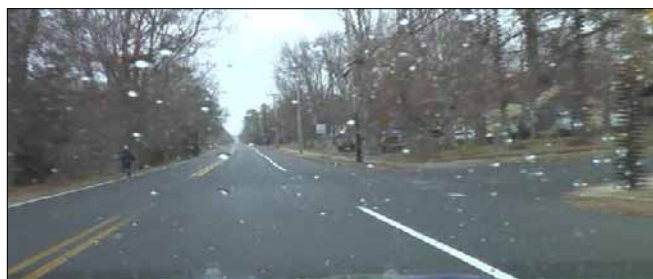
Photo 1. A recreational runner opts out of the unmarked shoulder and runs in traffic lane on Route 623.

Many segments of the byway have shoulders that can be used by cyclists and/or pedestrians (see **Photo 1**). Enhanced access for pedestrians and cyclists should be a priority of the Corridor Management Plan. Where applicable, the Natural Heritage Trail should incorporate and expand on local bicycle and multi-use trails or networks. Along some segments, including Route 47, the wide shoulder is used by many as a functional bicycle trail. These should be designated as such and marked with appropriate signage or pavement markings.

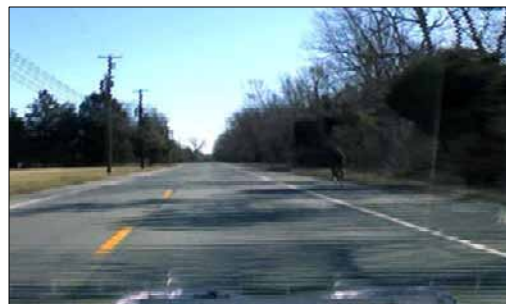
Photo 2. A cyclist uses an unmarked shoulder as a bike lane on Route 47.

Though the total number of vehicular/cyclist or pedestrian incidents is low, the byway can be made safer and more inviting to recreational cyclists (see **Photo 2**). Most conflicts have occurred at intersections. Where appropriate, the byway should seek to guide cyclists and pedestrians through intersections and alert oncoming motorists to their presence. This could be accomplished by striping bicycle lanes through problematic intersections or by improving signage. Dotted or colored bicycle lanes help guide cyclists through intersections and alert motorists to the potential presence of cyclists. This type of infrastructure is already present in some municipalities along the Byway; for instance, dotted cycle lanes guide cyclist through the intersection of CR 653 on CR 679. The dataset used in the crash analysis is not large enough to recommend specific intersections, although potential candidate locations for further investigation include along US 9 in Tuckerton and to the west, and on CR 542 and intersections along SR 47.

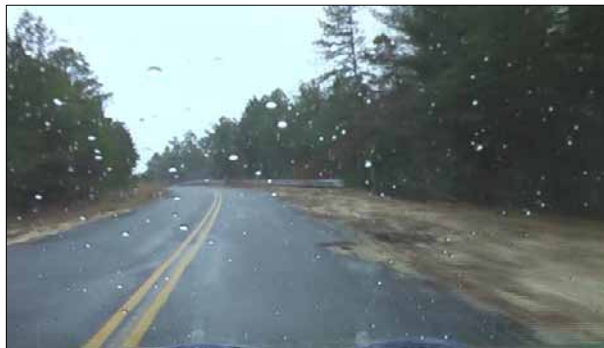
Photo 3. On this poorly maintained segment of Route 542, the edge has eroded.

Where natural road edges are utilized, it is essential that those edges be maintained and clearly delineated. In some locations on Routes 542 and 653, the road edge has badly degraded (see **Photo 3**), increasing the likelihood that automobiles will leave the roadway and presenting additional potential crash hazards.

The roadway edges within the scenic byway should remain natural. The use of curbs and gutters is typical in urban and suburban conditions. These types of roadway edges are appropriate where the byway passes through suburban settings such as Woodbine, Port Elizabeth, and Mays Landing. Elsewhere, the character of the byway should be maintained with natural edges. The edges of the byway may have paved or gravel shoulders and swales or guide rails where necessary.

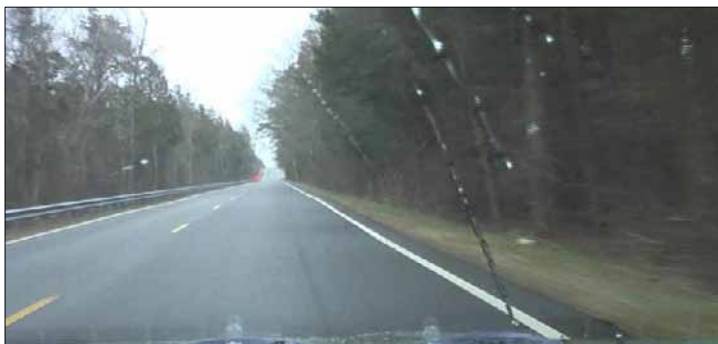
Photo 4. A narrow shoulder and clear zone poses a potential safety hazard on Route 623.

Shoulder widths should be as wide as practicable (see **Photo 4**). On some segments of the byway, including Route 47, the shoulder is used in practice as a bicycle/multi-use path. In these locations, it is essential that cyclists and other users be protected from the flow of traffic. In locations where functional wide shoulders cannot be achieved, the clear zone beyond the roadway should be expanded. Where continuous shoulders or extra-wide clear zones are impractical or otherwise not achievable, intermittent turnouts should be created to facilitate the storage of stopped or disabled vehicles. The western half of CR 548 in Maurice River Township and CR 623 in Hamilton and Mullica Townships are examples of such locations.

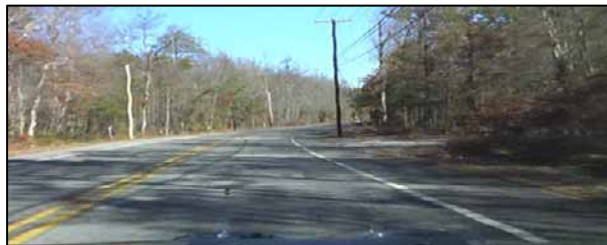
Photo 5. This utility pole on the inside radius clear zone poses a safety hazard on Route 610.

Clear zones, the forgiving, traversable areas that provide safety from fixed objects, should be maintained on the byway. These areas should be kept clear of trees, utility poles, boulders, and other fixed objects (see **Photo 5**). Along the byway route, fixed object crashes are the most common form of crash. Clearing these zones could be an effective measure for reducing the overall number of crashes and making the byway safer.

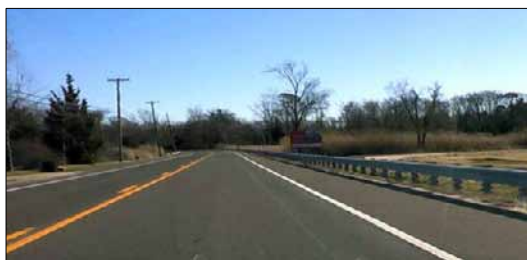
Photo 6. A lengthy stretch of guide rail on a straight portion of Route 47.

Unnecessary guide rails should be removed. For several lengthy guide rails along straight road segments, the function of the guide rail is not immediately apparent. One considerable length of guide rail sits on the west side of the roadway along Route 623 as the route passes the Makepeace Wildlife Management Area (see **Photo 6**); other smaller sections occur along Route 47.
