NEW JERSEY DEPARTMENT OF TRANSPORTATION

DIVISION OF RESEARCH AND EVALUATION
BUREAU OF STRUCTURES AND MATERIALS

JANUARY 1968

EVALUATION OF METALLIC BRIDGE DECKSINDEX

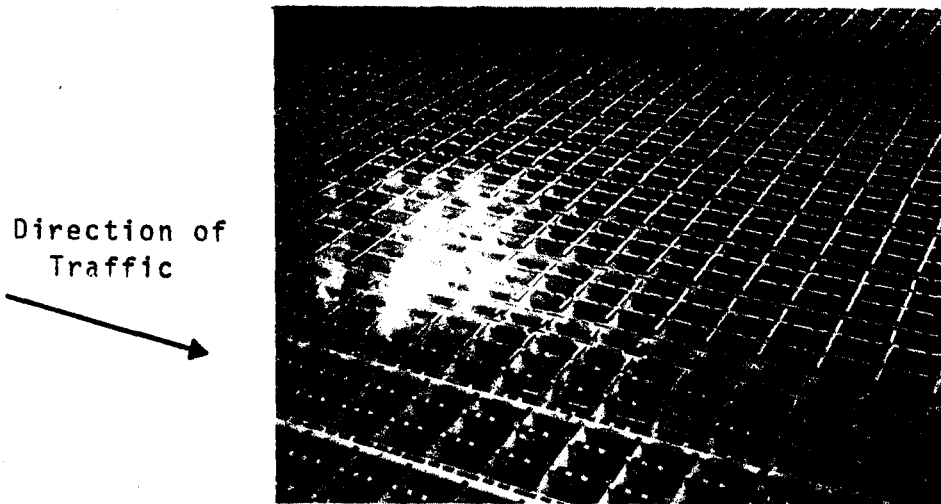
ROUTE 40 - ATLANTIC CITY, INSIDE THOROFARE

2. Route 40, Atlantic City Inside Thorofare. At 25 mph., the driver experienced fair vehicle control. The grid surface was noted to be worn and polished. A total of six (6) accidents were recorded for the period studied. An AADT of 19,960 was considered to be high. The average skid test value of 28 was considered poor.

Description: Bridge 421' long, grid deck 72' long, 4-15.5' lanes; 2"x3" rectangular grid, longitudinal serration 1/16" deep.

Grid conditions: worn and polished.

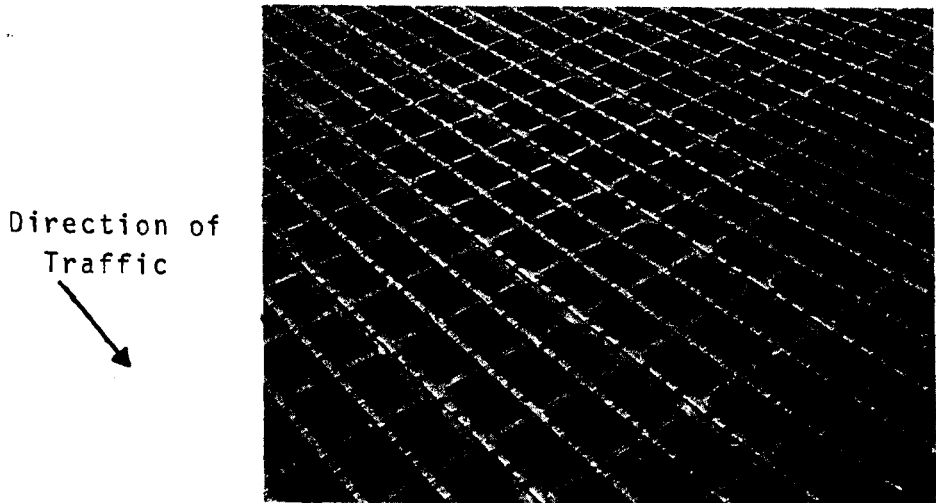
ROUTE 71 - SHARK RIVER, BELMAR

4. Route 71, Shark River Belmar. On this bridge, fair vehicle control was observed at 35 mph. The surface condition of the deck was worn and polished. The average decelerometer reading of 29.5 was considered to be poor. A total of 10 accidents occurred on the structure for the

period studied, with a medium AADT of 13,700.

Description: Bridge 858' long, grid deck 75.8' long, 4-12.5' lanes; 2"x3" rectangular grid, longitudinal serration 1/8" deep.

Grid conditions: worn and polished.

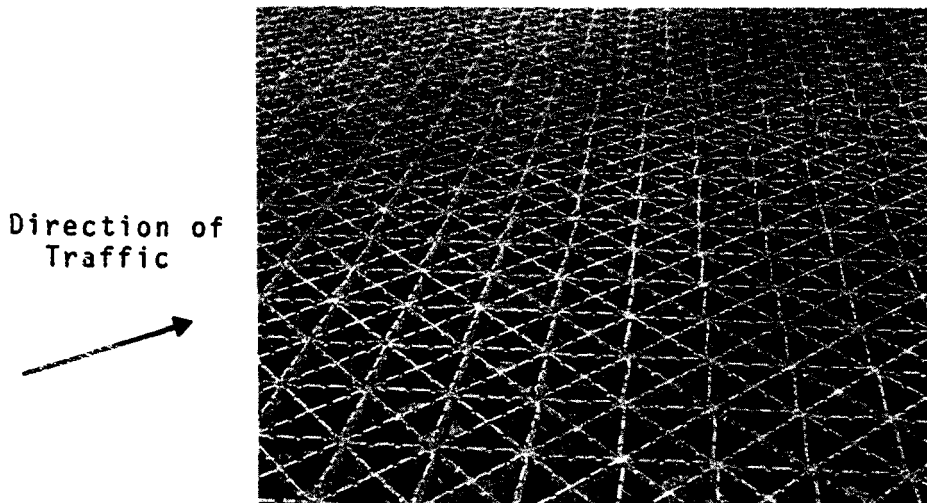
ROUTE 52 - SHIPS CHANNEL, SOMERS POINT

1. Route 52, Ships Channel Sommers Point. Configuration number 2 is biaxially serrated box-type grid. The sole example of this grid being the Route 52 Ships Channel Bridge. The deck surface was worn and polished and the driver noted good control at the posted speed of 50 mph. A decelerometer reading average of 32.5 was considered poor. A total of 12 accidents was recorded, with a medium traffic volume of 13,450.

Description: Bridge 1,444' long, grid 61' long, (4) 12.5' lanes; all edges serrated 3/16" deep.

Grid conditions: worn and polished.

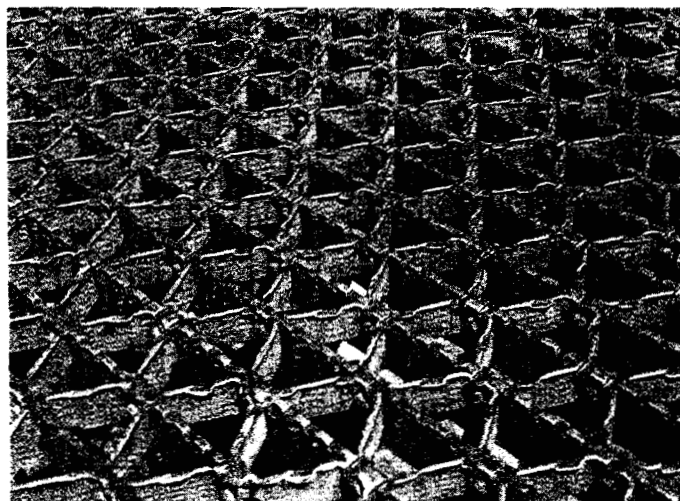
ROUTE 30 - BEACH THOROFARE, ATLANTIC CITY

2. Route 30, Atlantic City Beach Thorofare. The driver commented that control was fair. The grid deck surface was worn and polished. The traffic and accident data showed the AADT to be 19,500 (high), and (6) accidents were recorded. The average decelerometer value of 34 is poor, the approaches averaged 22 (Fair).

Description: Bridge 492' long, grid deck 69' long, (6) 12.5' lanes: grid 2 3/4"x2 1/2" serrated cross grid, serrated longitudinally 1/8" deep.

Grid conditions: worn and polished.

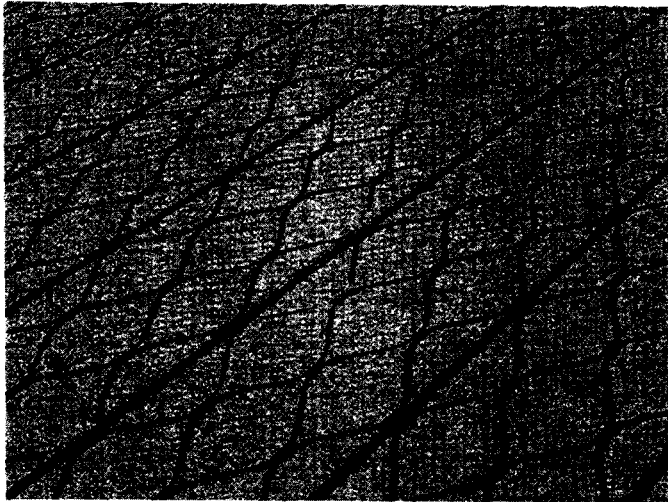
ROUTE 70 - RIVIERA BEACH

1. Route 70, Riviera Beach. Configuration number 4 is a concrete filled grid with reinforced steel members protruding through. The average decelerometer reading of 30 is considered poor. Vehicle control was similar to control on other concrete roadways. The deck was in fair condition i.e. not worn. The decelerometer readings on the concrete approaches to the bridge ranged

from 20-24 which is considered fair but not unusual for concrete pavements. It may be noted that although the deck was concrete filled it possessed poorer anti-skid properties than the paved approaches. This may be due to the fact that steel grid is exposed through the concrete thereby allowing contact between the steel grid and the vehicle tires. No accidents were reported, AADT was estimated at 15,400 (high).

Description: Bridge 625' long, grid deck 64' long 2-24' lanes; grid concrete filled.

Grid conditions: Fair condition.

3. Concrete filled grid decks as evidenced by the Route 70 Riviera Beach deck ^{WERE} found to possess poor anti-skid properties. This may have been due to the fact that the concrete did not completely cover the steel members. The protruding steel members would offer a lower coefficient of friction to the tire than would concrete to the tire.

2. In instances where it is desirable to fill the grid deck with concrete (eg. Route 70 Riviera Beach), it is recommended that the deck be covered completely to approximately one (1) inch above the metallic grid work, thereby allowing no contact between the tire and the metal.

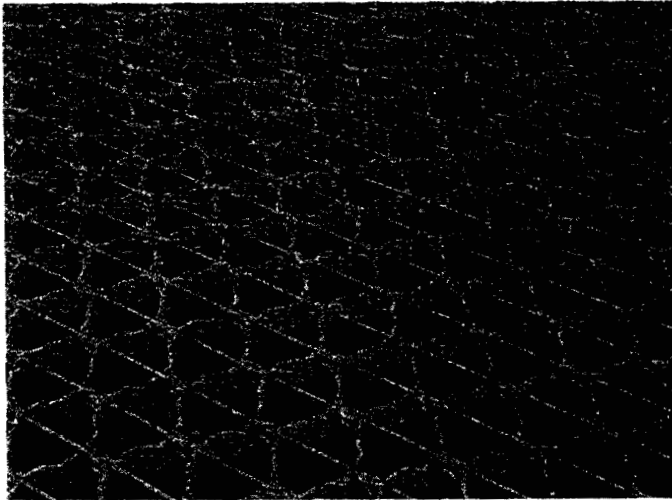
OCEAN AVENUE - SHARK RIVER INLET, BELMAR

Description: Bridge 123' long, grid deck 93' long, 4-10' lanes; grid 2 3/4"x2 3/4" curved grid, curved serrations.

Grid conditions: Good condition, not polished.

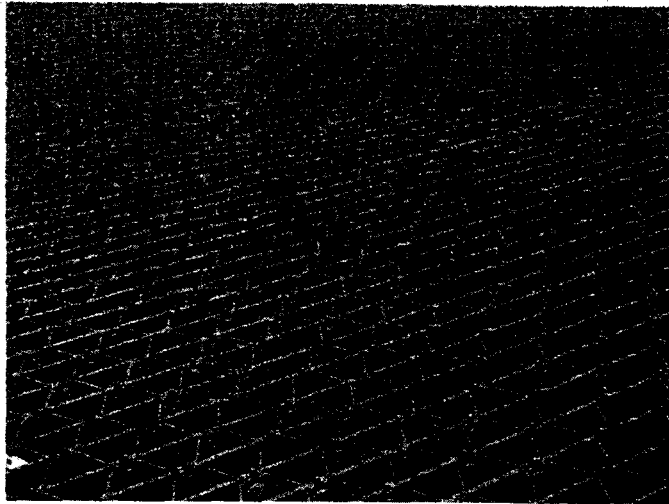
OCEAN DRIVE - CORSON'S INLET

The drivers noted good vehicle control and stability. The grid deck was worn and the wheel paths polished. A few studs were missing from the deck, but the remaining

seemed to be in fair condition. The 1966 AADT was 1,150 vehicles, which is a low volume. The studs were installed in 1960. The grid deck is located just south of a toll booth, therefore, the northbound traffic must brake on the grid, causing greater wear and polishing. The average decelerometer reading was 33. (poor). Southbound, the grid appears upon leaving the toll booth. The average decelerometer reading was found to be 24, which is fair.

Description: Bridge 0.3 miles long, grid 56' long 2-12' lanes; grid - studded no serrations.

Grid conditions: worn and wheel path polished, studs missing.

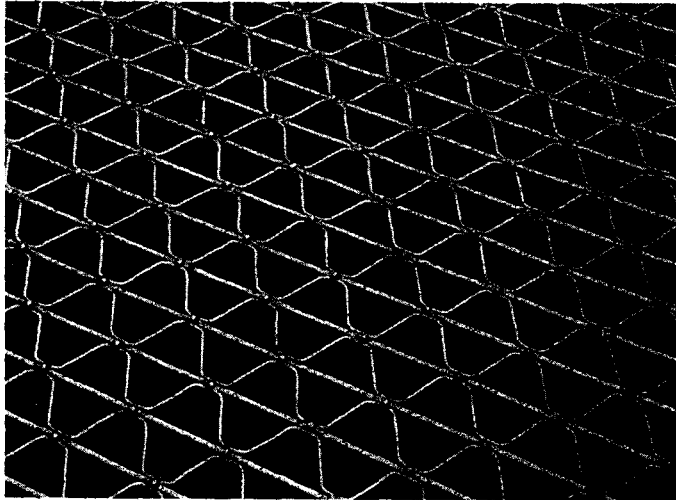
ROUTE 531 - PASSAIC RIVER, GILLETTE

2. County Route 531, Passaic River Gillette (Configuration 8A). Good vehicle control was noted at 35 mph. However, during the decelerometer tests, the vehicle was found to side skid. The average decelerometer reading (grid) was 31, which is poor; the approaches averaged 21 (Fair). The studs and the deck were worn and a few studs were missing. The approximate 1966 AADT was 1,500 vehicles. No accident data were available.

Description: Bridge 87' long, grid deck 87' long, 2-10' lanes; grid - studded, (non serrated) transverse members.

Grid conditions: Studs and deck worn, studs missing.

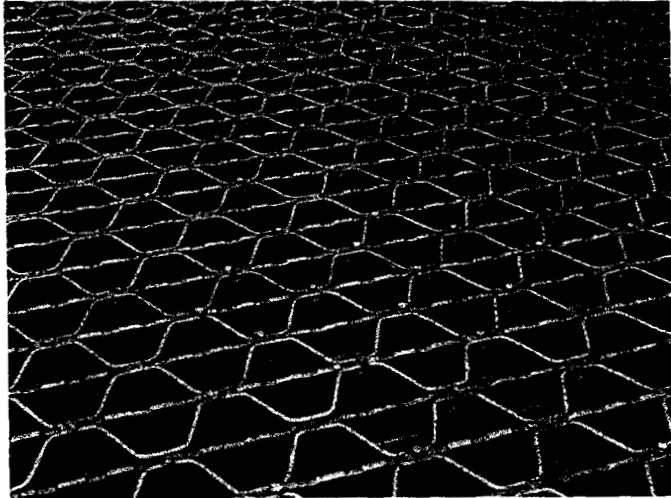
COUNTY ROAD - JAQUI CREEK, MORRISTOWN

3. County Route 50 (Jaqui Pond), Morristown (Configuration 6A). Good vehicle control was noted at 35 mph. However, during the decelerometer tests some side skid was noticed. The bridge deck was very worn and several studs were missing. This deck unlike the others was not polished. The approximate 1966 AADT was 3,200, which is low, and no accident data was available. An average decelerometer reading (grid) of 32 was rated as poor, whereas the approaches averaged 21 (Fair).

Description: Bridge 53' long, grid deck 53' long 2-10' lanes; grid serrated transversely studs at joints.

Geometrics: Poor sight distance both approaches poor alignment both approaches.

Grid conditions: Very poor condition of studs and deck.

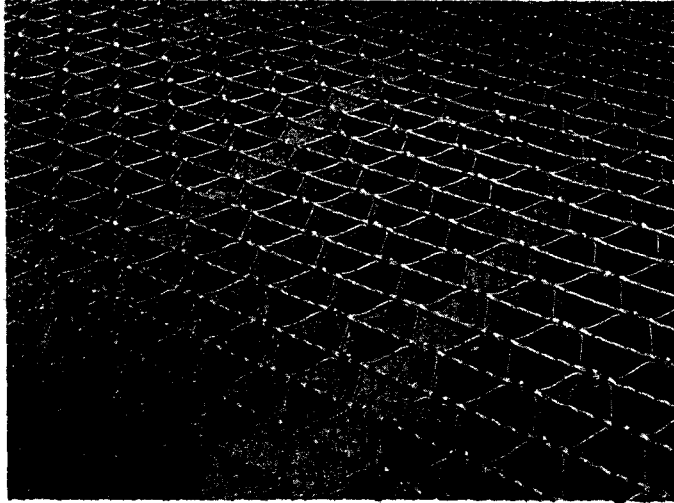
ROUTE 1 & 9 (truck) PASSAIC RIVER

4. Route 7 & 9 (truck) Passaic River (Configuration 6B). The portion of the deck studied was studded and longitudinally serrated. The deck surface was extremely worn.

Description: Bridge - serration on longitudinal members, studs at junction points of cross grids, 1 lane studded.

Grid conditions: Very poor condition of stud and decks, deck very worn and polished.

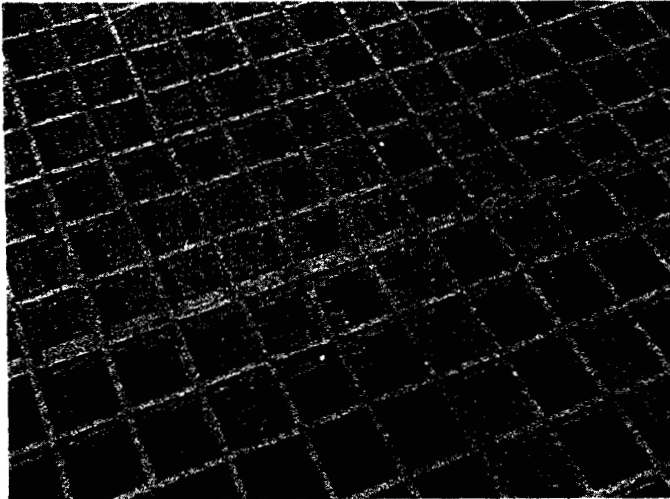
ROUTE 35 - SHARK RIVER, BELMAR

1. Route 35, Shark River Belmar. The driver noted poor directional stability and control. The deck surface was polished and slightly worn. The 1966 AADT of 22,670 was high. Ten (10) accidents were reported for the period studied. The average decelerometer reading (grid) of 34 was considered poor, whereas, the approaches averaged 29.

Description: Bridge 478' long, grid deck 82' long, 4-10' lanes; grid 3"x2 1/4" serrated box-type grid.

Grid conditions: worn and polished.

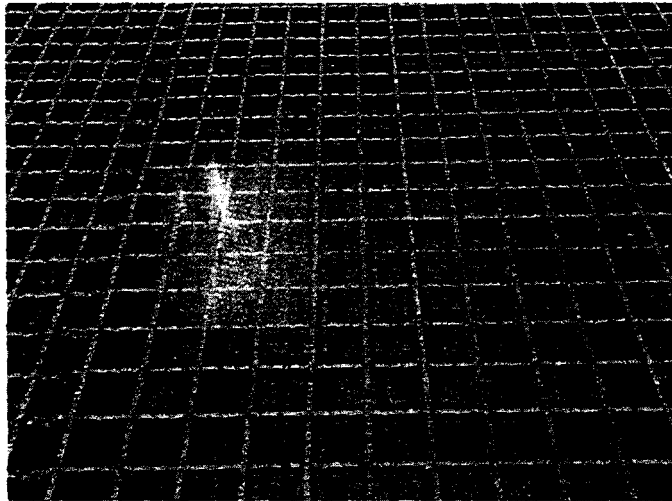
ROUTE 9 - NACOTE CREEK, PORT REPUBLIC

2. Route 9, Nacote Creek, Port Republic. Poor vehicle control and a very worn and polished deck were observed. The AADT for this deck was 2,570 which is low. No accidents were reported for the period studied. The average

Description: Bridge 250' long, grid deck 37' long, 2-15' lanes; grid 2 1/2"x2" serrated grid serration 1/16" deep.

Grid conditions: very worn and polished.

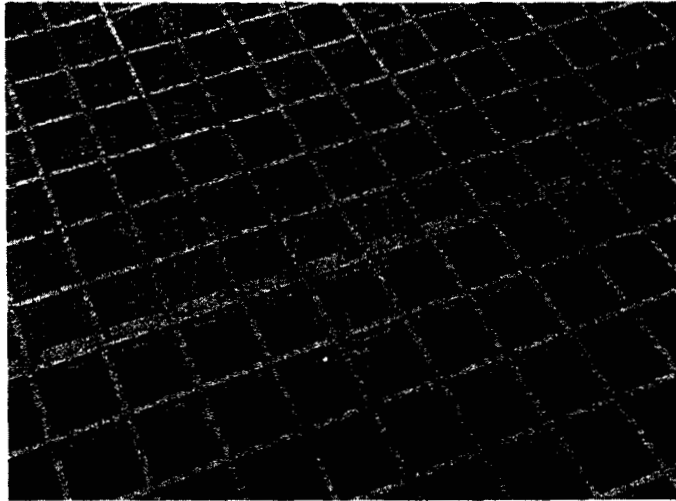
ROUTE 9 - BASS RIVER, NEW GRENA

3. Route 9, Bass River New Gretna. The driver noted poor vehicle control. The grid was worn and polished and the average decelerometer reading (grid and approaches) was 31 (poor). The 1966 AADT of 4,100 was low.

Description: Bridge 342' long, grid deck 38' long, 2-15' lanes; grid 2 1/2"x2" box-type serrated grid, serrations 1/16" deep.

Grid conditions: worn and polished.

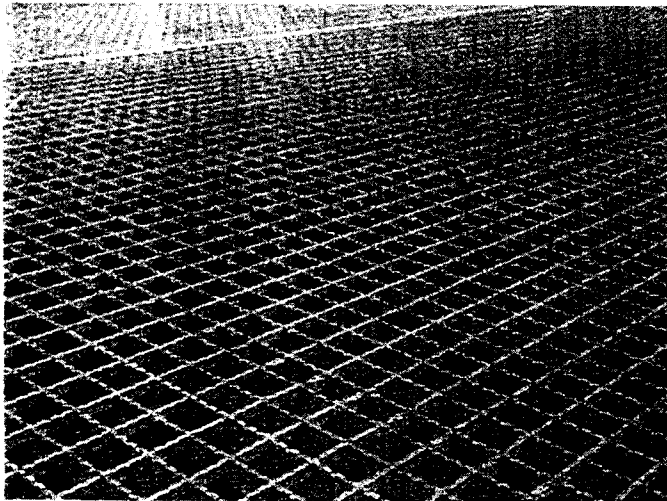
ROUTE 50 - TUCKAHOE RIVER, TUCKAHOE

4. Route 50, Tuckahoe River. The driver noted poor vehicle control and the grid was found to be worn and polished. The 1966 AADT of 4,600 was low. Six (6) accidents were reported for the period studied. The average decelerometer reading of 31 was considered poor.

Description: Bridge 175' long, grid deck 38' long, 2-15' lanes; grid 2 1/2"x2 1/2" serrated box-type grid, serrations 1/16" deep.

Grid conditions: worn and polished.
