NEW JERSEY DEPARTMENT OF TRANSPORTATION

PORTLAND CEMENT CONCRETE PAVEMENT DAMAGE
DUE TO JOINT INTRUSION AND THERMAL EXPANSION

DIVISION OF RESEARCH AND EVALUATION

March 1968

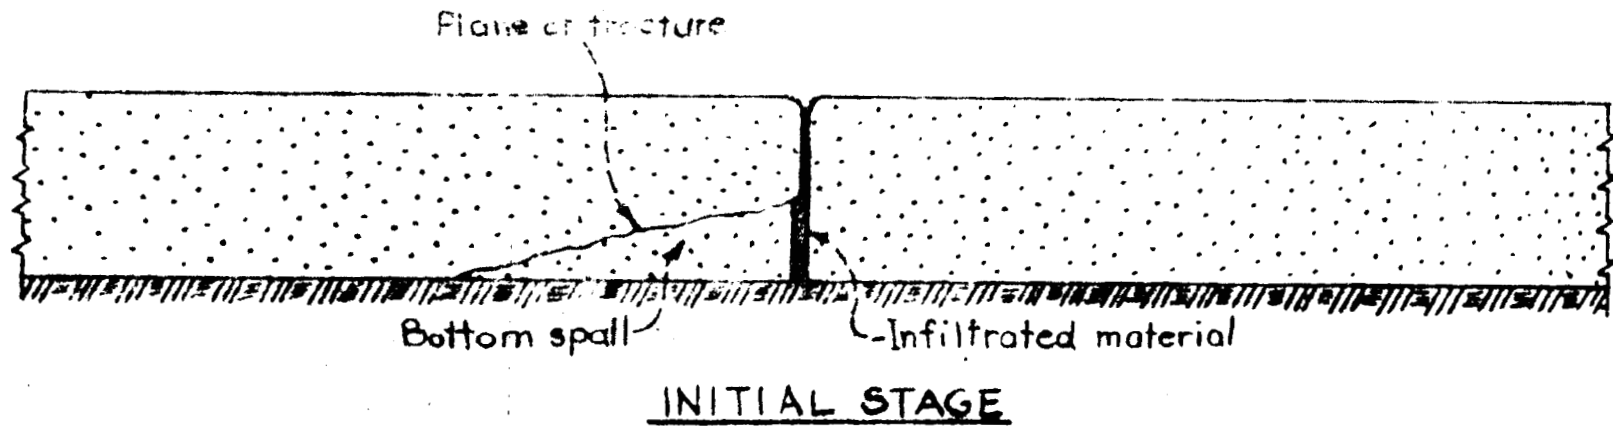
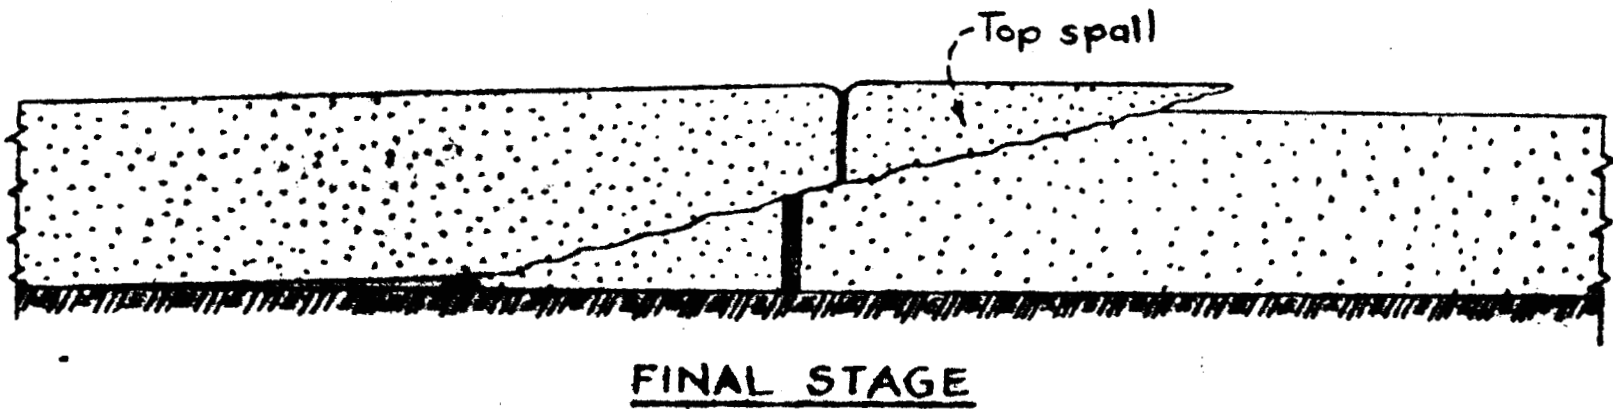
FIG. 11

TYPICAL BLOW-UP AT A JOINT

"In case of 'blow-ups', large accumulations of foreign non-compressible matter in the joints usually cause, first a rupturing or shearing off at the bottom of the pavement on one side of the joint; this is in turn followed by a shearing off of the top of the pavement on the opposite side of the joint. The result of this happening is a movement of the slab ends towards each other and a raising of one or both slabs".¹ The mechanics of the process are shown in Figure 1.1. Examples of "blow-ups" are shown in Figure 1.2.

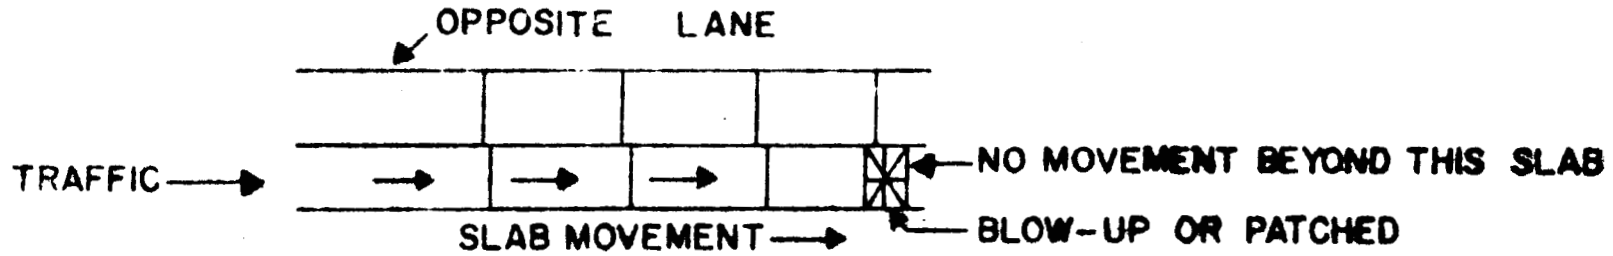
FIG 3.1

1. Slab movement in the direction of traffic, with a blow-up at the end of the movement.
2. Slab movement in both directions, with blow-ups somewhere in the middle of the movement.
3. Slab movement against the direction of traffic, with blow-ups at the end of the movement.
4. No slab movement, but usually joint failures on both sides of the blow-up.

SLAB MOVEMENT IN THE DIRECTION OF TRAFFIC

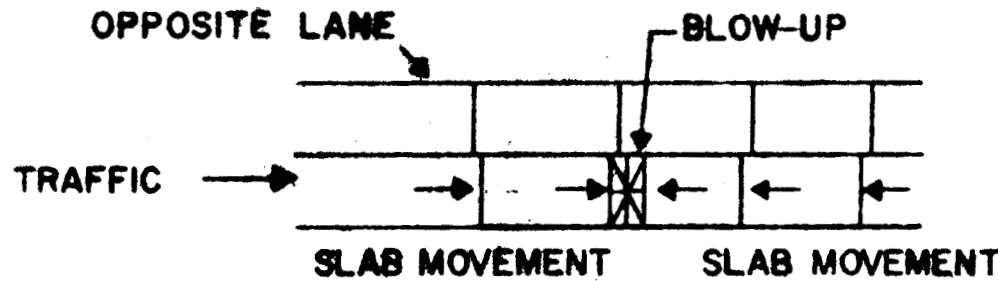
TYPE 2

SLAB MOVEMENT BOTH WAYS AND BLOW BETWEEN.

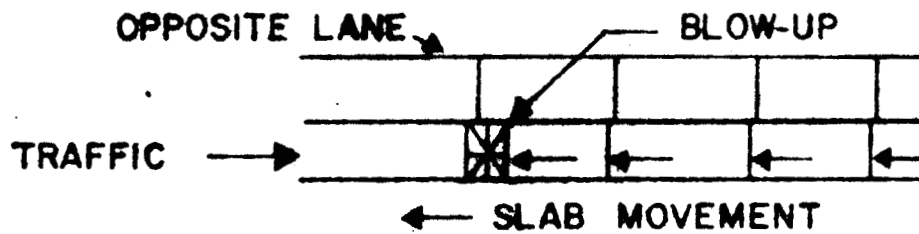
TYPE 3

SLAB MOVEMENT AGAINST TRAFFIC

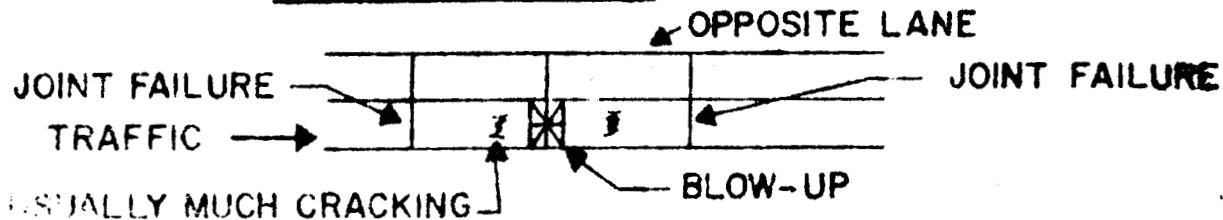
TYPE 4

NO SLAB MOVEMENT

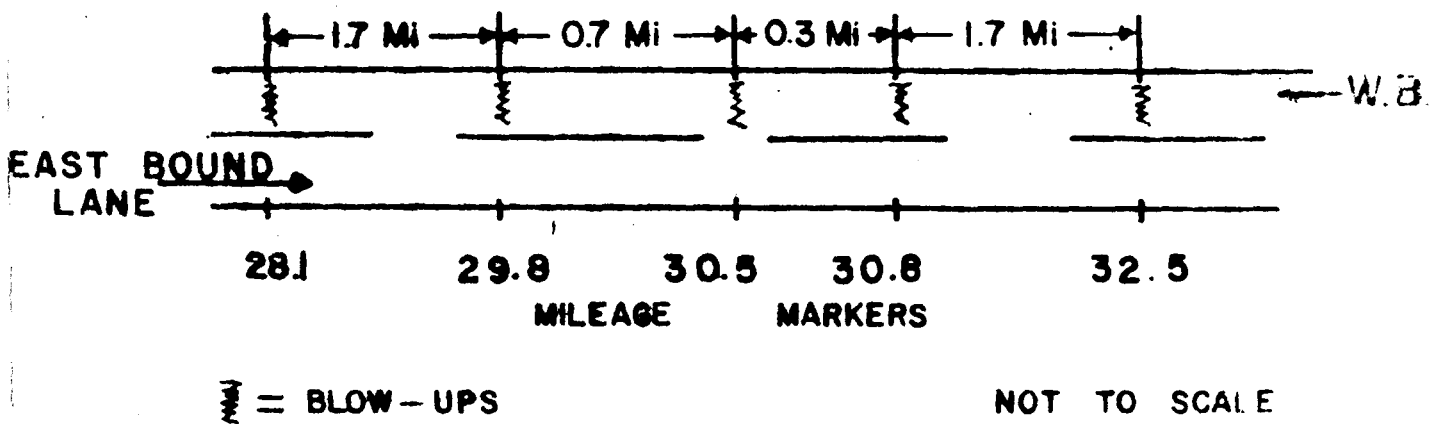
FIGURE 4.1

Recurrences of 1966 blow-ups in 1967 may be exemplified in section 1305000 between milepost number 28.1 and milepost number 32.5. A survey of this section indicated numerous joint failures and slab movements both before and after the blow-ups. Slab movement was continuous in the westbound lane from one blow-up to another. Figure 4.1 below, shows the frequency of blow-ups in this section.

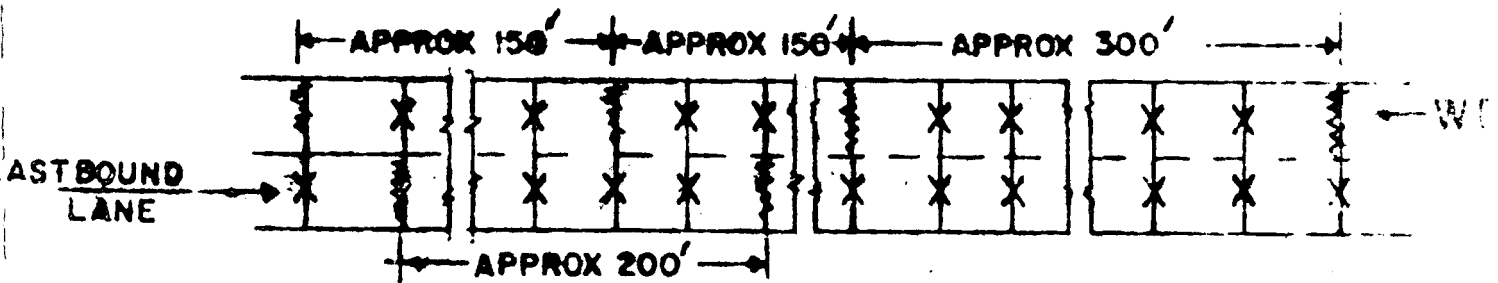
FIGURE 4.2

Blow-up recurrences were found in the vicinity of milepost number 15. This area is covered with surface treatments. Blow-ups and joint failures were numerous. Slab movement was noted in both lanes of traffic.

Figure 4.2 below, shows a typical 600 foot section with blow ups and joint failures.

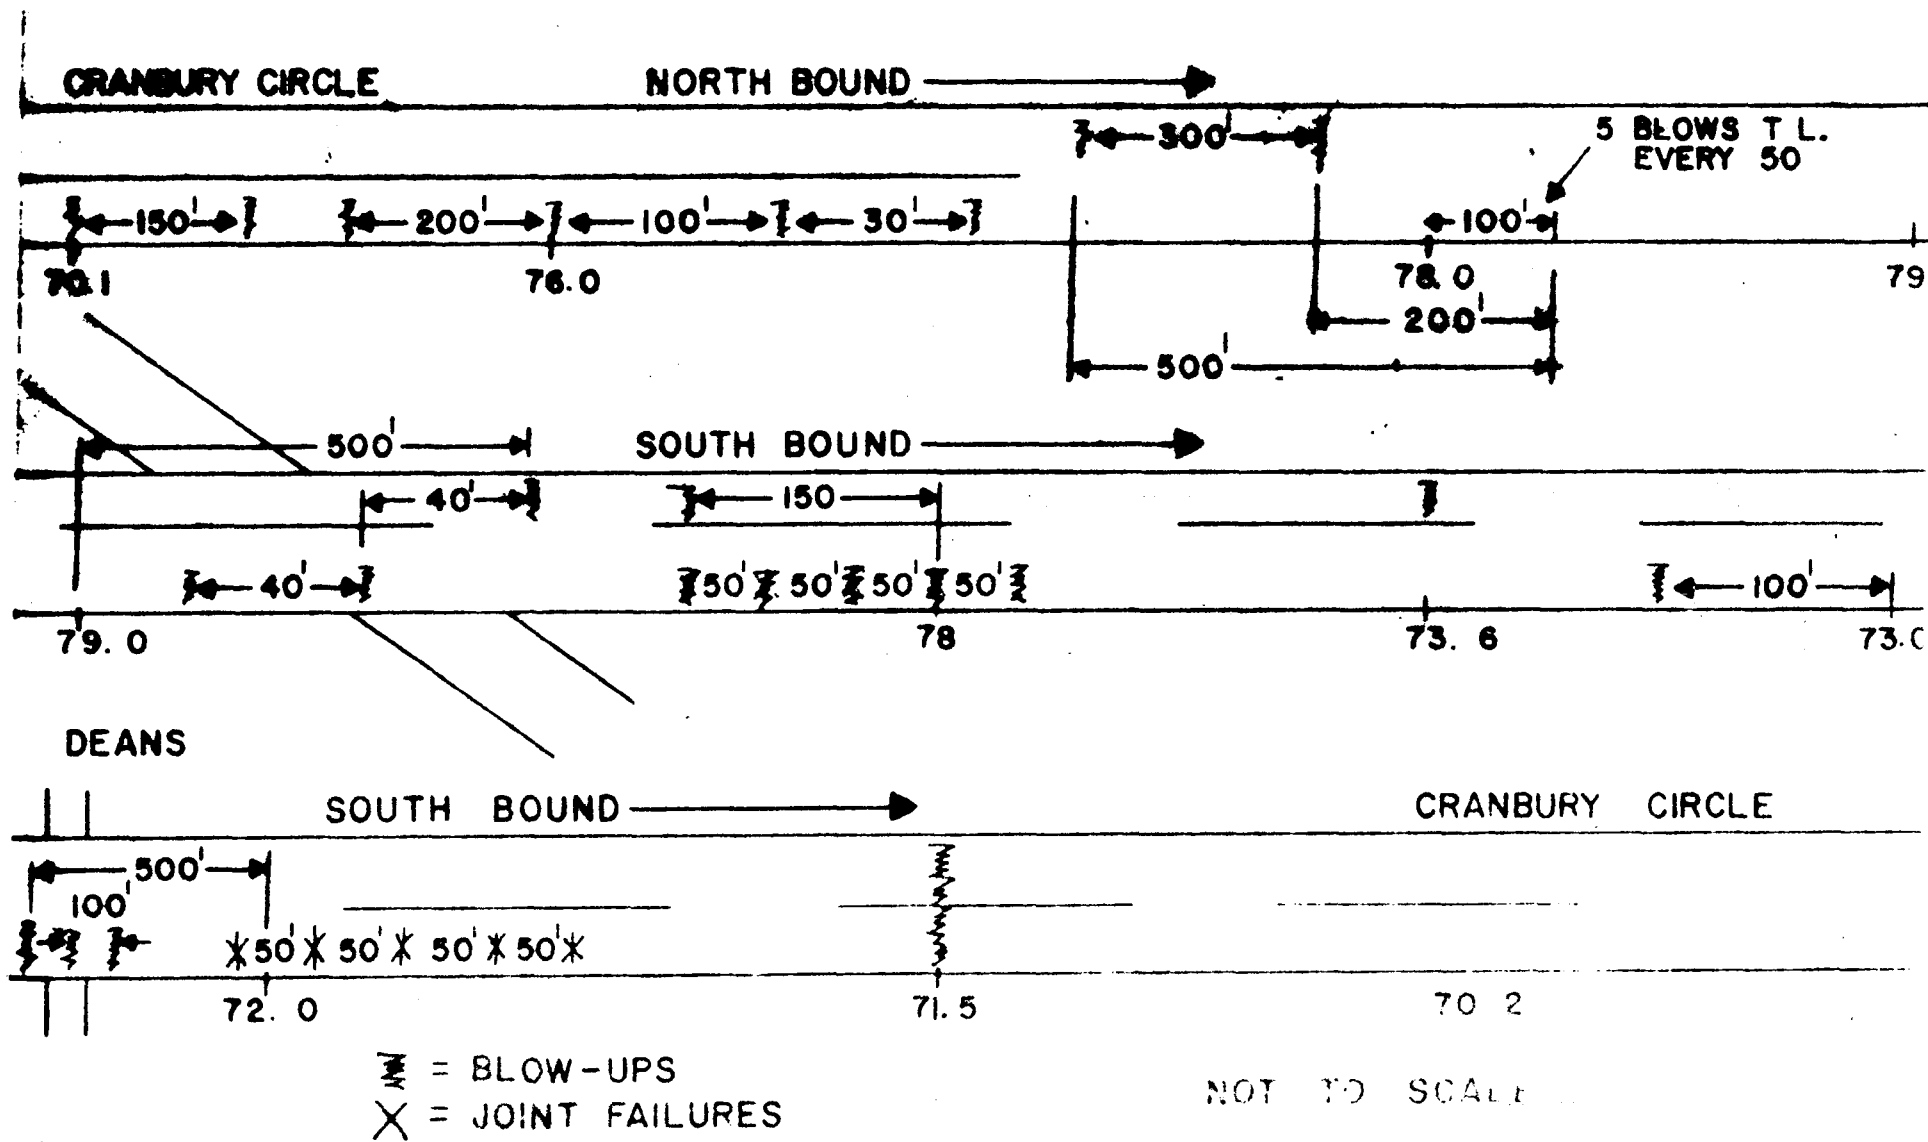
FIGURE 4.3

The above mentioned sections are on Route 130, Eastbound and Westbound lanes, ^{between} [REDACTED] Cranbury Circle and Deans. As can be seen from the diagrams in Figure 4.3 many serious blow-ups are located in these sections. Many of these recurrences are 50 feet to 100 feet apart. In some areas practically every slab has some type of serious blow-up or other type of pavement damage. Generally, recurrences are noticed in areas where dirty joints and slab movements are present. These sections of Route 130 between Cranbury Circle and Deans seem to possess all the ingredients for future recurring blow-ups.
