NEW JERSEY CONCRETE MEDIAN  
BARRIER DELINEATION

WILLIAM L. MULLOWNEY

BUREAU OF OPERATIONS RESEARCH  
DIVISION OF RESEARCH AND DEVELOPMENT  
NEW JERSEY DEPARTMENT OF TRANSPORTATION

OCTOBER 1979

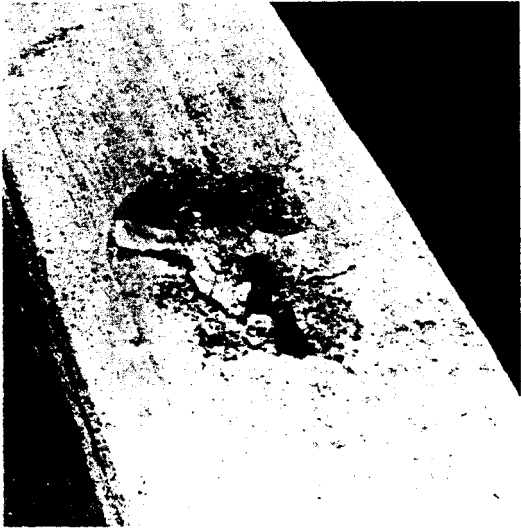
A problem was encountered with the stud installation. According to the people interviewed, at times the stud penetrated the barrier too deeply, or at an angle, hit a piece of aggregate and failed to go in, pulled out of

the barrier with or without a chunk of the barrier attached or rotated when an attempt to tighten the nut was made. Approximations of the frequency of an unusable stud installation varied. The inspector estimated a five percent occurrence, the contractor thought five percent was too high, and the job foreman claimed it occurred three out of five times.

In December, an inspection of the areas around the 201 studs yielded evidence of 64 failures to install a stud. This evidence took the form of small gouges in the top barrier surface, holes where the stud pulled out and the presence of unusable studs which were too deep in the concrete or at an excessive angle (see Figure 4).

FIGURE 4  
EXAMPLES OF UNUSABLE STUD INSTALLATION

1. Use Hilti stud W6-20-27 D12 instead of W6-20-22 D12 or equivalent. The shank length of the recommended stud is longer (27mm vs. 22mm). This change should increase the amount of the threaded portion of the stud available for use.

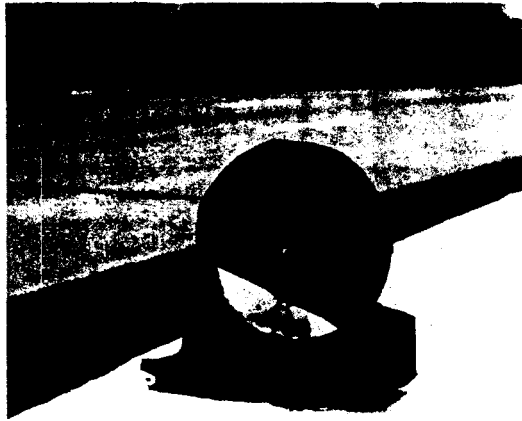
Vandals have apparently defaced several devices by cutting them with some implement, or attempting to pry the device off the barrier, or turning the mount so the reflectors did not face motorists. Whether any of the other damaged or missing reflectors were the products of vandalism is unknown (see Figure 5).

MOUNT CUT

3. Several reflectors may have been vandalized by removing the nut and bolt holding them to the mount. If such vandalism would be a problem, as in an urban area, vandal resistant nuts or a rivet could be substituted for the bolt. This will make vandalizing the devices and replacing them more difficult. In a previous research study, rivets were successfully used in this way.

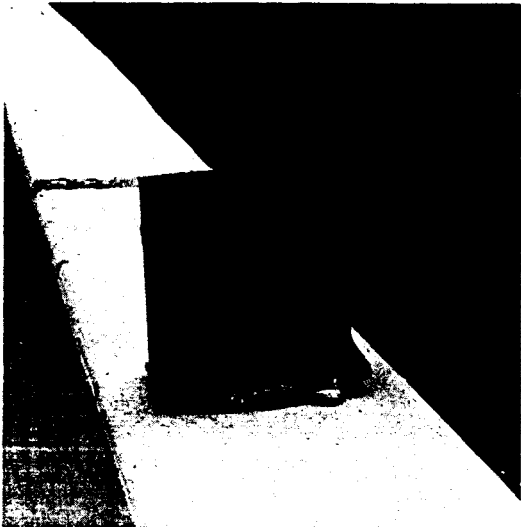
REFLECTOR SPRAY PAINTED

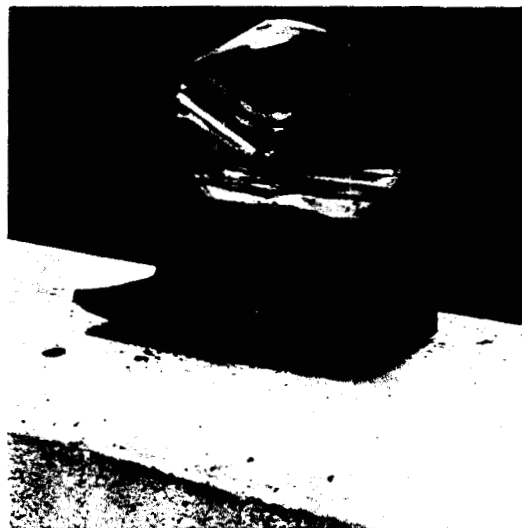
In addition to the suspected lack of primer usage and lack of washers, evidence of improper installation techniques was found on 17 devices. Thirteen delineators were installed without the paper being peeled off to expose the butyl adhesive, thus no bonding between the adhesive and barrier occurred. Four devices were apparently installed with the reflectors parallel to the motorists' line of sight. This positioning was not believed to be the result of vandalism since no residue of the adhesive was found in the normal position (see Figure 6).

INSTALLED PERPENDICULAR TO INTENDED POSITION  
REFLECTORS NOT VISIBLE TO MOTORISTS

4. The problems with an improper installation technique, including reflectors parallel to traffic and the failure to use a primer, can be overcome with more intensive inspection.
