SNOWPLOWABLE RAISED REFLECTIVE  
PAVEMENT MARKERS AT HAZARDOUS  
LOCATIONS IN NEW JERSEY

PROJECT NO. - 4668

BUREAU OF OPERATIONS RESEARCH  
DIVISION OF RESEARCH AND DEVELOPMENT  
NEW JERSEY DEPARTMENT OF TRANSPORTATION

FINAL REPORT

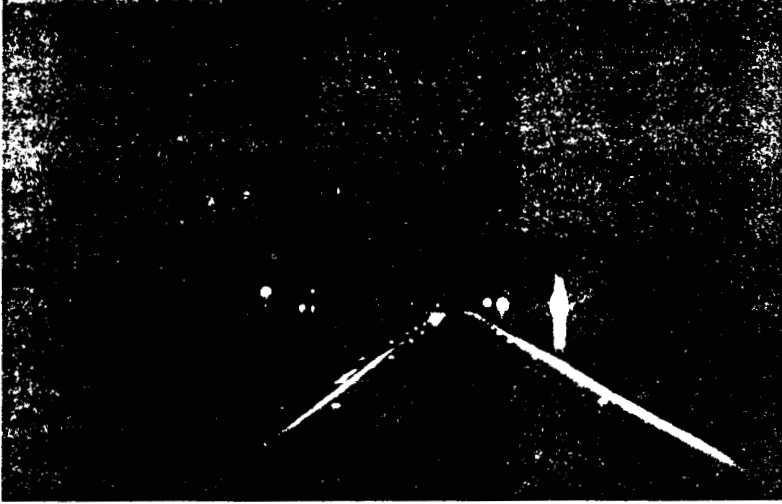
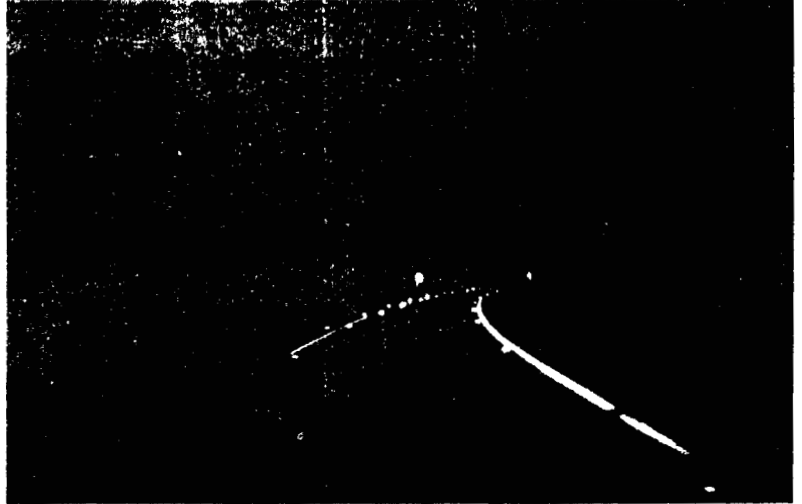
FIGURE 8  
NIGHTTIME VIEWS OF ROUTE 29

Since the Route 29 site has several curves with trees and undergrowth near the road edge, the night sight distance of the markers is limited. However, with low beams the markers can be seen to the farthest point where the road curves out of site. Refer to photos in Figure 8.

Five to six dashed center stripes were visible to two engineers while riding in a car at 30 mph with low beams. This is about a 200 to 240 ft. stripe visibility. The longest distance that markers could be seen as judged from 16mm movies is about 1400 ft. and this was limited by a horizontal curve.

The markers at night were quite effective when observed. It seems that they visually dominate the existing striping which was in good condition. The 40 to 50 ft. spacing was adequate around the curves in that the roadway was clearly well delineated from the approach and in the curves.
