**EXPERIMENTAL
COST EFFECTIVE RECONSTRUCTION
OF BRIDGE DECKS**

AN INTERIM REPORT

JULY 1981

New Jersey Department of Transportation

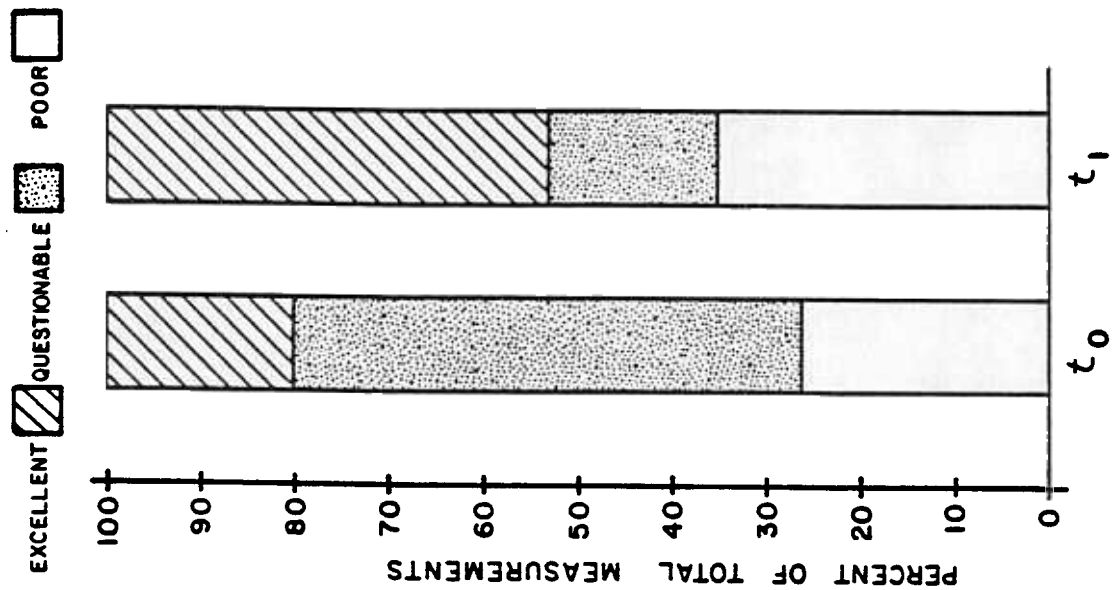
Figure 1: DISTRIBUTION OF ELECTRICAL RESISTANCE MEASUREMENTS ON MEMBRANE - TREATED DECKS BY LEVEL OF PERFORMANCE .

While an examination of the distribution of the results yielded by this method (see Figures 1 and 2) reveal an apparent increase in the proportion of measurements in the "poor" performance category, any suggestion

In the case of the subject installations, a 9% overall increase in the proportion of measurements in the "poor" performance category is more than offset by a 27% increase at the "excellent" level. Individually, although structure numbers 2 and 4 do not follow that performance pattern in percentile grading, all of the installations display an increase in the median resistance value, suggesting a drier condition beneath the membrane.

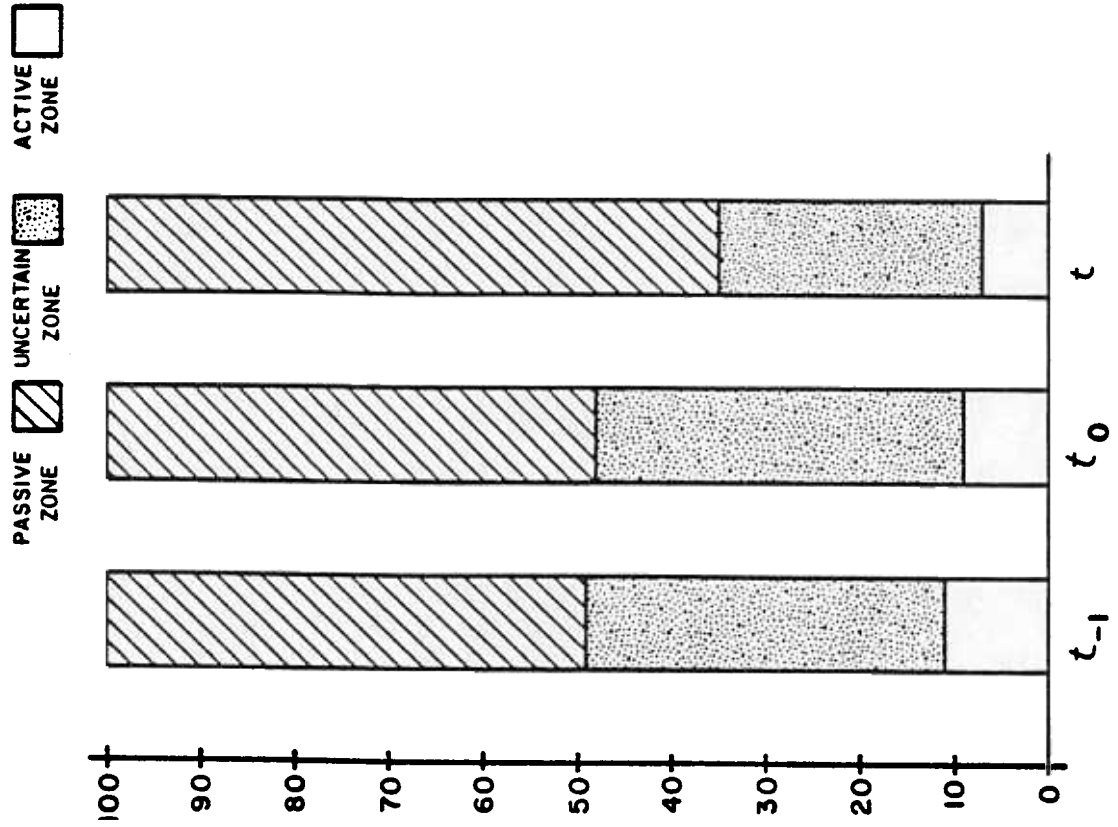
Figure 1A: DISTRIBUTION OF ELECTRICAL POTENTIAL MEASUREMENTS ON MEMBRANE - TREATED DECKS BY LEVEL OF CORROSION ACTIVITY.

From an inspection of the distribution of the combined electrical potential data presented in Figure 1A, there appears to be a general trend toward a decrease in the level of corrosion activity within the group of bridges

An analysis of pre-restoration (" t_{-1} ") data revealed that approximately 11% of the total measurements indicated the probability that corrosion of reinforcing steel was occurring. Immediately after restoration (time " t_0 ") this figure dropped slightly to 9%. By the end of the initial performance period (" t_1 "= 25 to 33 months), the proportion in the "active" corrosion zone had decreased to approximately 7%. This trend of decreasing corrosion activity is supported by a 20% increase in measurements in the "passive" or "safe" zone and a 30% decrease in the "uncertain" zone since installation of the system.

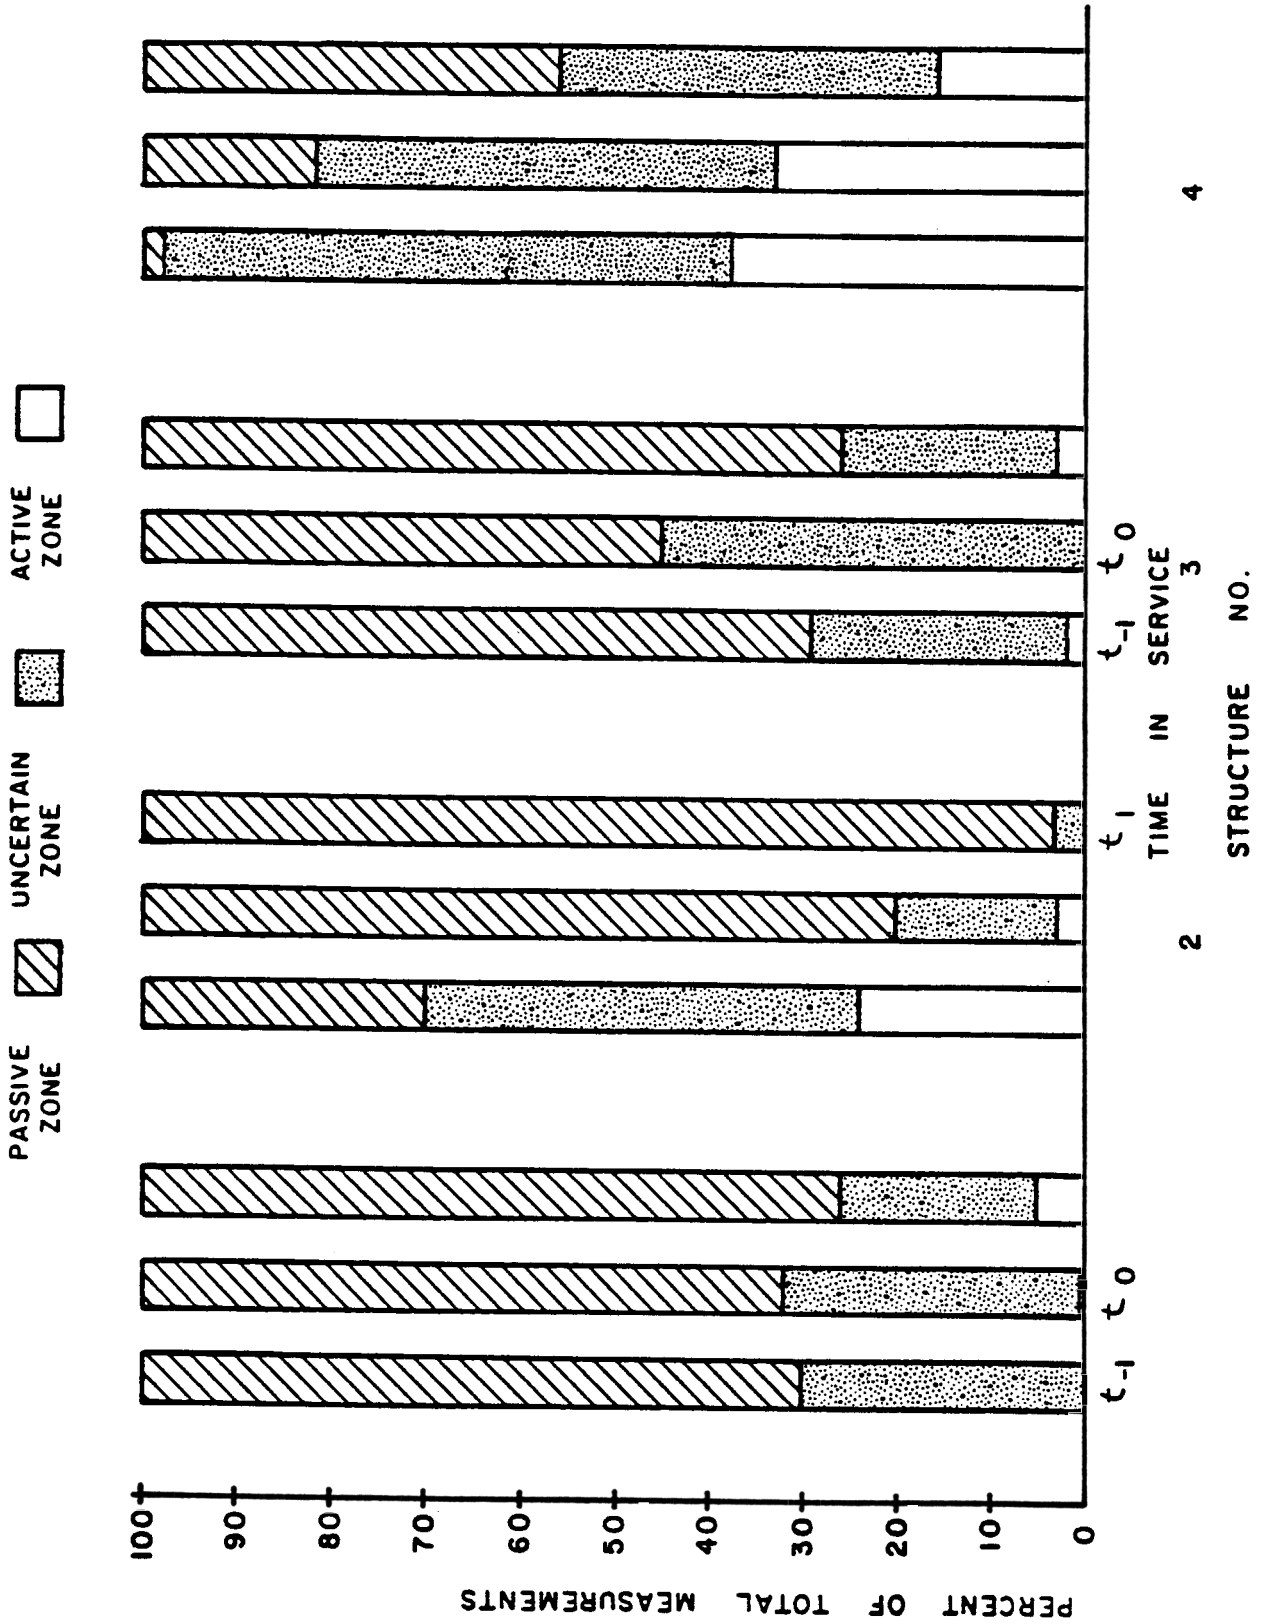
Figure 3: DISTRIBUTION OF ELECTRICAL POTENTIAL MEASUREMENTS ON INDIVIDUAL MEMBRANE TREATED DECKS BY LEVEL OF CORROSION ACTIVITY

On an individual basis, Figure 3 shows that data from Structure No. 1 (Liberty St.) and Structure No. 3 (Elizabeth River) follow a trend somewhat different to that of the group as a whole. In these cases the proportion of potentials indicating probable corrosion activity increased from less than 1% to 5% and from 0 to 4% respectively. A further investigation of data from Structure No. 1 indicates that this increase in activity occurred exclusively in Span No. 5 of the structure. Thirteen out of eighty-one or 16% of the measurements taken in this area indicated the presence of active corrosion. It should be noted that Span No. 5--the longest within the structure--was also the only span showing any initial corrosion activity or any visible signs of distress during this evaluation period. An examination of data from Structure No. 3 revealed no apparent explanation for the slight increase in corrosion activity.

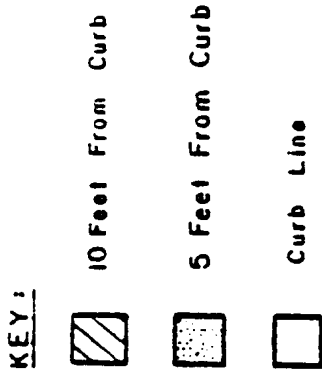
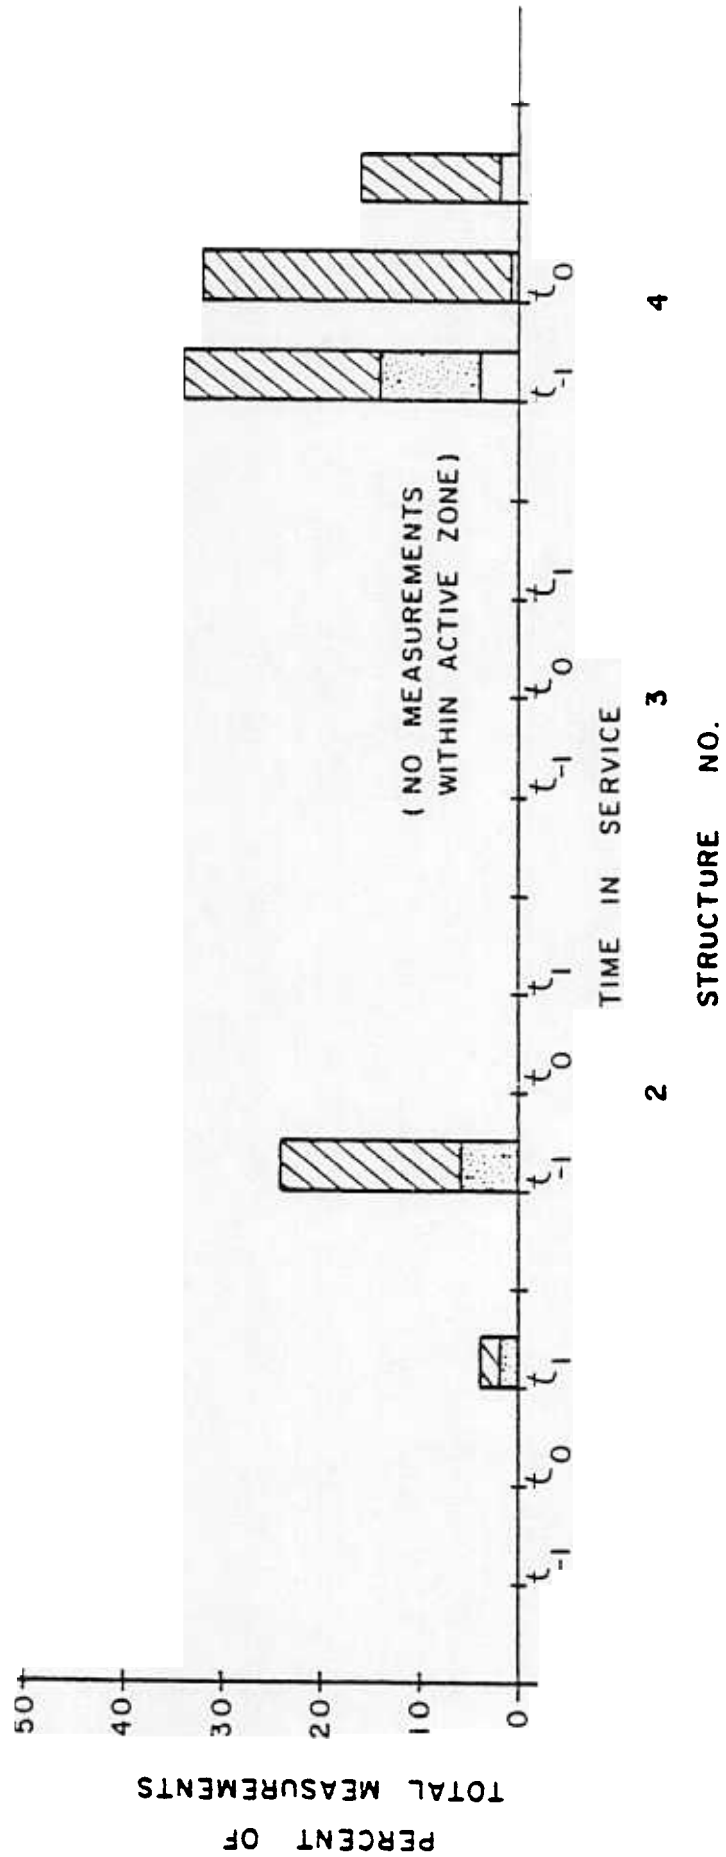
Figure 4: PROPORTION OF HALF-CELL POTENTIAL MEASUREMENTS IN THE ACTIVE CORROSION ZONE, BY STRUCTURE AND LOCATION.

In an attempt to detect further trends within the results yielded by this technique, the proportions of measurements in the active corrosion category have been divided by locations (i.e., curblines, 5 feet from the and 10 feet from curb). In the distribution of active corrosion measurements displayed in Figure 4, 66% of the pre-restoration data, 97% of initial and 80% of the follow-up data occurred 10 feet from the curblines. These percentages strongly suggest that the corrosion process tends to be more active in the traffic lane than in the curblines and shoulder areas. This is somewhat surprising in that it is usually at the boundary areas that water and salts intrude.
