SECOND GENERATION PAVEMENT OVERLAYS

A Final Report

Prepared By
New Jersey Department of Transportation
Bureau of Transportation Structures Research

1. Report No. FHWA/NJ-86-013-7778		2. Government Accession No.		3. Recipient's Catalog No.	
4. Title and Subtitle Second Generation Pavement Overlays				5. Report Date July 1987

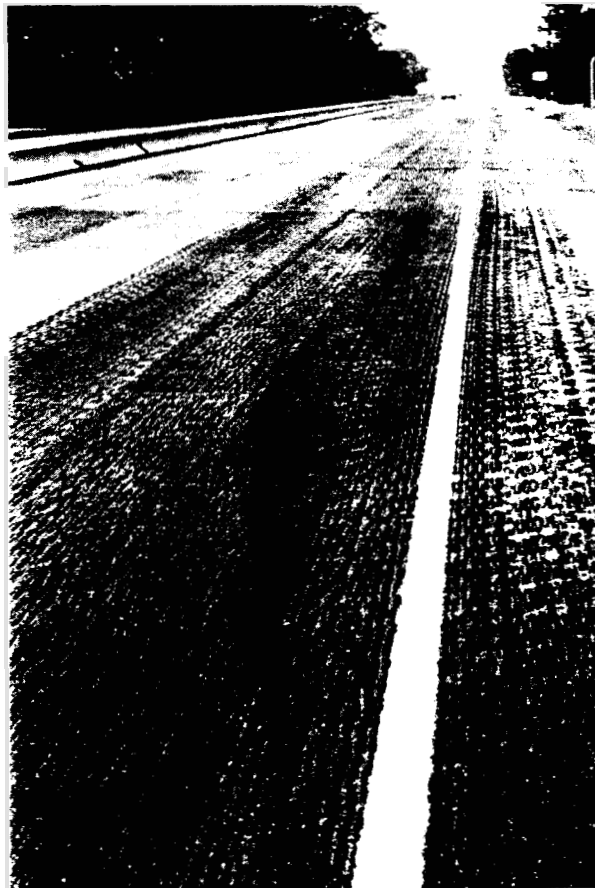
PHOTO 2
POOR MILLING TEXTURE

Overly fast or slow machine speeds can cause striations. The rotation speed of the cutting drum is constant and the tip speed of the cutting teeth is approximately 1000 to 1100 feet/minute. When the forward speed of the machine exceeds 45-50 feet/minute, the tendency is to pull the teeth through the material causing striations. The same problem of striating can occur when the machine is too slow (10 feet/min. or less) or milling in an extremely fine mix with a high asphalt content. For example, at a slow forward speed and constant drum speed the milling machine acts as a saw, leaving a continuous striation, rather the desired textured surface. When the speed is slow and AC content is high, the bond between the asphalt cement and the aggregate is not broken, preventing the aggregate from being dislodged.

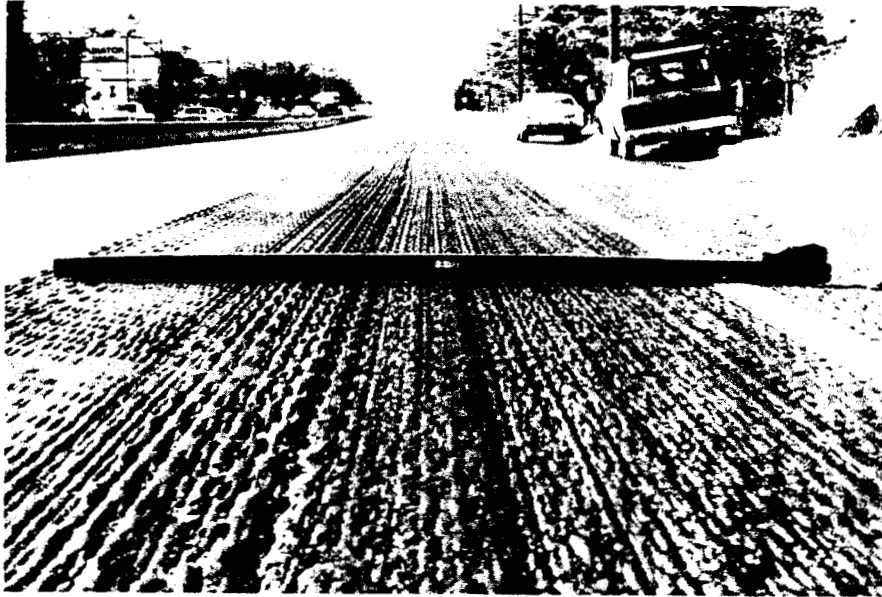
Originally, it was planned that the milling would be accomplished in a single full width pass. However, the contractor used two machines to make the required 12'-4" width. If one of the units was down for repair the other would continue to mill. This constant surging of one machine past the milled surface of the other resulted in a poor cross slope. In some cases there would be a slight "V" (Photo 5) and in other cases an inverted "V". Other cases of shoddy workmanship occurred in the vicinity of manholes as shown in Photos 6 & 7.

PHOTO 5
IMPROPER CROSS SLOPE DUE TO USE OF 2 MACHINES

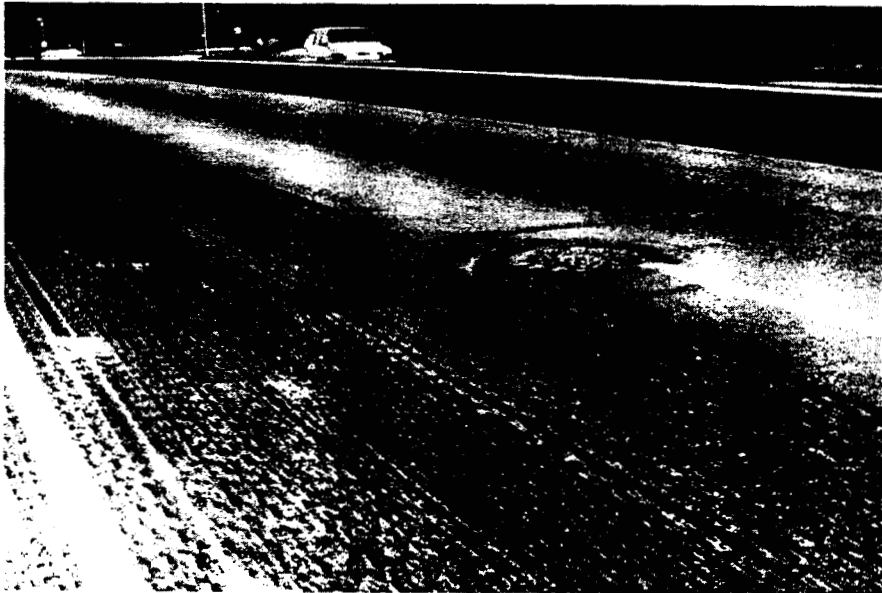
PHOTO 6
POOR WORKMANSHIP AT MANHOLE

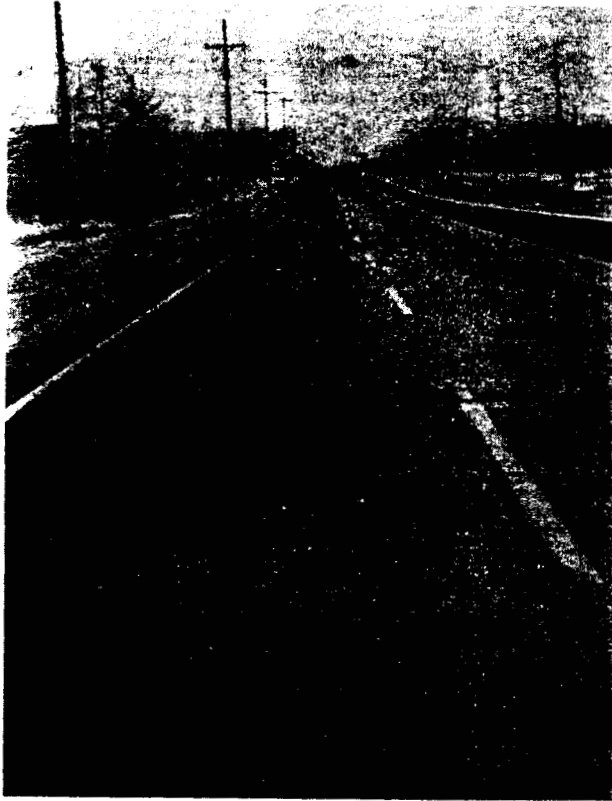
PHOTO 13
STRIPPING OF ROUTE 1 REPAIRED AREA

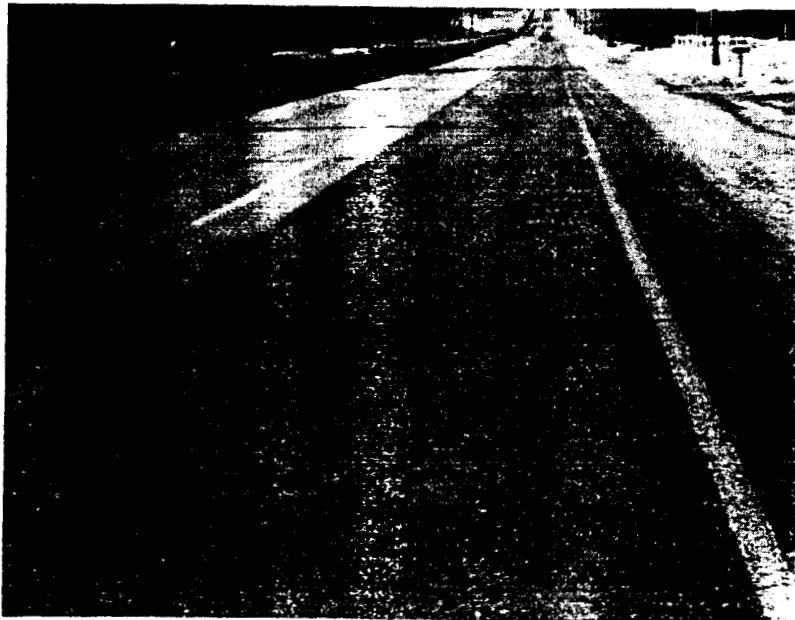
PHOTO 14
POTHOLING OF ROUTE 1 REPAIRED AREA

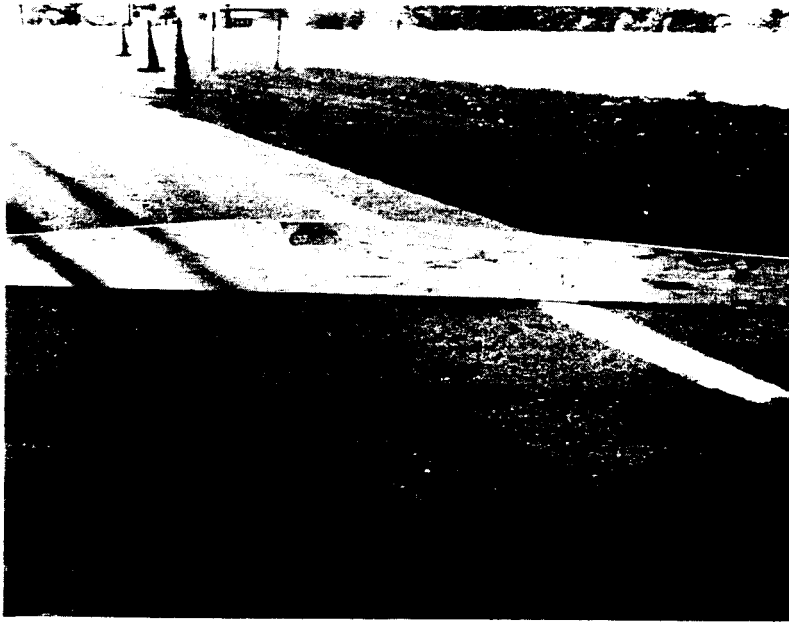
PHOTO 15
PAVEMENT CONDITION ON ROUTE 1 PROJECT PRIOR TO OVERLAY

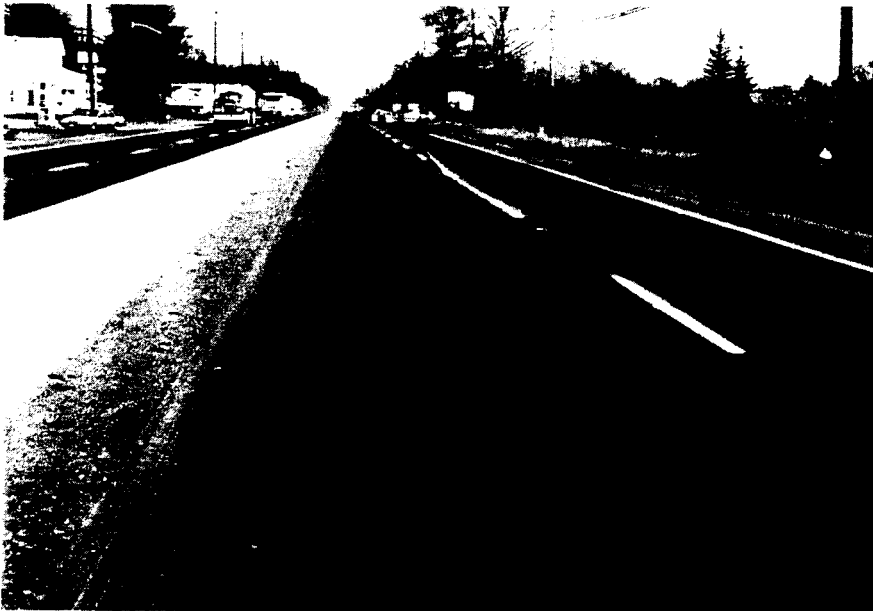
PHOTO 16
APPEARANCE OF ROUTE 1 PROJECT AFTER 10 YEARS SERVICE

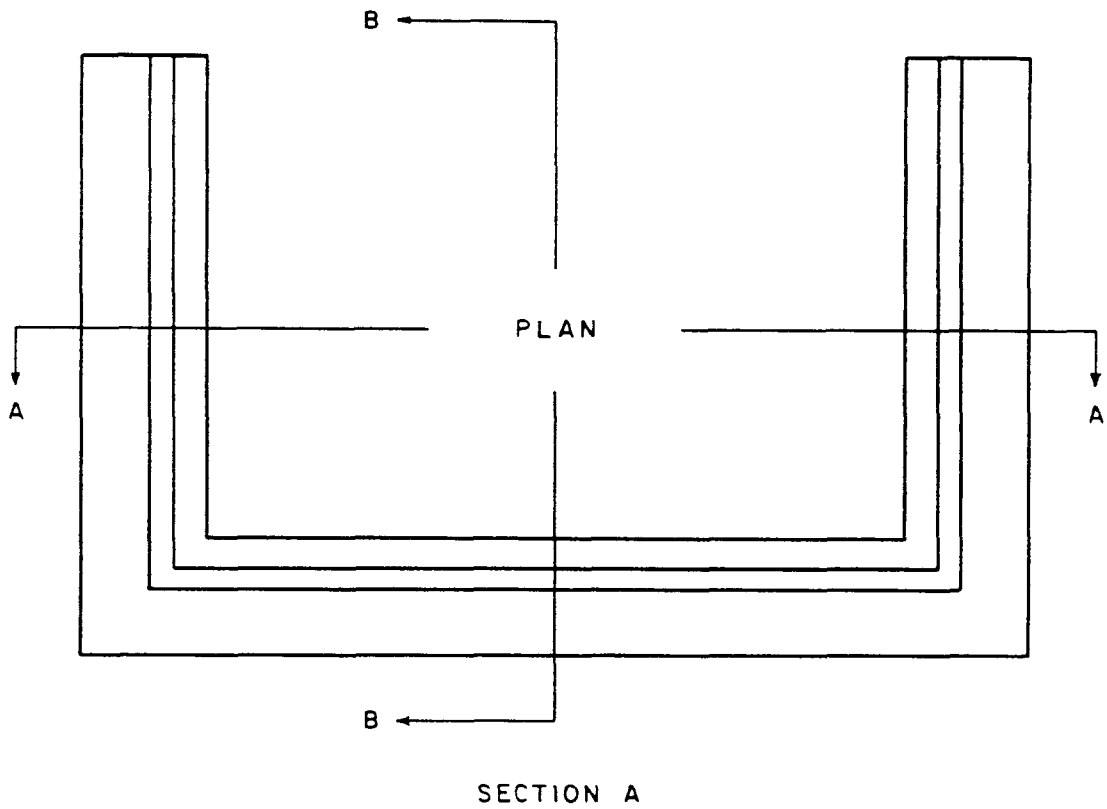
Historically, the three-sided U-shaped extension frames used for raising inlets also left much to be desired (see Figure 2). First, the three-sided unit is subject to distortion during the cooling process after casting. Secondly, the method to hold it in place was very poor. The unit had a 3" wide by 3/4" thick flange running around the perimeter of the casting and depended on the overlay (1-1/4") to hold it in place. A passing vehicle riding over the grate would cause rocking of the extension frame with the subsequent cracking of the thin overlay over the edge of the flange. The result was a loose, noisy inlet.

FIGURE 2 :
ORIGINAL DESIGN OF CAST IRON
EXTENSION FRAME FOR EXISTING INLET
(PLAN VIEW)

To overcome the aforementioned problems, a new 4-sided frame (Figure 3) was developed. Provisions were made for bolting the extension units to their respective frame castings. To preclude any localized overstressing of the cast iron, a light coat of a bedding compound was applied to the old frame to insure uniform seating.

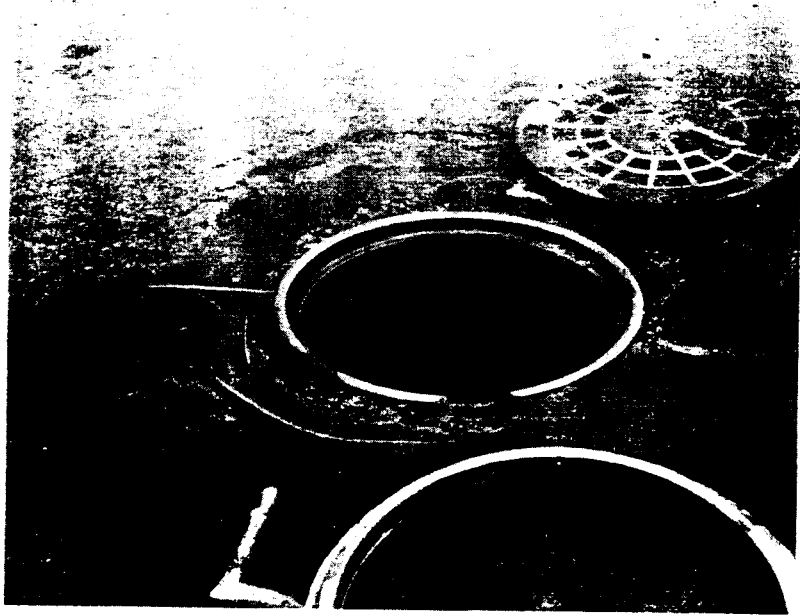
PHOTO 24
SPALLED MANHOLE FRAMES - ROUTE 93 PROJECT

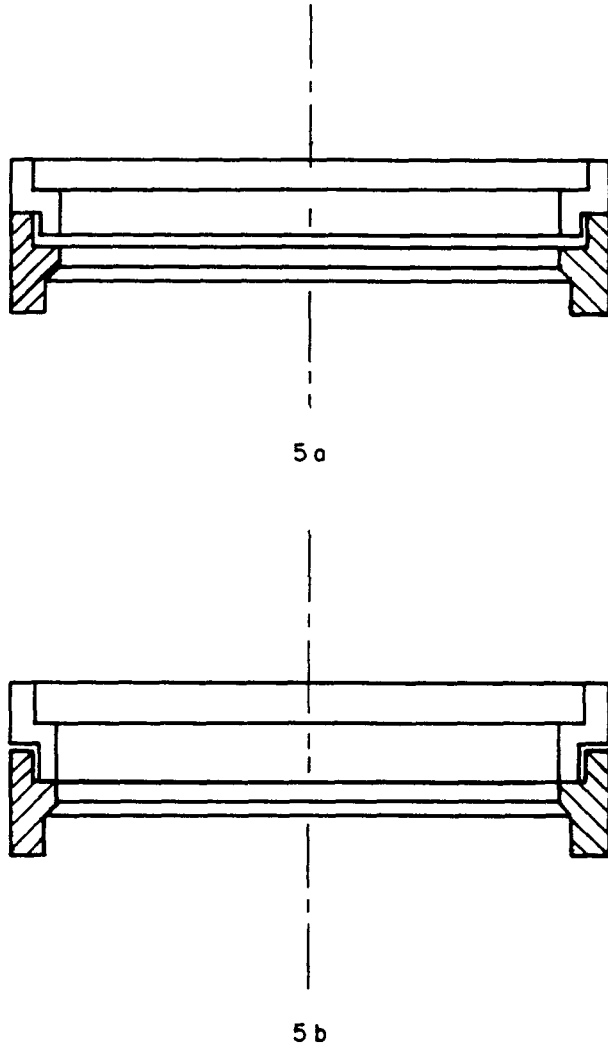
FIGURE 5 :
IMPROPERLY FITTED MANHOLE COVERS

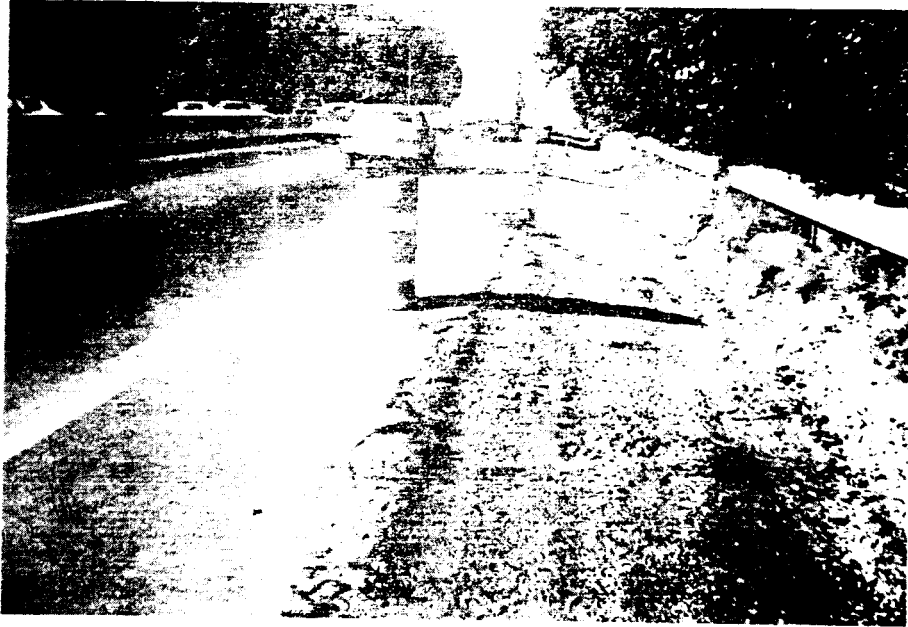
PHOTO 33
EXAMPLE OF JAGGED EDGE DUE TO EXCAVATING

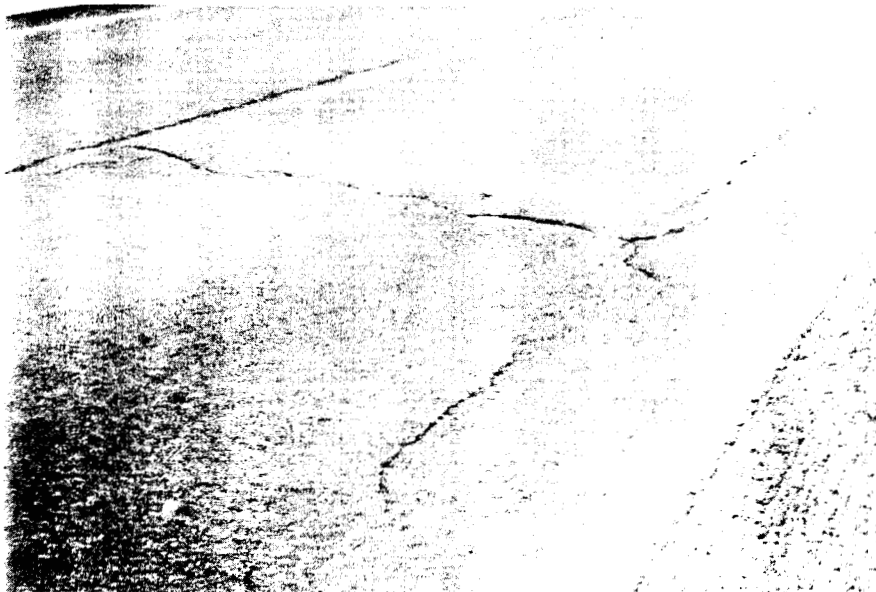
PHOTO 36
TYPICAL REFLECTION CRACKING IN CONTROL SECTION

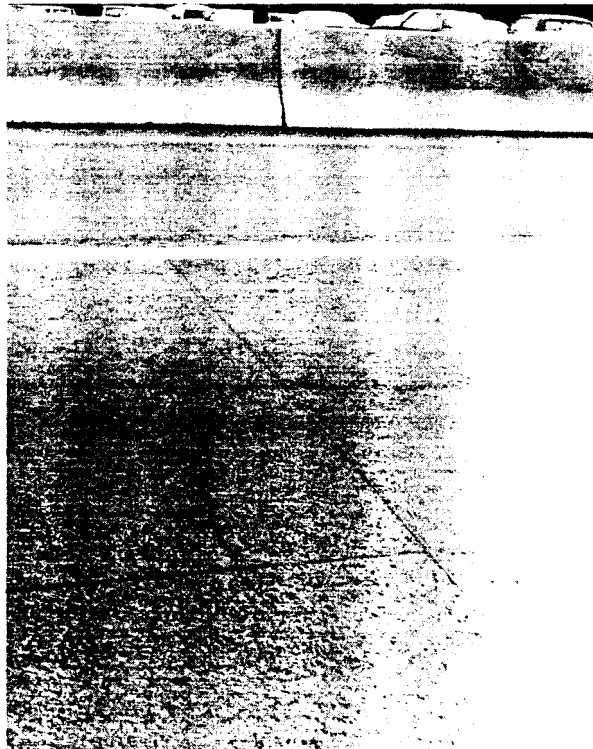
PHOTO 39
CORNER CRACK

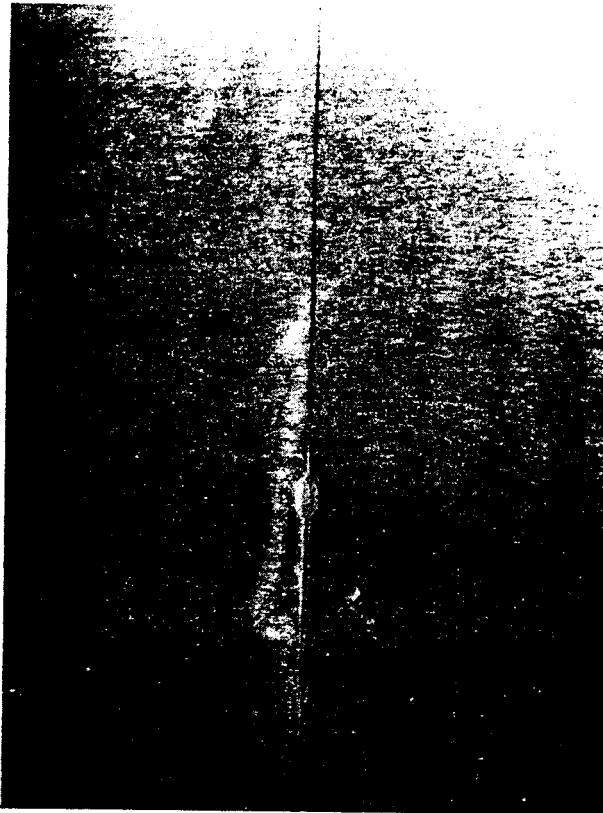
PHOTO 52
UNDERPOURING OF JOINT SEALANT ON ROUTE 40 & 322 PROJECT

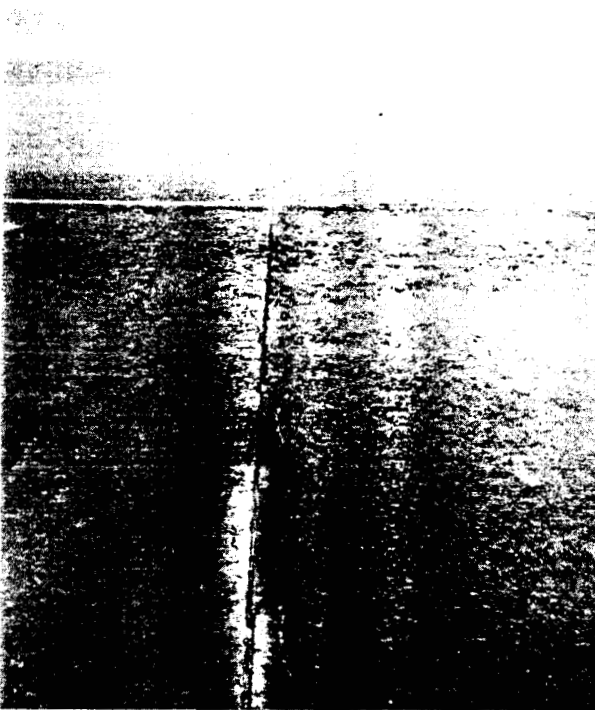
PHOTO 54
IMPROPERLY REFERENCED SAW CUT,
SKEWED TO LEFT

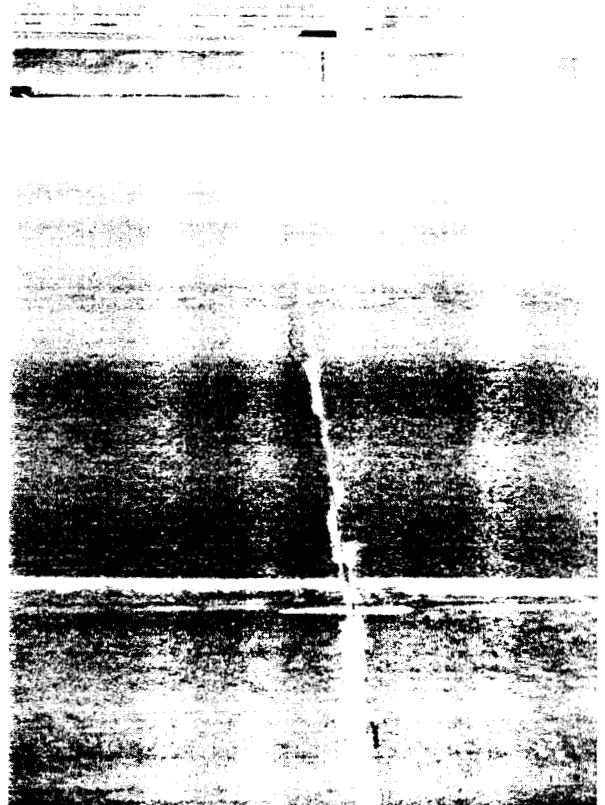
PHOTO 55
IMPROPERLY REFERENCED SAW CUT,
SKEWED TO RIGHT

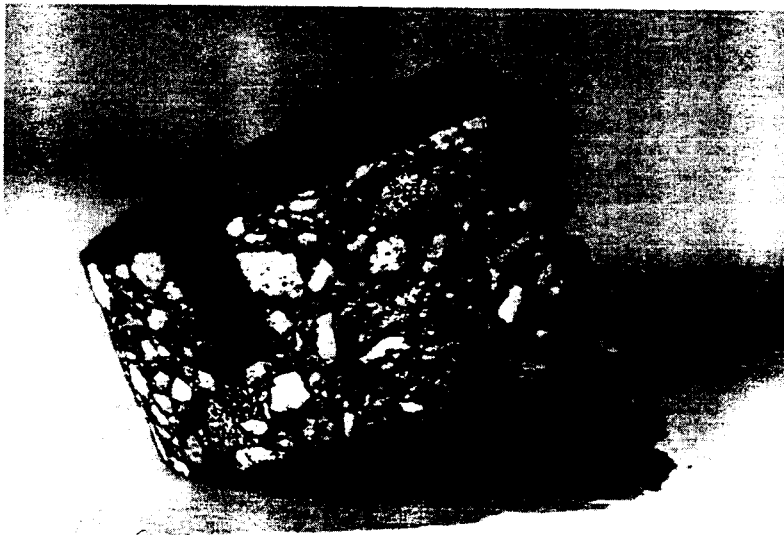
PHOTO 57
CLOSEUP OF CORE SHOWING SEALER ATTACHED

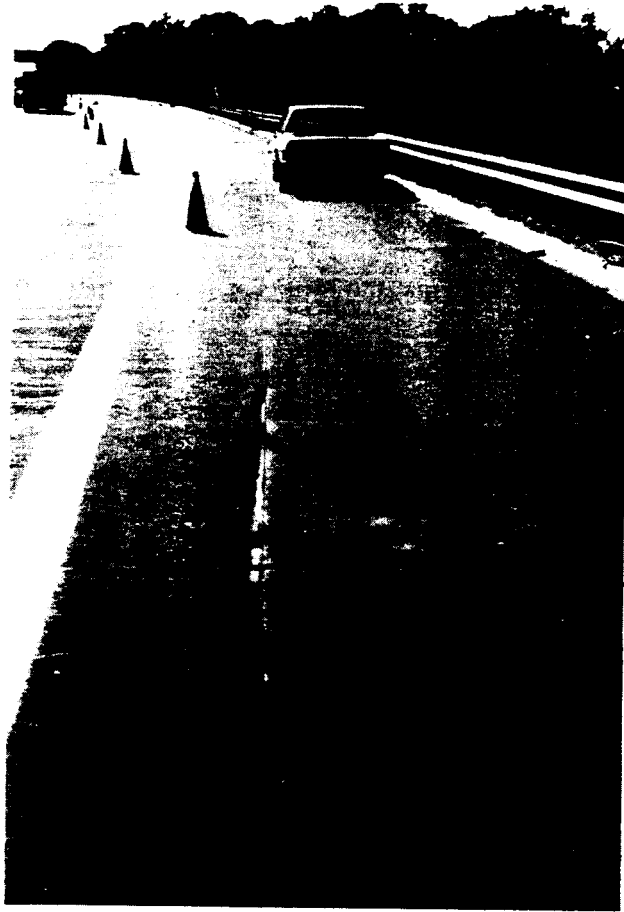
PHOTO 58

ROUTE 80 PROJECT: OVERVIEW OF IMPROPERLY REFERENCED LONGITUDINAL JOINT

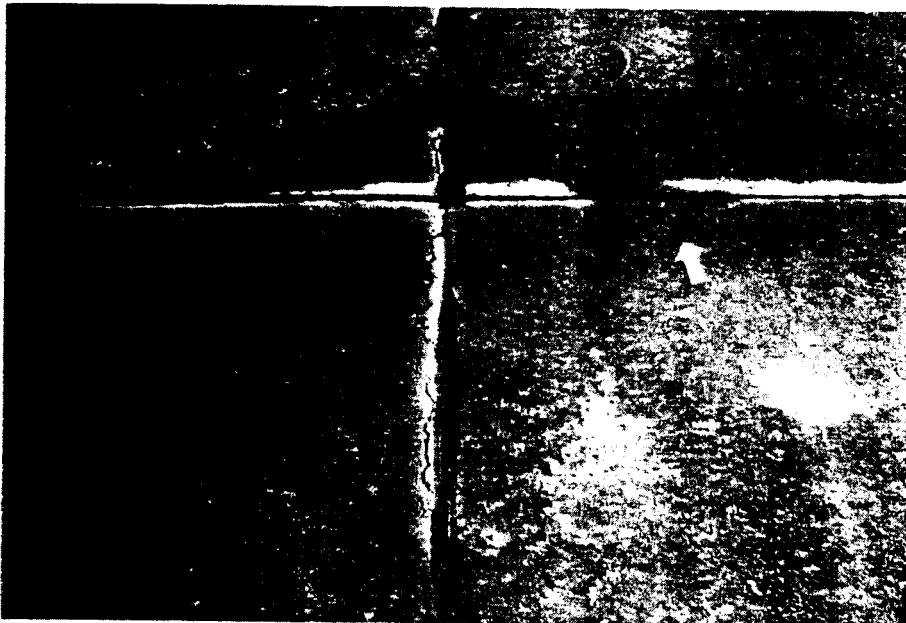
PHOTO 59

ROUTE 80 PROJECT: CLOSEUP OF IMPROPERLY REFERENCED LONGITUDINAL JOINT

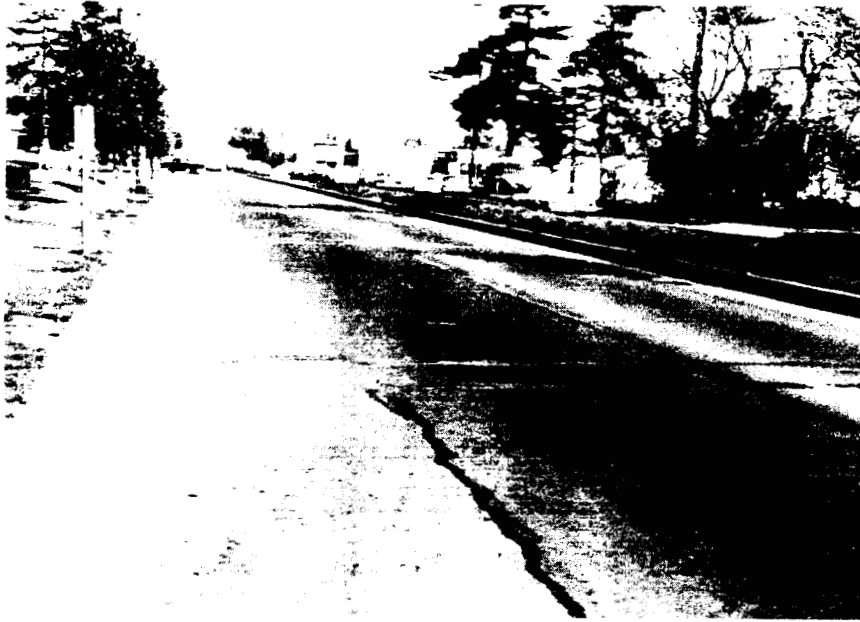
PHOTO 62
SOUTH BROAD STREET PROJECT
LONGITUDINAL AND TRANSVERSE REFLECTION CRACKING AFTER 7 YEARS SERVICE

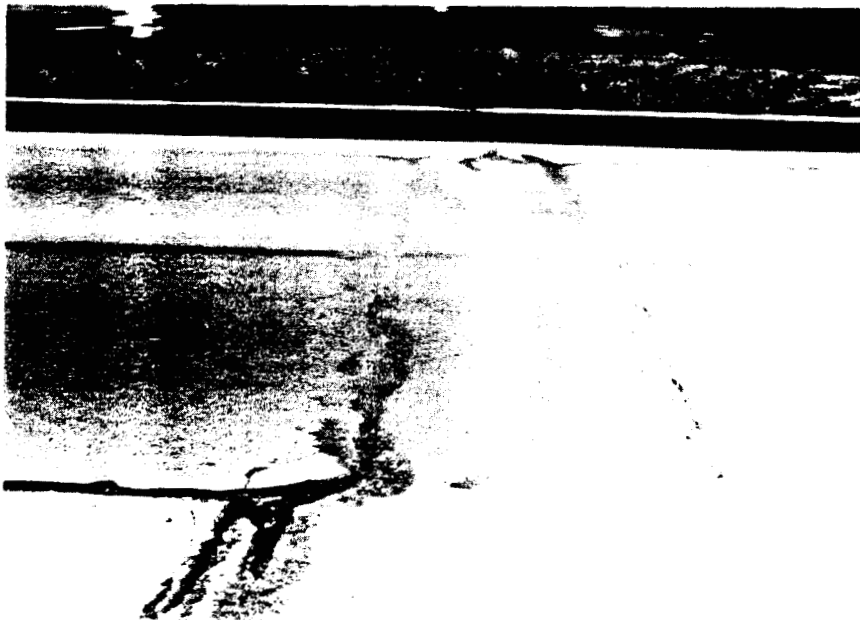
PHOTO 63
REFLECTION CRACKING AT ENDS OF CONCRETE "REPAIR"

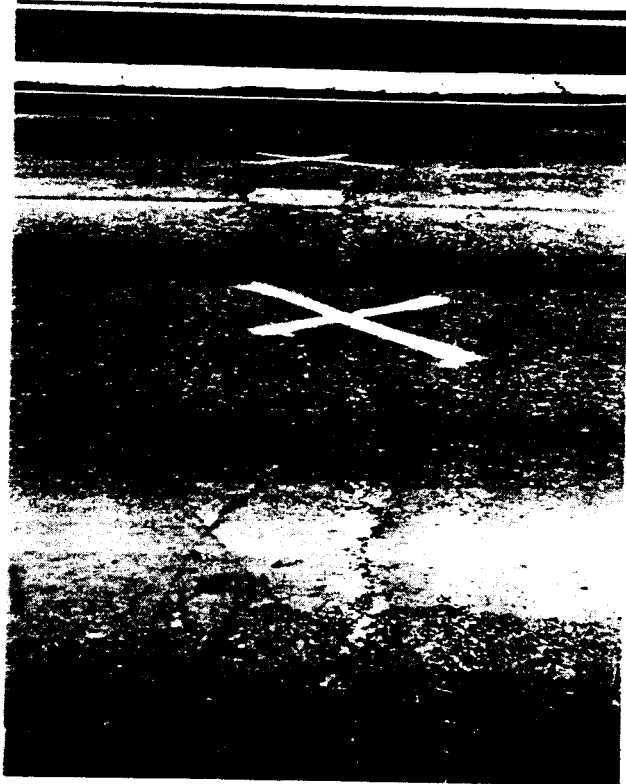
PHOTO 64
ROUTE 10 PROJECT: APPEARANCE OF OVERLAY SURFACE

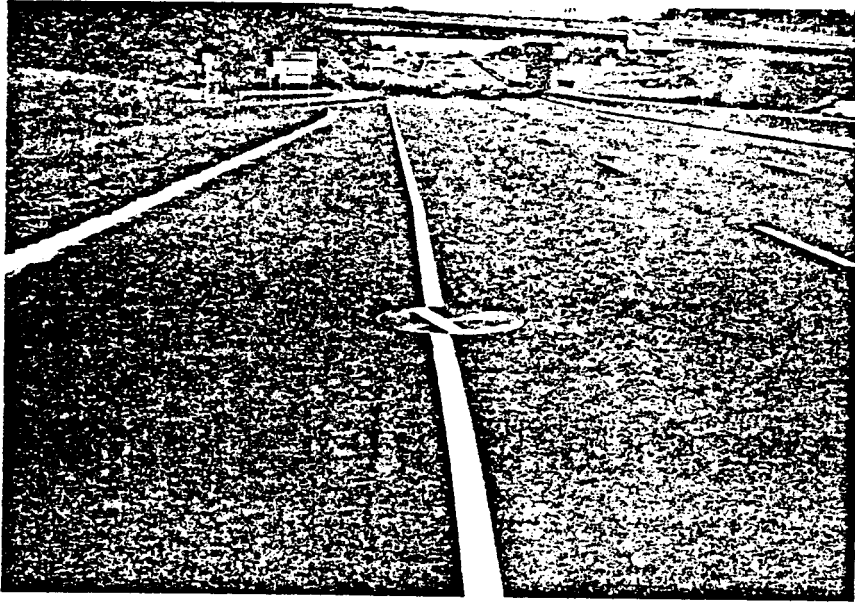
PHOTOS 3 & 4
ROTATING COVERS

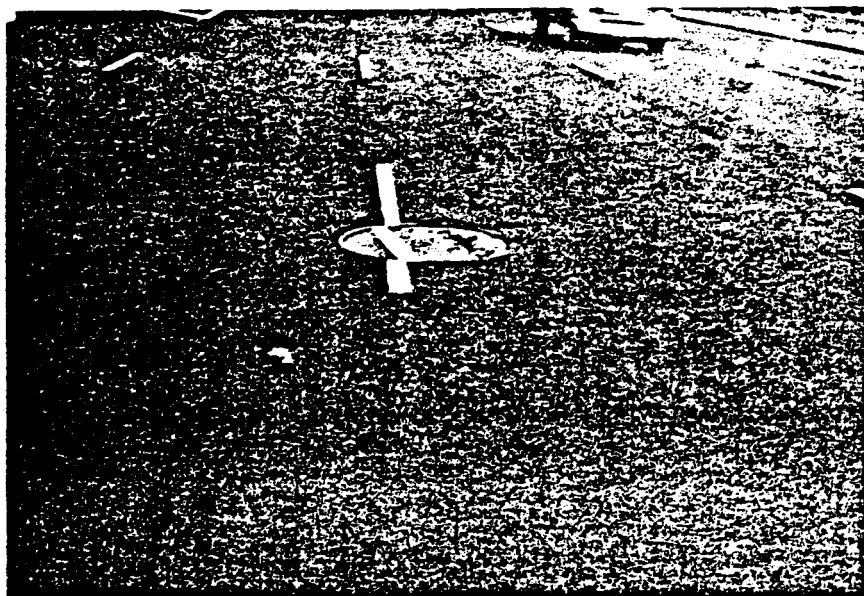
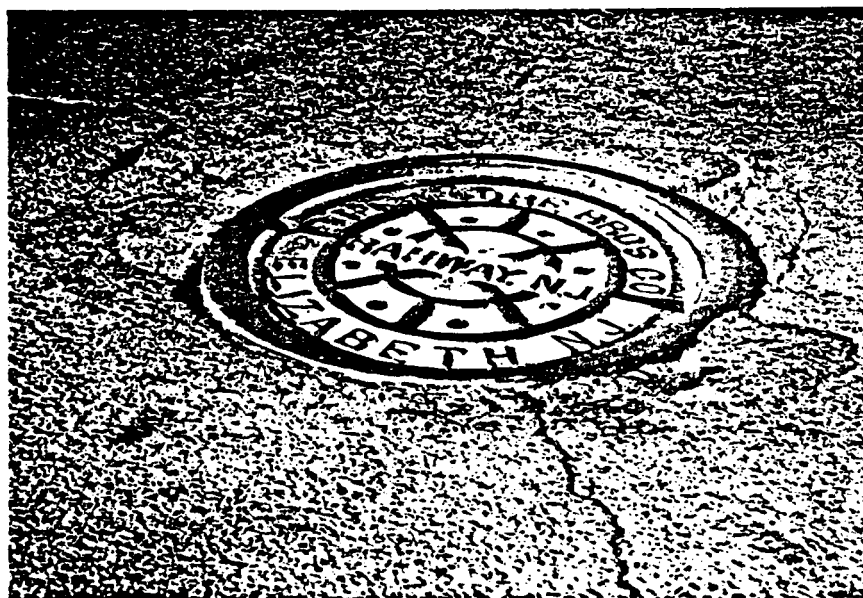
PHOTOS 5 & 6 (UNIFORM WEAR)
COVER DEPRESSED DUE TO WEAR OF COVER SEAT

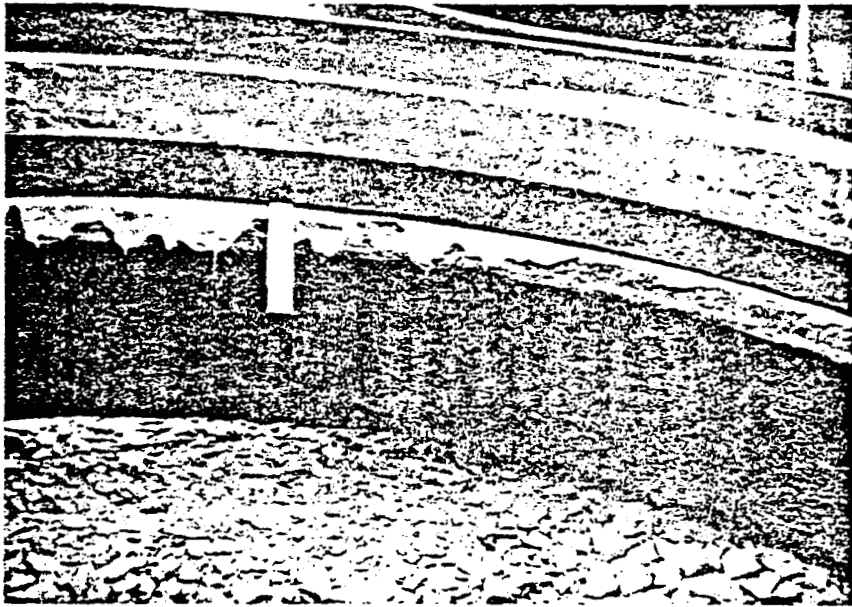
PHOTO 11: POOR INSTALLATION PRACTICES;
NO CONTACT OF EXTENSION RING WITH EPOXY

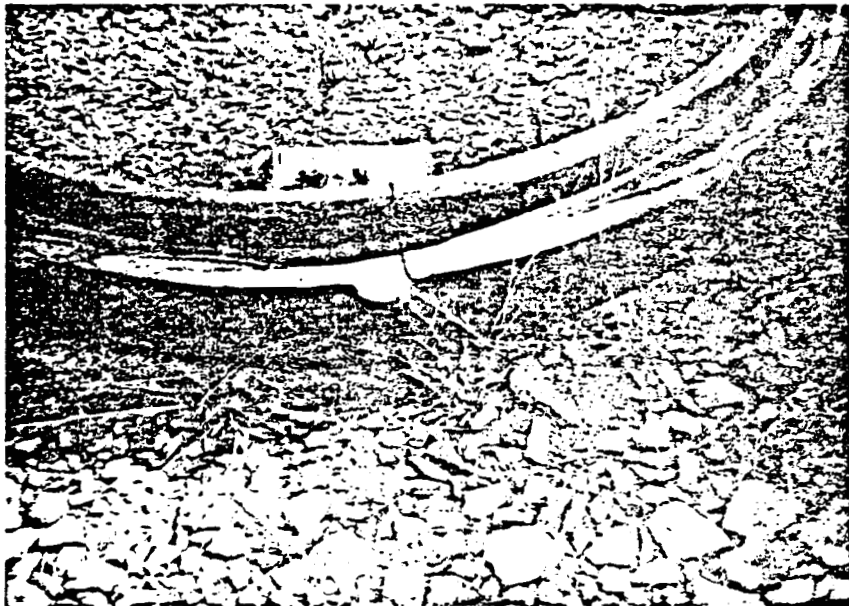
In placing an extension ring on a casting exhibiting localized non-uniform wear as described in 4.2.3, the projection of the non-worn part of the seat in the vicinity of the pick holes also prevents the proper bedding and bonding of the extension ring. This unworn segment of the seat can in certain cases (such as wear at the top of the old manhole frame) cause rocking of the ring and cover and failure by cracking of the extension ring (photo 12). This cracking may occur as follows: as vehicles strike the approach side, the ring is pressed down striking the seat; milliseconds later, the ring is violently depressed on the trailing side with a resounding impact. Repeated impacts can cause failure of the cast iron ring. The way to alleviate

PHOTO 12
CRACKING OF EXTENSION RING DUE TO UNEVEN SEATING

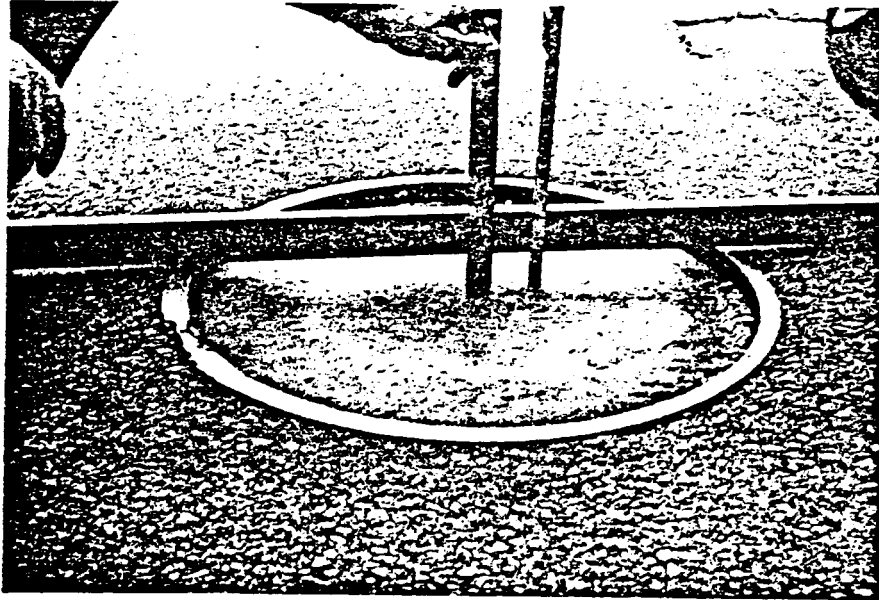
PHOTO 17
HAZARDOUSLY DEPRESSED COVER

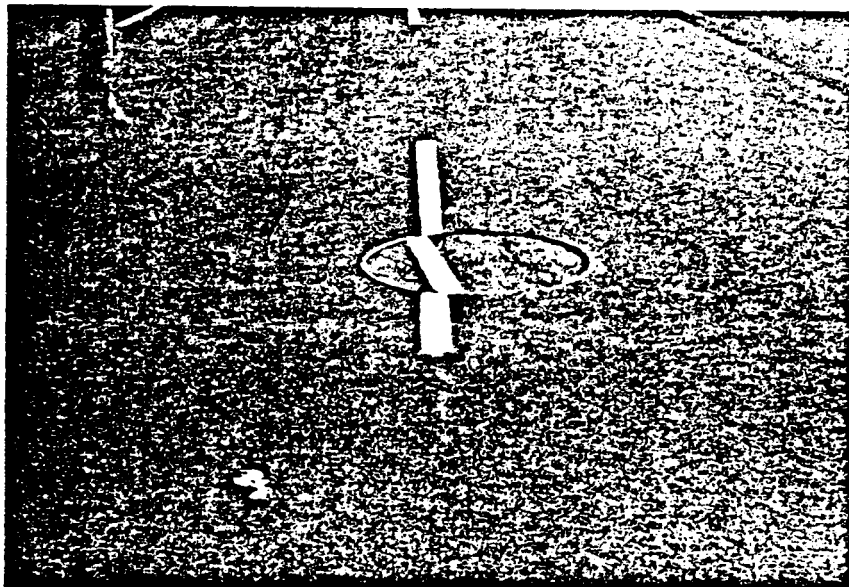
PHOTO 18
DEPRESSED COVER; POOR RIDEABILITY

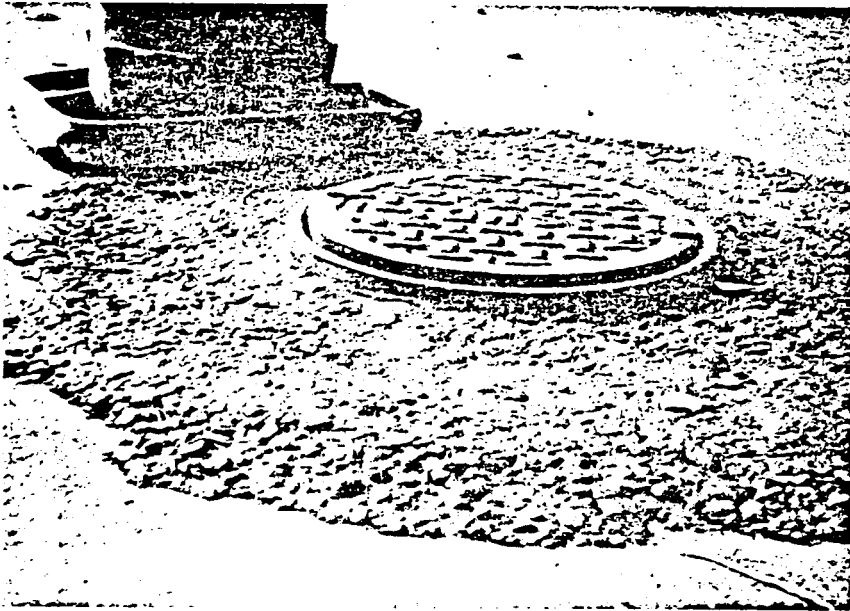
PHOTO 20

DEPRESSED RESET SANITARY HEAD - NO RAMP
COVER BROKEN BY DYNAMIC JUMP OF TRUCK
