FIELD EVALUATION OF A FUSION-BONDED WHITE
POLYESTER COATED GUIDERAIL

Initial Report

August, 1986

New Jersey Department of Transportation
Bureau of Transportation Structures Research

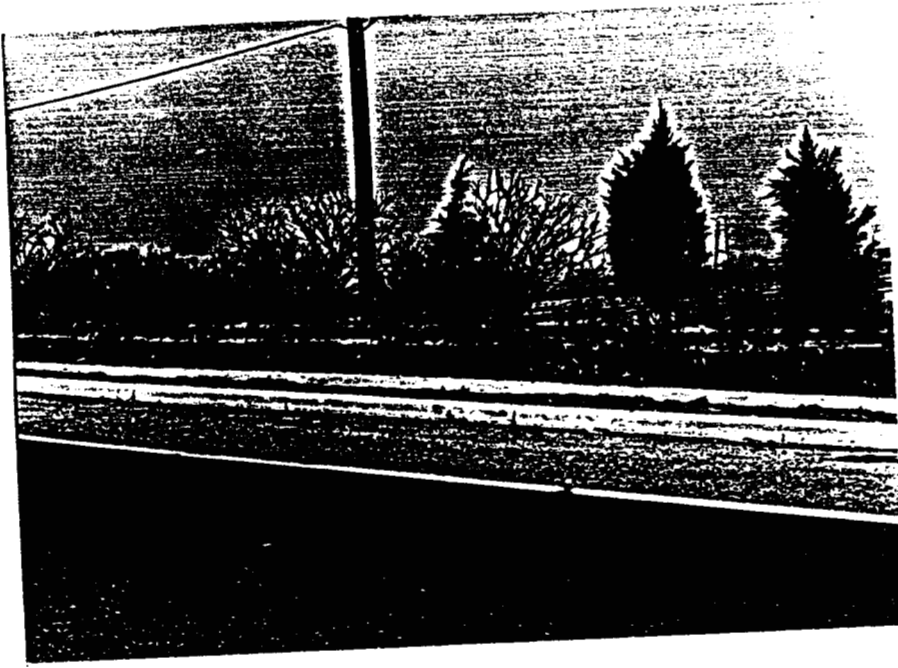
Figure 2: White Painted Guiderail

The estimated traffic in this area is 28,400 vehicles per day. This location historically has a low accident rate (less than five accidents per million vehicle-miles). Therefore, damage to these guiderail sections was expected to be due more to corrosion than to vehicular impact. In the past, this location has had white painted galvanized guiderail, and as can be seen in Figures 2 and 3, corrosion of the rail is extensive.

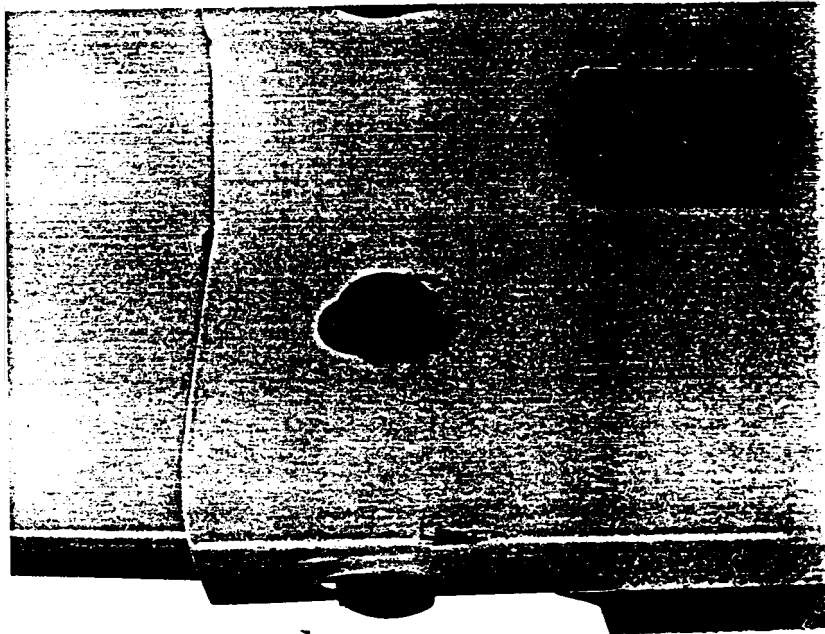
Figure 8: Rusting Around Bolt Heads

To date, two condition surveys have been conducted — the first in February, 1985 and the second in July, 1985. Every scratch, nick and rust spot was recorded on survey forms. The general condition of the polyester coated guiderail is good. Most rust spotting is localized around the bolt heads and on the edges where the coating was inadvertently crushed during installation. See Figure 8.

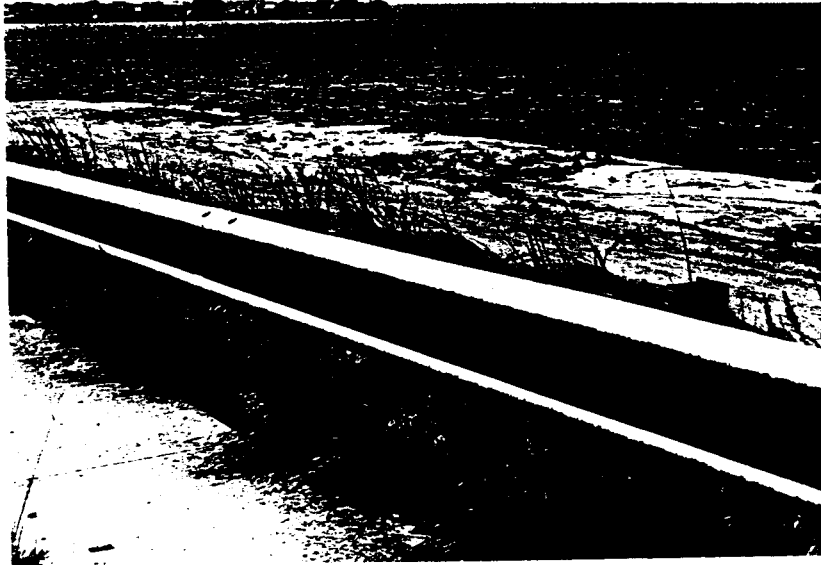
Figure 10: Daytime Appearance of Galvanized Guiderail

The galvanized control section exhibits no damage to date. No impacts have occurred and no rust is evident. See Figure 10.

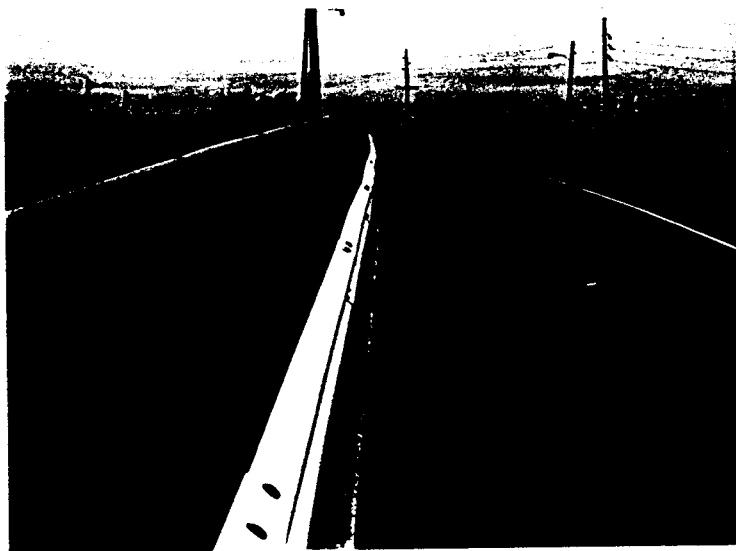
Figure 11: Daytime Appearance of Polyester Coated Guiderail

The white polyester coated guiderail is significantly more visible and clearly delineates the roadside edge better than the galvanized rail. This is apparent in daylight hours (see Figure 11), and it is expected to be even more vivid at night. Night visibility will be checked later in the course of this study. Reflectometer results tabulated below confirm this opinion. These results show that the average reflectance of the galvanized rail is 26.6, while that of the polyester coated rail is 76.2, almost three times brighter.
