New Jersey Department of Transportation  
Bureau of Research

## Technical Brief

### In Place Rehabilitation of Pipes Using Polymer Composites

**In Place Rehabilitation of Pipes Using Polymer Composites**  
**NJDOT Research Report No: FHWA-NJ-2010-012**

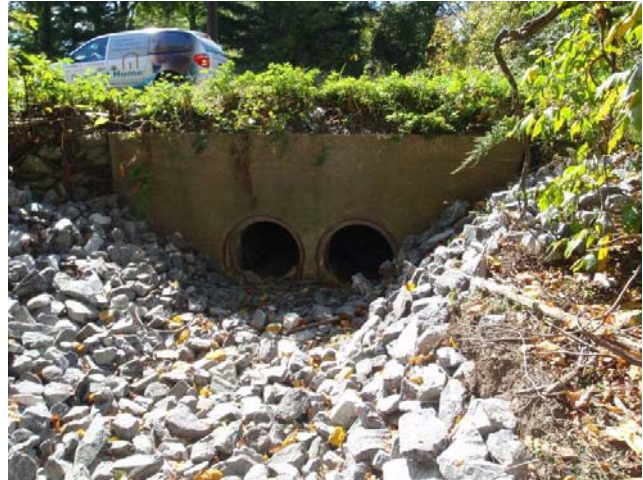
The pipes were built in 2-foot segments and there were some misalignments between the segments due to settlement. The site was selected because: (a) the structure was easily accessible on both ends; (b) the length was reasonable, (c) traffic safety was not needed and (d) space was available next to the site for preparation of rehabilitation materials.

The pipes were fitted with new plastic pipe liners after they were damaged by utility relocation construction work. At this point, it was decided that more work could not be done at this site. Since an alternative site could not be found within a timely manner, the research work was concluded at this site.

A two stage repair method, of the twin culverts selected, was determined to be the most cost effective means of rehabilitation. In the first stage of rehabilitation, the misaligned joints and the broken segments were fixed with fiber reinforced rapid set composite that has minimum or no shrinkage. This composite had to be applied with various thicknesses and therefore a Portland based system was chosen. High strength composites are very efficient for application where thin coatings are suitable.
