In Place Rehabilitation of Pipes Using Polymer Composites

FINAL REPORT
December 2010

1. Report No. FHWA NJ-2010-012		2. Government Accession No.		3. Recipient's Catalog No.	
4. Title and Subtitle FINAL REPORT In Place Rehabilitation of Pipes Using Polymer Composites				5. Report Date December 2010

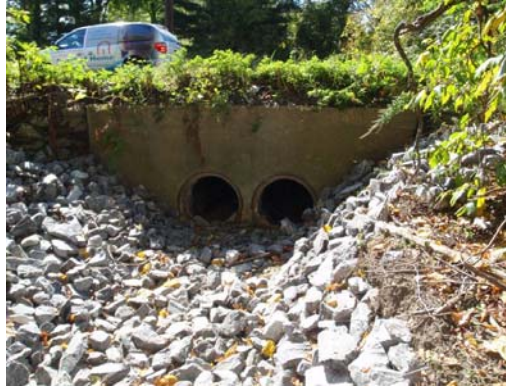
Pictures of the two culverts are shown in Figures 2, 3 and 4. The pipes were built in 2-foot segments and there were some misalignments between the segments due to settlement. The site was selected because: (a) the structure was easily accessible on both ends; (b) the length is reasonable, (c) traffic safety is not needed and (d) space is available next to the site for preparation of rehabilitation materials.

Figure 2. Clay pipe culvert: view of inlet side

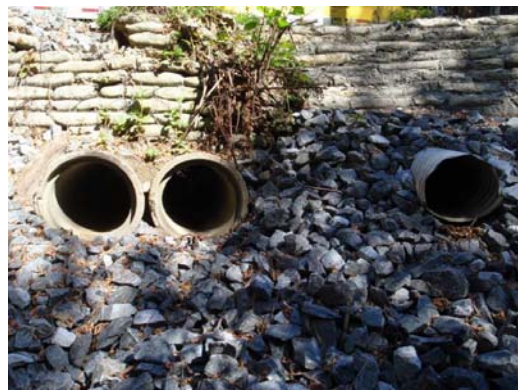
Figure 3. Clay pipe culvert: view of outlet side

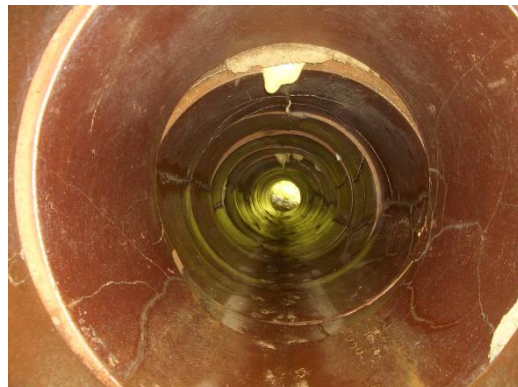
Figure 4. Clay pipe culvert: view of interior

The pipes were in reasonable condition. The joints between the pipes were deteriorated, and in certain locations, the joints had become misaligned due to settlement. This misalignment created gaps in the joints.

Additionally, there were three locations where the pipes were broken. The primary weaknesses, therefore, were the misaligned joints, the broken pipe segments and the joint between the clay pipe and the end concrete pipe.

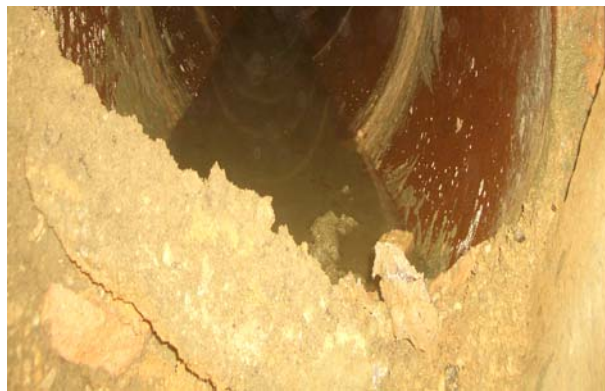
During late September 2009, there was local utility relocation construction work that was conducted perpendicular and above the twin pipe culverts. This utility relocation construction work resulted in a cave in of the twin pipe culverts, resulting in the pipes filling up with soil and other construction debris, as shown in Figure 10.

Figure 10. Damage caused to culvert by utility relocation work

Although Gloucester County water jetted the pipes clean within weeks of the cave-in, the research team couldn't apply the inorganic polymer coating because of the cold temperatures and wet conditions during the late fall of 2009.
