Compatibility of Highway Railroad Crossing Gates with  
Overhead Catenary System High Voltage Power for Trains

Final Report  
June 2010

This report describes an investigation to determine the root cause of the incidents. Using information from known incidents along with site investigations, analysis is presented to identify crossings with the potential for line-to-earth faults or gate arm entanglement. Modifications are suggested for sites identified as having potential problems are presented.

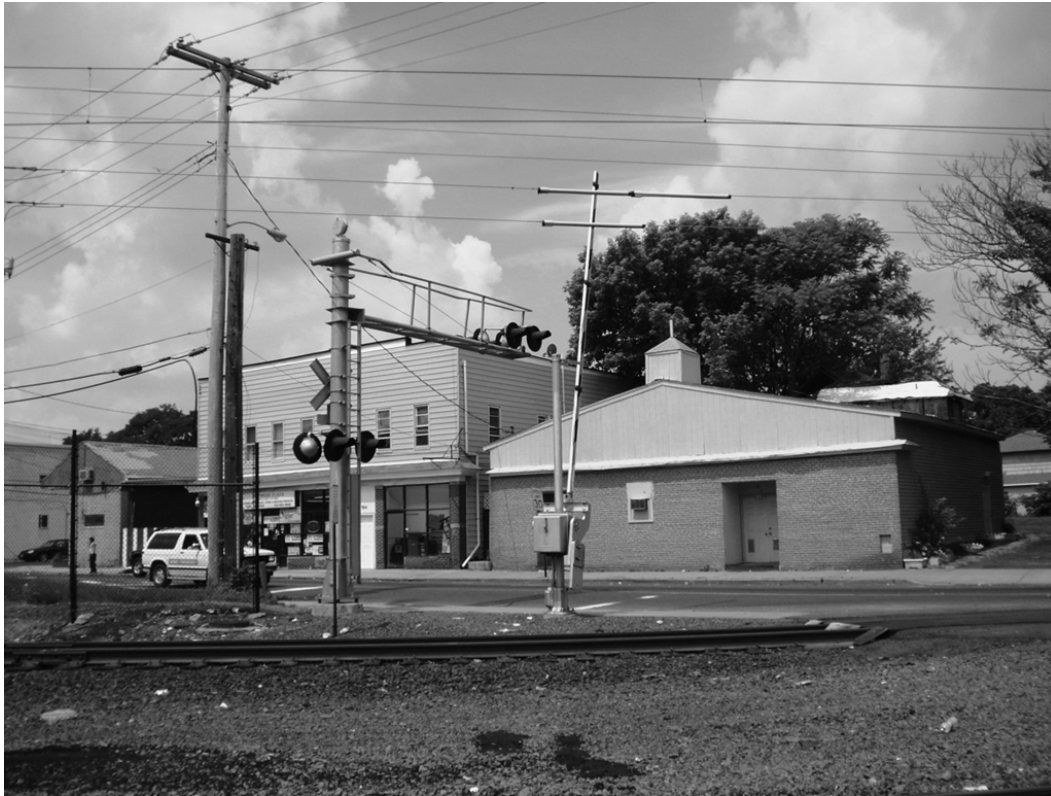
A crossing gate at Westwood Ave. on the NJCL is shown in Figure 16. Two noticeable modifications to this site are insulated wires and the gate arm mechanism has been adjusted so that the gate arm is not completely vertical when it is in the up position.

Figure 16. Insulated power lines at the Westwood Ave. crossing on the NJCL

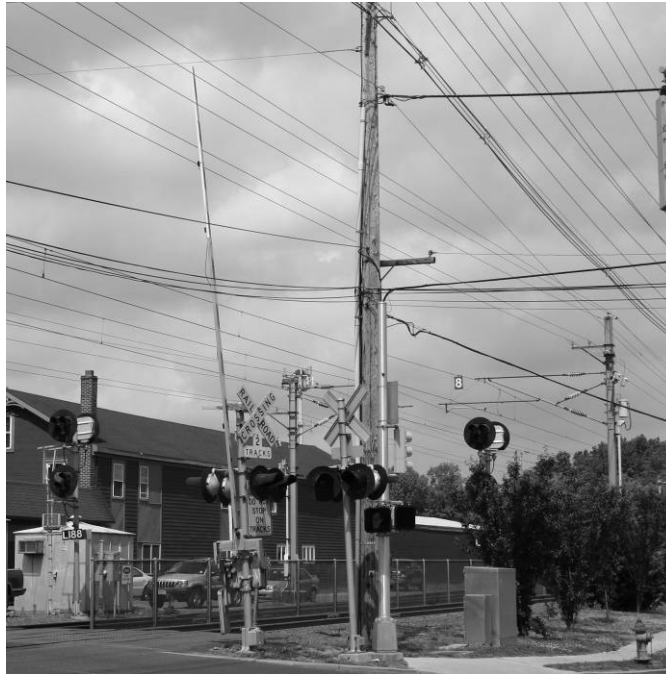
Figure 30. NW crossing gate

Observation of the northwest and southeast gate arms suggest both gate arms are capable of contacting the signal power wires and the catenary wires. The pedestrian crossing gate arm is not long enough to contact any wires, and has not been identified in any incidents.

The northwest crossing gate arm is shown in Figure 30. Not seen in the figure is the difference between the support structures of track 1 as opposed to track 2. The support structure of track 1 is actually lower than that of the support structure for track 2. As a result of this, signal power wires have a 6 foot difference in height.

During a site visit on June 13, 2005 at approximately 10:30 AM it was observed that the northwest bound gate arm made repeated contact with the signal power wires. This was the result of swaying of the arm in the wind. Weather information provided for the previous mentioned date has the maximum wind speed approximately being 10 mph and at the time of the visit, the recorded average wind speed was approximately 6 mph. As these wind speeds are not unusual for this location, it appears as though this contact occurs regularly. However, with the tip flashing light relocated below the level of the signal power lines, it appears to be unlikely that this contact will lead to entanglement.

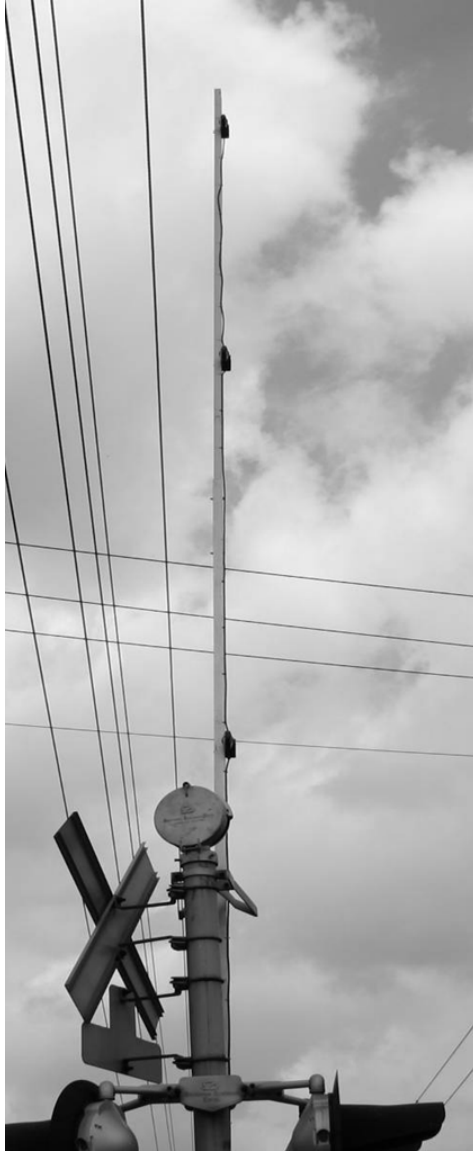
Figure 33. Crossing gate arm at SE corner

Figure 33 shows a close-up image of the southeast crossing gate arm. The spacing of the flashing light units here is typical of that found on most NJCL crossing gate arms. Clearance is approximately eighteen inches. While it is difficult to discern from the figure, this gate would contact the nearby wires at its very tip, below the tip flashing light.

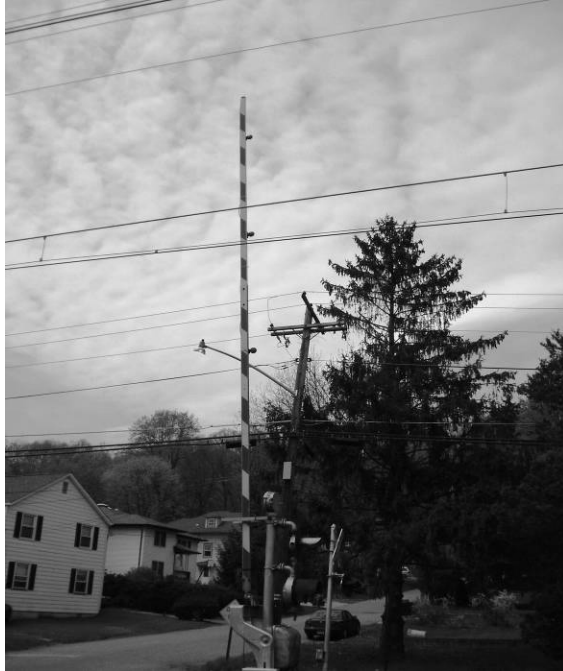
Figure 36. Northern crossing gate

The northern gate arm depicted in Figure 36 has had a known incident with the catenary wire. From data acquired from site visits and information provided by NJ Transit, it is found that the horizontal distance between the gate mechanism and the catenary is between 8 to 10 feet. Using the length of the gate arm of 32 feet, it is possible for the gate to touch the catenary line.

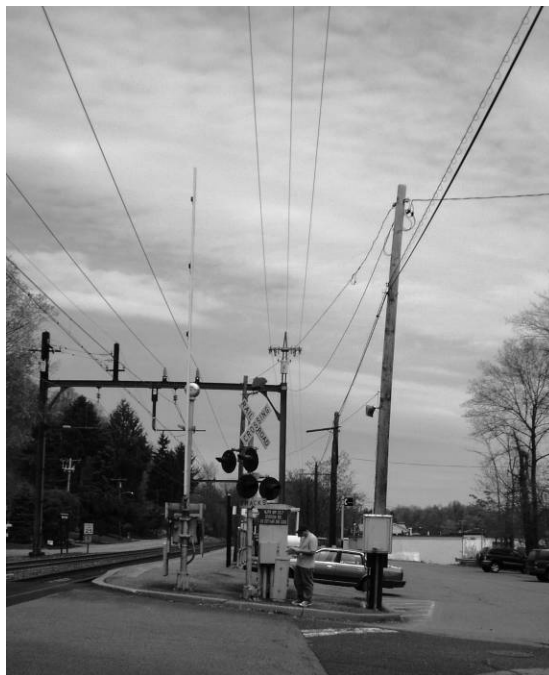
Figure 37. Eastern crossing gate

The eastern gate is shown in Figure 37. This figure also includes the feeder line and the signal mast. The horizontal distance here is approximately between 8 to 10 feet. With having a gate arm with length of 24 feet it is found that the feeder line of the catenary and the gate arm are approximately the same.

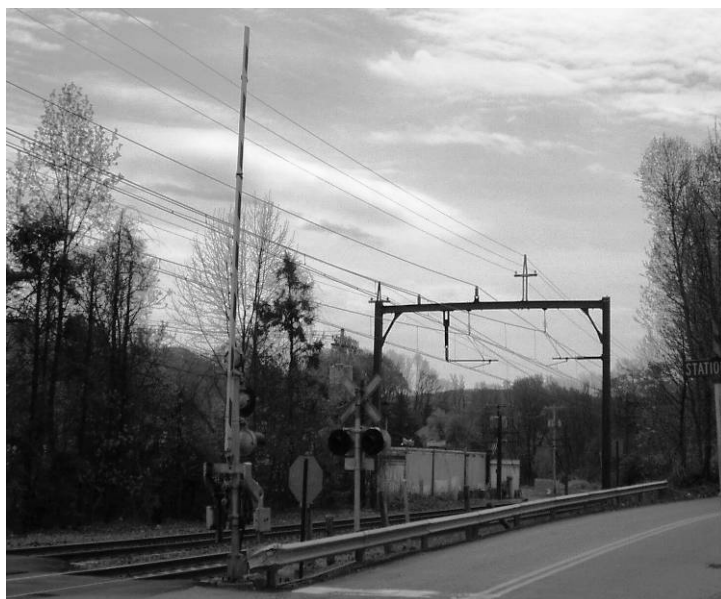
Figure 38. Southern crossing gate and support structure

Figure 38 shows the southern gate arm. Once again, using a horizontal distance of 8 to 10 feet and a gate arm length of 23 feet, it is possible for this gate arm to touch the catenary.

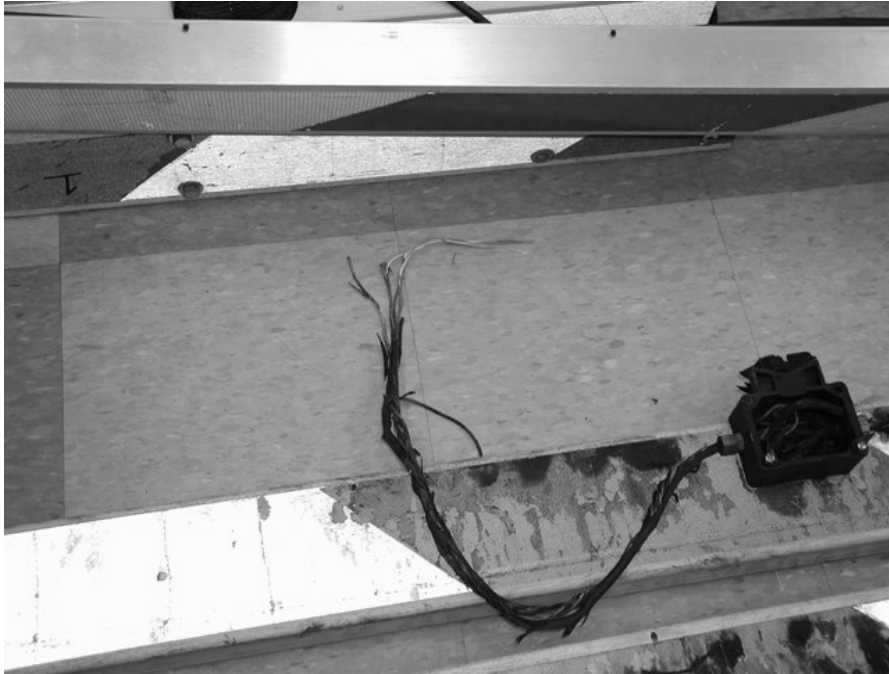
Figure 40. Damaged gate arm, flashing light unit, and copper wire

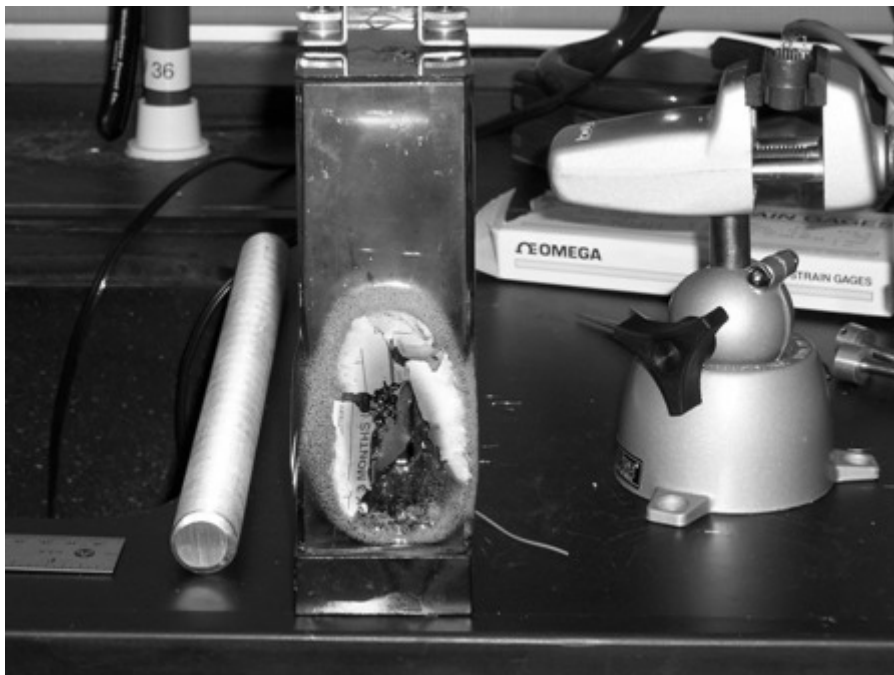
Figure 41. Damaged relay

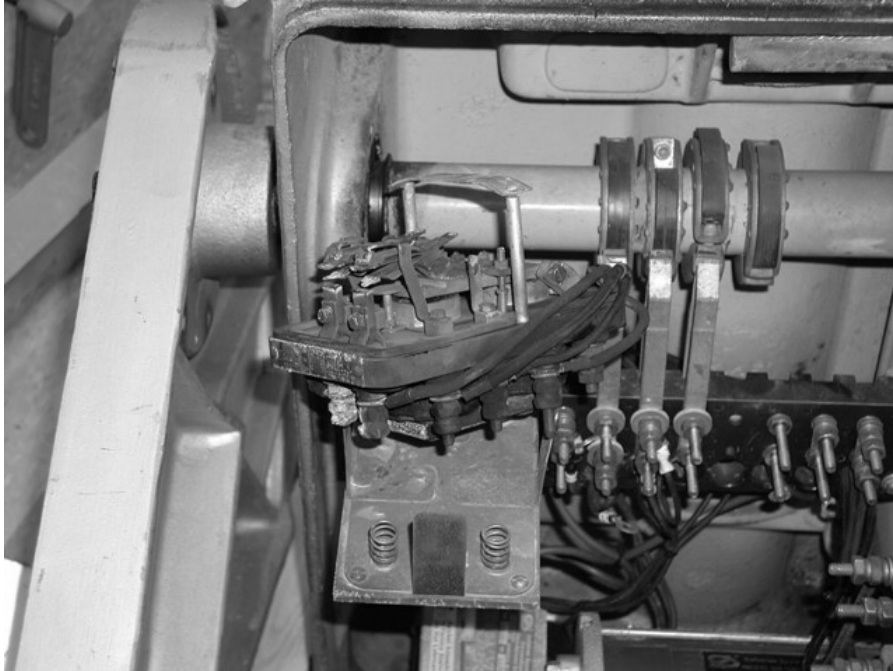
Figure 44. Internal damage to gate arm mechanism
