**New Jersey Department of Transportation
CORRECTIVE ACTION NOTICE**

CAN No. CAN057

Subject: Beam Guide Rail End Treatment

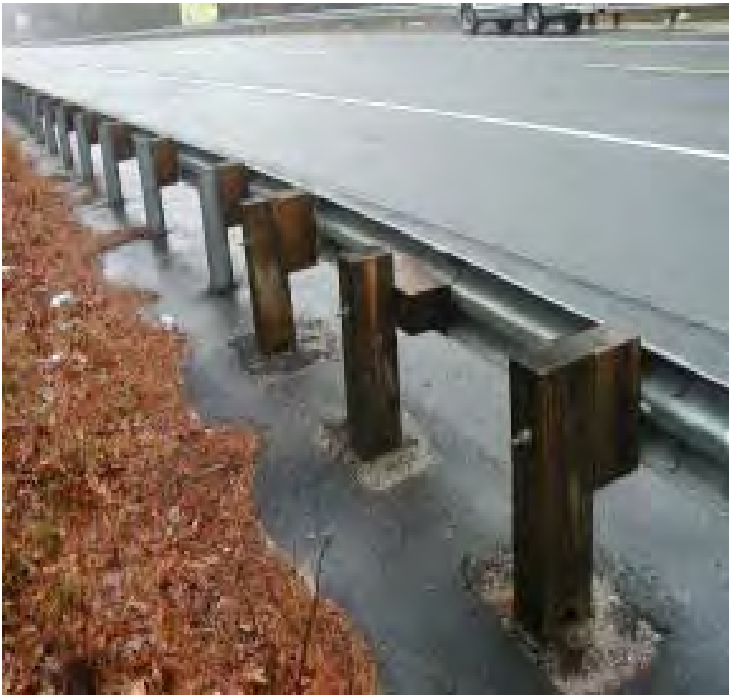
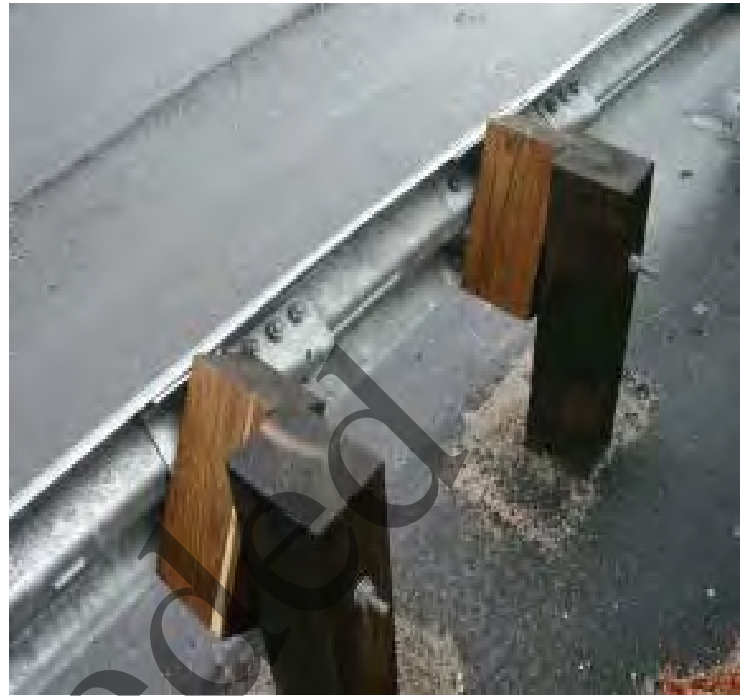
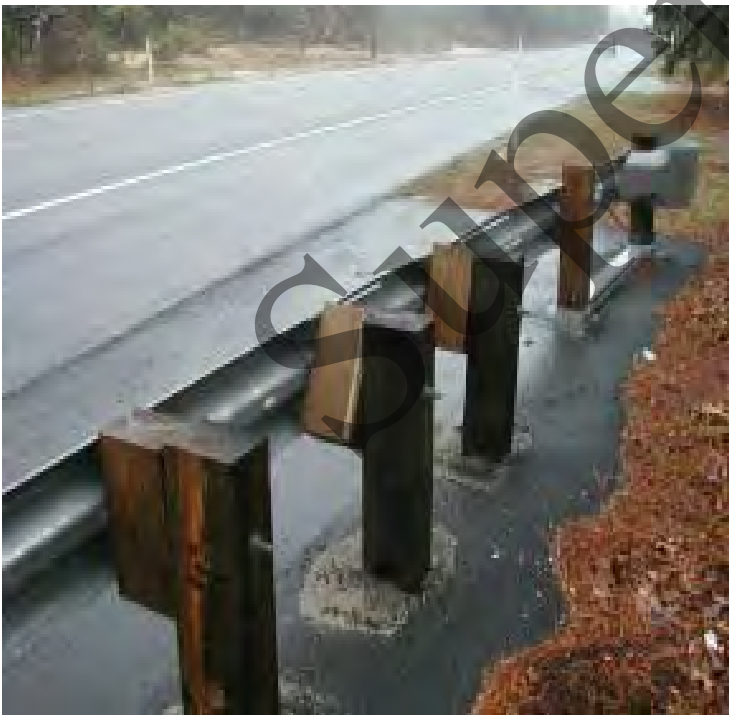
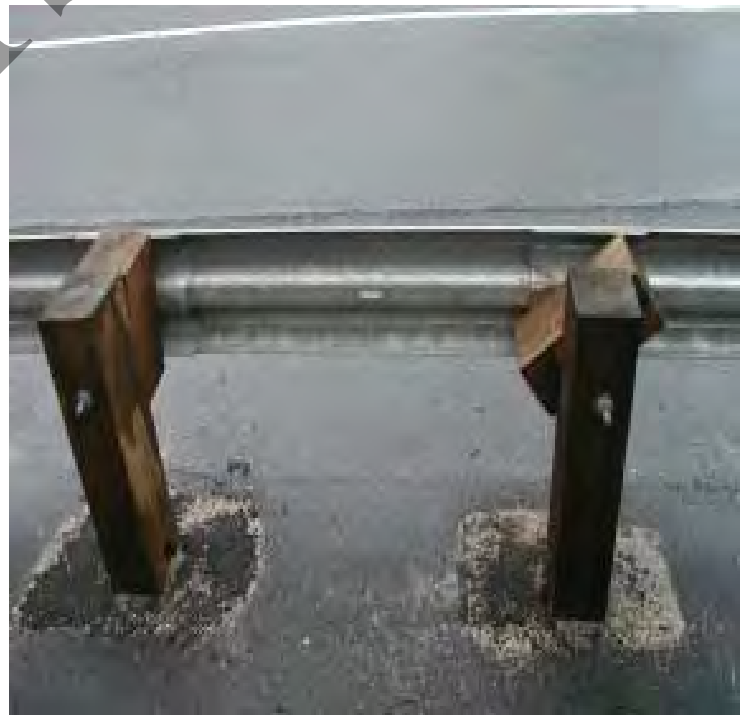
A recent field inspection by staff of the Traffic Signal and Safety Engineering Unit revealed that wood blockouts on several guide rail end treatment installations are not nailed to the posts. As a result, as the wood weathers and dries out, the blockouts are free to rotate (see-attached pictures).

The requirement to nail the wood blockouts to the posts is part of the manufacturers' installation instruction for beam guide rail end treatments. Guide rail end treatments were tested and approved based on these installation procedures. Failure to comply with them may result in the systems not performing properly.

To address the above situation, after the blockout is attached for the types of guide rail end treatments listed below, a galvanized steel 10d common nail must be driven through the block and into the post to prevent rotation when the wood shrinks. The intent of this Corrective Action Notice is to advise Resident Engineers and other Construction personnel of this installation requirement for future construction contracts.

This installation requirement applies to the **FLEAT 350, SKT 350, SRT 350, and ET 2000** end treatments. For additional information, the installation manual can be downloaded from the manufacturer's web site at: www.roadsystems.com for the FLEAT 350 and SKT 350 end treatments, and at: www.highwayguardrail.com for the SRT 350, and ET 2000 end treatments.
