STATE OF NEW JERSEY
DEPARTMENT OF TRANSPORTATION

Composite Pavement Rehabilitation Techniques

By Robert J. Blight
Principal Engineer
Pavement Management & Technology

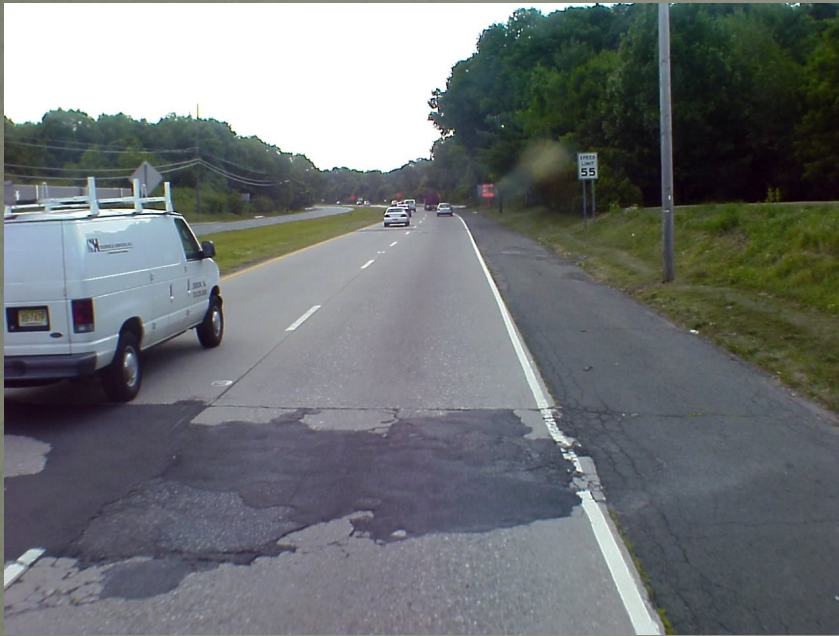
Before Rehab

- SDI = 2.07
- Ride Quality
 - MP 13.4-14.75, IRI=197.2
 - MP 14.75-15.25, IRI=154.7
 - MP 15.25-15.75, IRI=143.8
 - MP 15.75-17.03, IRI=151.5
 - Ride Quality for the project, IRI=168.6

- Visual Survey of JRC Pavement
- Rehab. Design of Asphalt Outside Shoulder
 - Roadway Excavation
 - Pave with 3" min. & var. 25M64 Base Course
 - Pave with 4" (2 lifts) of high quality HMA
- Full Depth Concrete Repairs with Very Early Strength Concrete
- Overlay Design with 4" (2 lifts) of high quality HMA
- 3 test sections and 1 control section

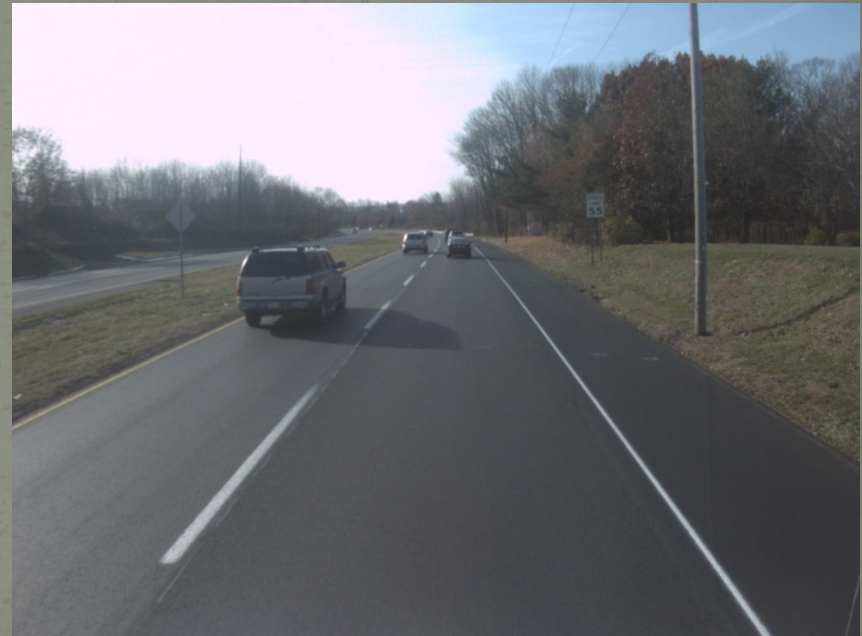
After Rehab

- SDI = 5.0
- Ride Quality
 - MP 13.4-14.75, IRI=88.3
 - MP 14.75-15.25, IRI=78.0
 - MP 15.25-15.75, IRI=77.7
 - MP 15.75-17.03, IRI=75.0
 - Ride Quality for the project, IRI=80.4

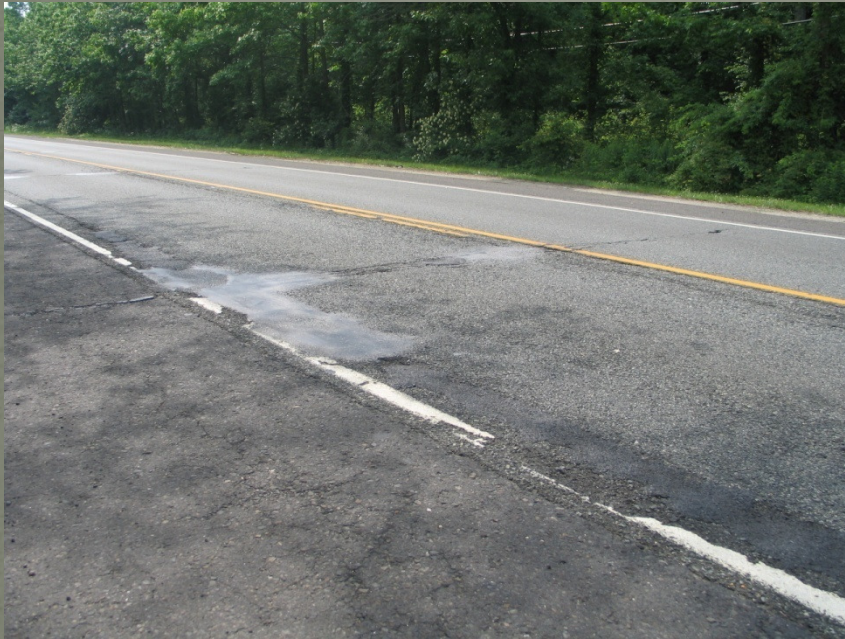
Before Rehab

- SDI = 1.56
- Ride Quality IRI = 157

- Visual Survey of Composite Pavement
- Cores performed to establish proper milling depth
- Full Depth Repair areas identified by visual survey
- Calculated approximately 5 million ESAL's
- Quantity for Slab Stabilization estimated from FWD testing
- Overlay Design consisted of milling 2" depth and resurfacing with:
 - 1.5" Superpave HMA 9.5H76 Surface Course
 - 2.5" Superpave HMA 12.5M76 Intermediate Course

- Located high deflection joints (> 15 mils deflection) with FWD during construction
- Failed joints were successfully (reduced deflection < 10 mils) grouted with HDP by Uretek
- Full Depth Repairs with HMA were performed on high severity joints/areas

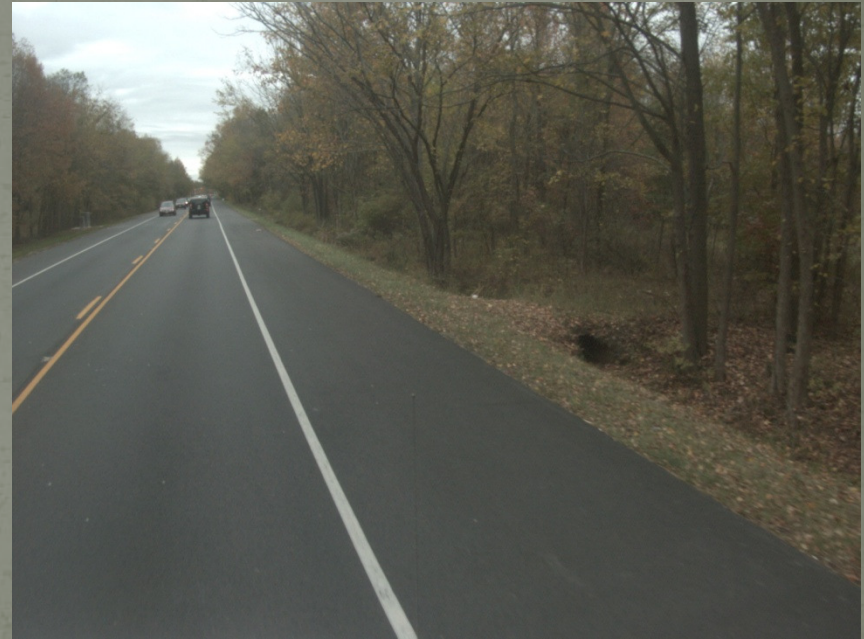
After Rehab

- SDI = 4.9
- Ride Quality IRI = 94
