BRIDGE RE-EVALUATION SURVEY REPORT

STRUCTURE NO. 3XXX-XXX
ROUTE I-287 SB OVER DARLINGTON AVENUE (CR 98) AND DARLINGTON BROOK
MAHWAH TOWNSHIP
BERGEN COUNTY

SAMPLE REPORT
(FOR GUIDANCE ONLY)

6TH CYCLE
May 27, 2005

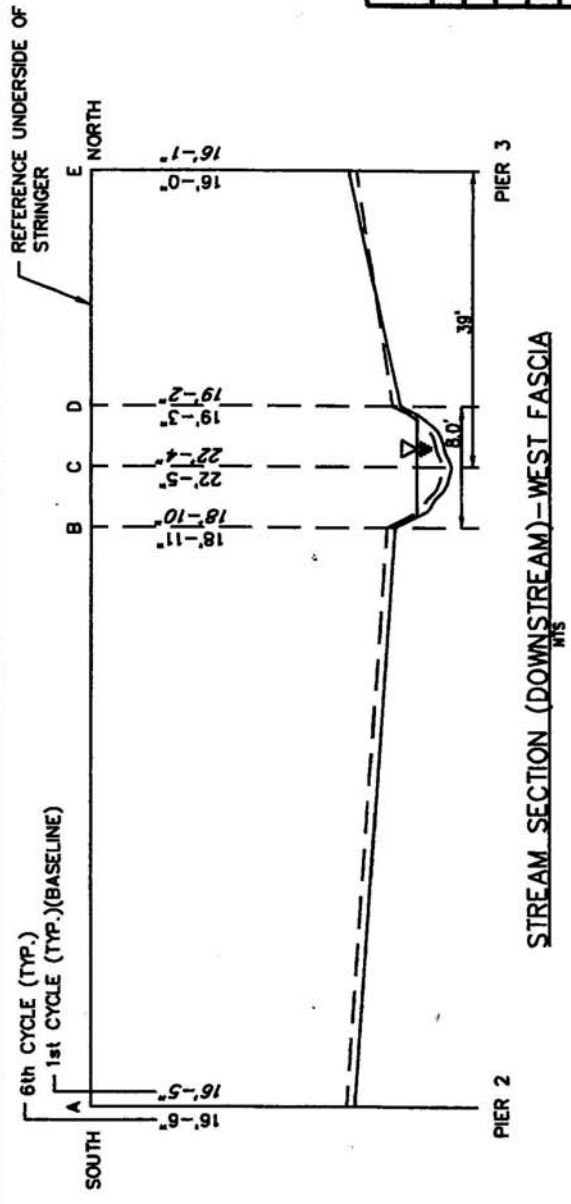
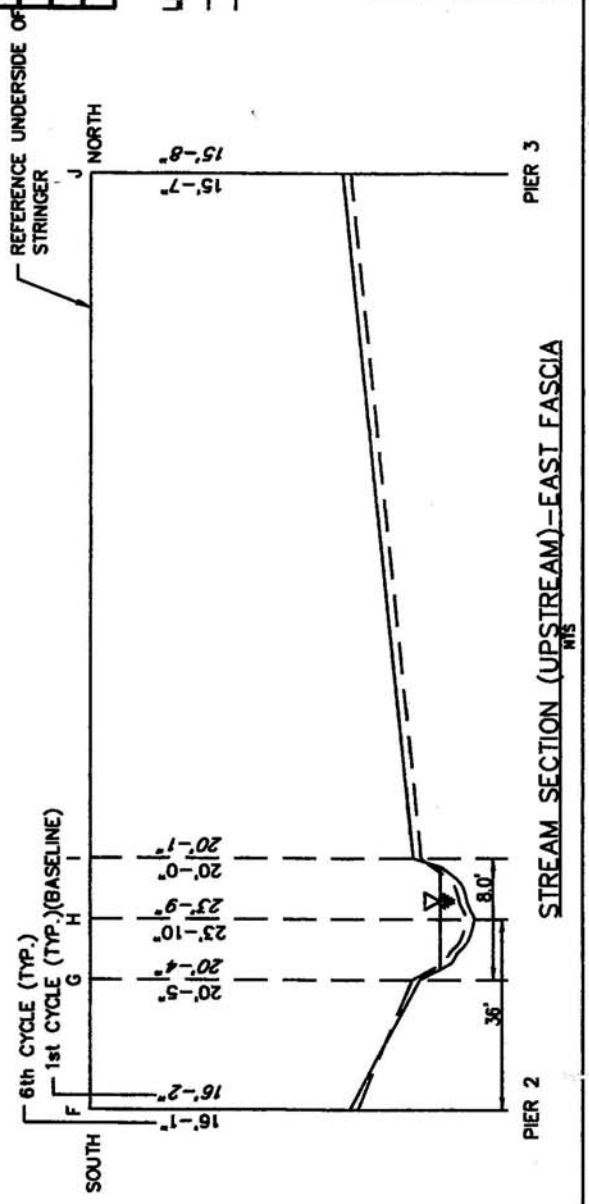
- NOTES:
1. REFERENCE UNDERSIDE OF STRINGER TO STREAMBED.
 2. PIER FOUNDATION INFORMATION NOT AVAILABLE.

POINT	CYCLE 1		CYCLE 6	
	CLEAR DIMENSION	WATER DEPTH	CLEAR DIMENSION	WATER DEPTH
A	16'-5"	--	16'-6"	--
B	18'-10"	--	18'-11"	--
C	22'-4"	--	22'-5"	0'-7"
D	19'-2"	--	19'-3"	--
E	16'-1"	--	16'-0"	--
F	16'-2"	--	16'-1"	--
G	20'-4"	--	20'-5"	--
H	23'-9"	--	23'-10"	0'-8"
I	20'-1"	--	20'-0"	--
J	15'-8"	--	15'-7"	--

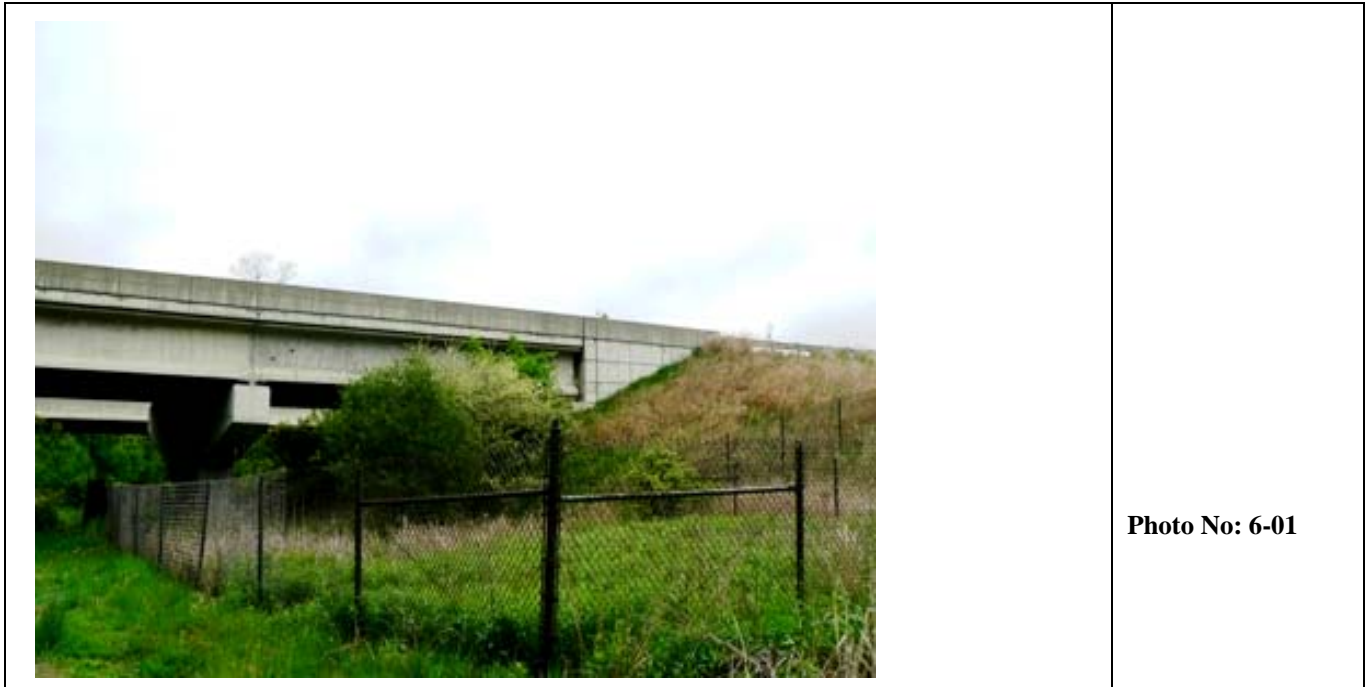
Photo No: 6-01

Location:	West elevation (span 1), looking East.
Description:	General View.

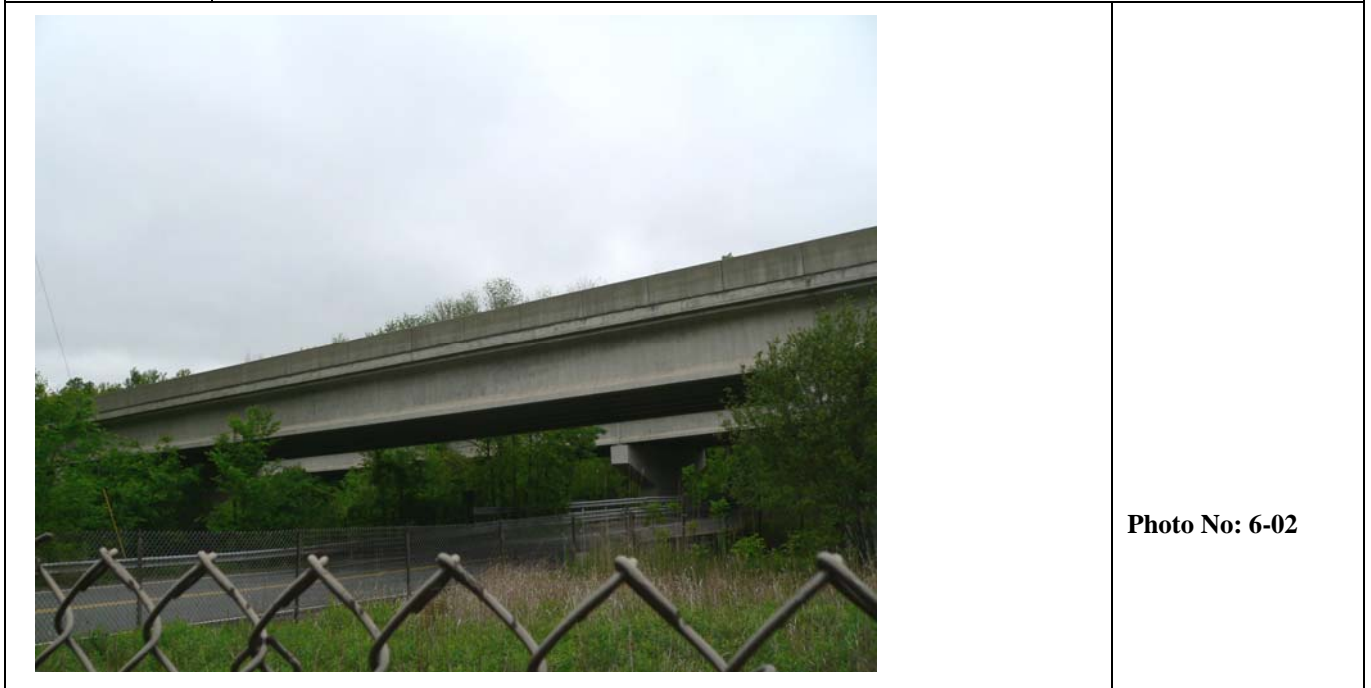
Photo No: 6-02

Location:	West elevation (span 2), looking Northeast.
Description:	General View.

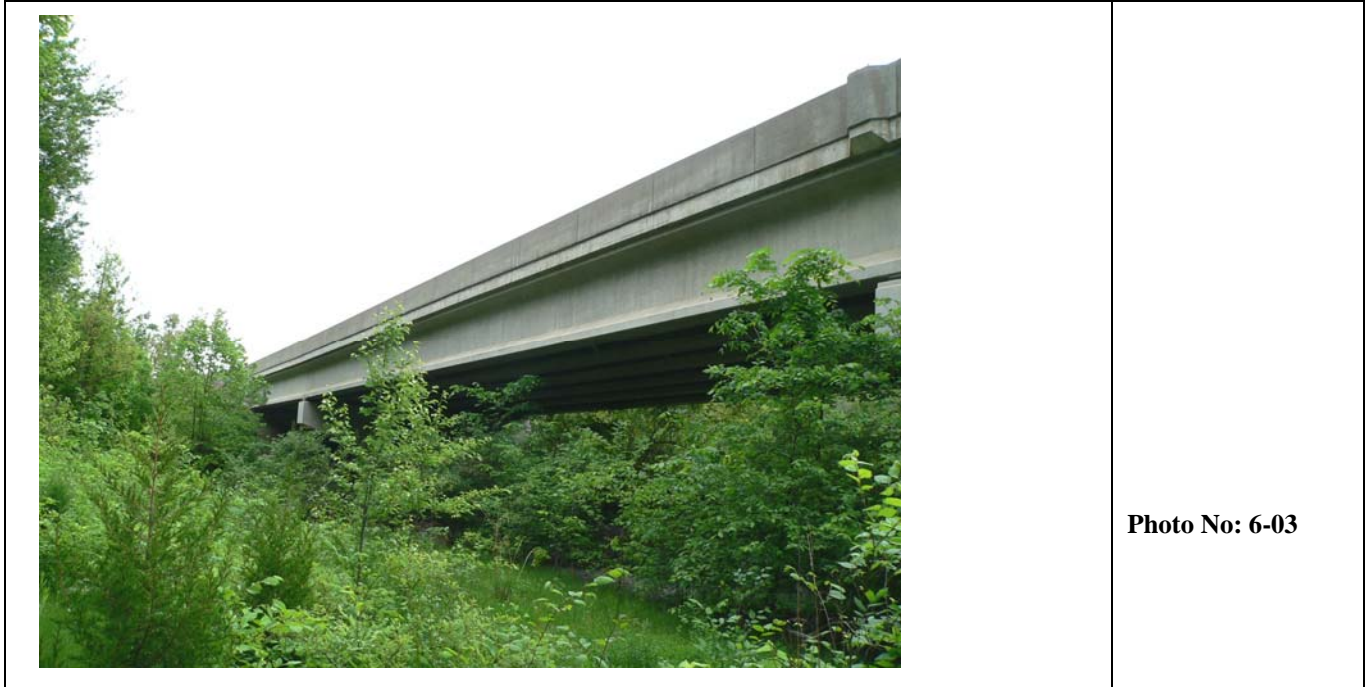
Photo No: 6-03

Location:	West elevation (spans 3 & 4), looking Northeast.
Description:	General View.

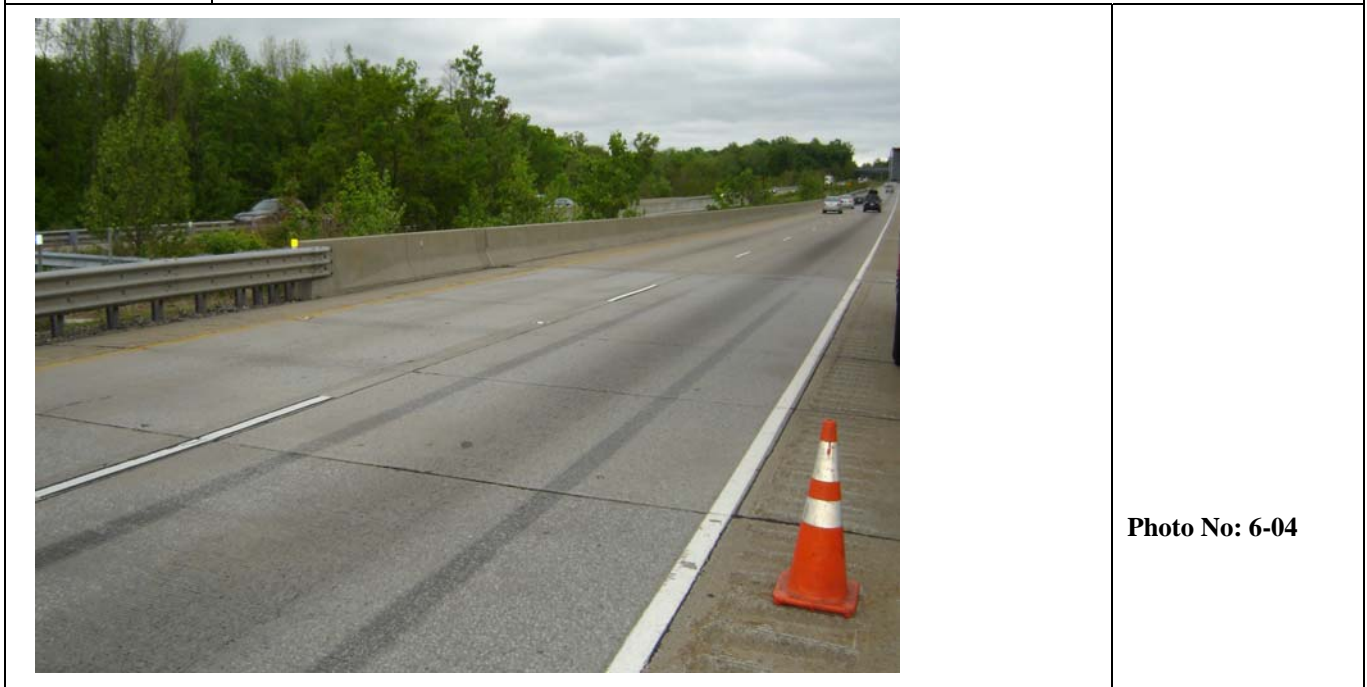
Photo No: 6-04

Location:	North approach roadway, looking Southeast.
Description:	General View.

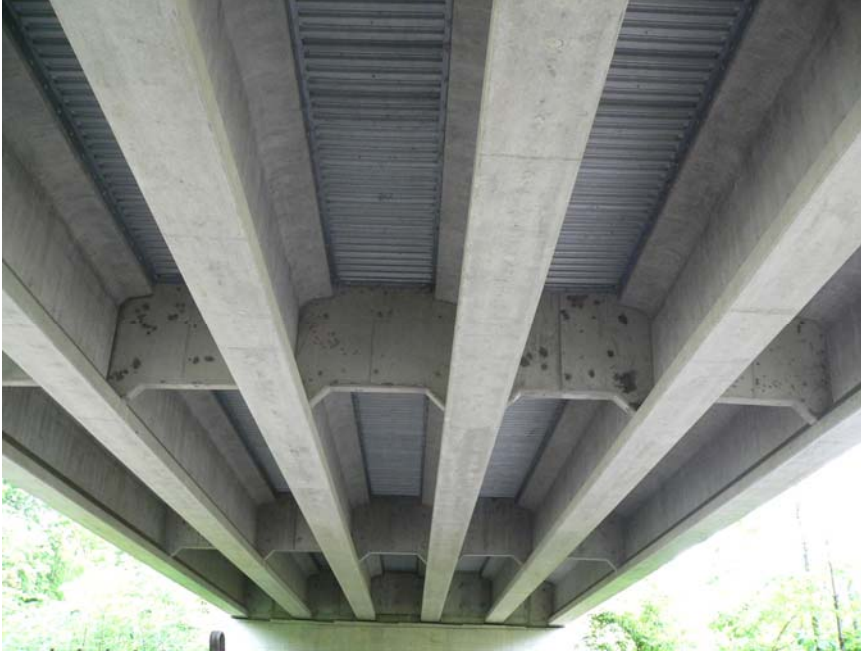
<p>Photo No: 6-05</p>
<p>Location:</p>	<p>Superstructure in span 2, looking North.</p>	
<p>Description:</p>	<p>General View.</p>
