**ENGINEERING INVESTIGATION & ANALYSIS
GEOTECHNICAL & STRUCTURAL
ASSESSMENT REPORT**

**112 BIG PIECE ROAD
FAIRFIELD, NEW JERSEY 08203**

Matrix No. 20-1052

August 2021

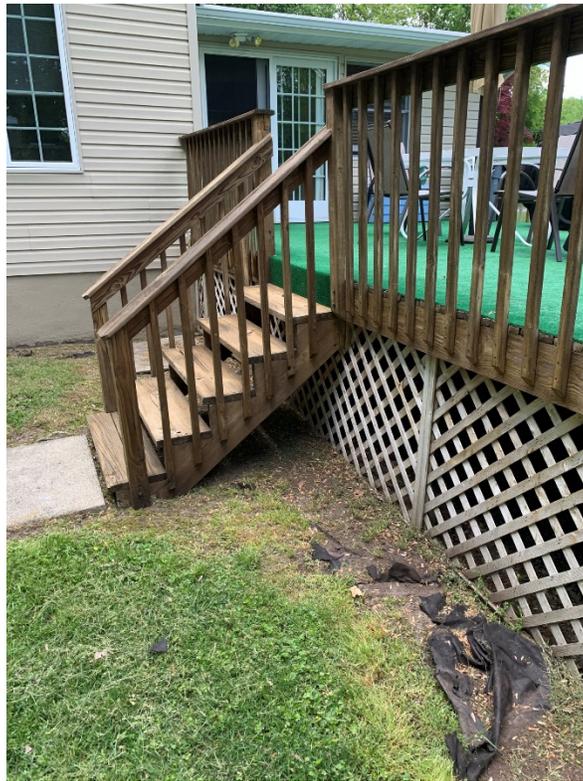
A timber deck was observed in the rear of the building, matching the width of the southeast addition of the house. The deck's timber subfloor is supported by timber posts embedded in concrete Sonotube footings. The deck floor, which is level with the first floor of the house, ranges from 35" to 52" above the adjacent exterior grade.

Photo 3. Rear of Building with Timber Deck

The southeast addition of the building is assumed to currently contain a concrete floor slab above CMU stem walls. The existing floor of this area will need to be demolished and removed, along with the fill soil beneath. The perimeter foundation walls will then be raised as described above, and the area filled in to match the existing adjacent grade. Following raising of the foundation walls, a new timber subfloor will need to be constructed for the addition area to replace the removed concrete floor slab. Additionally, the rear timber deck is anticipated to require raising to match the current ingress/egress heights of the main structure. This would require replacement or extension of the timber support posts.

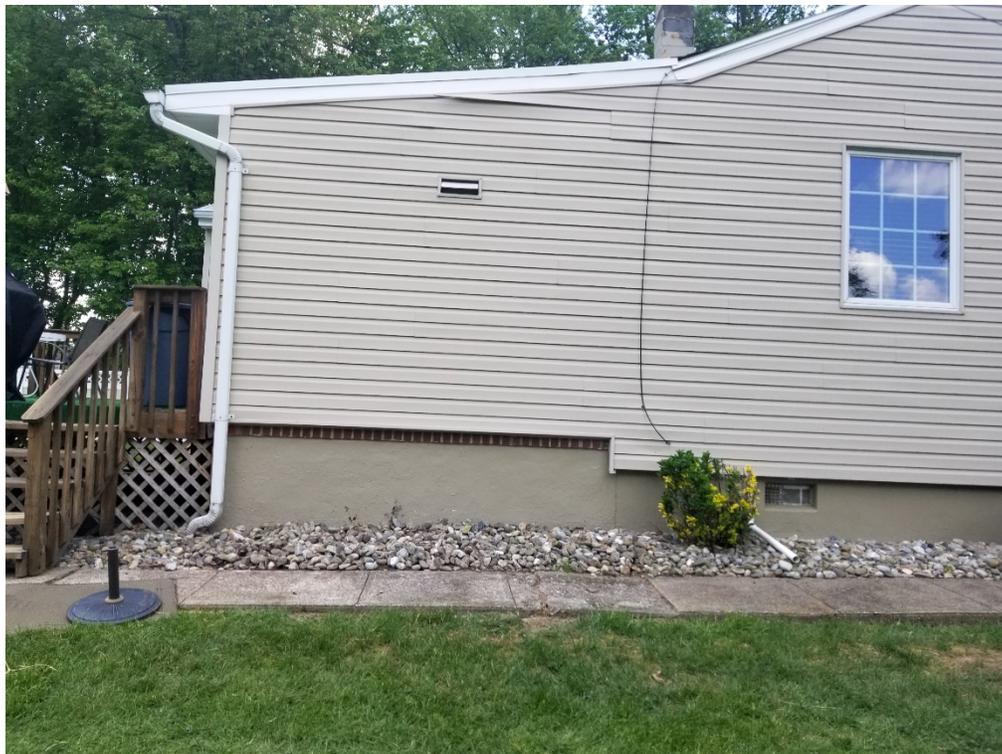
Adjacent to the front crawl space, to the south, is an addition to the house that connects the original building to the rear deck. This portion of the house sits atop a foundation system that could not be observed at the time of the inspection, as there is no crawl space or basement underneath. This area of the house is assumed to consist of a concrete floor slab supported by perimeter stem walls, with the space below the slab filled in with soil.

Photo 4. Southeast House Addition (Looking Southwest)

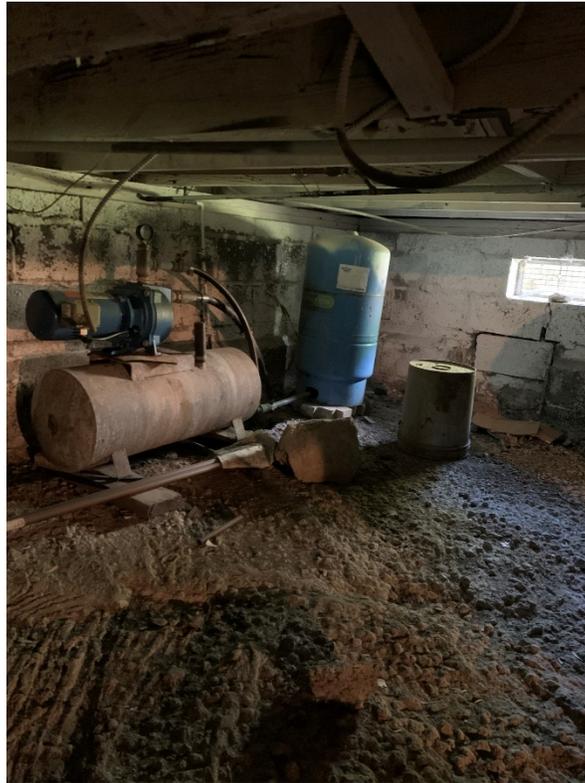
Various pieces of equipment and machinery were observed within the front crawl space of the building at the time of the inspection. The southwest pit within the crawl space floor contained a sump pump with PVC piping leading out the east side of the house. Also observed in the front crawl space was an electrical panel along the south wall (5" above the crawl space floor), a fuel storage tank on 4" high concrete blocks (currently out of service as per homeowner), and a water well pressure tank system in the northeast corner of the space. This system consisted of two storage tanks and a pump, with both tanks situated on 2" high stone/wood pedestals. Multiple PVC and metal pipes were also observed running through the front crawl space at varying elevations.

Photo 5. Water Well Pressure Tank & Pump System in Front Crawl (Looking North)

Additionally, any service equipment, whether outside or in the crawl space/ground floor rooms, such as air conditioning, heat pump compressors, gas meters, electric meters, and hot water heaters, must be elevated 3 feet above the BFE. For interior elements, this may include relocation to an upper floor and thus less usable living space. For this residence, the hot water heater and boiler in the basement laundry room, as well as the electrical panel and water well pressure system in the front crawl space, would require elevating 3 feet above the BFE onto the raised first floor. The exterior air conditioning unit and gas meter would also require elevating 3 feet above the BFE on a new or extended exterior platform.

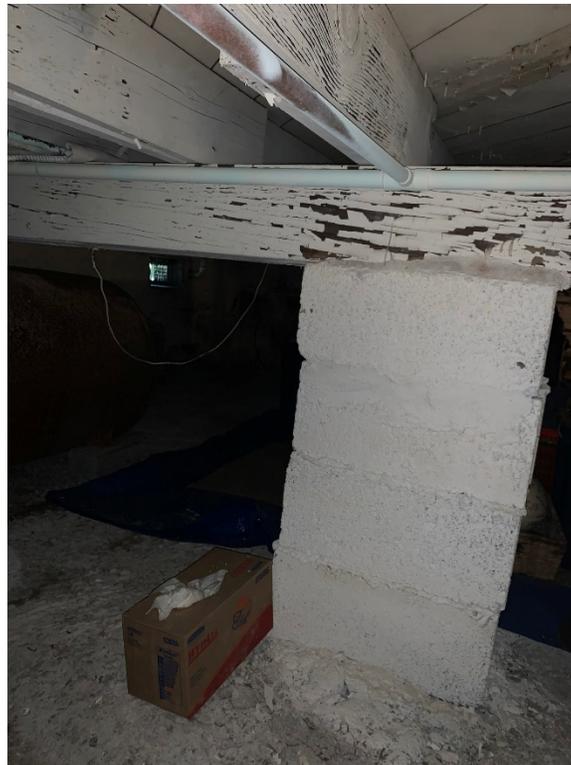
Encompassing the east portion of the house, beneath the first-floor level, is a rectangular crawl space with CMU foundation walls ranging from 35" to 37" in height. The first-floor surface above was measured at approximately 45" above the crawl space floor surface (surface is uneven). The CMU walls exhibited a 2" protrusion into the crawl space, approximately 12" above the crawl space floor. This likely signifies the use of 12" thick CMU blocks for the lower courses of the foundation walls. The subfloor of the level above is comprised of nominal 2x8 timber joists, spaced 16" on center, running north to south (front to rear of building). A support girder consisting of (3) nominal 2x8 timber beams runs perpendicular to the floor joists to provide additional support along the center of the crawl space. The girder bears on the CMU foundation

walls at each end and is supported at its midspan by a CMU block column consisting of (4) stacked 8x8x18 blocks. In the southwest corner of the crawl space, next to the entrance opening, a small pit was observed that was approximately 15” lower than the rest of the crawl space. The purpose of this pit is unknown.

Photo 6. Timber Floor Joists & Girder on CMU Pedestal (Front Crawl Space)

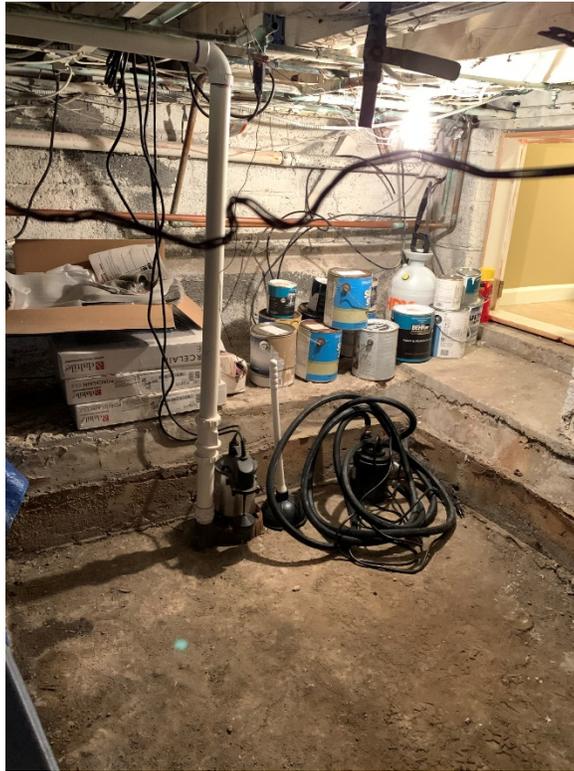
Photo 7. Pit with Sump Pump in Southwest Corner of Front Crawl Space (Looking South)

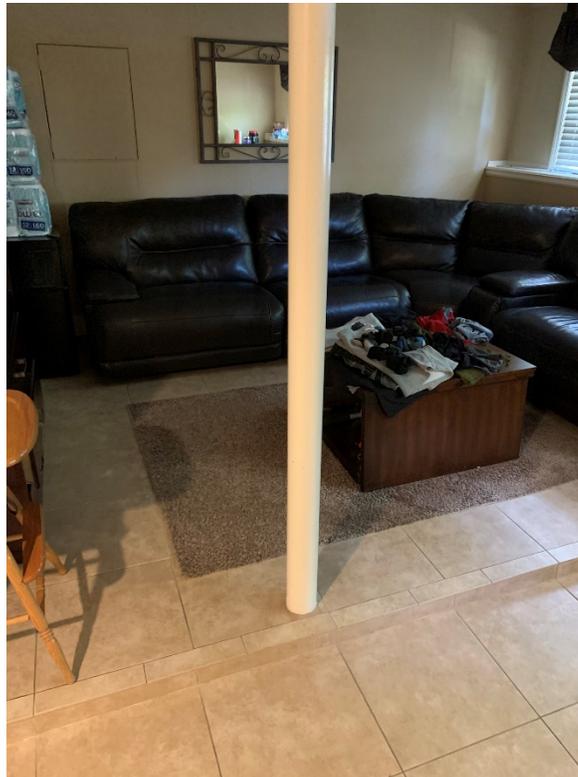
Photo 8. Steel Support Post in Basement (Looking West)

subfloor, must be removed and replaced by new steel, concrete, or masonry block columns. The new columns will need to include spread footings beneath to sufficiently support the building loads.

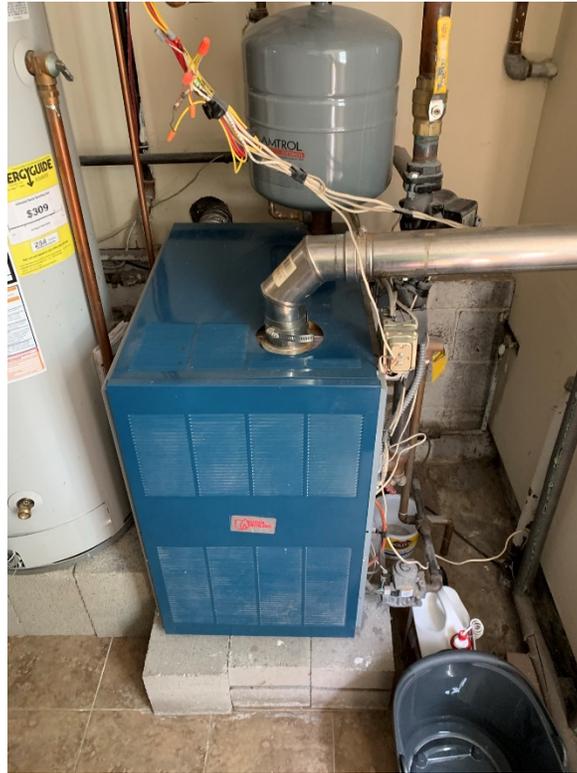
Within the laundry room in the southwest corner of the basement, a boiler, water heater, washer, and dryer were observed. The washer and dryer were located on the floor of the basement, while the water heater and boiler were raised approximately 11.5" and 7.5", respectively, above the basement floor on CMU block pedestals.

Photo 9. Boiler & Water Heater in Laundry Room (Looking Southeast)

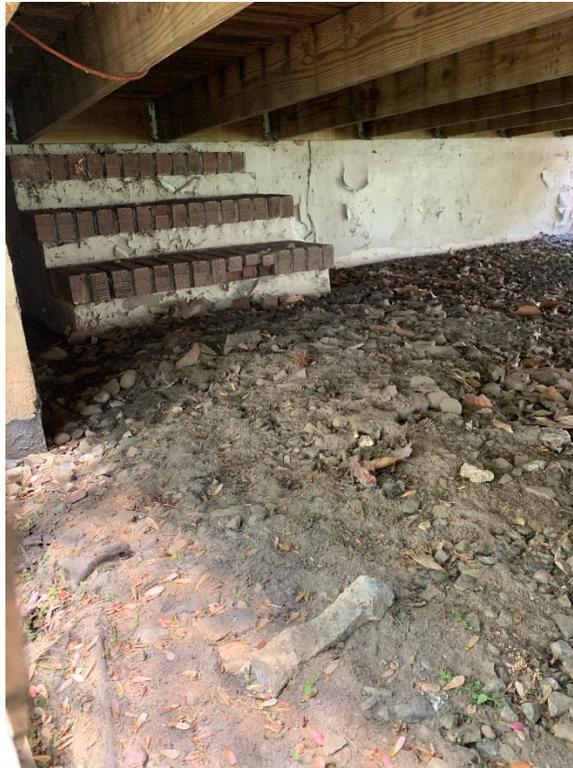
Along the south wall of the southeast house addition, brick stairs were observed beneath the rear timber deck leading up to the floor of the addition. These stairs are assumed to have once led to a rear entrance of the building, prior to construction of the rear deck.

Photo 10. Brick Stairs on South Wall of Southeast Addition (Below Rear Deck)

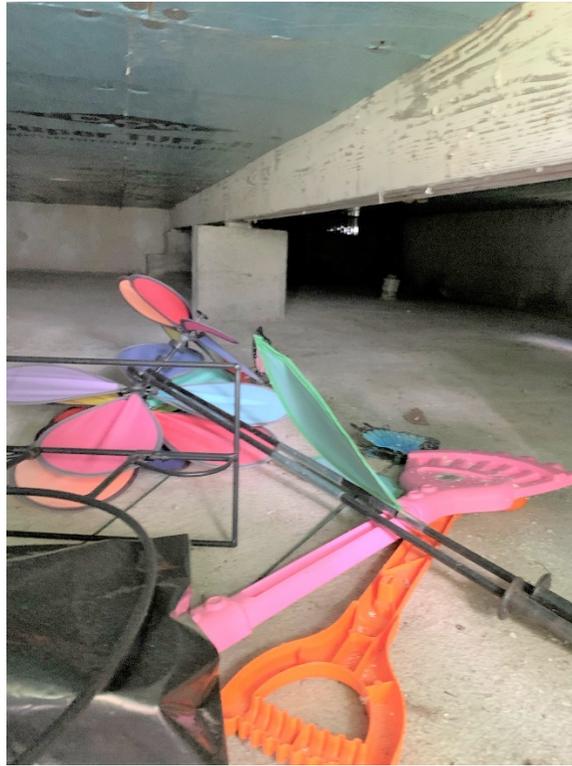
The rear southwest portion of the building, which appears to be another addition to the original building, is situated atop a second crawl space area with CMU foundation walls (same as front crawl space). The crawl space floor measured approximately 24” below the bottom of the insulated ceiling panels. This insulation covered the floor joists of the house, which could not be observed or measured. A girder consisting of (2) nominal 2x8 timber beams was observed running the length of the crawl space from, east to west, below the ceiling panels. This girder was supported at its end and at midspan by CMU block pedestals.

Photo 11. Timber Girder & CMU Pedestals in Rear Crawl Space (Looking Northeast)

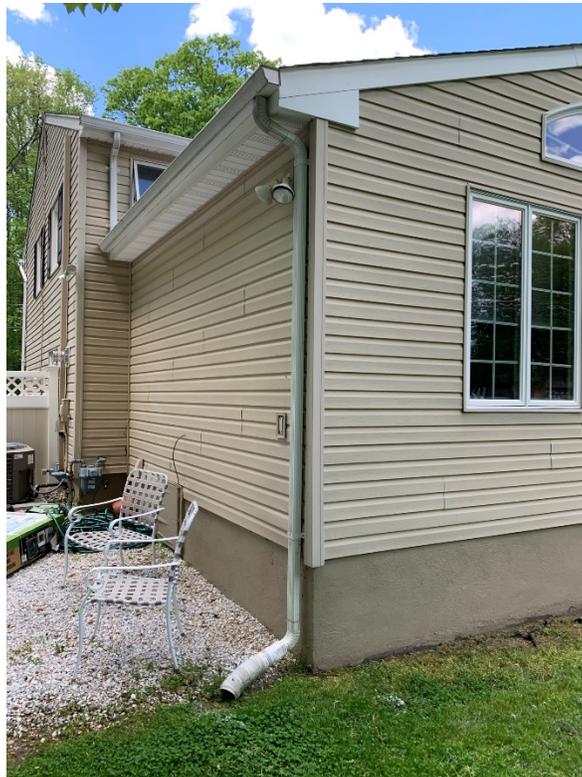
An air conditioning unit and gas meter were observed outside the building along the west wall. The air conditioning unit was situated atop a concrete pad that raised the unit approximately 5" above the exterior grade.

Photo 12. West Side of Building

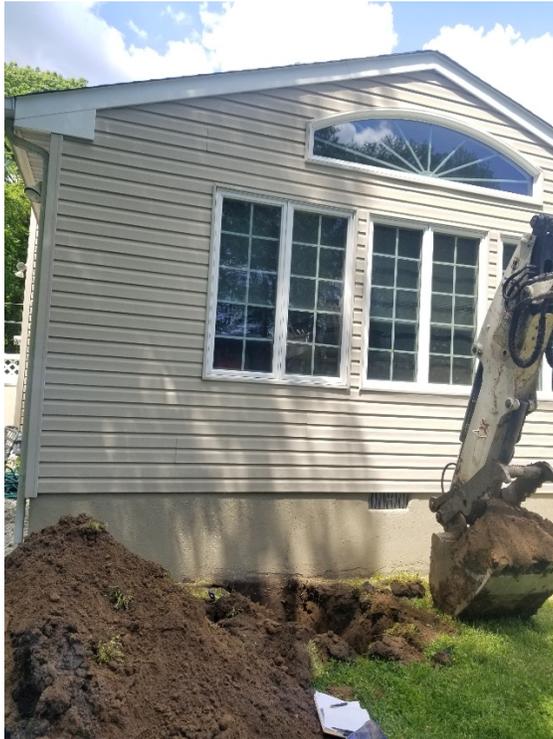
Photo 13. Test Pit TP-1 Location (Rear of Building – Rear Wall of Rear Crawl Space)

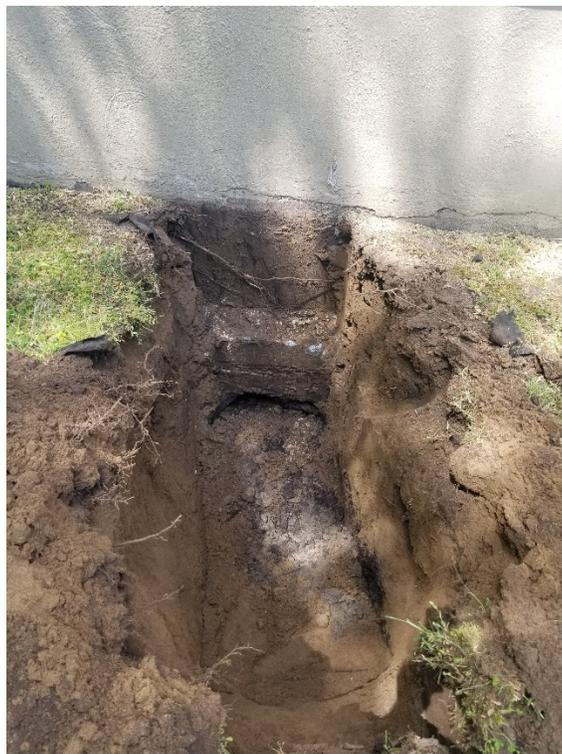
Test pits were conducted along the east wall of the southeast house addition and the rear wall of the rear crawl space. Below the foundation walls in the rear crawl space area, an approximately 12” wide concrete spread footing was revealed during the test pit excavation program. Based on our findings within the test pits and from conventional foundation construction, Matrix utilized a 16” wide footing as a minimum value for analysis, but believes the actual footings for the building to likely range from 16” to 24” in width. Prior to raising the house, Matrix recommends that the contractor confirm the foundation size and bearing adequacy with multiple test pits around the building perimeter.

Photo 14. Test Pit TP-1 Foundation Conditions

Matrix recommends that the existing foundation system of the residential building at 112 Big Piece Road be kept and extended to achieve the required design flood elevation. The existing CMU foundation walls and concrete footings are expected to provide sufficient support for the additional height of the newly raised building. Based on loading estimation and analysis for the existing building, Matrix estimates that the anticipated additional dead load of the required new courses of CMU would remain under an allowable bearing capacity of 2,500 psf for the shallow concrete strip footings at the Site.

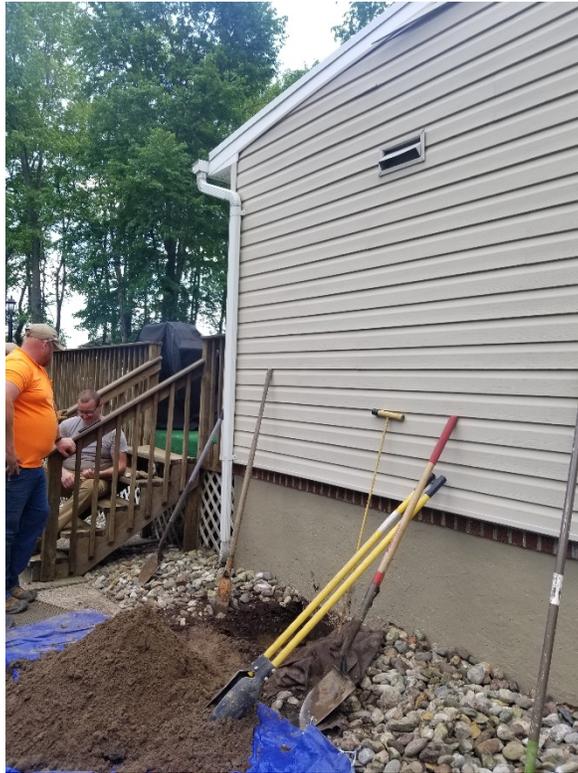
Photo 15. Test Pit TP-2 Location (Front of Building – North Cellar)

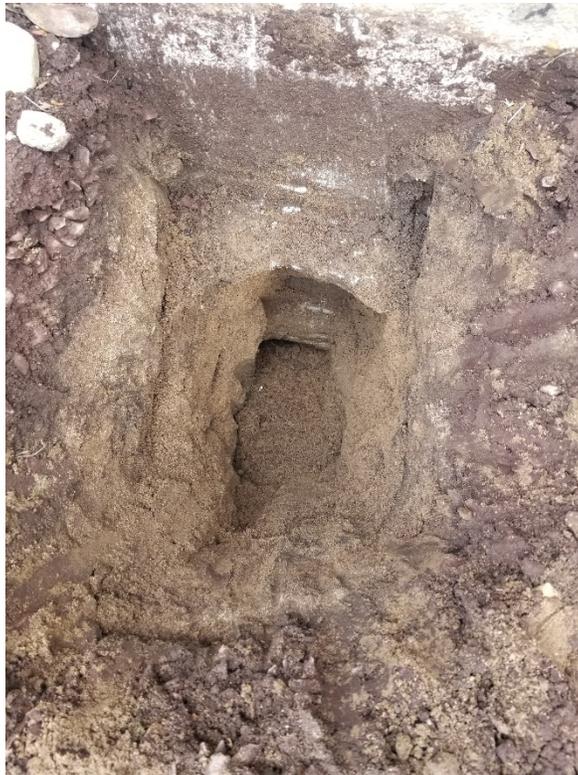
Photo 16. Test Pit TP-2 Foundation Conditions
