**ENGINEERING INVESTIGATION & ANALYSIS  
GEOTECHNICAL & STRUCTURAL  
ASSESSMENT REPORT**

**120 BIG PIECE ROAD  
FAIRFIELD, NEW JERSEY 07004**

Matrix No. 20-1052

August 2021

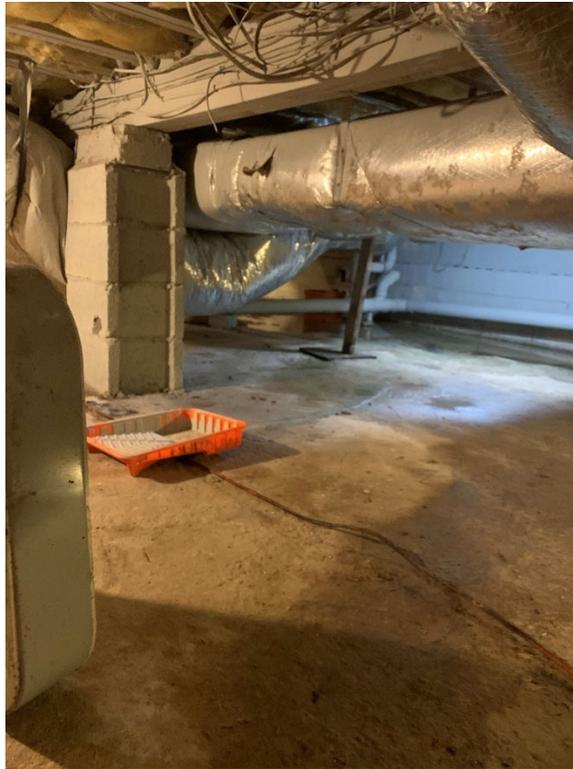
The front crawl space of the building, measuring 22'-8" long x 34'-4" wide, encompasses the house's main footprint. The foundation walls in this area consist of approximately 42" high CMU blocks. These walls widen approximately 20" above the crawl space floor, protruding 4" into the crawl space area (the southern wall, adjacent to the garage, does not have this protrusion). The subfloor of the first floor above consists of (2) adjoining nominal 2x8 joists typically spaced 16" on center and running east to west (front to rear of building). The joists are supported by a timber girder consisting of (3) nominal 2x8 members running perpendicular to the joists. The girder is supported at each end by the CMU foundation walls and along its span by three stacked CMU block pedestals. Two 4x4 timber posts were also observed providing further

**Photo 4. Front Crawl Space (Looking Northeast)**

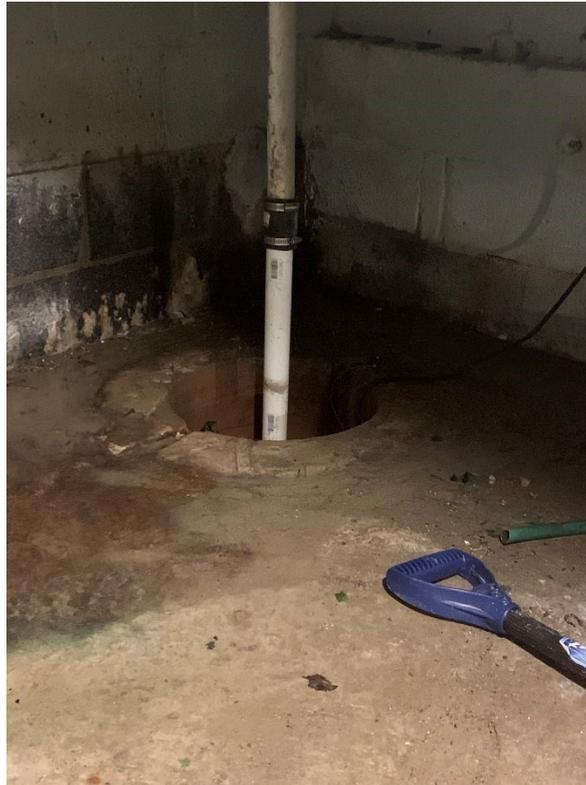
The only machinery observed within any of the three crawl spaces was a sump pit in the southwest corner of the front crawl space, near the entrance opening and along the front wall. Multiple metal and PVC pipes, as well as insulated air ducting, were also seen throughout the crawl space areas, at varying elevations.

**Photo 5. Sump Pit in Southwest Corner of Front Crawl Space (Looking West)**

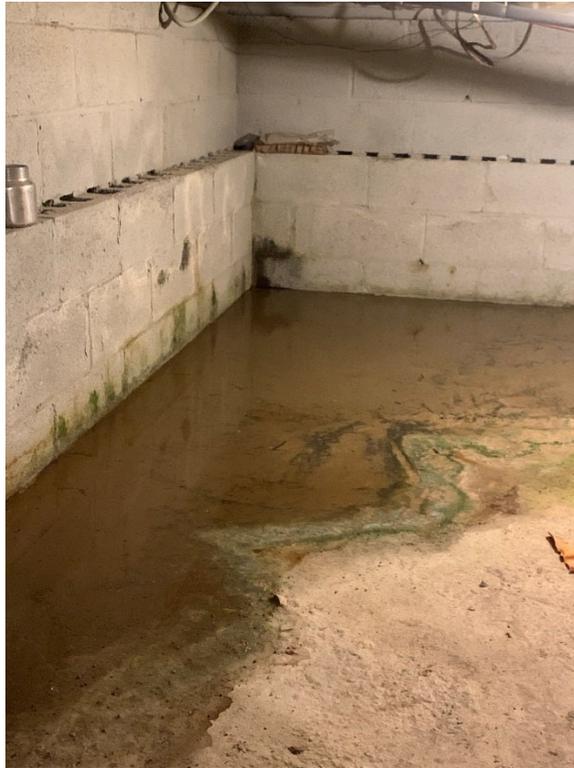
Standing water was noted within the front crawl space of the building in all four corners and some depressed areas of the floor at the time of the inspection. It also appeared as though the walls were seeping water into the crawl space at each corner.

**Photo 7. Standing Water in Northeast Corner of Front Crawl Space (Looking East)**

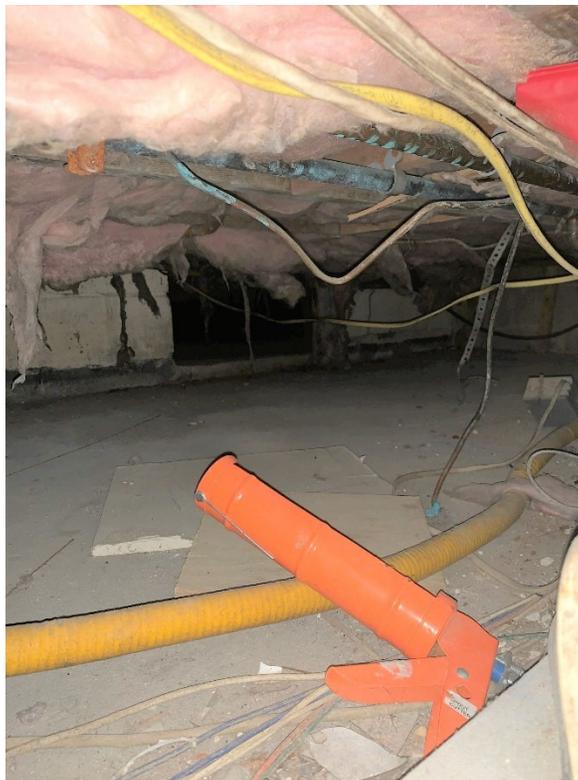
Immediately adjacent to the south, a second crawl space area consisting of approximately 18" high CMU foundation walls spans the perimeter of the southeast portion of the building. The tops of the foundation walls appeared to be uniform between the front and southeast crawl spaces, but the floor of the southeast crawls space was approximately 22" higher. An additional CMU wall spans the width of the space (north to south), approximately 6 feet from the rear wall, to provide an extra load-bearing foundation wall for the building. The perimeter walls of this crawl space continue west to encompass the adjacent garage area located in the southwest corner of the building. The first-floor subfloor above the southeast crawl space consists of single nominal 2x8 timber members running north to south (side to side of building). No girder was present in this crawl space; the floor joists are supported at either end by the perimeter CMU foundation walls.

**Photo 8. Southeast Crawl Space (Looking South)**

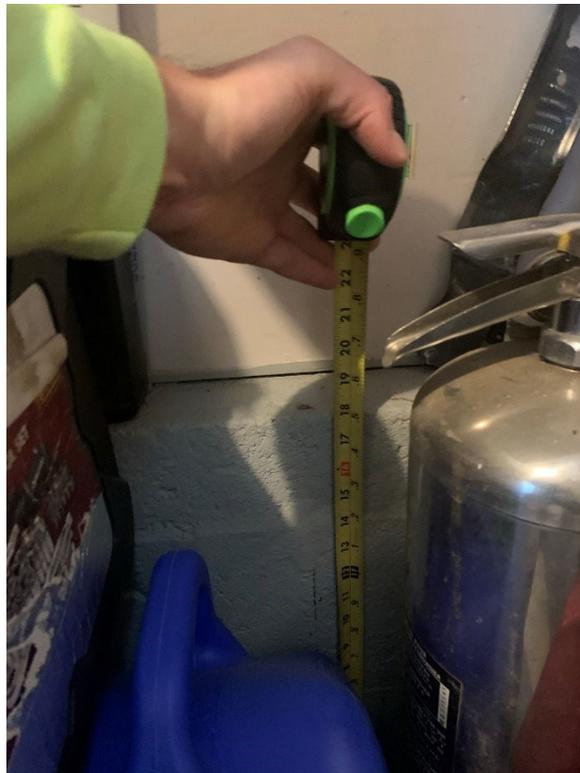
The garage area, located immediately west of the southeast crawl space and south of the front crawl space, consists of a ground-level concrete slab with 18" CMU foundation walls spanning the perimeter. The garage floor is level with the southeast crawl space floor, and the rear wall separating the two areas consists of a timber stud frame (not a foundation wall). Timber stairs lead from the garage level to the adjacent first floor in the rear of the building. There is a second floor above the garage, but the composition of the load-bearing walls could not be observed due to drywall covering frame.

**Photo 10. CMU Foundation Walls in Garage Area (Typical)**

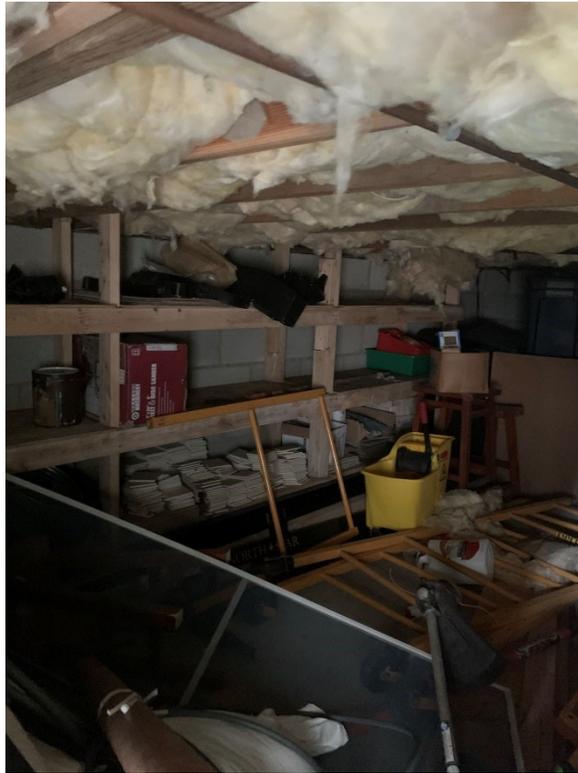
In the rear of the building, east of the front crawl space, a third ground-level crawl space area was observed. This area appeared to be an addition to the original building footprint, as the first floor above was elevated approximately 38" above the original first floor of the building (a small staircase connects the two floors). The CMU foundation walls in the rear crawl space measured approximately 54" high throughout the space, and the concrete floor of the crawl space is approximately 67" below the first-floor surface above. The first-floor subfloor consists of nominal 2x10 timber joists, spaced 16" on center, running east to west (front to rear of building). No girders were observed in this area; the floor joists are supported at either end by the perimeter foundation walls. The west edge of this crawl space shares the rear perimeter foundation wall of the original building. The CMU foundation wall along the shared west edge only extends 18" above the rear crawl space floor (the rest of the wall is the timber stud frame of the building).

**Photo 13. Rear Crawl Space (Looking South)**

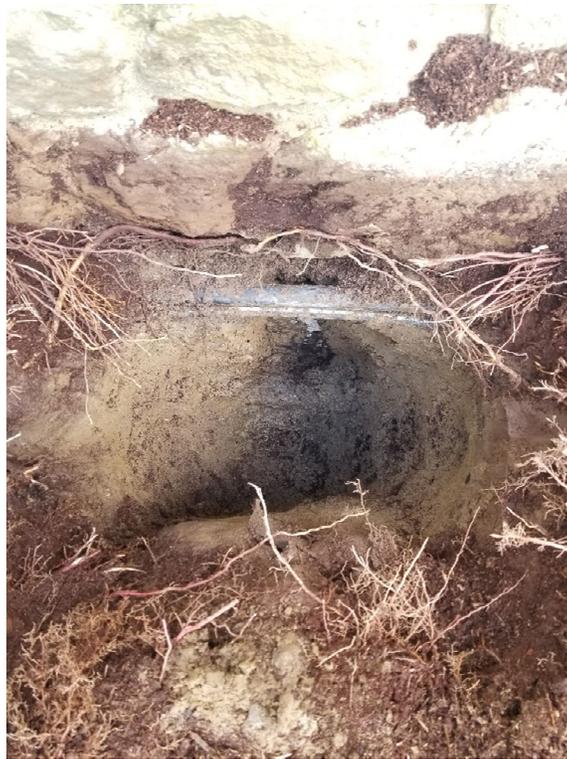
Two test pits were completed along the building perimeter to obtain information regarding the existing foundations of the building. Below the foundation walls in the front crawl space area, along the north wall, an approximately 22” wide concrete spread footing was revealed during the test pit excavation program. In the second test pit, located along the north wall of the rear crawl space, an approximately 32” concrete spread footing was observed. Based on our findings within the test pits and from conventional foundation construction, Matrix utilized a 16” wide footing as a minimum value for analysis, but believes the actual footings for the building to likely range from 16” to 24” in width. Prior to raising the house, Matrix recommends that the contractor confirm the foundation size and bearing adequacy with multiple test pits around the building perimeter.

**Photo 16. Test Pit TP-1 Foundation Conditions**

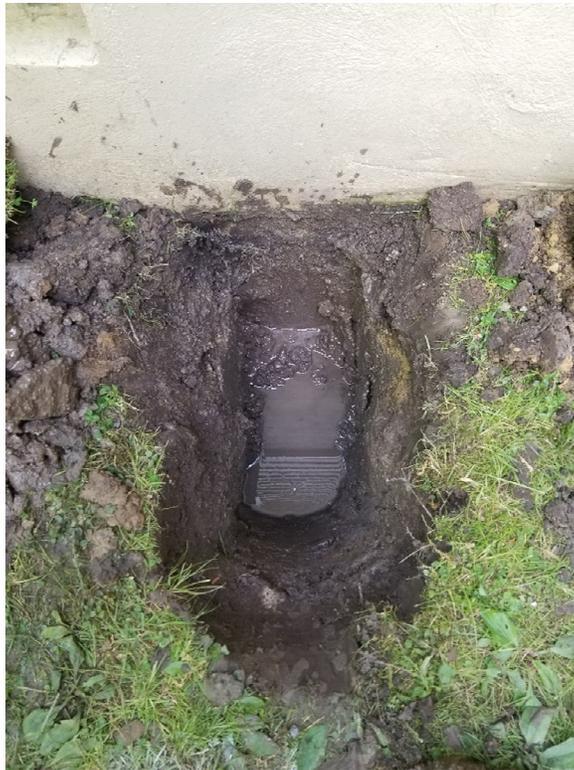
**Photo 18. Test Pit TP-2 Foundation Conditions**
