**ENGINEERING INVESTIGATION & ANALYSIS
GEOTECHNICAL & STRUCTURAL
ASSESSMENT REPORT**

**140 LITTLE FALLS ROAD
FAIRFIELD, NEW JERSEY 07004**

Matrix No. 20-1052

September 2021

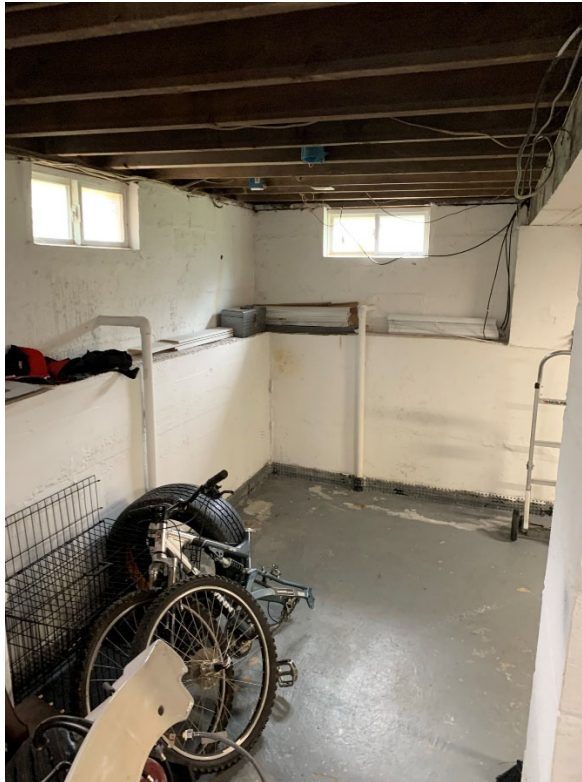
Photo 4. Basement CMU/Concrete Wall and Timber Subfloor (Southeast Corner)

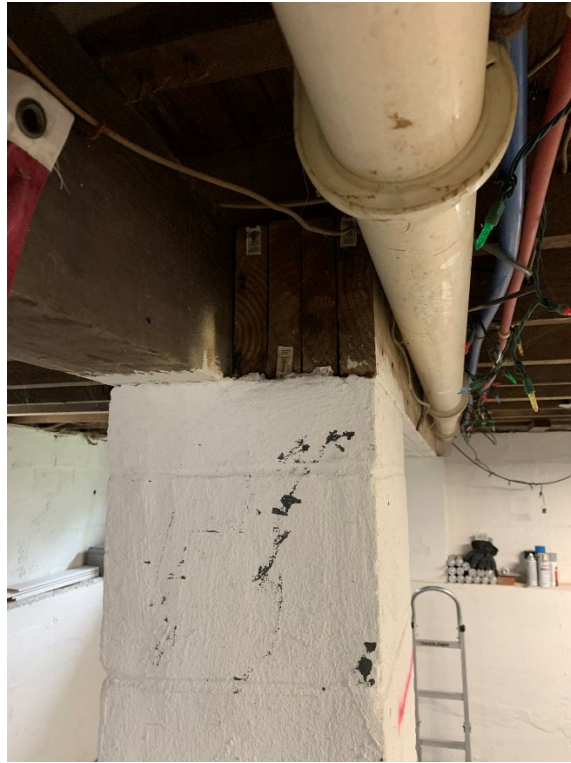
In the front basement, the first floor is supported by nominal 2x8 timber joists, spaced 16" on center, spanning the length of the area from east to west (front to rear of the house). These joists are supported at either end by the foundation walls, and a nominal 6x8 timber girder provides added support. The girder is located approximately 7' off the east (front) foundation wall, and is supported along its length by (2) 12"x16" CMU block columns and (2) 3" diameter steel jack posts. The longest clear span of this girder, located along the south-central portion of the basement, was measured at 11'-3" long. Immediately south of this clear span, an additional (4) nominal 2x8 timber members were observed next to the 6x8 girder to provide increased support for the southeastern corner of the of the first floor.

Photo 5. Front Basement Girder with Additional (4) 2x8 Beams for Southeast Corner

between the existing and new cast-in-place basement walls of the building. The existing concrete block pedestals and steel posts intermittently supporting the existing building's girders must be removed and replaced by new steel, concrete, or masonry block columns. These new columns will need to include a spread footing beneath to sufficiently support the building loads. Additionally, the rear deck is anticipated to require raising to match the current ingress/egress at heights of the main structure. This would require construction of new timber support posts for the timber deck substructure.

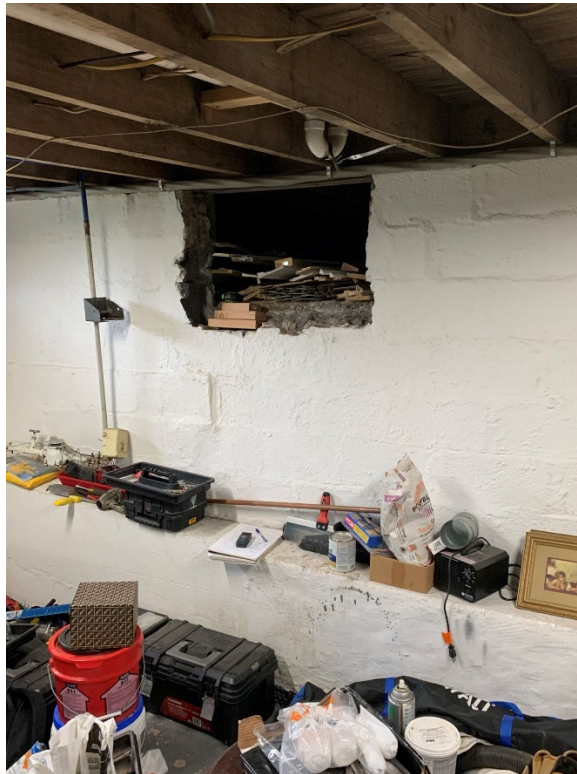
Photo 6. Front Basement Foundation Wall with Crawl Space Opening

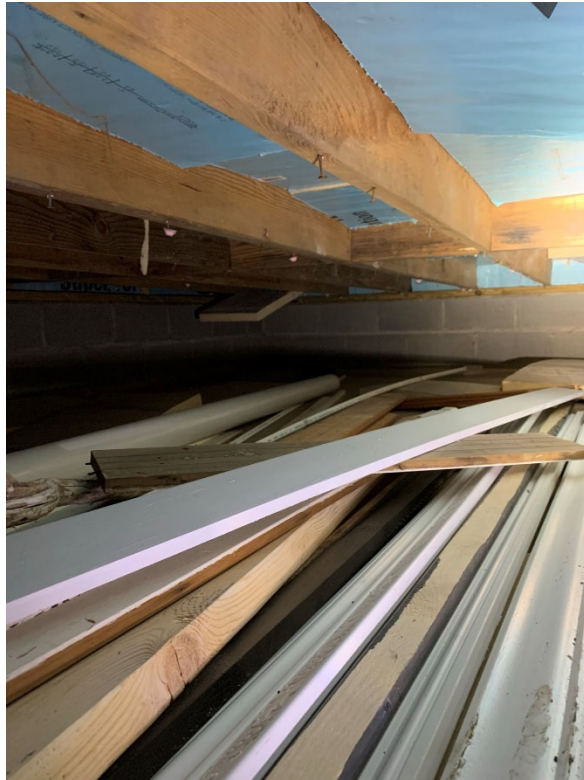
Photo 7. Southwest Crawl Space CMU Walls and Subfloor

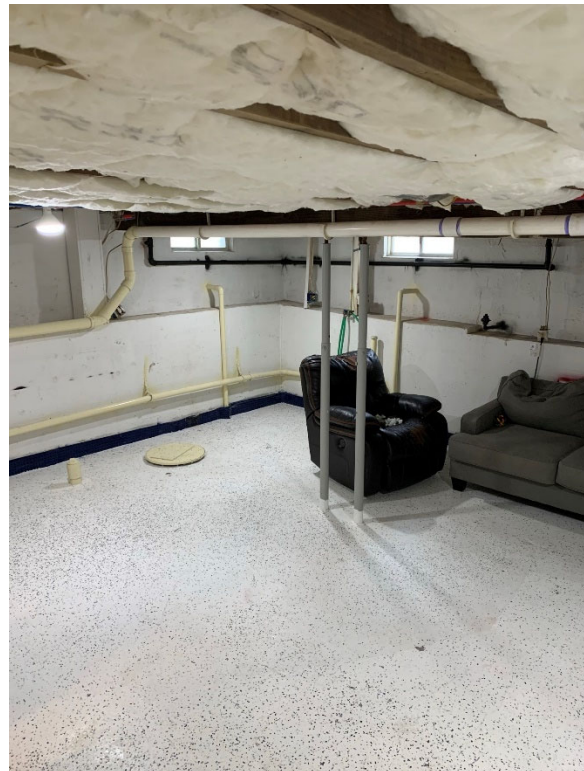
Photo 8. Front Basement Northeast Corner

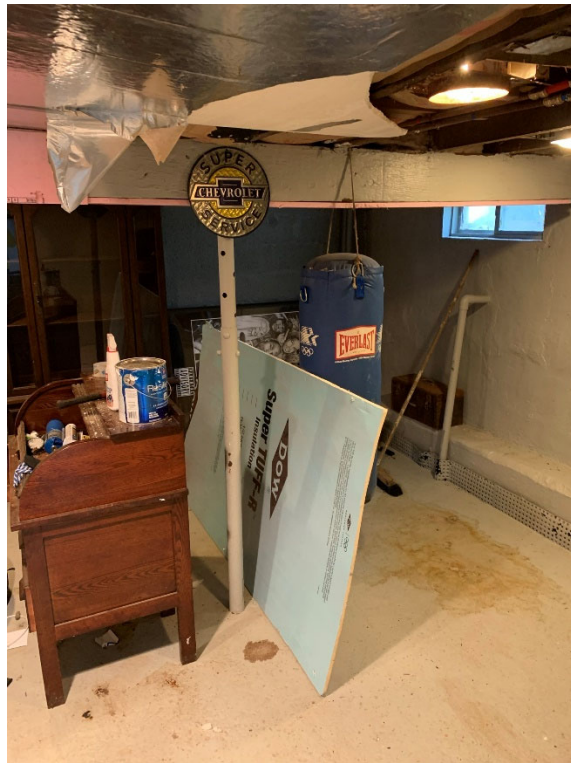
Adjacent to the front basement, in the northwest corner of the house, an additional basement room was observed with similar foundation wall construction. Along the north and south walls of this room, the concrete portion of the wall extended approximately 12" above the floor surface. No concrete lower wall was observed in the rear of the room (CMU blocks only from top to bottom). In the south and east wall (which is shared with the front basement), some CMU units had been removed in multiple places. The purpose of the removed blocks is unknown, but all removed CMU had been replaced with timber stud framing. The concrete floor of this room measured approximately 10" higher than the floor of the front basement. The bottom of the first-floor floorboards above this basement room measured approximately 6'-11" above the room's floor surface. The first floor above is supported by nominal 2x8 timber joists, spaced 16" on center, running east to west. A nominal 3x8 timber girder spans the width of the room and supports the joists at midspan. This girder is supported by the foundation walls of the basement as well as a 3" diameter steel jack post located at midspan of the girder.

Photo 9. Northwest Basement Room (Looking West)

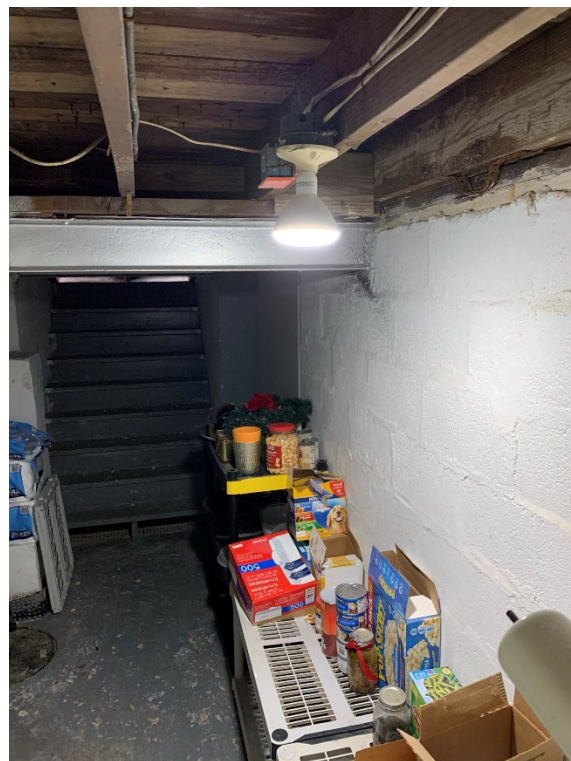
Immediately south of the northwest basement room detailed above, and adjacent to the front basement, a third basement room was observed with a set of concrete stairs leading to the backyard of the property. A hatch access door provides entrance to the basement from the backyard. The foundation walls of this basement room vary; along the south edge of the room, the walls appear to be constructed entirely with cast-in-place concrete, while the north wall (which is shared with the northwest basement room) consists

Photo 10. Backyard Access Basement Room (Looking at Building Rear)

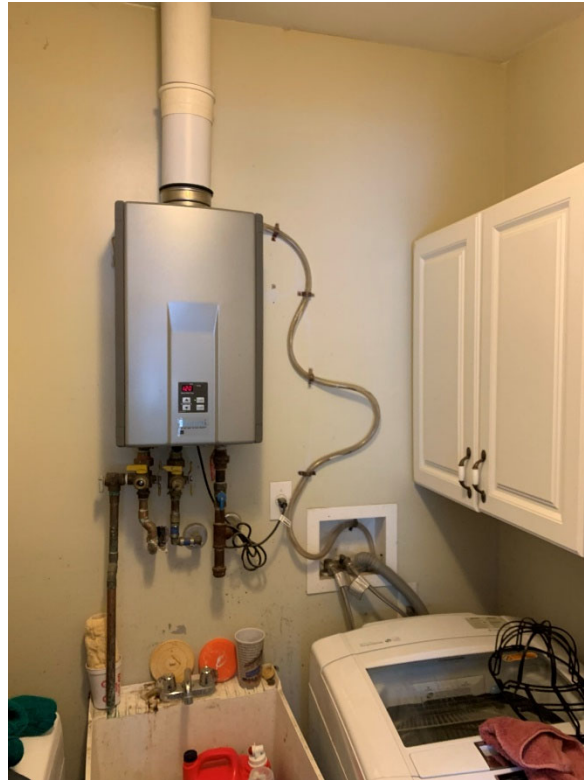
Most of the equipment for the house is located within the laundry room on the first floor. Within this room, a washer and dryer were observed on the floor, an electrical panel was built into the wall 45” above the floor, and a hot water heater was elevated 61” above the floor.

Photo 11. Hot Water Heater in First Floor Laundry Room

Additionally, any service equipment, whether outside or in the basement/crawl space, such as air conditioning, heat pump compressors, gas meters, electric meters, and hot water heaters, must be elevated at least 3 feet above the BFE. For interior elements, this may include relocation to an upper floor and thus less usable living space. For this residence, the hot water heater and electrical panel on the first floor will be raised along with the house. The exterior air conditioning unit would also require elevating 3 feet above the BFE on a new exterior platform.

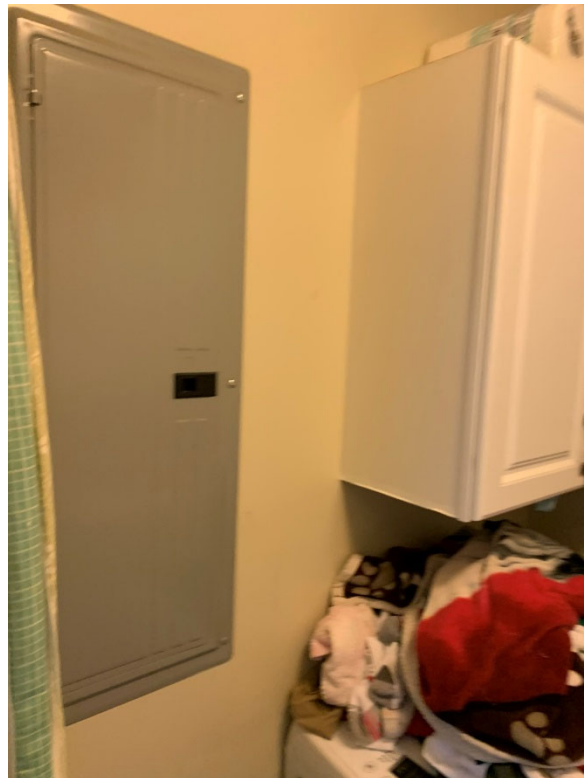
Photo 12. Electrical Panel in First Floor Laundry Room

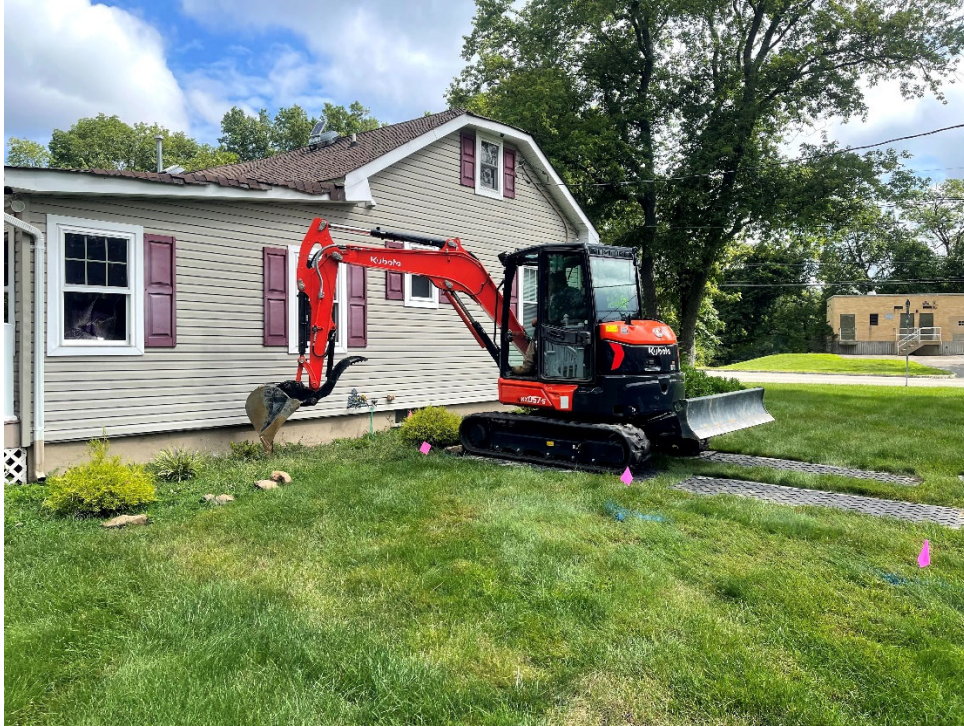
Photo 13. Test Pit TP-1 Location (South Wall of Building – Crawl Space)

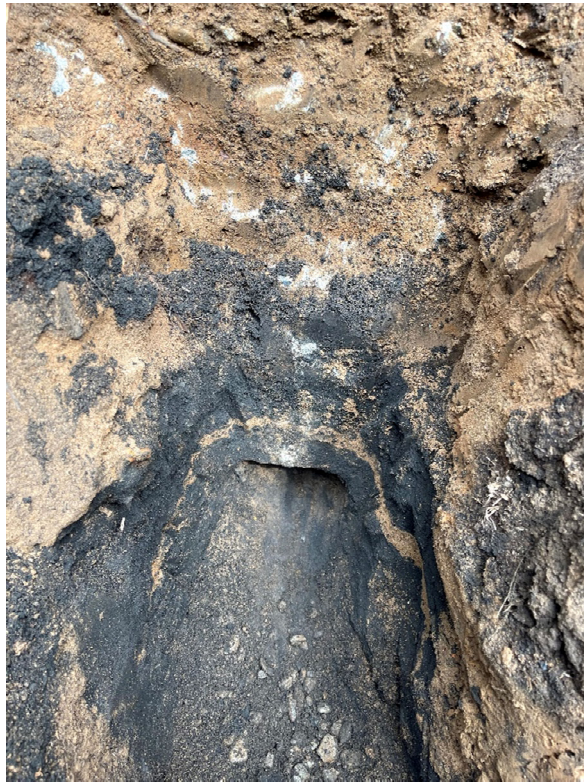
Test pit TP-1 was located in the southwest corner of the house, along the walls of the rear crawl space. At this location, the bottom of the CMU foundation wall was encountered at 36" bgs. There did not appear to be a spread footing beneath the wall.

A test pit excavation performed along the south crawl space wall revealed an approximately 36" deep concrete foundation beneath the CMU wall. The concrete foundation was encountered nearly at the exterior ground surface, and extended 36" into the ground. As per the resident, the construction of the crawl space foundation was completed internally by the homeowner. Exposed steel rebar was observed beneath the concrete foundation, within the 4" thick base of $\frac{3}{4}$ " crushed stone. The concrete foundation appeared to be equal in thickness to the CMU block wall above. Although a typical spread footing was not observed beneath the CMU wall of the crawl space, from conventional foundation construction Matrix assumed a 16" wide footing as a minimum value for analysis of the building foundation's structural capacity. Actual footings for the building are expected to range from 16" to 24" in width. Prior to raising the house, Matrix recommends that the contractor confirm the foundation size and bearing adequacy with multiple test pits around the building perimeter.

Photo 14. Test Pit TP-1 Foundation Conditions

Bottom of CMU wall encountered at 36" bgs - no footing observed beneath wall Steel Rebar exposed under foundation wall 3/4" Clean Crushed Stone Base beneath wall	
40				Bottom of Test pit @ 40 in. Test Pit Backfilled.

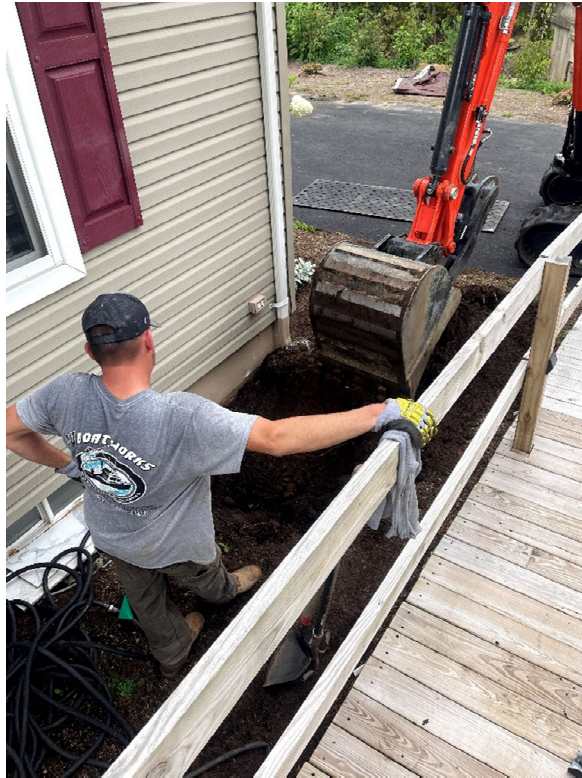
Photo 15. Test Pit TP-2 Location (Front Wall of Building – Northeast Corner)

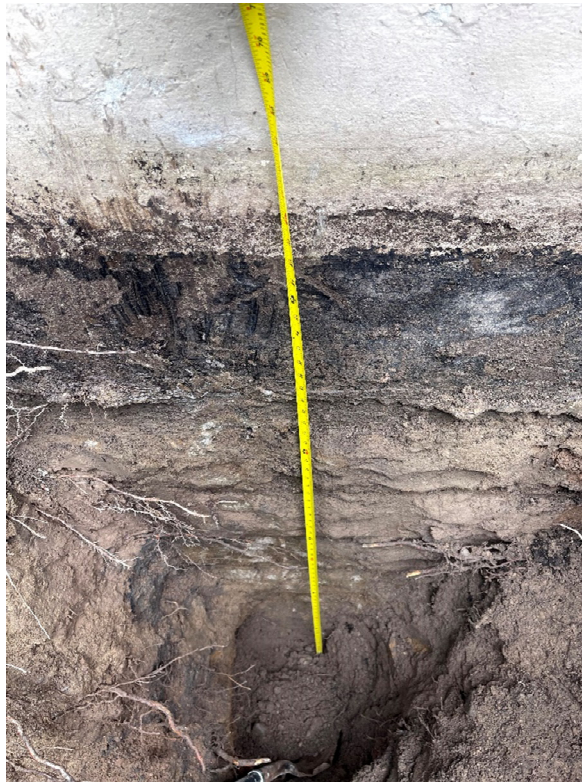
Test pit TP-2 was completed along the front basement walls, in the northeast corner of the building. Due to limited access, the concrete footing could not be reached during test pit excavation. The excavation was terminated along the length of the foundation wall at 63" bgs.

Photo 16. Test Pit TP-2 Foundation Conditions

Type and dimensions of the existing footings for the front basement walls could not be determined during the test pit excavation program. Prior to raising the house, the contractor is advised to perform multiple test pits around the building perimeter to verify the foundations at the site.
