**ENGINEERING INVESTIGATION & ANALYSIS  
GEOTECHNICAL & STRUCTURAL  
ASSESSMENT REPORT**

**1 MATT DRIVE  
FAIRFIELD, NEW JERSEY 08203**

Matrix No. 20-1052

August 2021

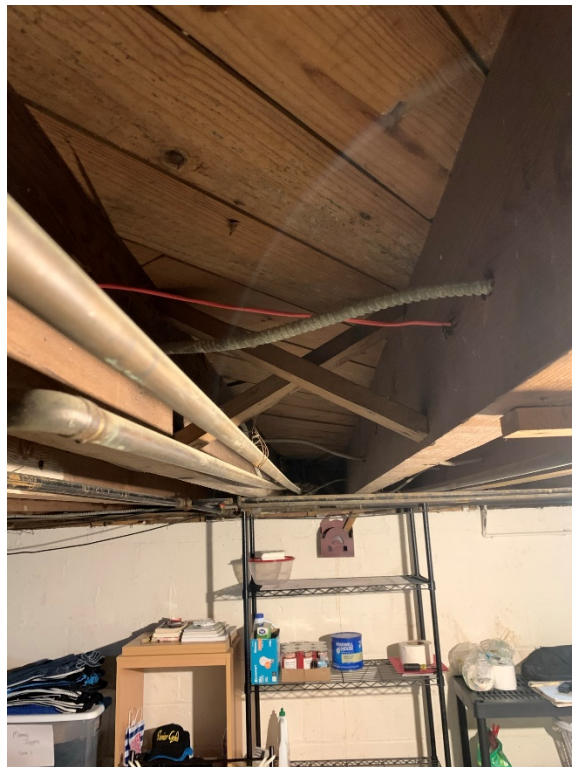
The basement walls and visible floor joists were in good condition at the time of the inspection. No notable damages or abnormalities were observed.

**Photo 4. Basement CMU Wall and Timber Subfloor**

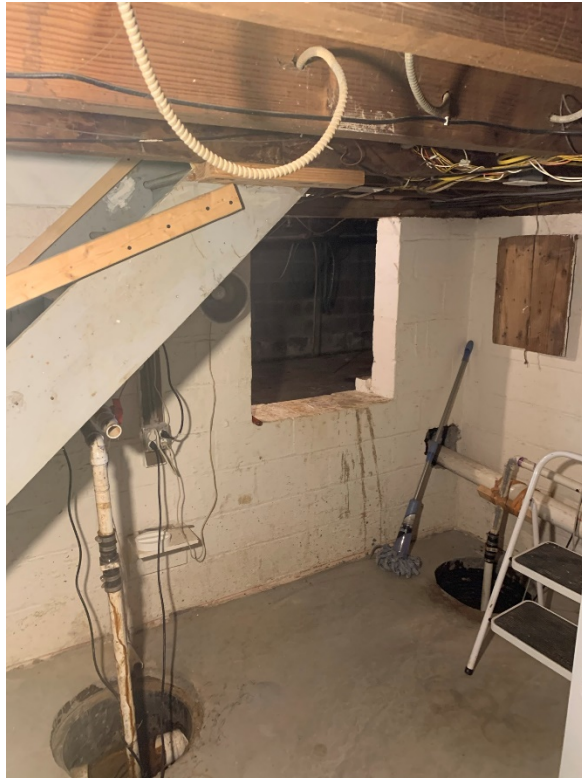
Various pieces of equipment and machinery were observed within the basement and crawl space at the time of the inspection. Two sump pumps were observed in the basement, both along the east wall. Located along the west wall, a water heater and boiler were observed situated atop CMU pedestals. The water heater was raised 8" above the basement floor, while the boiler was raised 11". Along the front (south) wall, a gas meter was observed about 45.5" above the basement floor, and a washer and dryer were located at floor level in the southeast corner of the basement. All piping, with the exception of the sump pump and washer/dryer PVC pipes, runs along the top of the basement connected to the first-floor joists.

**Photo 5. Basement Sump Pumps and Opening to Crawl Space**

Additionally, any service equipment, whether outside or in the basement/crawl space, such as air conditioning, heat pump compressors, gas meters, electric meters, and hot water heaters, must be elevated at least 3 feet above the BFE. For interior elements, this may include relocation to an upper floor and thus less usable living space. For this residence, the hot water heater, boiler, gas meter, and water well pressure tank in the basement/crawl space would require elevating 3 feet above the BFE.

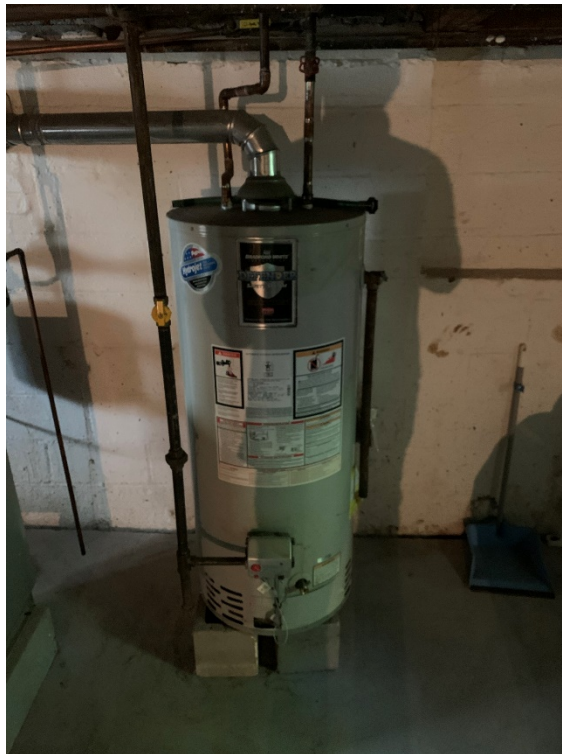
**Photo 6. Water Heater on CMU Blocks (Basement)**

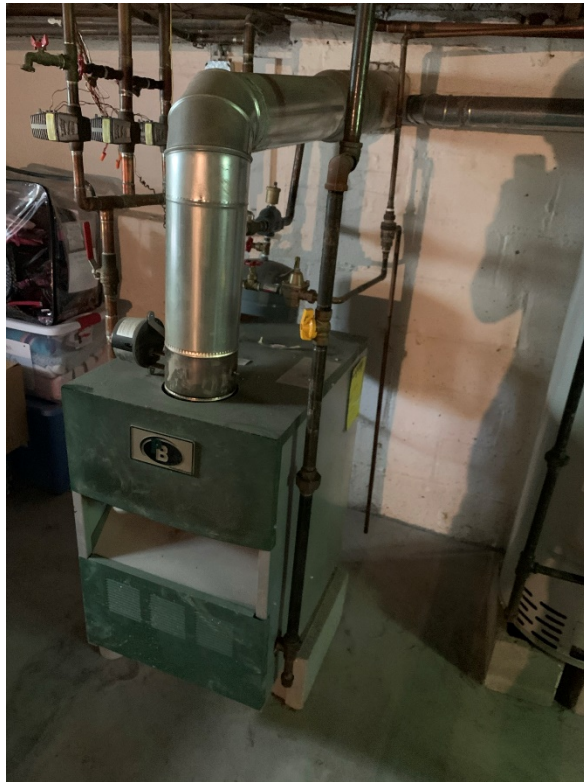
**Photo 7. Boiler on CMU Blocks (Basement)**

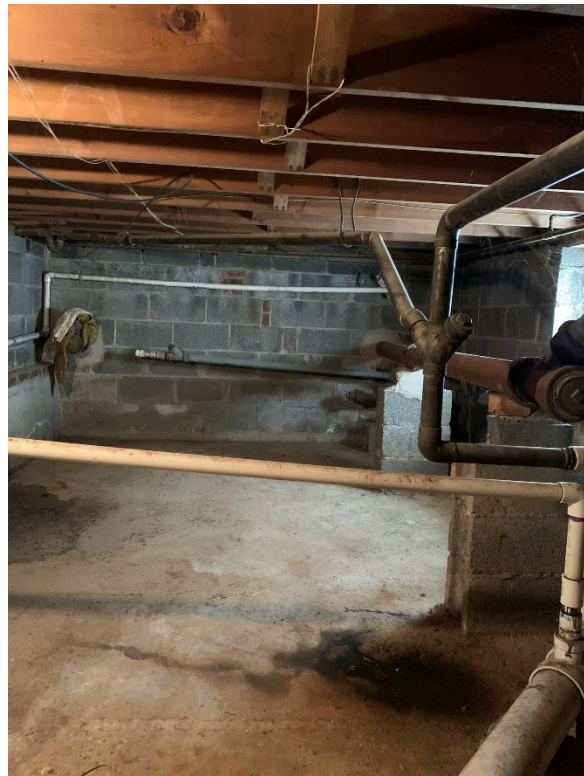
The crawl space area exhibited some damage to the CMU walls. Along the south (front) wall, two vertical cracks were observed running the height of the walls, originating from the crawl space floor level. Dark staining was noted on the walls at the bottom of these cracks and various other locations on the CMU walls along the south end of the crawl space, indicating possible water infiltration. Sediment buildup was also observed in the southeast corner of the crawl space.

**Photo 8. Crawl Space CMU Walls and Timber Subfloor (Looking North)**

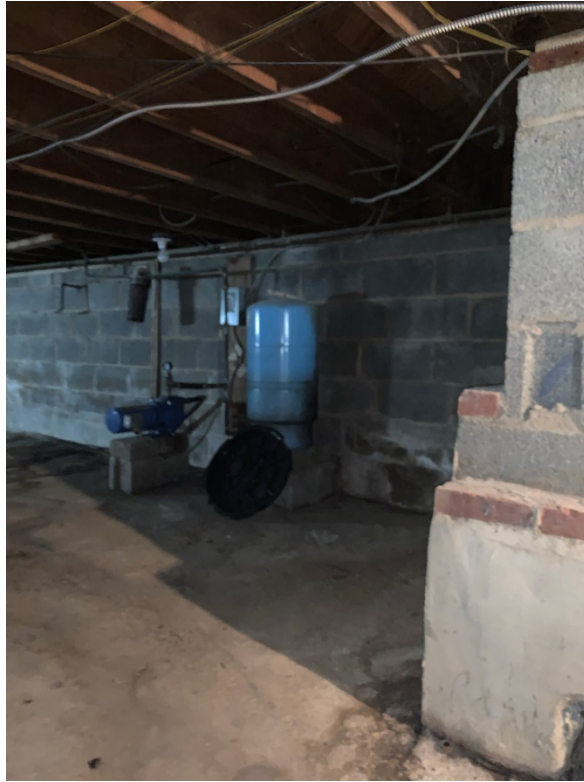
The crawl space contained a small water well pressure tank and water pump located along the west wall near the center of the area. Both pieces of equipment were situated atop CMU blocks and raised approximately 11" above the crawl space floor. Various metal and PVC sewer lines were also observed in the northern portion of the crawl space. One of these metal pipes, running out the rear of the building, was supported by two CMU block pedestals.

**Photo 9. Water Storage Tank and Pump (West Edge of Crawl Space)**

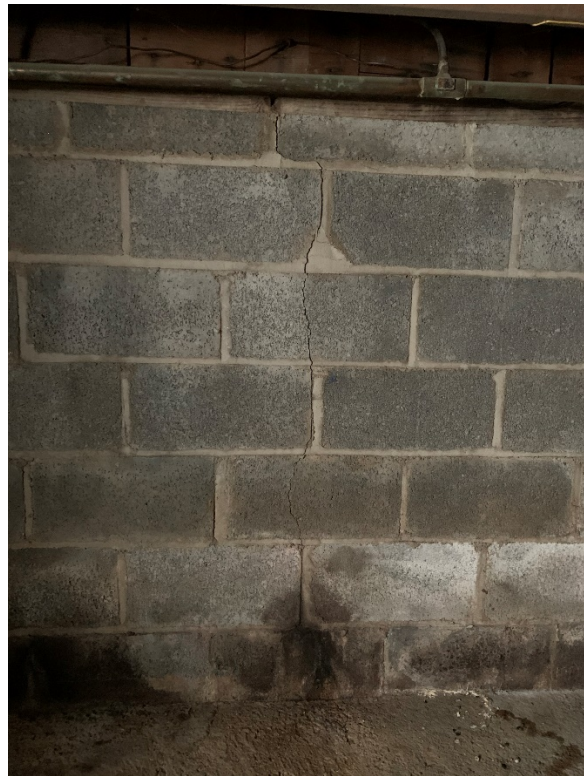
**Photo 10. Vertical Crack in South Crawl Space Wall (Typical for Two)**

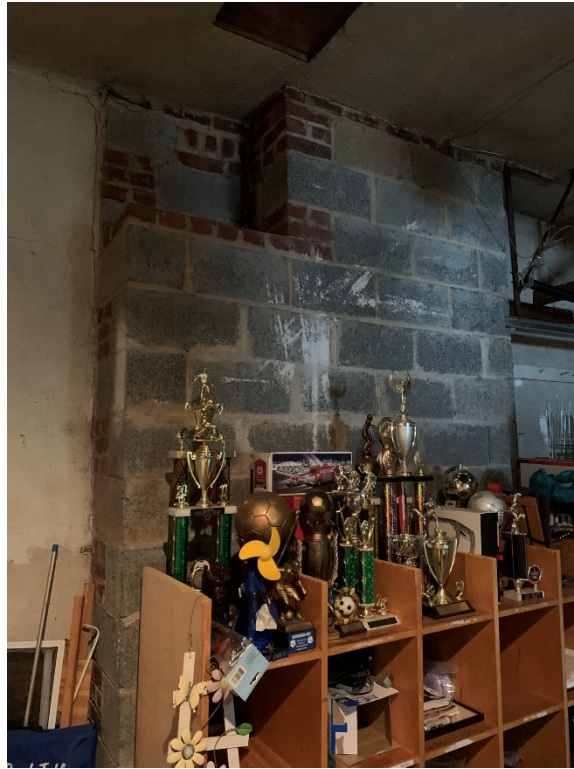
The garage area, adjacent to and west of the basement, is located at ground level (approximately 51.5” above basement floor) with concrete stairs leading down to the basement level. The CMU foundation walls continue around the perimeter of the garage to support the timber building frame, and extend approximately 9” above the garage floor surface. The garage is about 10’-7” in height measured from the ground surface. The chimney extends approximately 8” into the garage from the east wall.

**Photo 11. Chimney (East Garage Wall)**

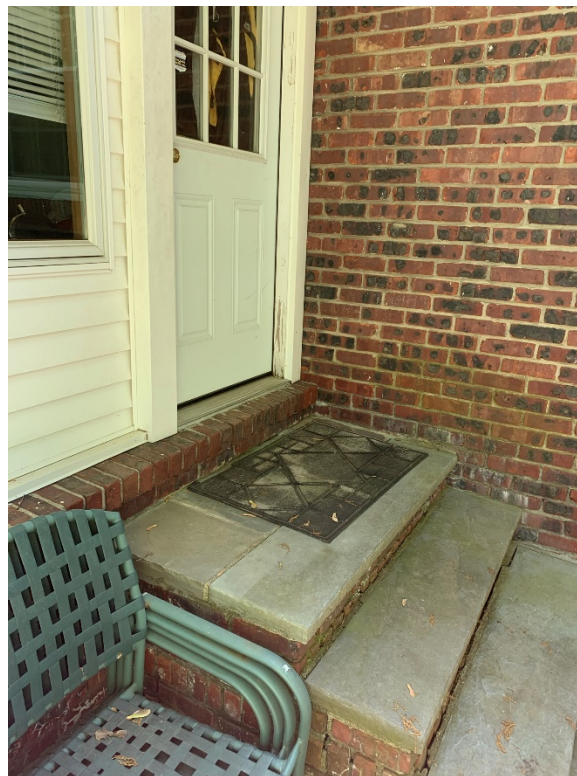
Located at the rear exterior of the building, a set of brick/concrete steps leading up to the rear extension appeared to be settling. The steps appeared to be falling away from the house, and cracks were noted between adjacent steps.

**Photo 12. Stairs to Rear Addition Entrance Door**

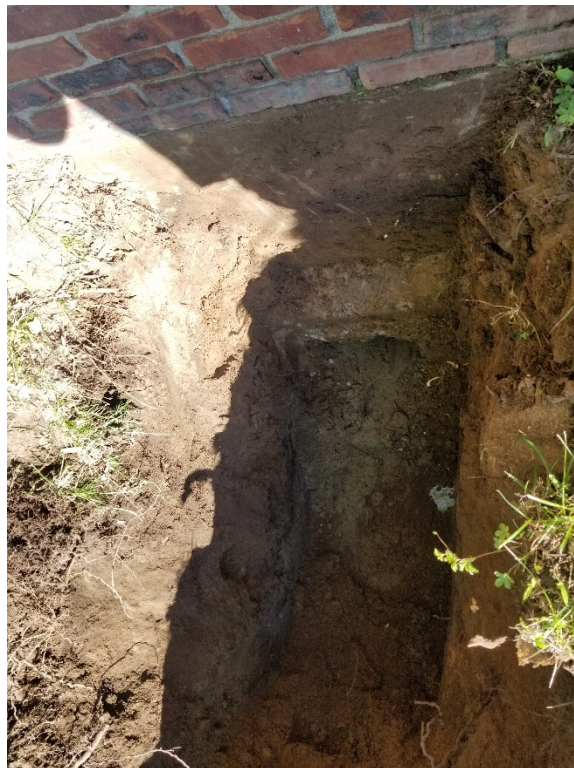
Two test pit excavations were performed along the crawl space walls (at the south and east walls) to determine the type and size of the building’s wall footings. The test pits revealed approximately 21” wide concrete footings at 46” to 48” bgs (bottom of footing), ranging from 8” to 9” in thickness. Based on our findings within the test pits and from conventional foundation construction, Matrix assumed a 20” wide footing as a minimum value for analysis, and the building is expected to possess similar dimensions throughout its foundations. Prior to raising the house, Matrix recommends that the contractor confirm the foundation size and bearing adequacy with multiple test pits around the building perimeter.

**Photo 14. Test Pit TP-1 Foundation Conditions**

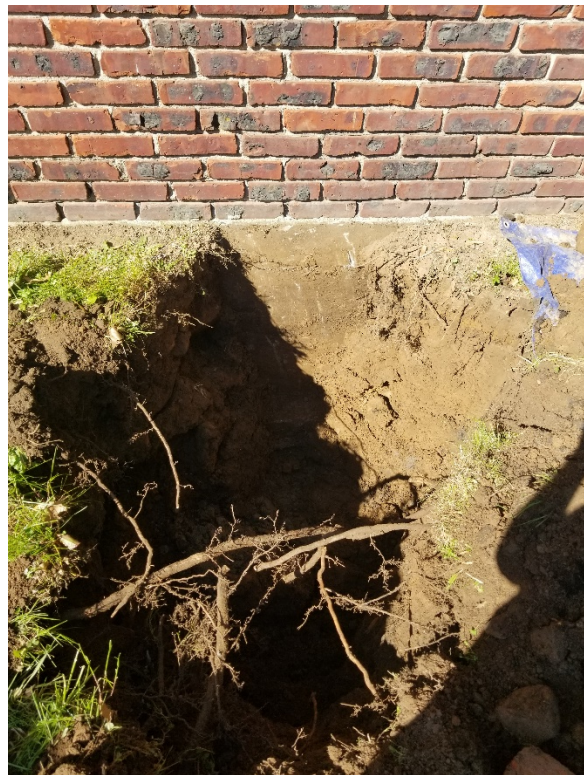
**Photo 16. Test Pit TP-2 Foundation Conditions**
