**ENGINEERING INVESTIGATION & ANALYSIS
GEOTECHNICAL & STRUCTURAL
ASSESSMENT REPORT**

**28 ADDISON DRIVE
FAIRFIELD, NEW JERSEY 07004**

Matrix No. 20-1052

October 2021

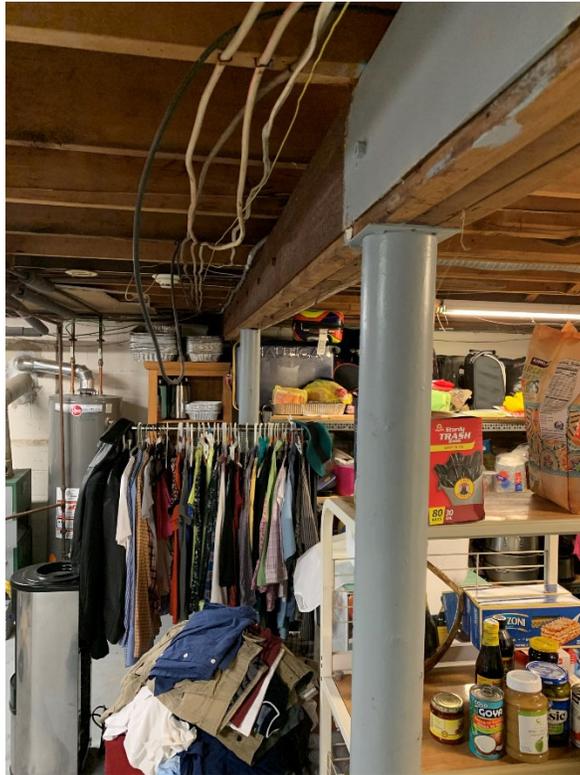
The floor above the basement is supported by nominal 2x10 timber floor joists, spaced 16” on center, running from front to rear of the building (north to south). A set of (3) connected nominal 2x10 timber members acts as a girder for the floor joists, located approximately 13’-6” off of the front wall of the basement. The girder is supported throughout its span, between the edge foundation walls, by (2) 4” diameter steel post columns that extend beneath the concrete floor (to presumed concrete spread footings). Since the south wall of the basement is shorter than the other walls, timber studs bridge the gap between the foundation wall and bottom of the girder. A timber stud member and 3” diameter steel jack post have been installed near the east edge of the girder, adjacent to each other, to provide additional support. The longest clear span of the girder measured 6’-10” along the westernmost span.

Photo 5. Basement Girder, Columns & Subfloor (Looking West)

The existing steel post columns intermittently supporting the building's basement girder must be removed and replaced by new steel, concrete, or masonry block columns. These new columns will need to include a spread footing beneath to sufficiently support the building loads. The existing columns supporting the front bedroom girder are expected to remain, and are proposed to bear on the newly constructed CMU foundation walls. The existing chimneys located along the west and east walls of the house will also require extending during raising of the house to keep the top of the chimneys above the roof level.

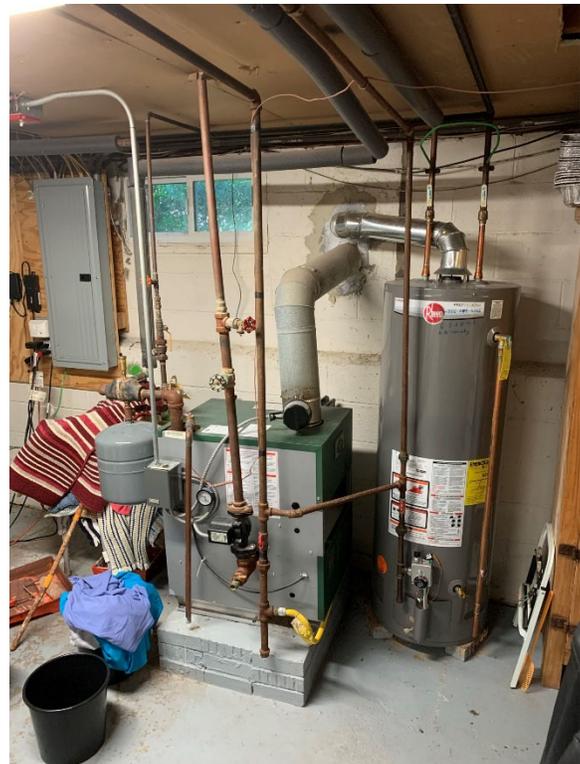
Photo 6. Basement Foundation Wall with Boiler, Hot Water Heater & Elec. Panel (Looking West)

Additionally, any service equipment, whether outside or in the basement/garage, such as air conditioning, heat pump compressors, gas meters, electric meters, and hot water heaters, must be elevated 3 feet above the BFE. For interior elements, this may include relocation to an upper floor and thus less usable living space. For this residence, the hot water heater, boiler, electrical panel, water meter, gas meter, central vacuum cleaner, and water filtration system in the building interior would require elevating 3 feet above the BFE onto the raised first or 1.5 floor. The two exterior air conditioning units would also require elevating 3 feet above the BFE on a new exterior platform.

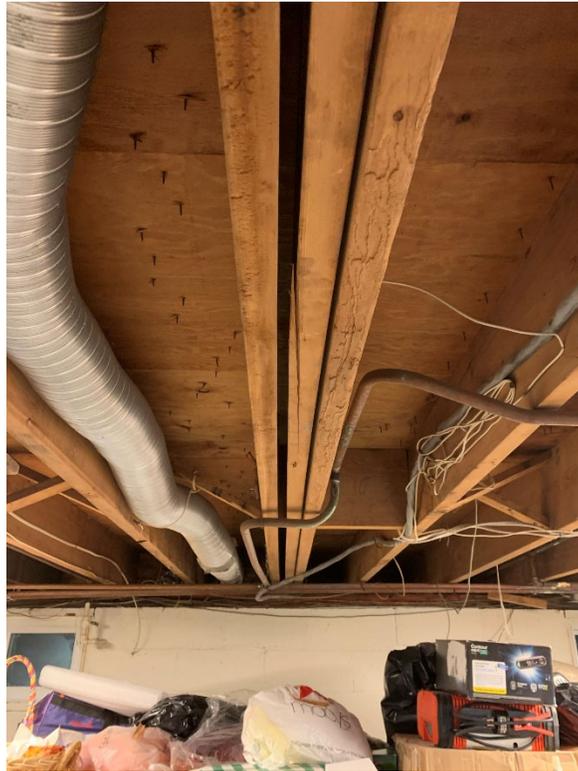
A few damaged areas were noted within the basement and along the exterior walls of the building. In the basement, near the center of the area, a horizontal crack was observed in the one of the floor joists for the 1.5-floor. The damaged joist was in the middle of a set of three joists; it is unclear if the crack is structurally significant. In the east wall of the rear addition, a crack was observed along the exterior brick façade. This crack originated from the lower left corner of a window, ran horizontally through the brick mortar joints (maximum 5/8” wide), then extended vertically downward beneath the adjacent ground surface. A similar crack was noted on the west wall of the rear addition, as well. In this location, two cracks were observed above and below a window, extending to the roof and into the ground, respectively.

Photo 7. Crack in 1.5-Floor Joist (Looking North)

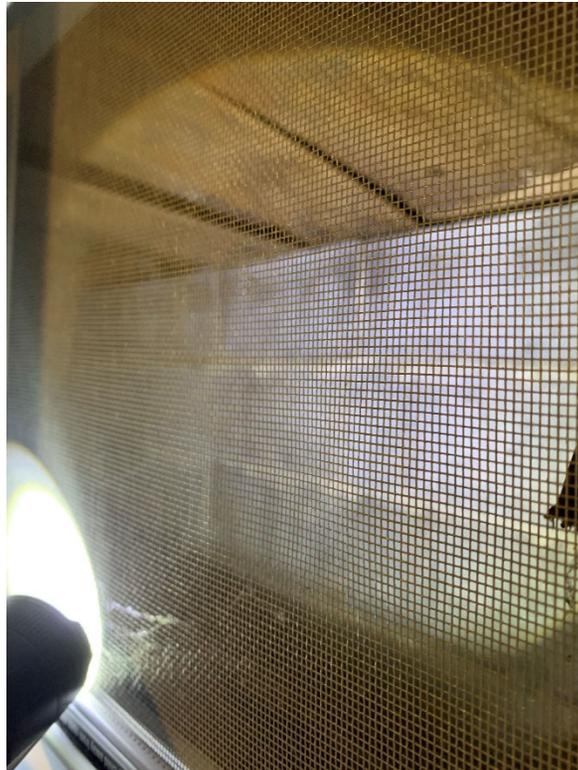
North of the rear basement wall, an additional CMU wall was observed through the basement window. This wall was located approximately 30” north of the basement’s rear wall, and extended about 11”-0” in width. This wall supports an apparent addition to the 1.5-floor of the house. The subfloor above the wall could not be observed at the time of the inspection, but the floor joists observed within the basement are expected to extend to this additional wall to support the 1.5-floor extension. The floor in this area consists of a concrete slab which is level with the exterior grade (approximately 49” above the basement floor).

Photo 8. CMU Foundation Wall for 1.5-Floor Rear Extension (Looking Northwest)

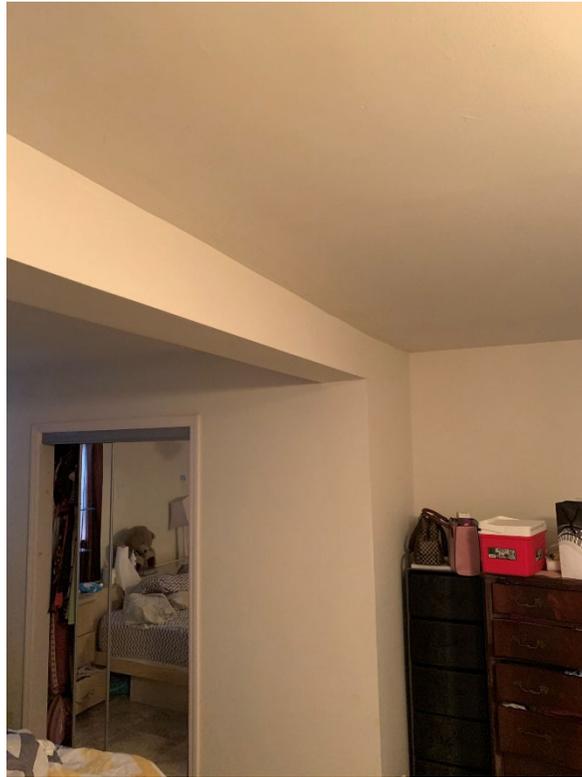
Photo 9. Front Bedroom/Converted Garage Girder & Column (Covered - Looking Southeast)

Within the front bedroom and rear addition, new concrete or masonry columns are recommended with a new timber girder to provide additional support and to decrease the tributary area of the various new foundation walls. Support for the second floor is expected to remain the same as the existing support, which consists of a steel girder in the front bedroom area supported by steel, concrete, or masonry block columns (unable to identify column type at time of inspection).

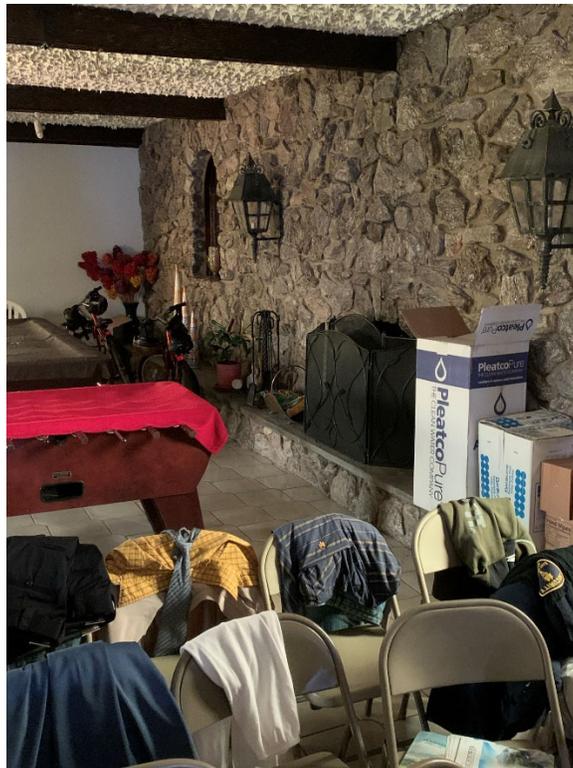
Photo 10. Decorative Stone Façade on Interior Wall of Rear Addition (Looking North)

Raising of the building should be undertaken with special attention to preserve the existing exterior brick façade covering the timber frame in the front and northeast side of the building, as well as the interior stone façade within the rear addition. If these façades are kept in place during raising, the process is liable to lead to some cracking in the existing façade. Alternatively, the brick and stone façades can be removed prior to raising, then replaced with a similar or more flexible finish after completion of the elevation process. The materials and labor involved in exterior and interior façade restoration of the house are not within the scope of this project.

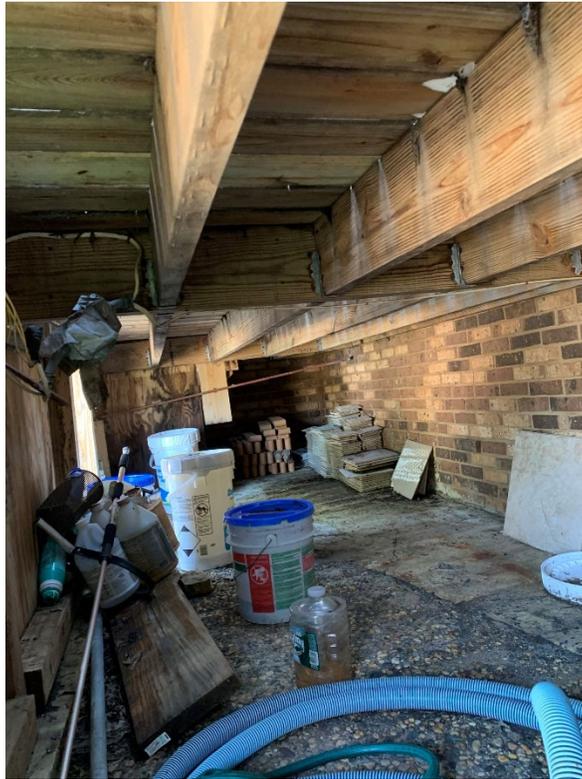
Along the north wall of the 1.5-floor area, a rear timber deck was observed at the elevation of the interior floor (raised approximately 47” above the adjacent exterior grade. This deck consists of nominal 2x8 timber floor joists and girders, connected to each other with metal face mount hangers. The girders are supported along the perimeter by 4x4 timber posts which are expected to be embedded in concrete footings below grade. A set of timber stairs leads down from the deck to the concrete floor of the backyard.

Photo 11. Rear Timber Deck Framing (Looking East)

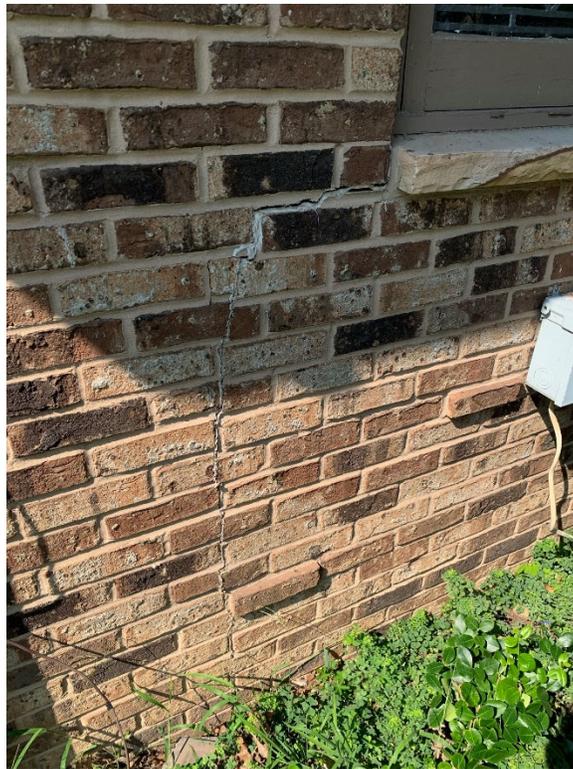
Photo 12. Crack in Brick Façade on East Wall of Rear Addition (Looking West)

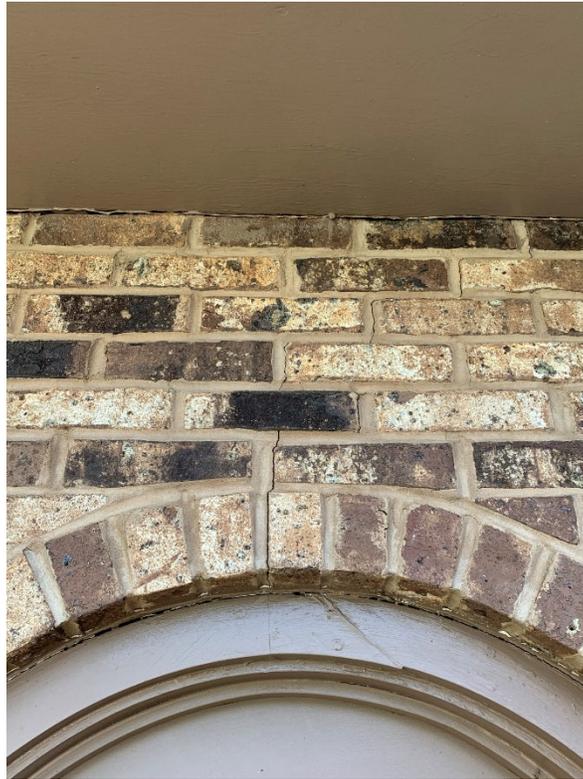
Photo 13. Crack in Brick Façade Above Window on West Wall of Rear Addition (Looking East)

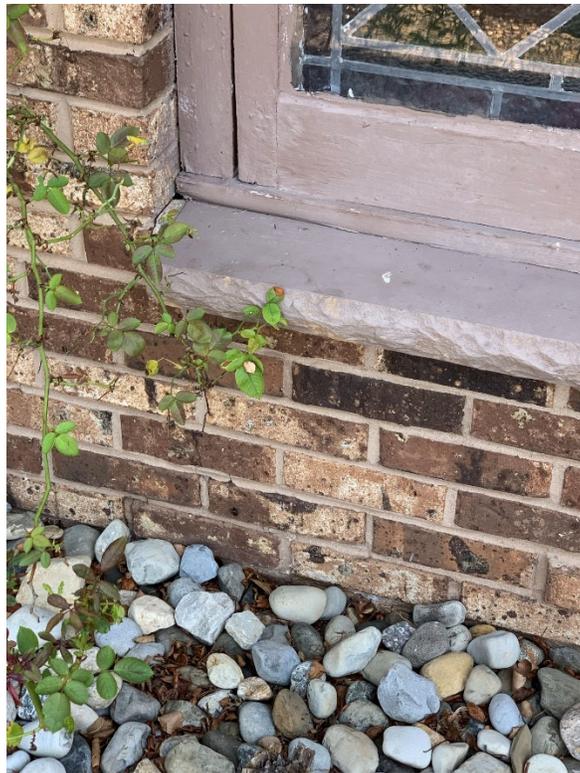
Photo 14. Crack in Brick Façade Below Window on West Wall of Rear Addition (Looking East)

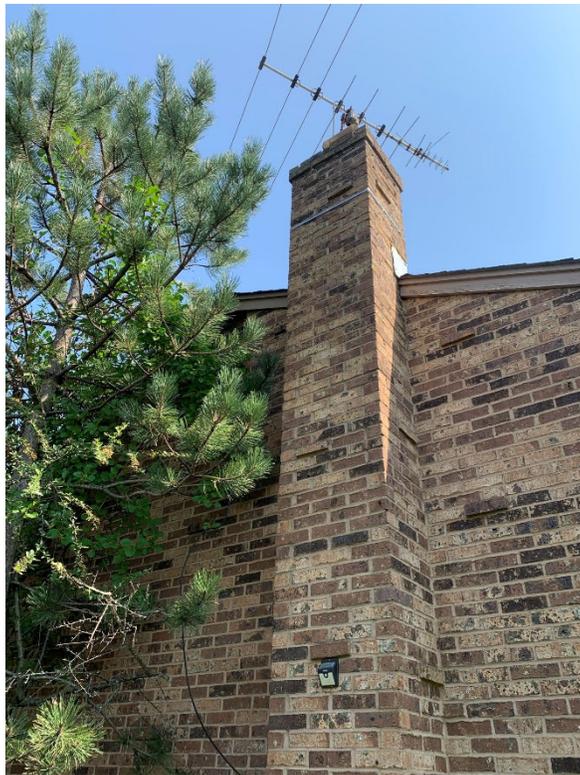
A brick-covered exhaust chimney was observed along the west wall of the building, adjacent to the basement area and connected to the piping of the boiler and hot water heater. The chimney is expected to be made up of CMU block, and measured approximately 17.5” deep x 25.5” wide.

Photo 16. Exhaust Chimney Along West Wall of Building (Looking Northeast)

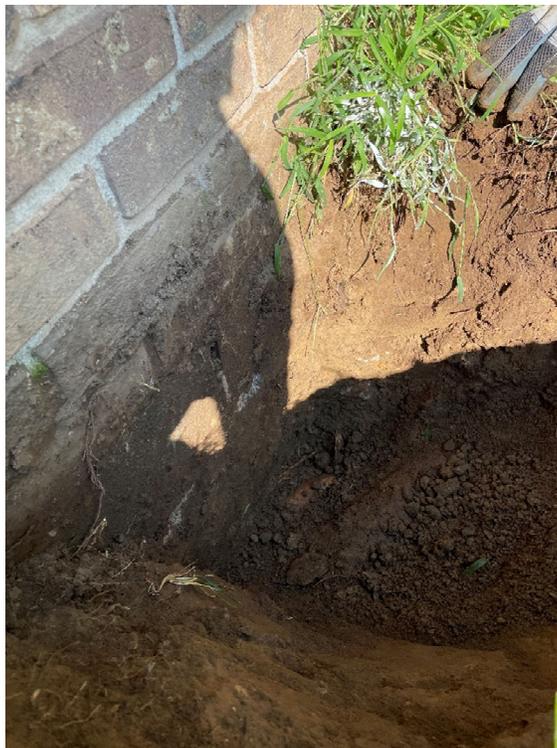
The top of concrete was not uncovered in test pit TP-1. A 12” thick tree root was encountered at approximately 24” bgs and could not be broken through, so the excavation was terminated at this depth.

Photo 18. Test Pit TP-1 Conditions (Tree Root in Excavation)

A test pit excavation along the east wall of the ground level was prematurely terminated at 24" bgs due to the presence of a tree root. Based on conventional foundation construction, Matrix utilized a 16" wide footing as a minimum value for analysis, but believes the actual footings for the building to likely range from 16" to 24" in width. Prior to raising the house, Matrix recommends that the contractor confirm the foundation size and bearing adequacy with multiple test pits around the building perimeter.
