**ENGINEERING INVESTIGATION & ANALYSIS  
GEOTECHNICAL & STRUCTURAL  
ASSESSMENT REPORT**

**28 COLE ROAD  
FAIRFIELD, NEW JERSEY 07004**

Matrix No. 20-1052

October 2021

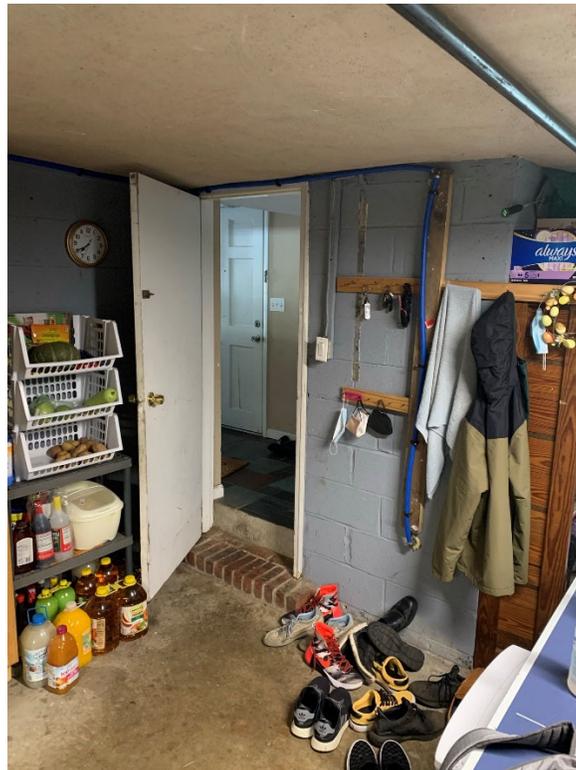
Within the garage area, the ground appeared to have settled beneath the eastern garage door, as a significant gap was noted between the ground surface and the bottom of the closed garage door. Multiple cracks were also seen throughout the concrete floor of the garage, and the floor surface was uneven throughout the space.

**Photo 3. Garage Entrance Door & CMU Foundation Walls (Looking West)**

The garage doors located along the north wall of the house will need to be removed prior to raising the house, then replaced at the ground level once the house is elevated and the new first floor is constructed. The existing CMU exhaust chimney located within the interior of the house will also require extending during raising of the house to keep the top of the chimney above the roof level.

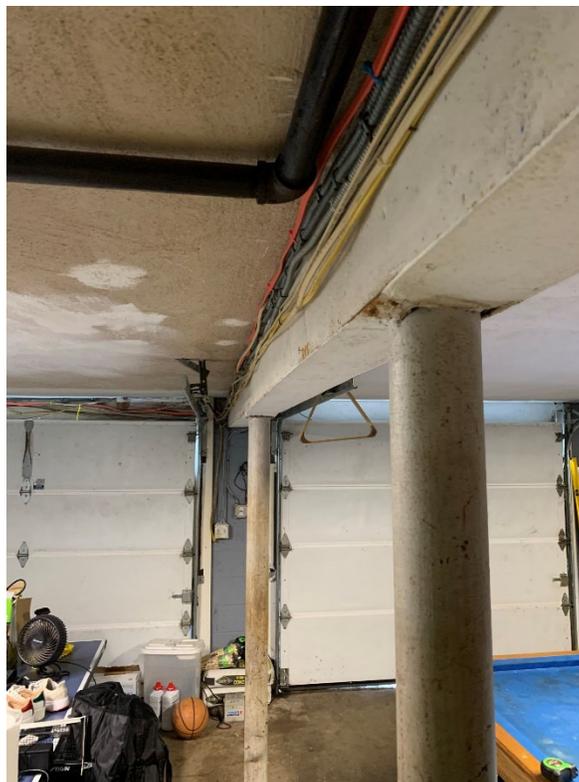
span, between the edge foundation walls, by (2) 4" diameter steel post columns that extend into the ground below the concrete floor slab. The longest clear span of the girder measured 7'-0" between the two steel post columns. The ceiling in the garage consists of ½" sheetrock paneling. Both the ceiling panels and the girder in the garage are covered in a stucco coating. The concrete floor of the garage was not evenly graded, as the distance from floor to ceiling varied in this area between 7'-2" and 7'-5".

**Photo 4. Garage Girder & Steel Post Columns (Looking Northeast)**

The existing steel post columns intermittently supporting the building's girders must be removed and replaced by new steel, concrete, or masonry block columns. These new columns will need to include a spread footing beneath to sufficiently support the building loads.

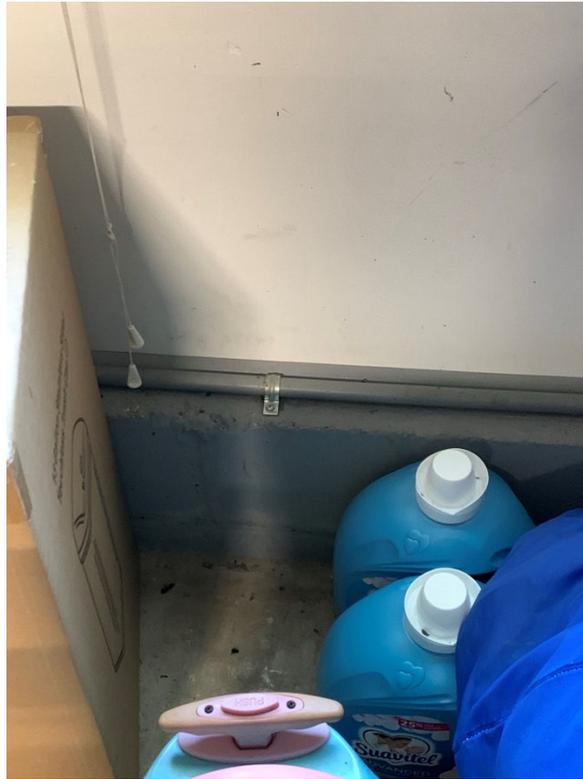
**Photo 5. CMU Wall Along Front Wall of Garage, Timber Frame Wall Above**

Renovations to the existing front CMU of the building will require removal of the existing brick façade. The façade may be replaced with a similar or more flexible finish after completion of the building elevation process. The materials and labor involved in exterior façade restoration of the house are not within the scope of this project.

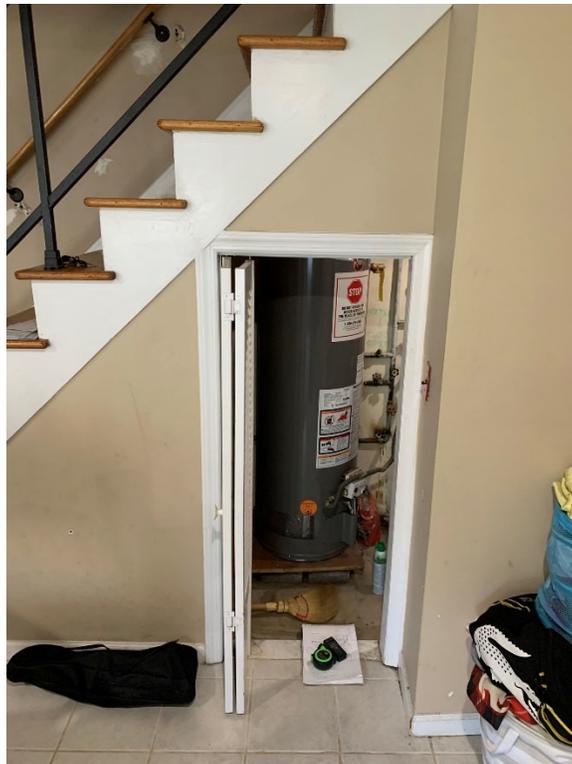
In the boiler room, located under the stairs to the second floor, a boiler and hot water heater were observed. The boiler was raised 12" above the concrete floor with CMU blocks, while the hot water heater was raised 5" above the floor on concrete blocks/pavers. Also in the boiler room, a CMU exhaust chimney connects to the exhaust pipelines of the hot water heater and boiler, extending up through the roof of the house. Outside the boiler room, in the hallway of the ground-level living space, a stacked washer and dryer unit was observed situated on the floor surface.

**Photo 8. Boiler Room Beneath Stairs to Second Floor with Hot Water Heater (Looking Northeast)**

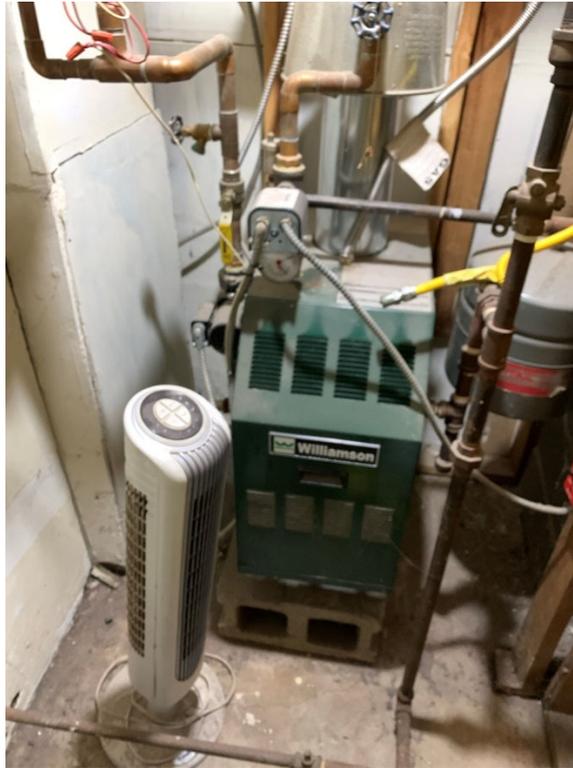
**Photo 9. Boiler in Boiler Room (Looking Southeast)**

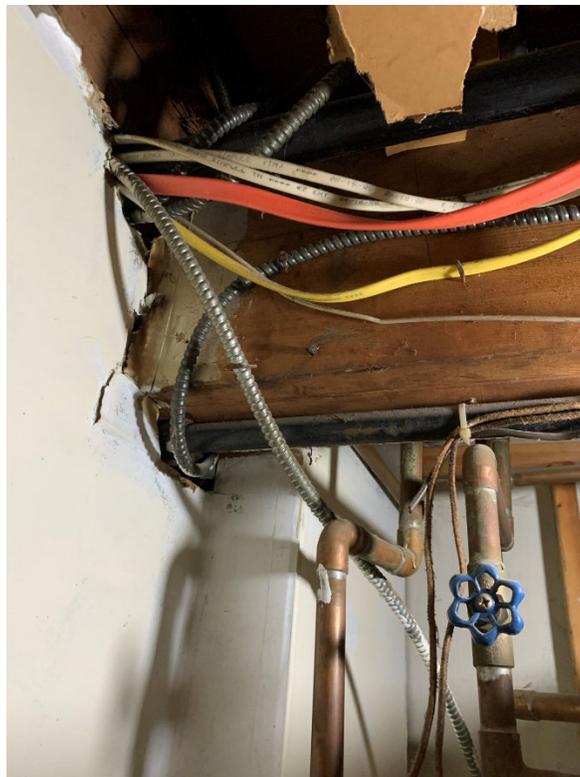
The remainder of the ground level, located south of the entrance vestibule and approximately 16" below the vestibule floor, consists of furnished living space. This space contains timber-framed partition walls that separate the area into a bathroom, bedroom, and living room. Similar to the garage, this area contains CMU perimeter foundation walls. While most of the walls are full height, the CMU block along the front wall of the house in this area appeared to extend only 24" above the floor surface – the rest of the wall is assumed to be timber framing. The concrete slab on grade in this area is covered with tile throughout, and measured approximately 7'-7" to the painted sheetrock ceiling. Beneath the stairs leading to the second floor of the house, a boiler room was observed that did not contain a sheetrock ceiling. From this room, the subfloor of the second floor was observed to consist of nominal 2x8 timber members, spaced 16" on center, running from front to rear of the house. These joists are supported by a girder consisting of (3) nominal 2x10 timber members spanning the full width of the ground-level living space from the south wall of the garage to the south exterior wall of the building. Though they could not be observed behind the finished sheetrock walls of the ground level, column supports are expected to be in place along the length of the girder to provide the necessary support for the building's loads.

**Photo 10. Timber Girder Above Boiler Room (Looking Southeast)**

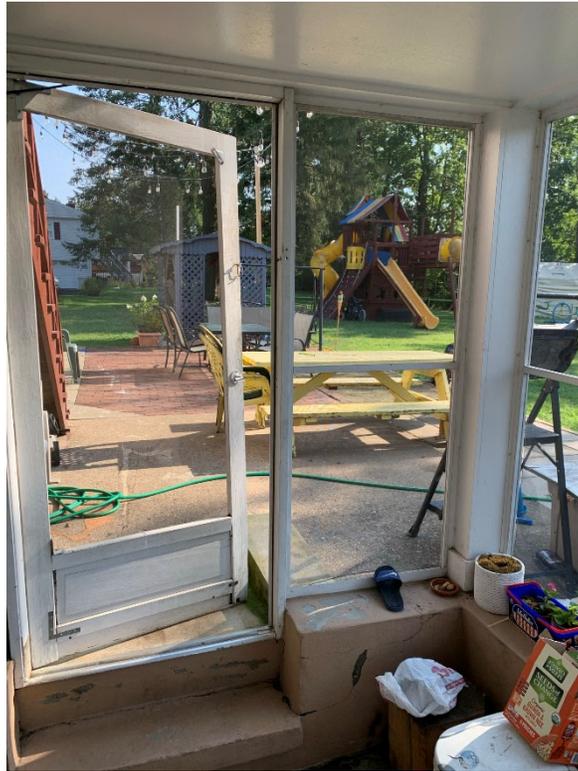
East of the ground-level living space, adjacent to the rear bedroom, an enclosed sun porch was observed. This porch measured approximately 9'-8" long x 11'-2" wide, and the concrete ground slab is approximately 5" below the interior ground level floor. The perimeter walls consist of CMU walls extending 21" above the ground floor, with glass windows comprising the remainder of the wall height (except the rear CMU wall of the house). Columns of unknown type or size are spaced intermittently along the perimeter walls between the windows, each covered in a 7"x7" timber enclosure and bearing on the lower CMU foundation walls. The columns provide support for the second floor above (sheetrock ceiling prevented observation of the subfloor). Concrete stairs connect the porch to the adjacent backyard patio of the property.

**Photo 11. Rear Enclosed Porch (Looking Northeast)**

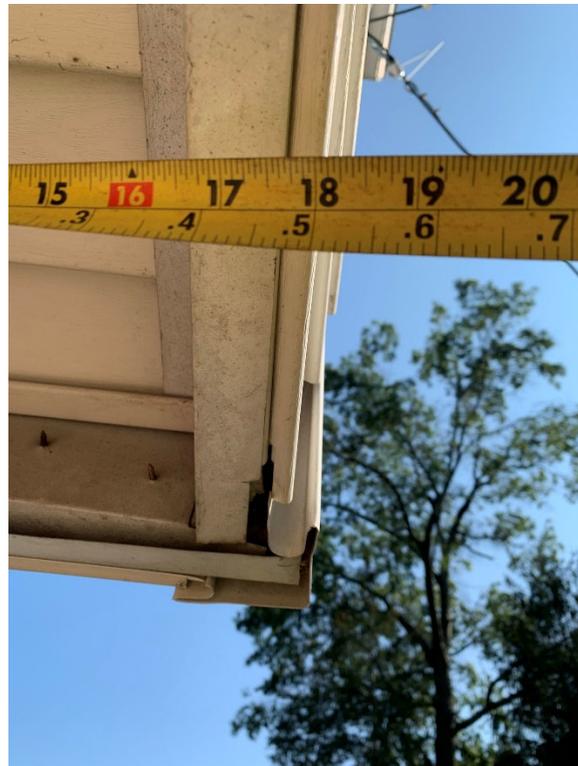
An approximately 18" overhang was observed on the second floor in the front and rear of the house, above the ground-level garage area only. These overhangs are cantilever, as there is no additional support for the overhanging areas of the second-floor joists.

**Photo 12. Second-Floor Overhang Over Garage Walls (Typ.)**

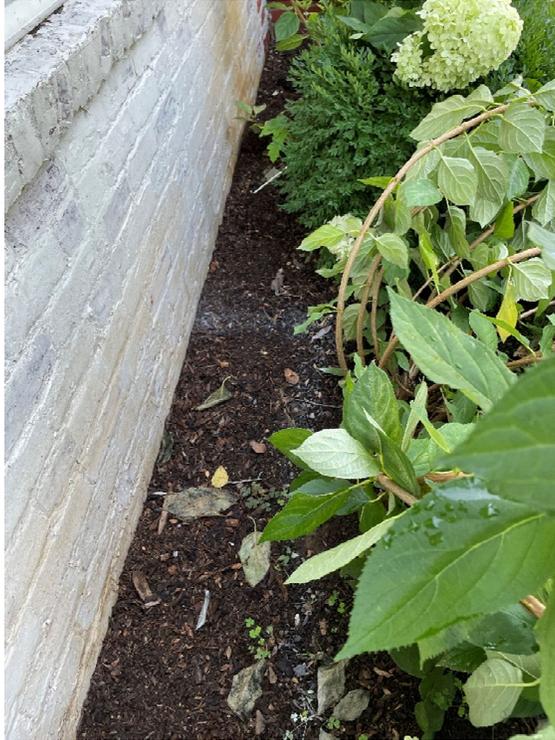
A test pit excavation conducted along the front wall of the garage was prematurely terminated at 30" bgs due to the presence of the groundwater table at that depth. Using a metal rod, the top of the concrete footing was encountered at 40" bgs, but due to groundwater obstructions the footing dimensions could not be measured. Based on our findings within the test pit and from conventional foundation construction, Matrix utilized a 16" wide footing as a minimum value for analysis, but believes the actual footings for the building to likely range from 16" to 24" in width. Prior to raising the house, Matrix recommends that the contractor confirm the foundation size and bearing adequacy with multiple test pits around the building perimeter.

**Photo 15. Test Pit TP-1 Location (Front Wall of Building – Garage)**

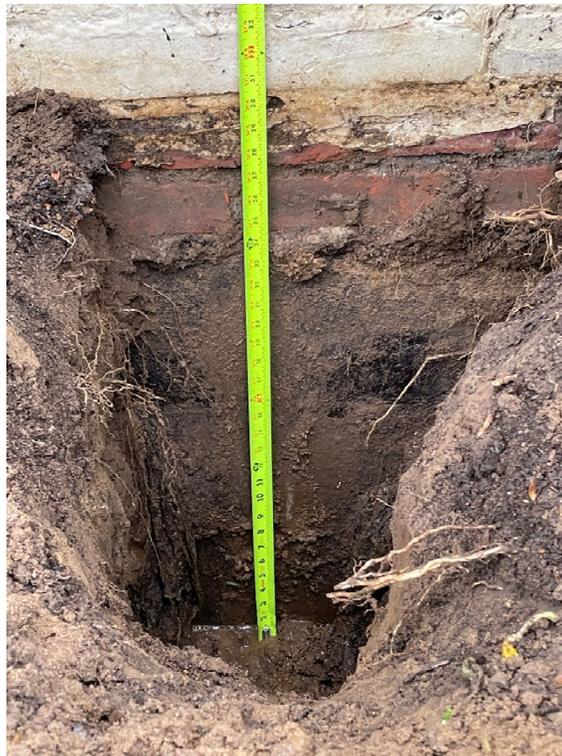
The test pit completed along the west wall of the building was prematurely terminated at 30” below the ground surface (bgs), due to the presence of groundwater. Using a metal rod, the top of concrete was encountered at 40 inches bgs. The high groundwater table within the test pit prevented measurement of the foundation wall footing dimensions.

**Photo 16. Test Pit TP-1 Conditions**
