**ENGINEERING INVESTIGATION & ANALYSIS
GEOTECHNICAL & STRUCTURAL
ASSESSMENT REPORT**

**30 CARLOS DRIVE
FAIRFIELD, NEW JERSEY 08203**

Matrix No. 20-1052

August 2021

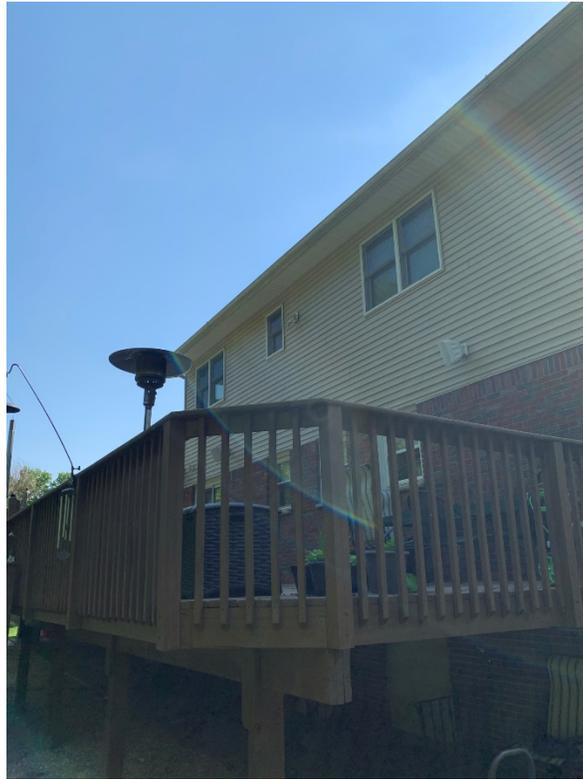
A timber deck was observed spanning the width of the house in the rear of the building. The deck is flush with the first floor of the house and approximately 71" above adjacent exterior grade on average. The deck consists of nominal 2x8 floor joists spaced 12" on center. The joists are supported at their east end by the rear CMU foundation wall of the house and at the west end by a timber girder [(2) nominal 2x10 members] on timber posts embedded in Sonotube footings.

Photo 3. Rear of Building with Timber Deck

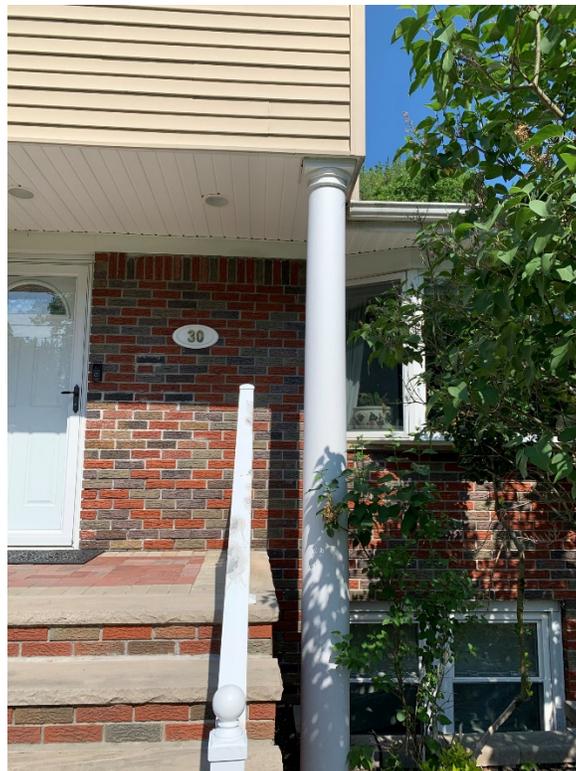
Photo 4. Column Supporting Second Floor Overhang in Front of Building (Looking West)

The existing steel post columns intermittently supporting the existing building's girders must be removed and replaced by new concrete or masonry block columns. Also, the two exterior columns supporting the second-floor overhang in the front of the building must be removed and replaced with longer columns of similar type. These new columns will need to include a spread footing beneath to sufficiently support the building loads.

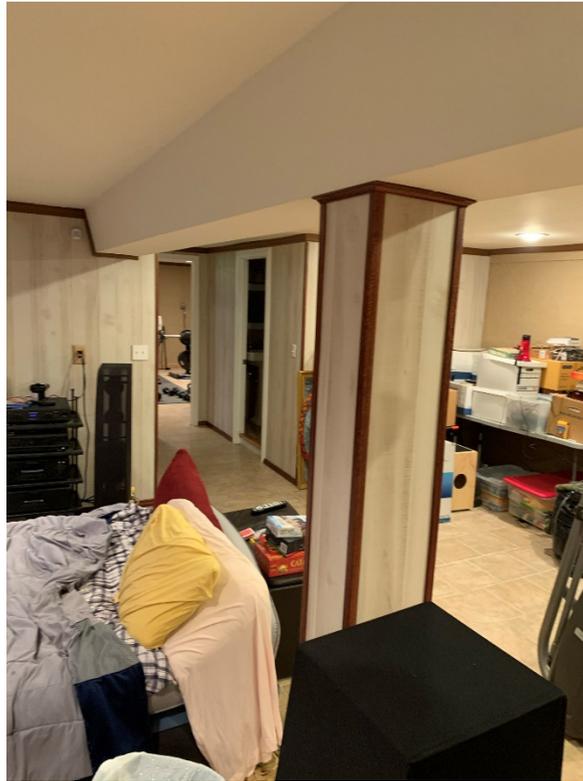
Within the completed finished portion of the building's basement, two large openings were observed in the ceiling, exposing the subfloor above. The joists visible in each of these openings had holes cut into their depth to allow for metal conduit to run through.

Photo 5. Finished Basement (Looking Southwest)

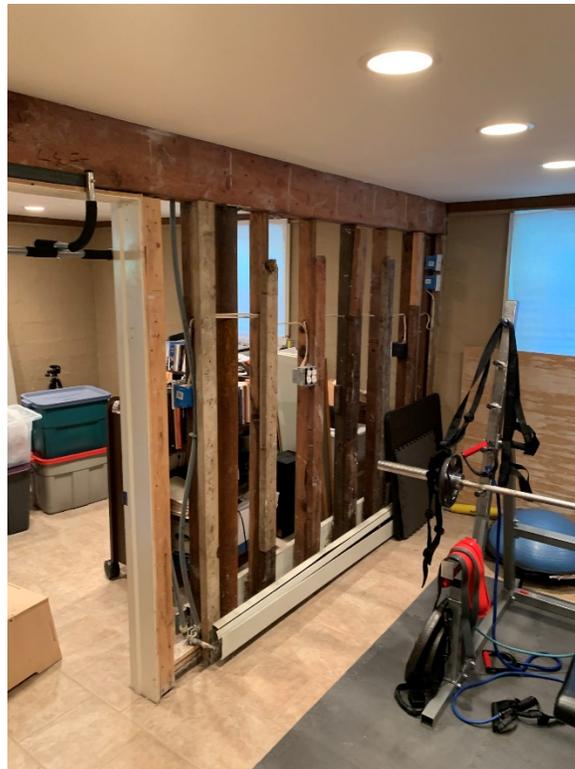
Photo 6. Unfinished Partition Wall in Basement with Girder & Steel Post (Looking Southeast)

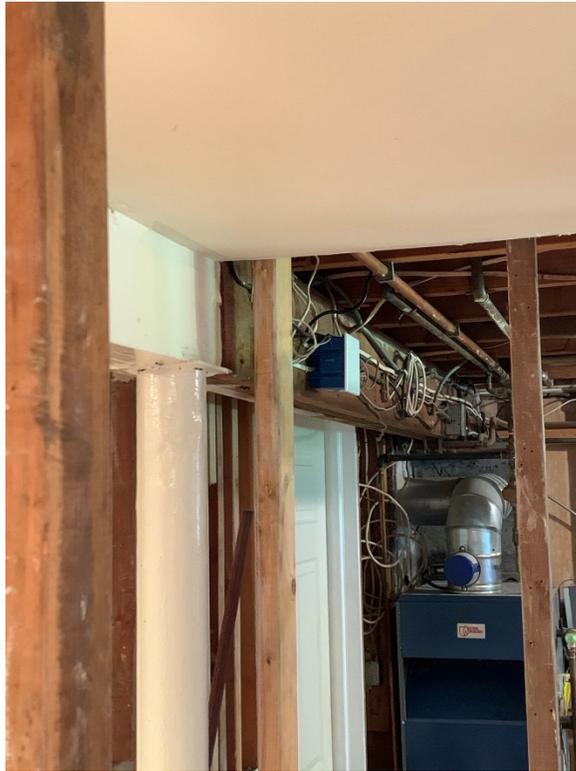
The subfloor of the first floor above the basement consists of nominal 2x10 timber joists typically spaced 16" on center and running east to west (front to rear of the building). These joists are supported by the perimeter CMU foundation walls of the basement as well as timber girders running north to south and spanning the width of the basement in the middle of the area. The two girders, which are nearly in line with each other along the middle of the space, each consist of (3) nominal 2x10 timber members. The girders are supported at one end by the CMU foundation walls, and at the other end (in the center of the basement) by a column of stacked CMU blocks. Both girders are further supported along their lengths by 4" diameter steel posts which extend down through the basement floor. The longest clear span of the north girder measured approximately 11'-6", while the south girder's longest clear span was approximately 9'-8" long.

Photo 7. South Girder & Steel Post in Basement (Looking North)

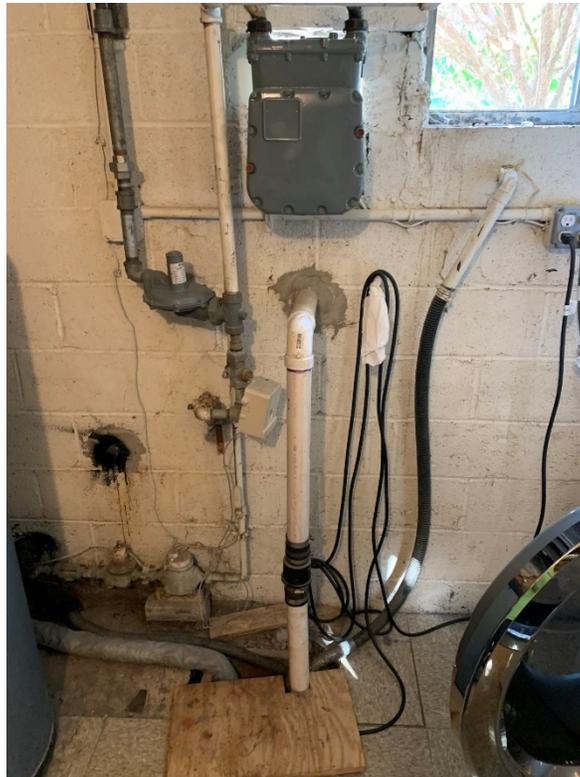
The basement, measuring approximately 26'-7" long x 52'-10" wide, encompasses the entire habitable footprint of the residence and supports two floors above. The foundation walls spanning the perimeter of the basement consist of 8x8x18 CMU blocks ranging from 85" to 85.5" in height. The basement floor measured approximately 8'-2" below the first-floor surface above. Since the basement is a finished area, most of the CMU walls are covered in a stucco veneer on their interior face. Apparent basement renovations were ongoing at the time of the inspection, as most partition walls still had exposed timber studs and the CMU walls along the front (east) wall were not coated with paint or stucco.

Photo 8. CMU Foundation Walls in Basement with Gas Meter & Sump Pit (Looking East)

Additionally, any service equipment, whether outside or in the cellar, such as air conditioning, heat pump compressors, gas meters, electric meters, and hot water heaters, must be elevated 3 feet above the BFE. For interior elements, this may include relocation to an upper floor and thus less usable living space. For this residence, the hot water heater, boiler, and gas meter in the basement, and the electrical panel in the garage, would require elevating 3 feet above the BFE onto the raised first floor. The 2 exterior air conditioning units, and the generator, would also require elevating 3 feet above the BFE on new or extended exterior platforms.

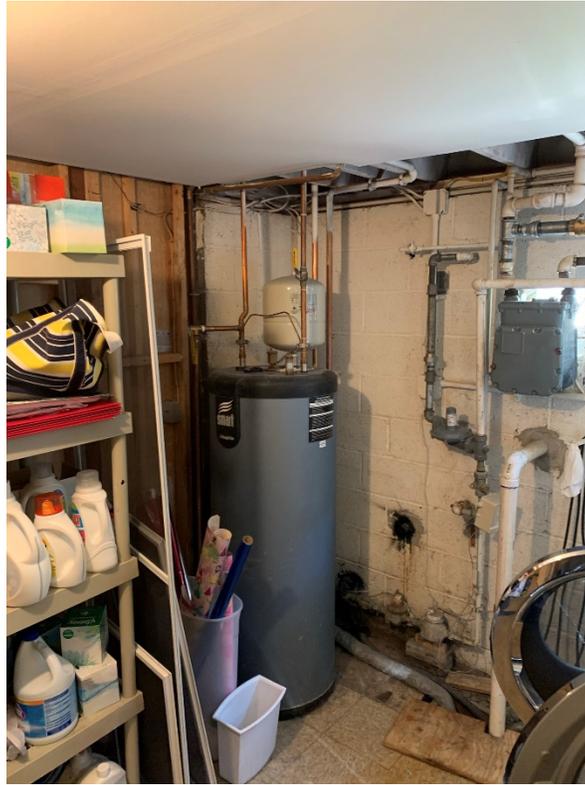
Photo 9. Hot Water Heater in Basement (Looking Northeast)

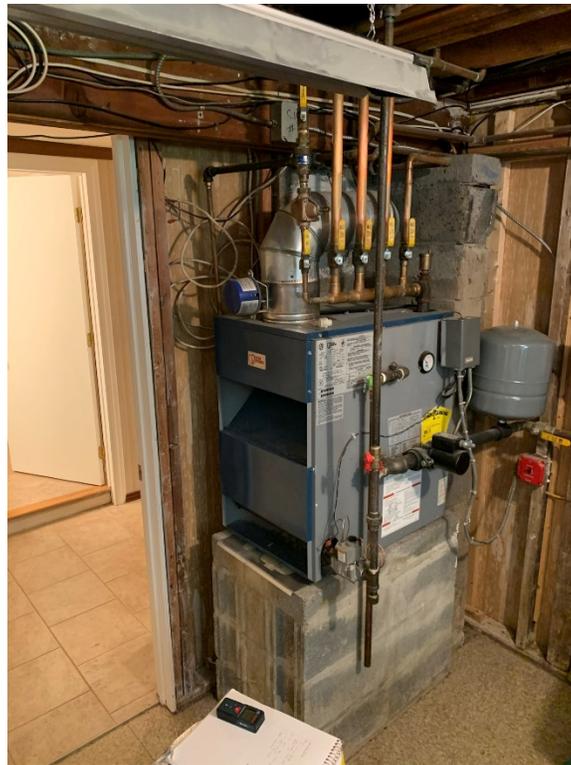
Photo 10. Boiler in Basement (Looking Northwest)

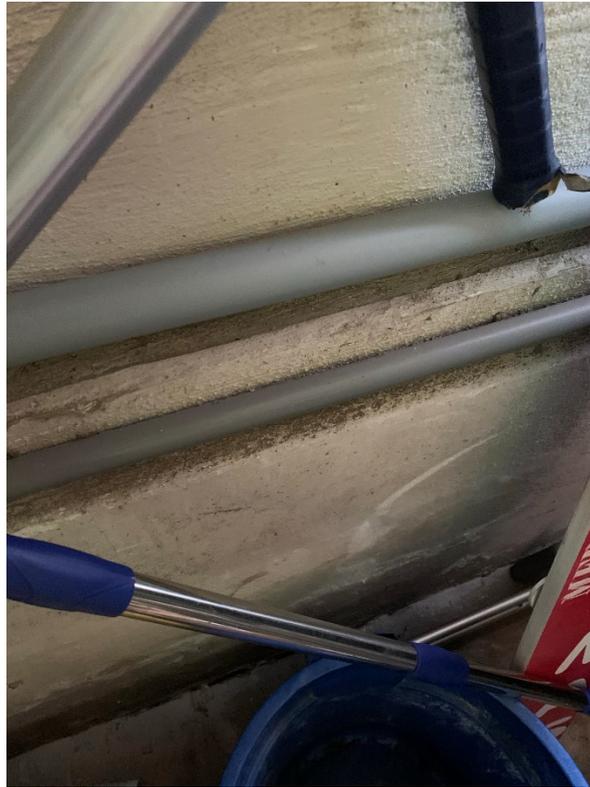
The garage area is located north of the basement, and the two areas are separated by a staircase that leads to the first floor of the house. The garage consists of a concrete slab on grade with apparent CMU walls measuring 32.5" high and spanning the perimeter (contractor to confirm wall type prior to raising the building). The wall along the north edge of the garage includes a small 1" notch located 4" below the top of the wall. Timber stud walls make up the garage frame above the foundation walls. The ceiling of the garage measured approximately 8'-9" above the garage floor. There is no floor above the garage, but an attic was observed below the roof in this area.

Photo 11. Typical Foundation Wall Along Garage Perimeter

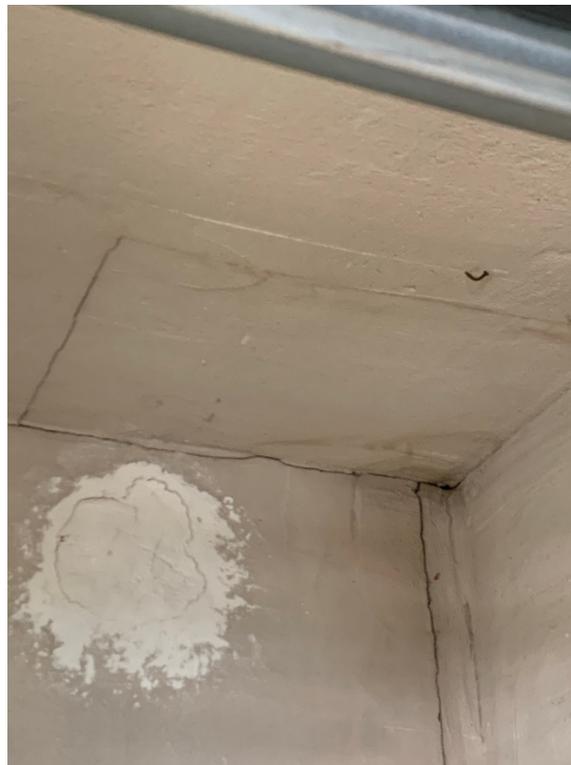
In the southeast corner of the garage, multiple cracks and water staining were observed in the wall and the drywall ceiling. Some exposed brick was also seen in the wall, likely the exterior of the brick chimney. The

Photo 12. Cracks & Water Staining on South Wall of Garage (Southeast Corner)

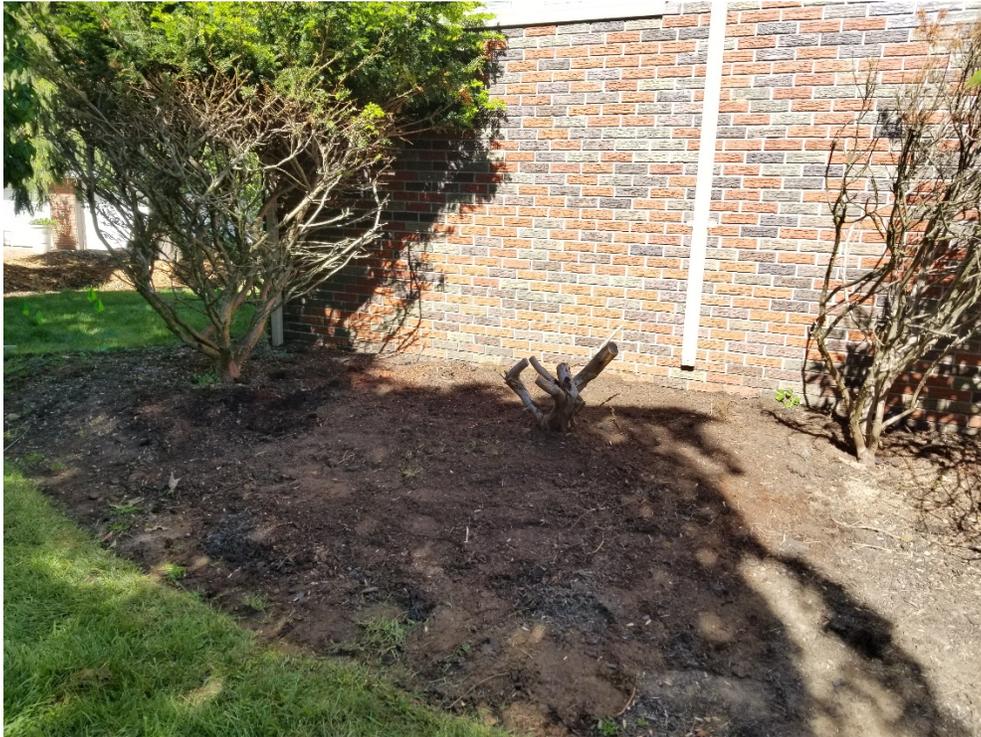
Photo 13. Test Pit TP-1 Location (Front of Building – Southeast Corner of Basement)

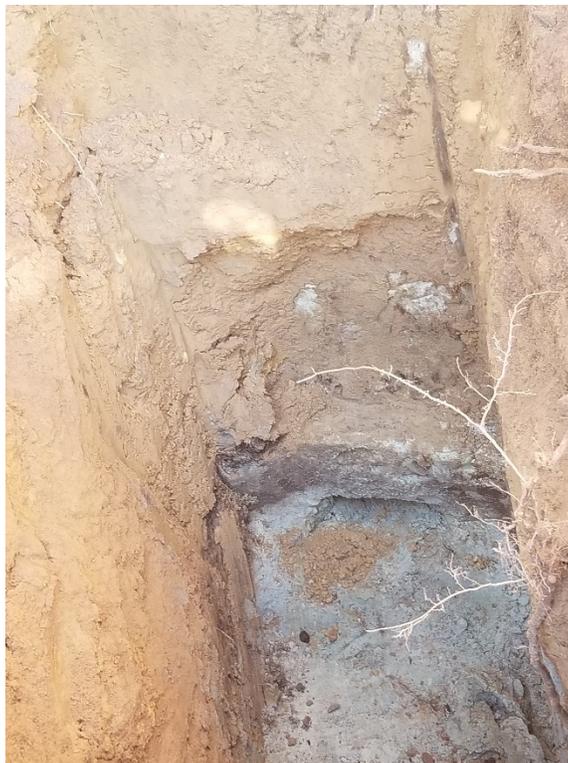
The top of the concrete was uncovered in TP-1(Front Yard) at 73” bgs. The concrete protrudes 4” from the wall and extends 10” deep at this location.

Below the foundation walls in the southeast corner of the basement, an approximately 16" wide concrete spread footing was revealed during the test pit excavation program. Based on our findings within the test pits and from conventional foundation construction, Matrix utilized a 16" wide footing as a minimum value for analysis, but believes the actual footings for the building to likely range from 16" to 24" in width. Prior to raising the house, Matrix recommends that the contractor confirm the foundation size and bearing adequacy with multiple test pits around the building perimeter.

Photo 14. Test Pit TP-1 Foundation Conditions

Matrix recommends that the existing foundation system of the residential building at 30 Carlos Drive be kept and extended to achieve the required design flood elevation. The existing CMU foundation walls are expected to provide sufficient support for the additional height of the newly raised building. Based on loading estimation and analysis for the existing building, Matrix estimates that the anticipated additional dead load of the required new courses of CMU would remain under an allowable bearing capacity of 2,500 psf for the shallow concrete strip footings at the Site.
