**ENGINEERING INVESTIGATION & ANALYSIS
GEOTECHNICAL & STRUCTURAL
ASSESSMENT REPORT**

**367 HORSENECK ROAD
FAIRFIELD, NEW JERSEY 08203**

Matrix No. 20-1052

August 2021

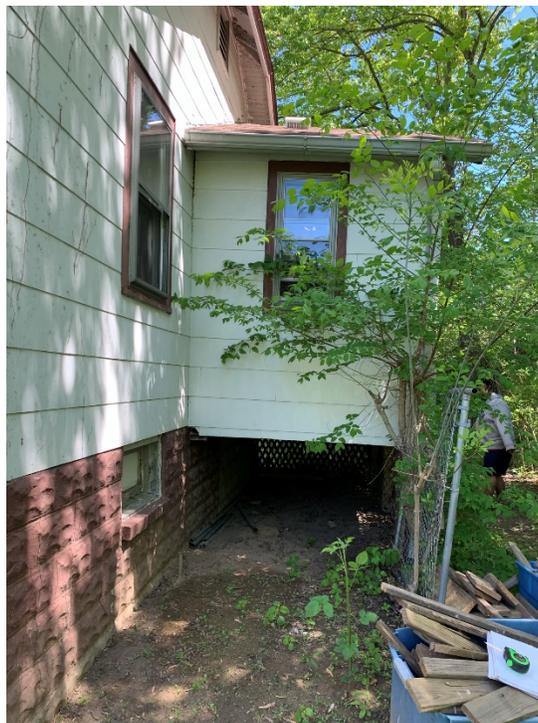
The east addition exhibited some differential settlement at the time of the inspection. The columns along the east edge of the addition had apparently settled, resulting in detachment of the addition from the original building frame (as evidenced by the gaps observed on either side of the addition between the two connecting frames).

Photo 2. 367 Horseneck Road (East Addition)

The CMU block columns supporting the east addition appeared to have settled at the time of the inspection. Matrix recommends that these columns be removed and replaced with new concrete or CMU columns following raising. The new columns should be founded on a new concrete strip footing encompassing all three columns and appropriately sized to help prevent future differential settlement that was evident in the existing condition of the house's east addition at the time of the inspection. The groundwater table was observed between 4 and 6 feet bgs during the subsurface investigation, which may require the use of dewatering during construction of the new east addition footing. As previously noted, the groundwater table

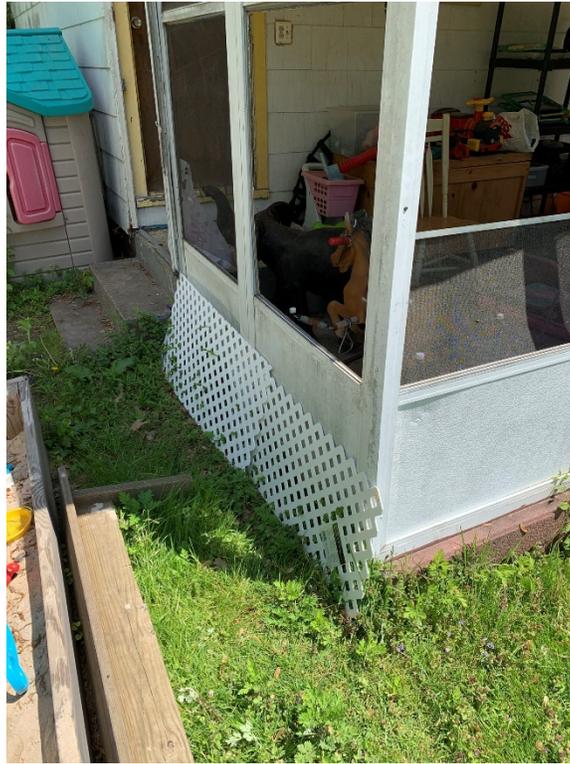
The patio in the rear of the building exhibited notable weathering. Paint loss was observed throughout the area on the landing and patio floor. A large crack was also seen in the concrete slab surface spanning the width of the patio (east to west).

Photo 3. Rear Enclosed Patio

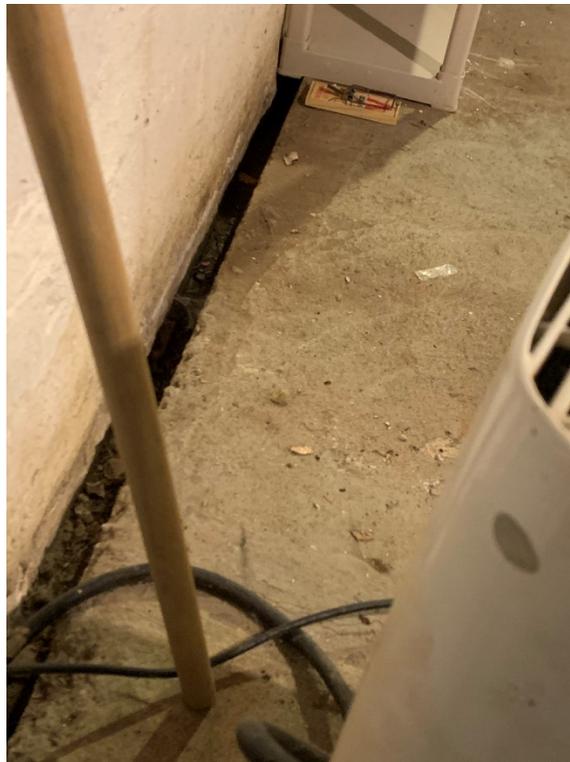
The main basement of the building measures 25' x 35'. The CMU walls of the basement range from 69" to 71" in height (measured from the basement floor to the top of the block wall). The CMU blocks were observed to have a decorative finish on the exterior face, which was visible on the portion of the wall above exterior grade. A small trench was observed along the perimeter of the basement floor, creating a gap between the walls and the concrete floor slab. This trench measured 2" to 3.5" in width and ranged from 3" to 4" deep. The purpose of this trench is not explicitly known, but appears to serve as a drainage channel for the basement area.

Photo 4. Trench Along Basement Walls

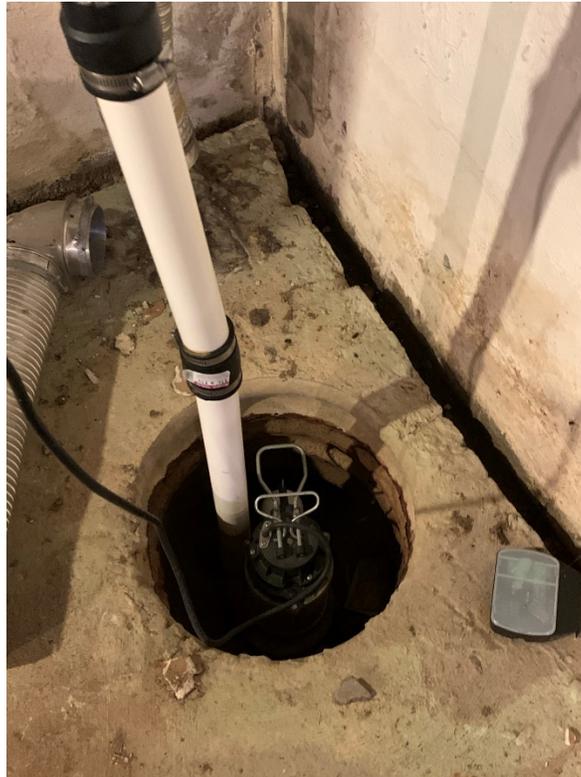
Two sump pumps were observed within the basement area of the building, in opposite corners (southeast and northwest). Also observed in the basement, in the center of the area, was a water heater situated at the floor level and a boiler set atop three courses of stone block. A gas meter was mounted on the front (north) wall of the basement. Multiple PVC sewer lines run down from the rear of the building and across the basement to exit out of the front wall. The electrical panel for the building was located on the east wall of the basement, near the top of the wall.

Photo 5. Sump Pump in Basement (Southwest Corner)

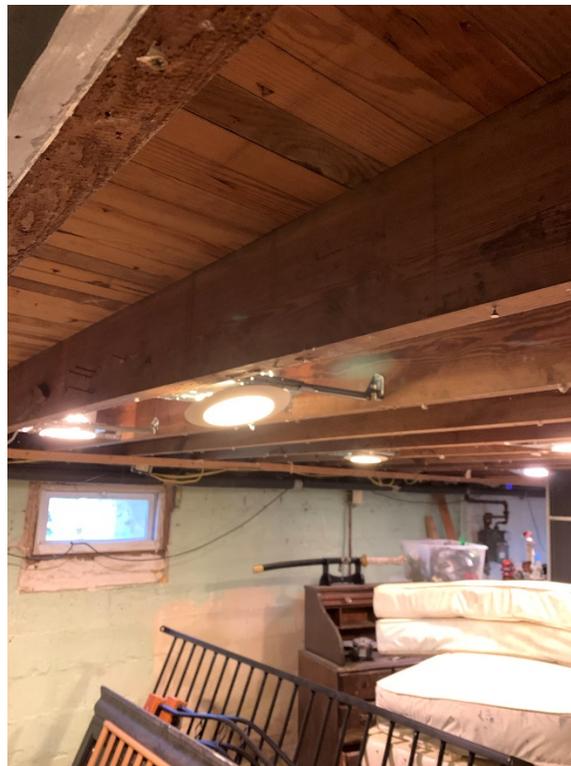
Timber nominal 2x8 floor joists, spaced 16" on center, run north-to-south (front-to-rear of building) above the basement walls. These joists are supported on either end by the basement CMU walls, as well as a timber girder running perpendicular to the joists in the middle of the basement. The girder is made up of (2) connected nominal 2x8 timber beams and is supported along its length by seven 4x4 timber posts. The longest unsupported span of the girder measured approximately 9 feet, and a brick exhaust column (non-structural) was observed in the middle of that span.

Photo 6. Floor Joist Layout for First Floor

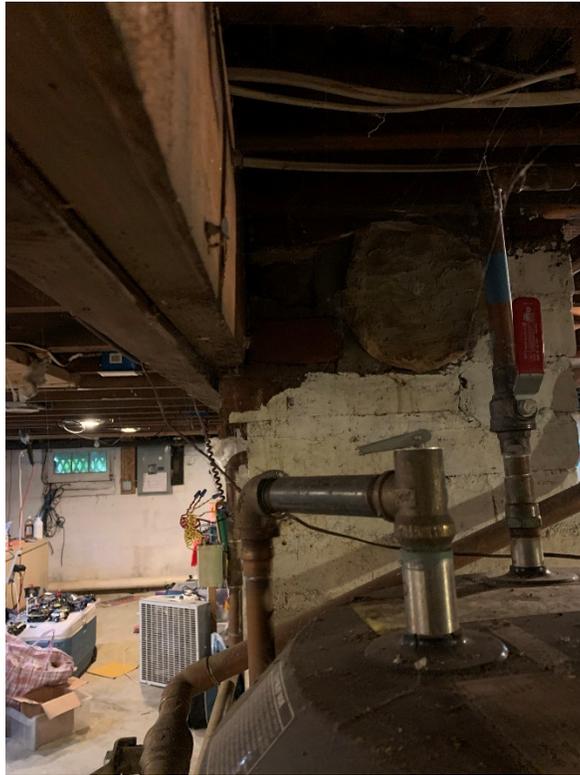
The building at 367 Horseneck Road is a rectangular structure built on concrete masonry unit (CMU) basement/foundation walls. Two additions have since been built adjacent to the original building foundation. The timber frame of the building is supported by nominal 2x8 timber girders spanning the CMU foundation walls.

Photo 7. (2) 2x8 Timber Girder in Basement

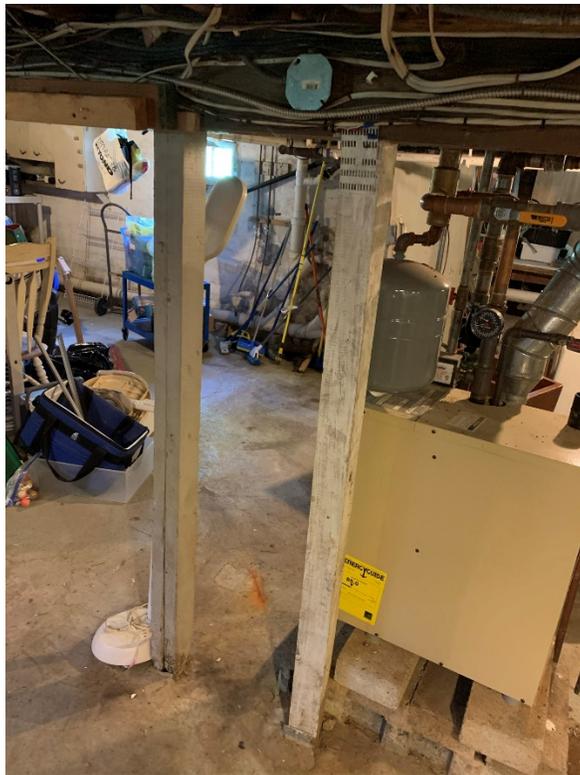
Photo 8. Timber 4x4 Girder Support Posts (Typ.)

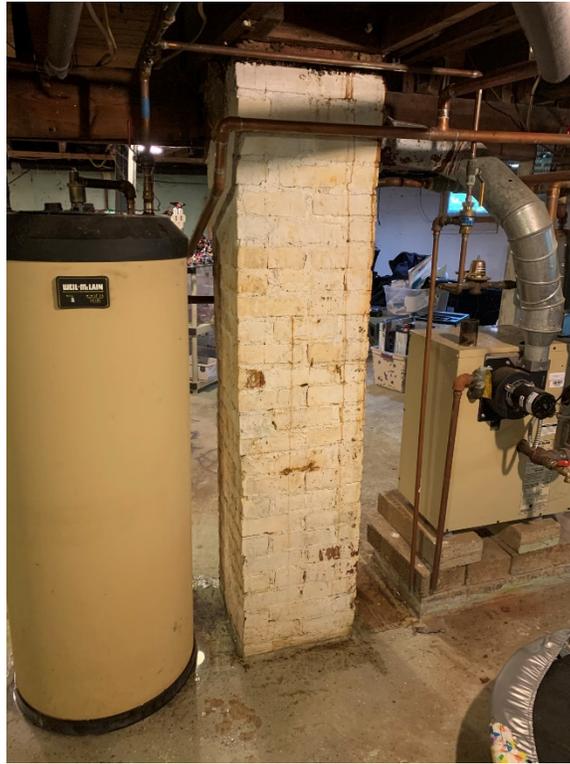
Within the basement, multiple cable trays and support channels were observed to be damaged and hanging, along with the electrical cables. Some water ponding was observed around the water heater located in the center of the basement, though the rest of the basement was dry.

Photo 9. Water Heater (Left) and Boiler (Right) in Basement

Additionally, any service equipment, whether outside or in the basement, such as air conditioning, heat pump compressors, gas meters, electric meters, and hot water heaters, must be elevated 3 feet above the BFE. For interior elements, this may include relocation to an upper floor and thus less usable living space. For this residence, the hot water heater, boiler, gas meter, and electrical panel in the basement would require elevating 3 feet above the BFE.

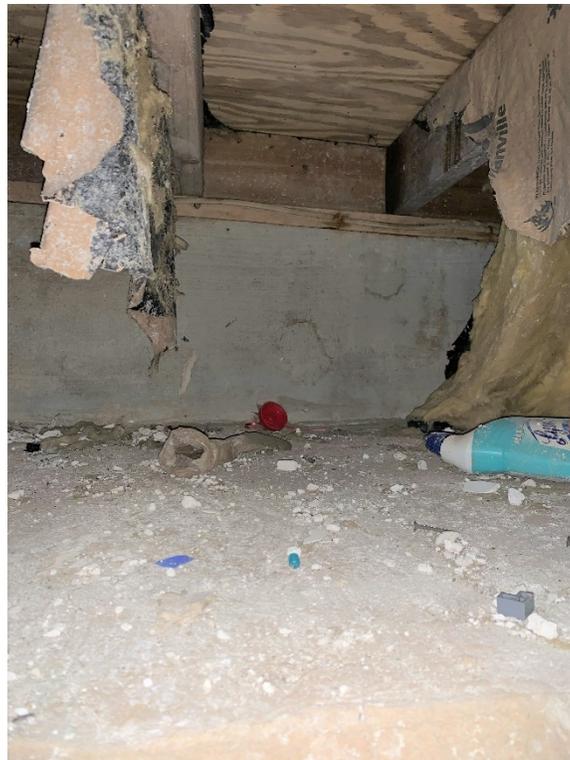
Adjacent to the main basement area to the south (rear), a recent addition had been constructed. This relatively narrow area, approximately 19'4" long x 6'-5" wide, consists of cast-in-place concrete foundation walls supporting a timber frame structure. A set of timber stairs lead from the basement level to the building's first floor. The floor of the rear addition is a concrete slab with varying elevation – immediately adjacent to the basement, the stair landing is 5.5" higher than the basement floor. A second ledge in the concrete floor, south of the stair landing, raises the floor another 6.5". The concrete foundation walls measured 21" in height from the highest floor elevation. Above these foundation walls, a timber platform has been constructed with nominal 2x6 timber beams running north to south to cover the remainder of the addition space. Timber 4x4 posts are spaced evenly along the length of the platform area to support the structure opposite the concrete foundation wall. This portion of the house was unfinished at the time of the inspection, as flood damage had halted further construction at the Site.

Photo 10. Rear Addition Foundation Wall

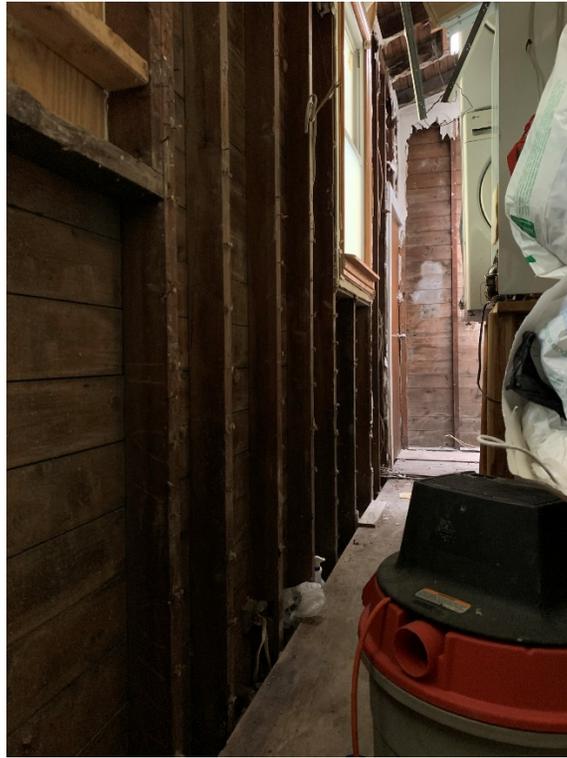
Horizontal cracks were observed in the rear concrete stairwell landing in the rear addition, adjacent to the basement floor. As noted above, the rear addition was unfinished at the time of the inspection, and the timber frame of the building was visible throughout this area.

Photo 11. Unfinished Rear Addition

The rear addition of the house currently consists of an unfinished room located approximately 5 feet below the first-floor level, with a timber subfloor supported by timber posts. If kept at the same elevation following rising, the floor of this addition would be below the design flood elevation and rendered unusable. Matrix recommends that this area of the house be elevated to match the first floor following raising of the building, which will maintain the existing usable living space for the resident. A new timber subfloor will need to be constructed within the rear addition area to match the elevation of the newly raised first floor. Inclusion of a new timber subfloor will also create over 8 feet of space below, which can be used for storage at the resident's discretion.

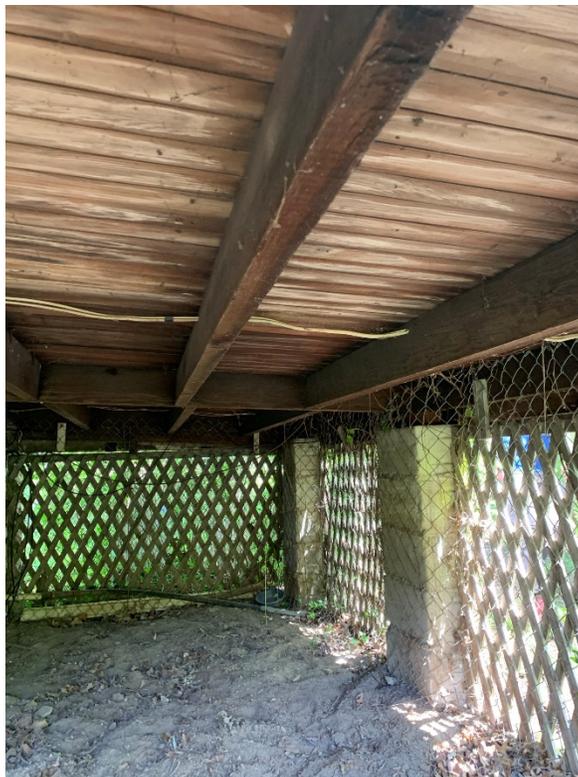
East of the basement area, a second addition was observed which added footage to the first floor of the building. This 14'-6" long x 6'-4" wide area is supported by the CMU basement wall along the west edge and a series of three concrete block columns along the east edge. The subfloor of the addition consists of nominal 2x6 timber beams running in both directions (north-to-south and east-to-west) and at equal elevation, with the transverse beams (east-to-west) sitting atop brick pedestals above the concrete block

Photo 12. East Addition Columns and Subfloor

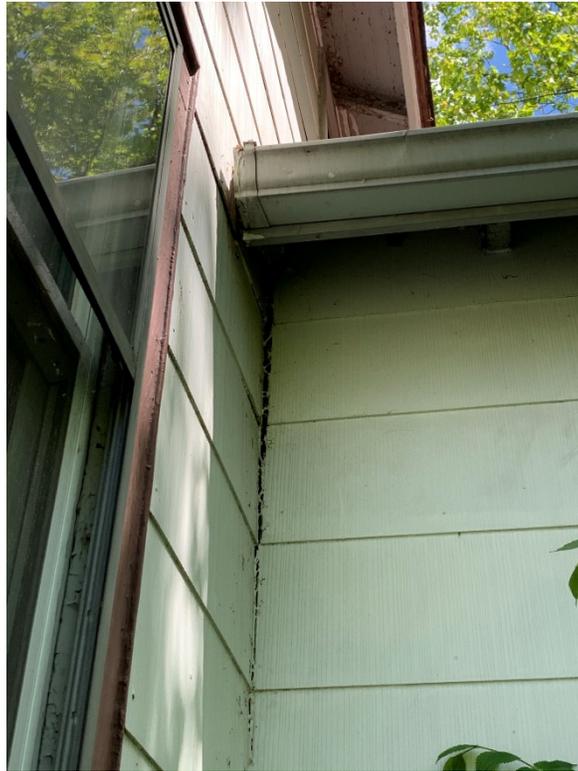
Photo 13. Separation of East Addition from Main Building Frame

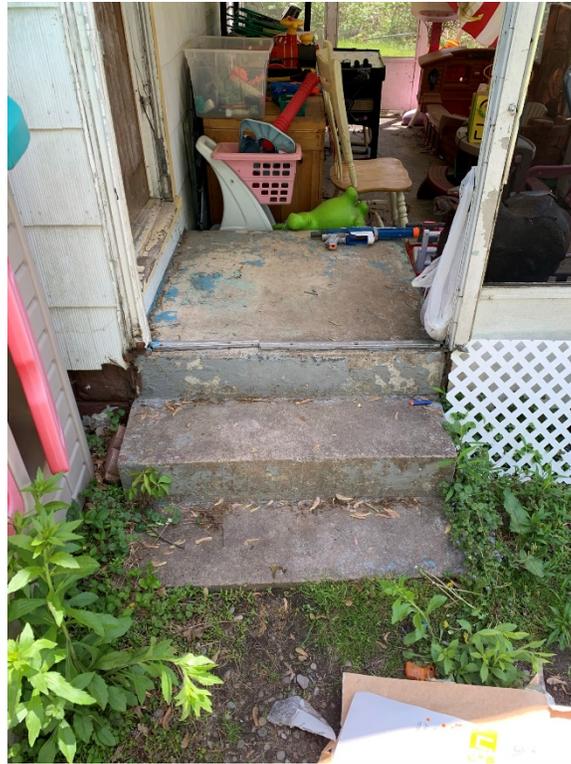
South of the rear addition, an enclosed patio area was observed. The patio consists of a concrete slab on grade with the top of slab 9" to 12" above the adjacent exterior grade. Concrete steps lead from the outside of the patio to a concrete landing approximately 13.5" above the patio floor surface. From the landing, a rear access door connects the patio to the rear addition of the residence.

Photo 14. Concrete Steps to Patio Landing

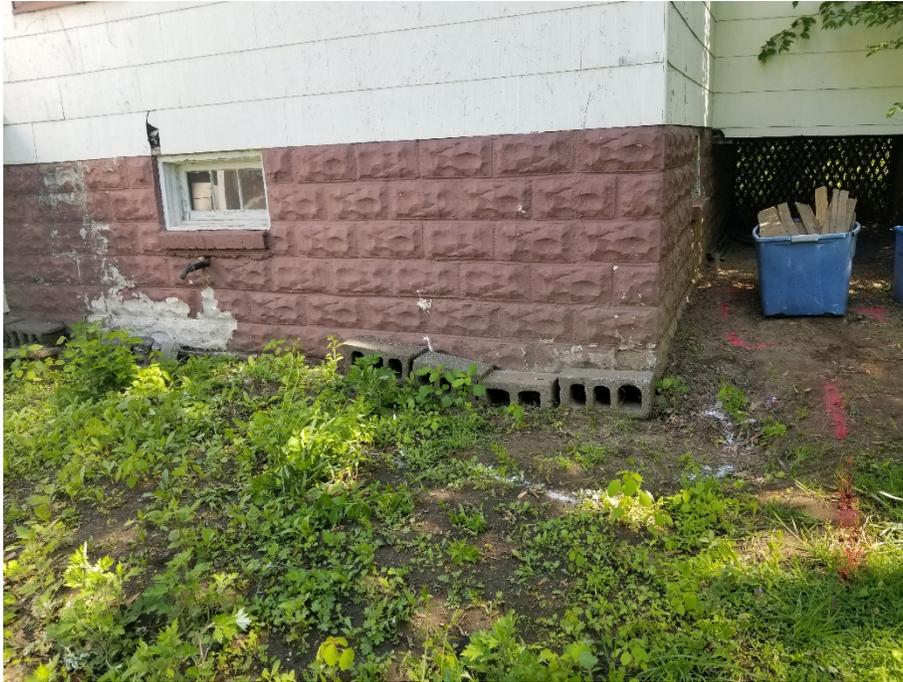
Due to site constraints along the edges of the existing building, test pit excavation could be completed at only one location at the Site. The single test pit was located at the southeast corner of the basement area to obtain details of the building's main foundation conditions. Based on our findings within the test pits and from conventional foundation construction, Matrix assumed a 16" wide footing as a minimum value for analysis, but believes the actual footings for the building to likely range from 16" to 24" in width (typical footing size for residential homes). Prior to raising the house, Matrix recommends that the contractor confirm the foundation size and bearing adequacy with multiple test pits around the building perimeter.

Photo 15. Test Pit TP-1 Location (Southeast Corner of Building – Basement)

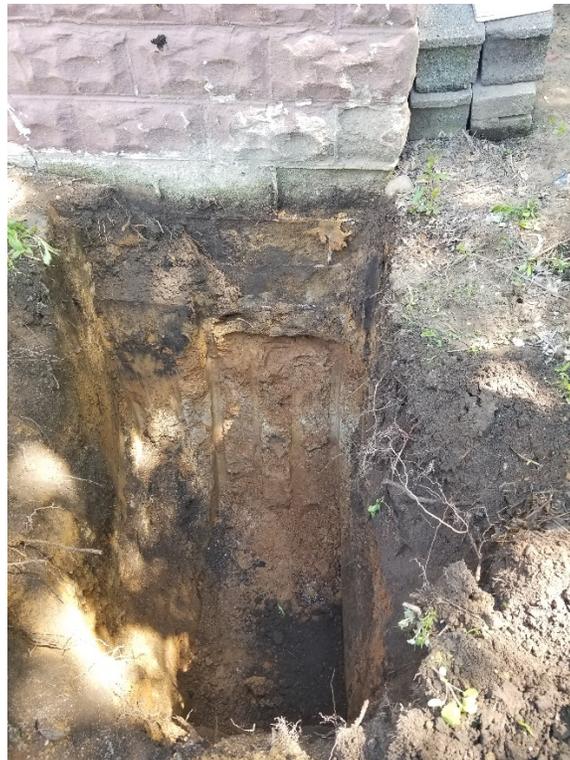
Photo 16. Test Pit TP-1 Foundation Conditions
