**ENGINEERING INVESTIGATION & ANALYSIS
GEOTECHNICAL & STRUCTURAL
ASSESSMENT REPORT**

**44 BIG PIECE ROAD
FAIRFIELD, NEW JERSEY 08203**

Matrix No. 20-1052

August 2021

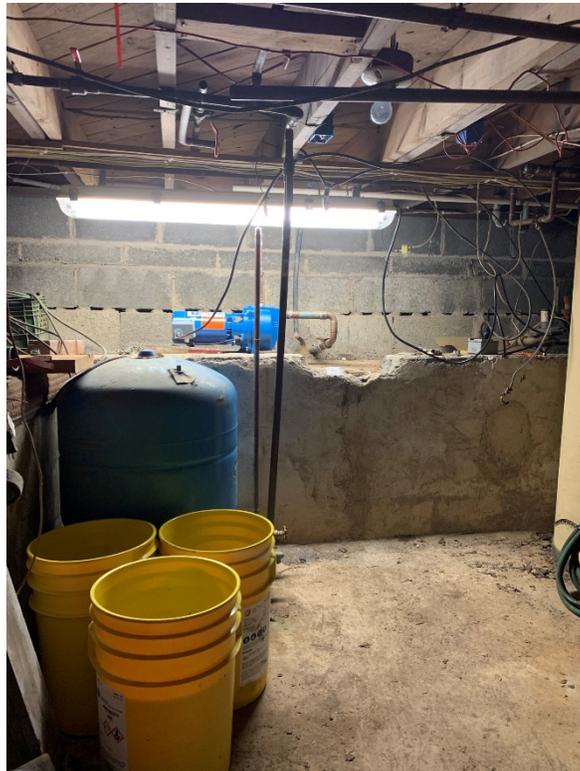
In the northeast cellar, a 31.5" high concrete foundation wall spans the perimeter of the building. This wall is assumed to be the original building's foundation. Currently, an additional 29" of CMU wall has been added above the original concrete foundation walls to form the existing foundation for the northeast portion of the building. Nominal 2x8 timber members comprise the floor joists for the building's first floor, supported by a set of (6) nominal 2x8 members bolted together to form a girder running east-to-west in the middle of the northeast cellar area. The girder is supported by the perimeter CMU walls as well as two additional CMU pedestals spaced along the length of the girder. A steel jack post has also been installed between the two pedestals for additional support of the girder. The first-floor joists are not evenly spaced throughout this portion of the building, with spacing typically varying between 12" and 14".

Photo 4. North Cellar (North Wall)

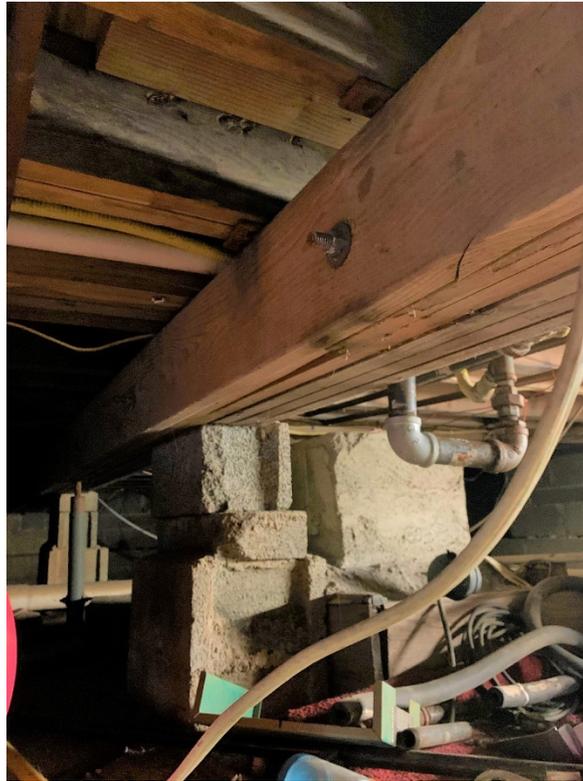
Photo 5. Girder in North Cellar

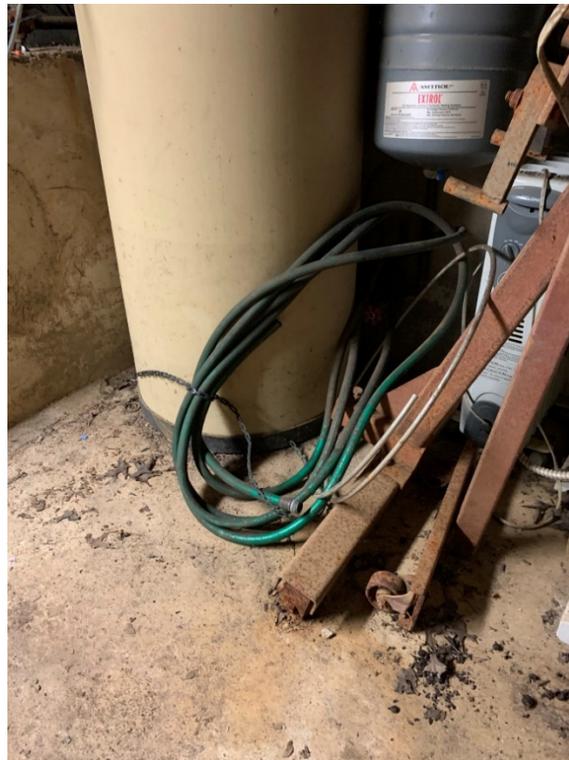
Various pieces of equipment and machinery were observed within the north and south cellars of the building at the time of the inspection. Two sump pumps were observed – one in the southeast corner of the south cellar and one in the east edge of the north cellar. Also observed in the north cellar (all near the north edge of the building) was a water heater situated at the cellar floor level, a water well pressure tank on a 4” high concrete pad, and a water pump located atop the original concrete perimeter wall (approximately 31.5”

Photo 6. Hot Water Heater at Ground (North Cellar)

Additionally, any service equipment, whether outside or in the cellar, such as air conditioning, heat pump compressors, gas meters, electric meters, and hot water heaters, must be elevated 3 feet above the BFE. For interior elements, this may include relocation to an upper floor and thus less usable living space. For this residence, the hot water heater in the cellar would require elevating 3 feet above the BFE onto the raised first floor. The 2 exterior air conditioning units would also require elevating 3 feet above the BFE on a new or extended exterior platform.

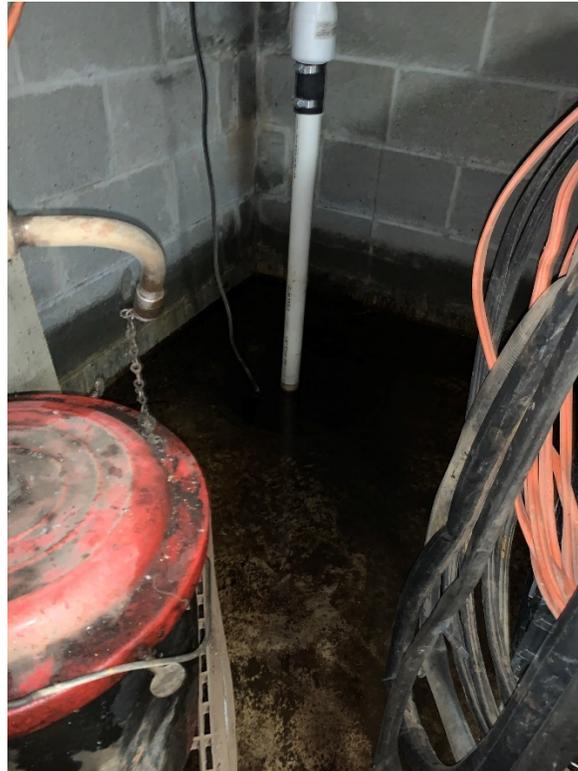
Within the south cellar of the building, approximately 1” of standing water was observed in the southeast corner directly above the sump pump. Also, a hole was observed in the north wall of this cellar portion, near the floor surface. At this hole, water was seen seeping through the CMU block and into the cellar. No water was observed in the north cellar or west crawl space at the time of the inspection.

Photo 7. Sump Pump with Standing Water (South Cellar)

bgs during the subsurface investigation, but standing water was observed within the south cellar at the time of the inspection. Dewatering is not expected to be a concern for this project, but may be required during construction of the new foundation wall within the garage area. As previously noted, the groundwater table can be impacted by seasonal variations, precipitation, and other climatic factors. Presence of groundwater at foundation depths may severely impede the constructability of footings due to possible inflow of groundwater into the open excavation. The appropriate measures to be taken for groundwater control during construction should be determined in the field at the time of excavation and are the responsibility of the Contractor.

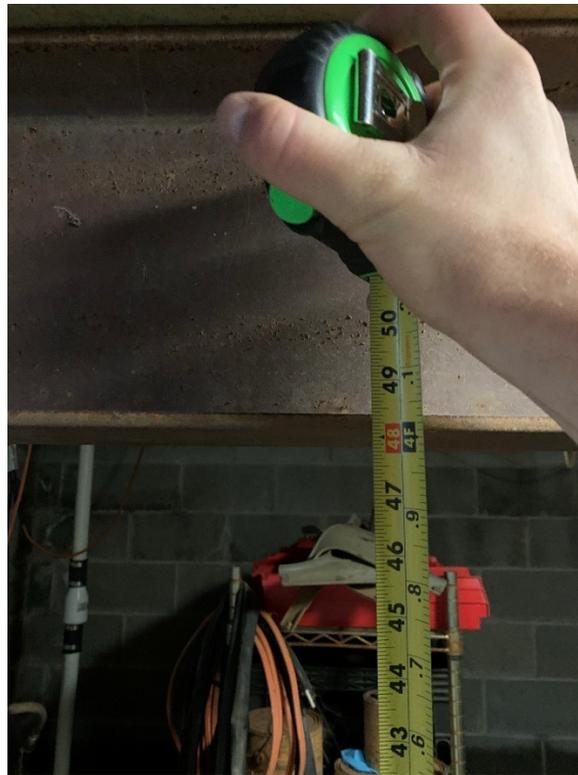
Immediately adjacent to the south, a second cellar area consisting of 56” high CMU foundation walls spans the perimeter of a relatively new portion of the residential building. Concrete block columns were also observed intermittently along the walls of this cellar. A steel W8X13 girder spans the width of the cellar (east-to-west), with timber nominal 2x8 floor joists above.

Photo 8. W8x13 I-Beam Girder (South Cellar)

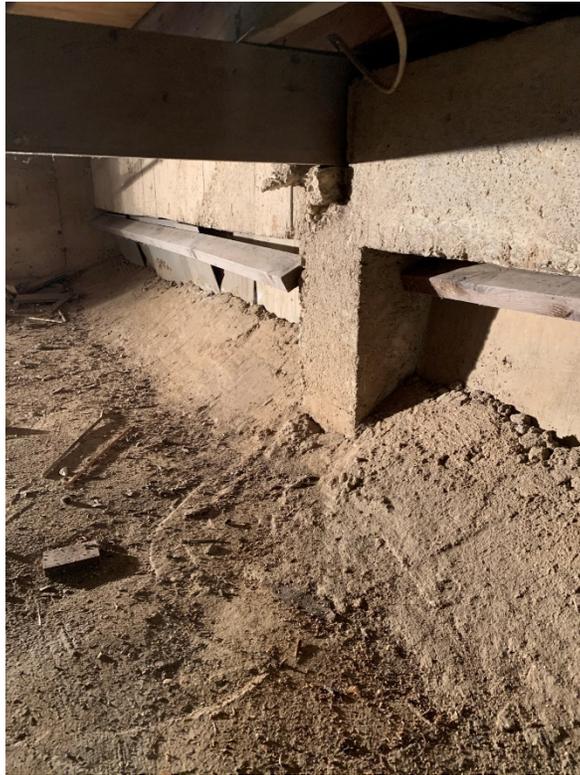
West of these cellar areas, and additional crawl space supports the remainder of the building. The floor of the crawl space is considerably higher than the cellar floors, as the perimeter concrete foundation walls (8” thick) are only approximately 29” high. The timber nominal 2x8 floor joists in this area are supported by a girder consisting of (2) nominal 2x8’s running east-to-west. One concrete pedestal provides an additional point of support at the mid-span of the girder. The western edge of the crawl space, adjacent to the garage, does not contain a wall. Rather, this edge of the building is supported by a concrete beam approximately 11.5” deep with a concrete column located at midspan. Beneath this beam is timber shoring held upright by sloped poured concrete within the crawl space area. The reason for this change in foundation type is unknown, but likely was necessitated by the presence of the existing garage floor slab immediately adjacent to the beam.

Photo 9. Concrete Beam and Column (West Edge of Crawl Space)

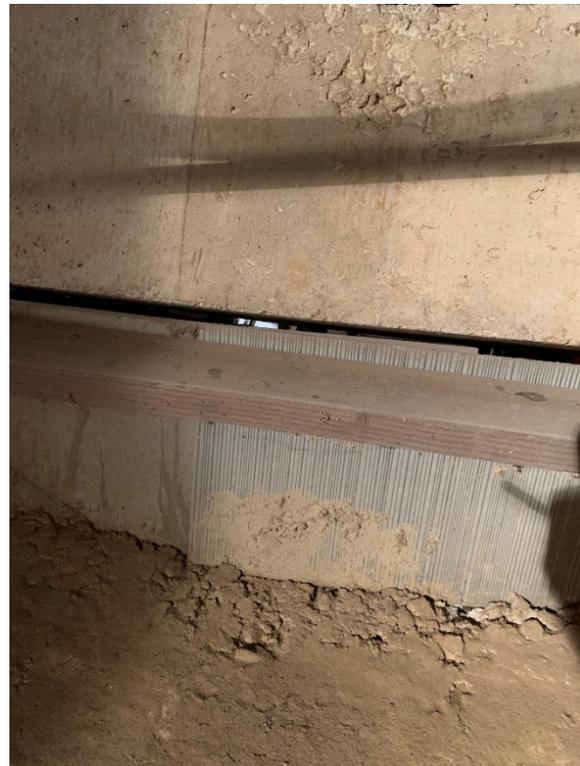
In the west crawl space, a vertical crack was observed in the concrete wall at the west edge of the hatch opening. This crack ran from the edge of the opening to the floor surface of the crawl space. Also, a gap was visible between the shoring sheets and the concrete beam along the west side of the crawl space, allowing visibility into the adjacent garage.

Photo 10. Shoring Below Concrete Beam (West Edge of Crawl Space)

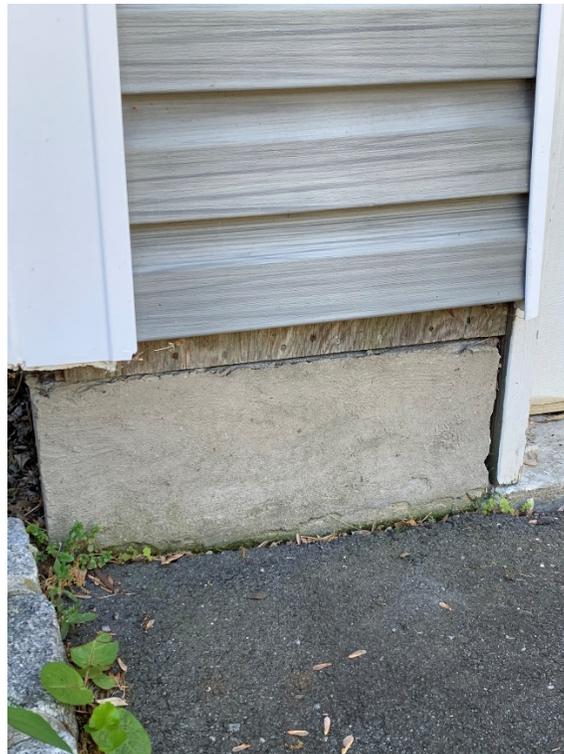
Photo 12. Concrete Below Garage Area

The slab on grade beneath the garage area must be replaced with a new CMU or concrete wall to elevate the building uniformly throughout its footprint. The groundwater table was observed between 7 and 8 feet

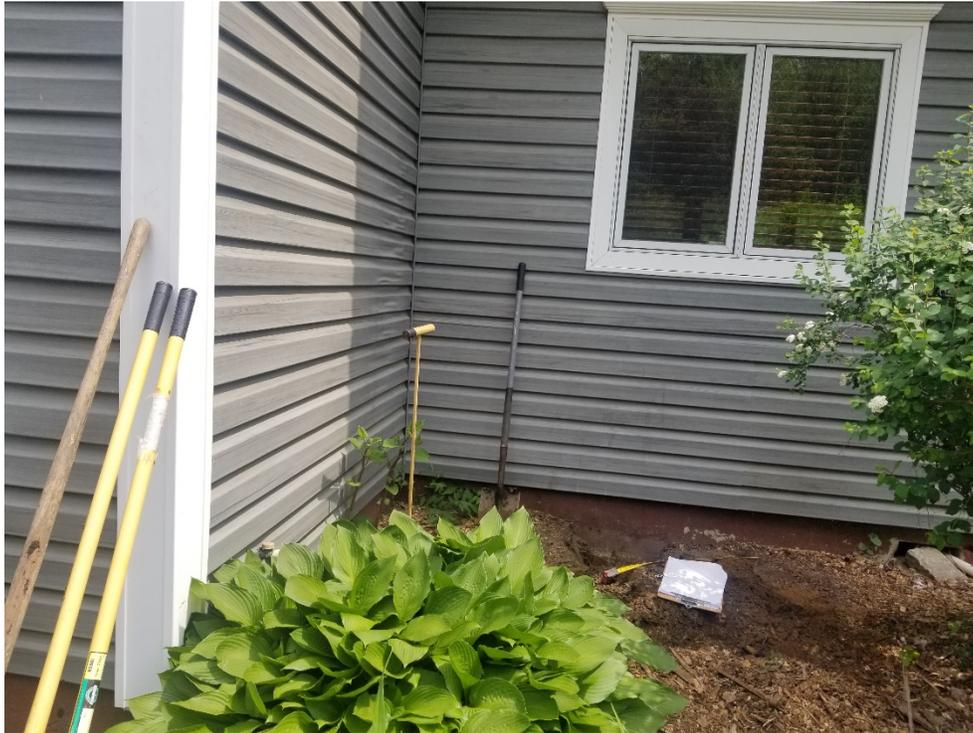
Photo 13. Test Pit TP-1 Location (Front of Building – Crawl Space)

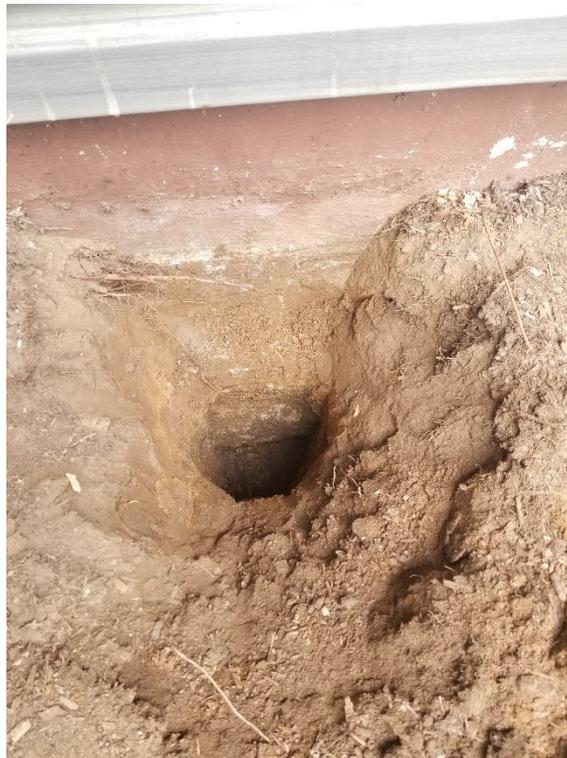
Below the foundation walls in the west crawl space area, an approximately 16” wide concrete spread footing was revealed during the test pit excavation program. Based on our findings within the test pits and from conventional foundation construction, Matrix utilized a 16” wide footing as a minimum value for analysis but believes the actual footings for the building to likely range from 16” to 24” in width. Prior to raising the house, Matrix recommends that the contractor confirm the foundation size and bearing adequacy with multiple test pits around the building perimeter.

Photo 14. Test Pit TP-1 Foundation Conditions

Matrix recommends that the existing foundation system of the residential building at 44 Big Piece Road be kept and extended to achieve the required design flood elevation. The presence of three separate subfloor areas is expected to provide sufficient support for the additional height of the newly raised building. Based on loading estimation and analysis for the existing building, Matrix estimates that the anticipated additional dead load of the required new courses of CMU would remain under an allowable bearing capacity of 2,500 psf for the shallow concrete strip footings at the Site.

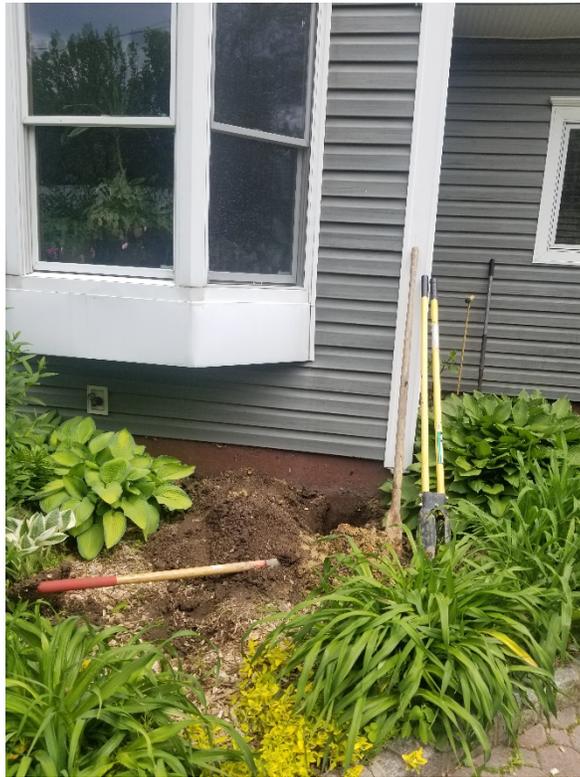
Photo 15. Test Pit TP-2 Location (Front of Building – North Cellar)

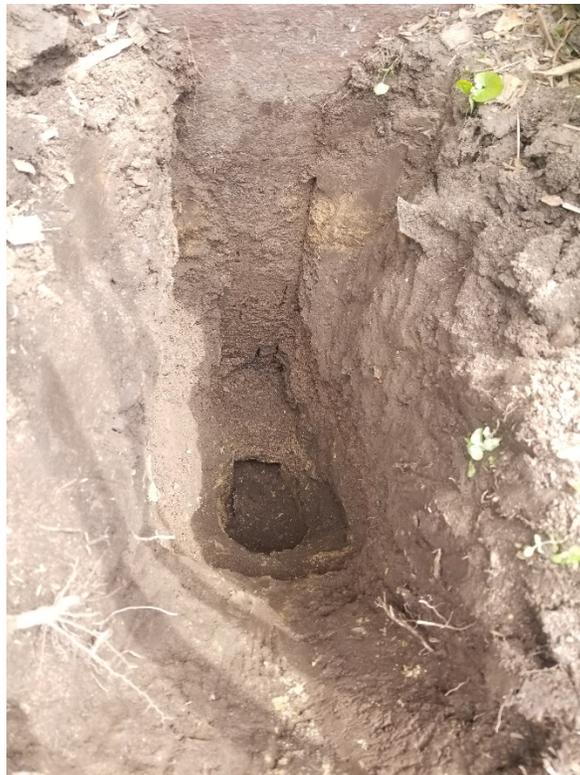
Photo 16. Test Pit TP-2 Foundation Conditions
