**ENGINEERING INVESTIGATION & ANALYSIS
GEOTECHNICAL & STRUCTURAL
ASSESSMENT REPORT**

**47 ADDISON DRIVE
FAIRFIELD, NEW JERSEY 07004**

Matrix No. 20-1052

October 2021

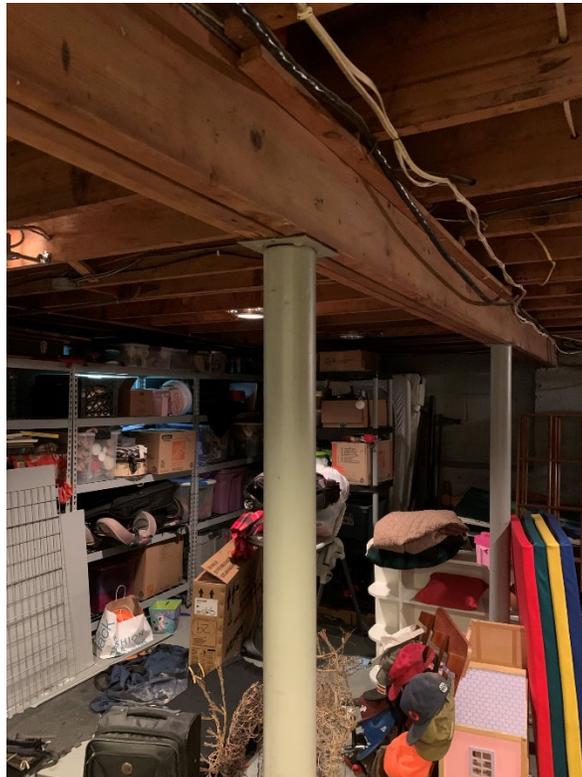
The floor above the basement is supported by nominal 2x10 timber floor joists, spaced 16" on center, running from front to rear of the building (east to west). A set of (3) connected nominal 2x10 timber members acts as a girder for the floor joists, located approximately 13'-0" off of the front wall of the basement. The girder is supported throughout its span, between the edge foundation walls, by (2) 4" diameter steel post columns that extend beneath the concrete floor (to presumed concrete spread footings). Since the south wall of the basement is shorter than the other walls, timber studs bridge the gap between the foundation wall and bottom of the girder. The longest clear span of the girder measured 7'-4" along the northernmost span.

Photo 4. Basement Girders, Columns & Subfloor (Looking Northwest)

The existing steel post columns intermittently supporting the building's girders must be removed and replaced by new steel, concrete, or masonry block columns. These new columns will need to include a

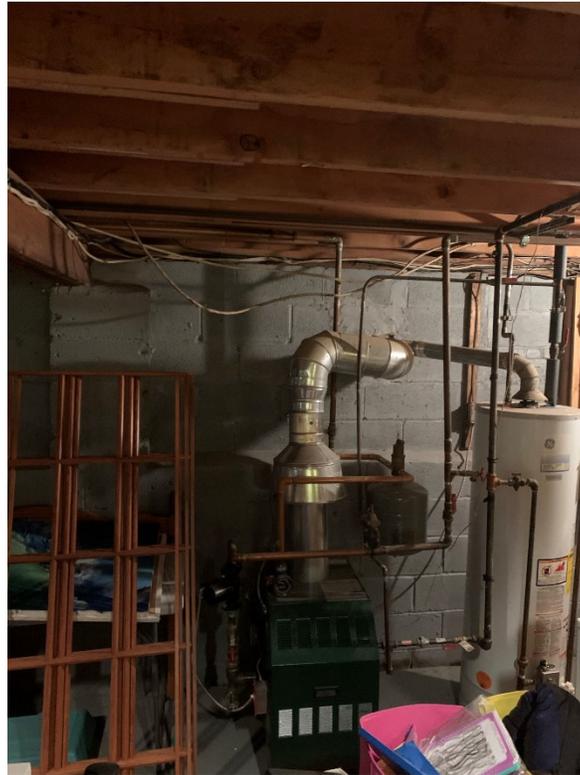
Most of the building's equipment and machinery were located in the basement, along the north foundation wall. In this space, a boiler and hot water heater were observed situated on the floor of the basement, an electrical panel was mounted 33" above the floor on the north wall, a water meter was elevated 12" above the floor in the northeast corner, and a sump pit was installed within the floor in the northeast corner. Also, along the east (front) wall of the basement, a gas meter was observed with its bottom elevated approximately 52.5" above the floor surface. Various PVC pipes and metal conduits were also observed running along the walls of the basement to feed the floors above.

Photo 5. Basement Foundation Walls with Boiler & Hot Water Heater (Looking North)

Additionally, any service equipment, whether outside or in the basement/garage, such as air conditioning, heat pump compressors, gas meters, electric meters, and hot water heaters, must be elevated 3 feet above the BFE. For interior elements, this may include relocation to an upper floor and thus less usable living space. For this residence, the hot water heater, boiler, electrical panel, water meter, and gas meter in the building interior would require elevating 3 feet above the BFE onto the raised first floor. The exterior air conditioning unit would also require elevating 3 feet above the BFE on a new exterior platform.

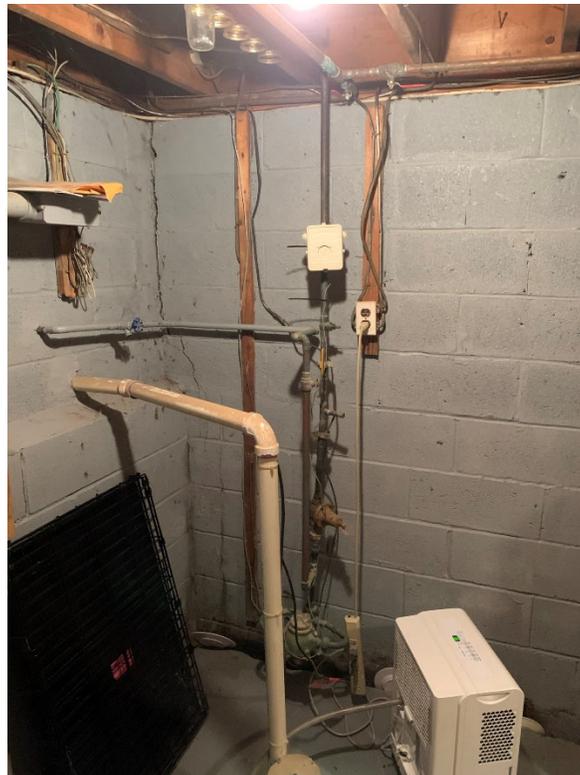
A couple of damaged areas were noted along the foundation walls of the basement. In the northeast corner, a vertical crack was observed originating at the top of the wall and running down the corner to nearly the floor surface of the basement. This crack decreased in width from top to bottom of the wall. Also, in the northwest corner of the basement a large opening/hole was observed in the exterior of the foundation wall. This opening appeared to originate from the exterior face of the wall and measured approximately 8" deep, which is likely the full depth of the wall. This opening could not be seen from inside the basement due to the presence of storage shelves in the northwest corner.

Photo 6. Vertical Crack in Basement Wall (Northeast Corner)

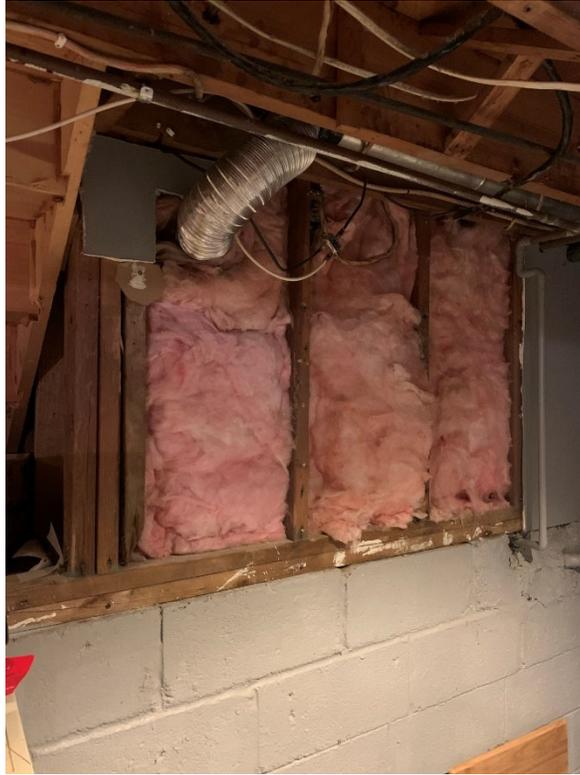
Photo 7. Lowered CMU Foundation Wall in Basement (Looking South)

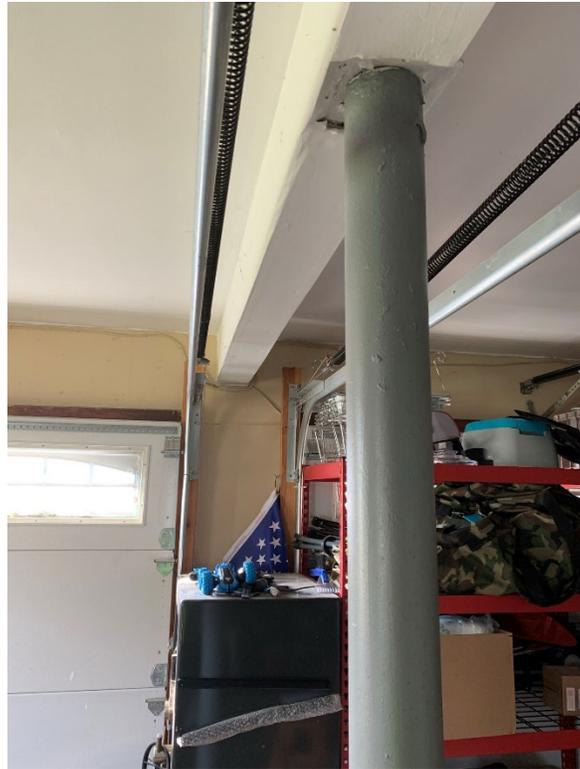
Photo 8. Garage Girder & Column (Looking South)

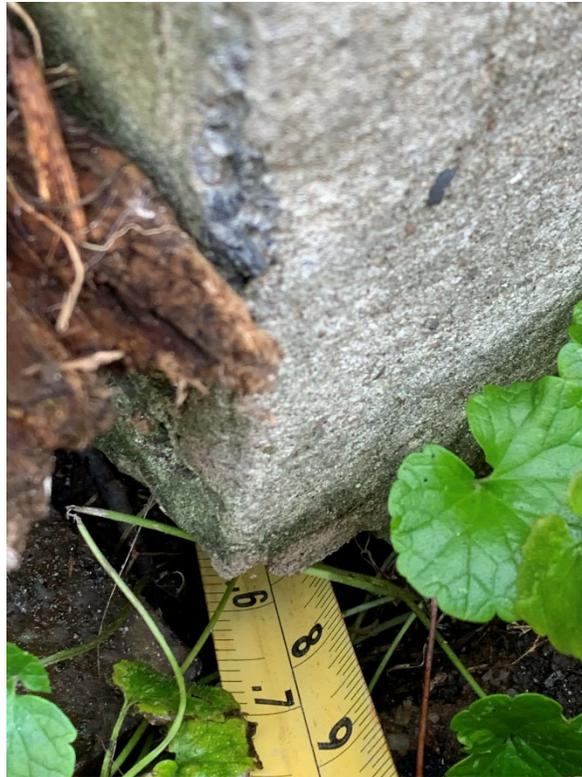
Photo 10. Hole in Basement Foundation Wall (Northwest Corner)

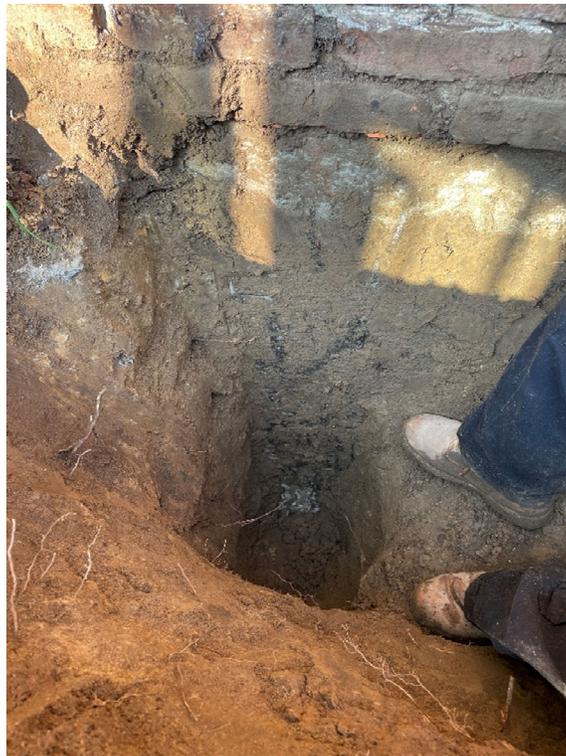
A test pit excavation along the east (front) wall of the basement revealed a concrete spread footing with a top approximately 51" below the exterior grade. The water table was observed at about 54" bgs, so the bottom of concrete and thickness of the footing could not be determined at the time of the excavation. Based on our findings within the test pit and from conventional foundation construction, Matrix utilized a 16" wide footing as a minimum value for analysis, but believes the actual footings for the building to likely range from 16" to 24" in width. Prior to raising the house, Matrix recommends that the contractor confirm the foundation size and bearing adequacy with multiple test pits around the building perimeter.

Photo 12. Test Pit TP-1 Foundation Conditions
