**ENGINEERING INVESTIGATION & ANALYSIS  
GEOTECHNICAL & STRUCTURAL  
ASSESSMENT REPORT**

**52 RIVEREDGE DRIVE  
FAIRFIELD, NEW JERSEY 08203**

Matrix No. 20-1052

August 2021

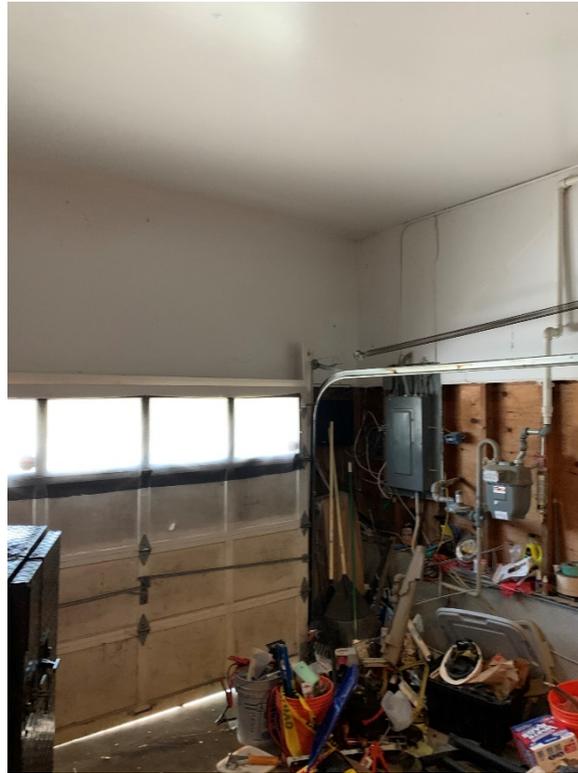
Within the garage, an electrical panel and gas meter were observed along the east wall in the northeast corner. Both pieces of equipment were located approximately 54” above the garage floor surface. No other machinery could be seen within the garage at the time of the inspection.

**Photo 3. Garage Area with Electrical Panels & Gas Meter (Northeast Corner)**

3 feet above the BFE. For interior elements, this may include relocation to an upper floor and thus less usable living space. For this residence, the boiler and water heater on the first floor, and the electrical panel and gas meter in the garage, would require elevating 3 feet above the BFE. The exterior air conditioning unit would also require elevating 3 feet above the BFE on a new or extended exterior platform.

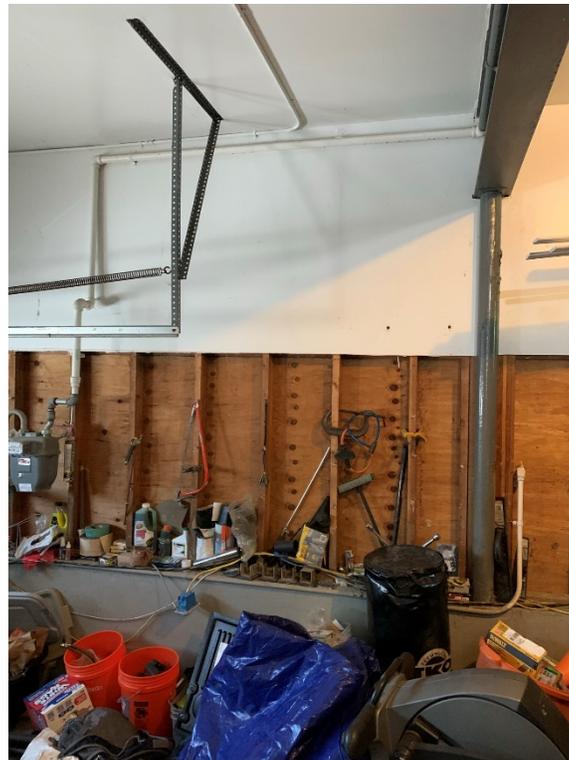
A steel W16x40 girder was observed running the width of the garage (east to west) in the middle of the area to support the second-floor timber joists (unable to view joists in garage at time of inspection). The girder was supported at the east end by a 4" diameter steel post bearing on top of the concrete foundation wall. The west edge of the girder was obscured by interior walls, but is expected to end at, and bear on, the west concrete foundation wall of the garage (similar to the east end).

**Photo 4. Steel W16X40 Girder with Steel Post (East Wall)**

Elevation of the concrete/CMU foundation walls by 6 feet will raise the garage ceiling to 16'-6" above the floor surface. The existing steel posts supporting the W16x40 girder are recommended to be kept, and they will bear on the newly raised concrete foundation walls of the garage.

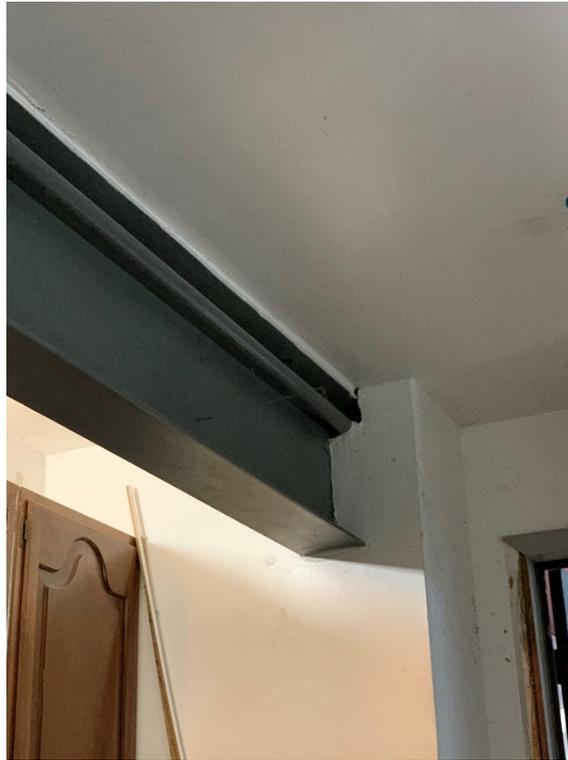
**Photo 5. Steel W16X40 Girder (West Wall)**

girder should be kept below the new first-floor level and a new load-bearing timber wall built above to carry the load from the second floor down to the steel girder. The girder possesses sufficient strength to support the combined loading of a newly constructed first floor and the existing second floor, distributed by the new load-bearing wall above. The existing steel posts supporting the steel girder can be removed during raising, as the girder will bear directly on the newly raised concrete walls of the garage. The existing foundation system of the building is expected to sufficiently support the additional loading from the raised walls and a new first floor, but footing size must be confirmed around the garage walls prior to construction.

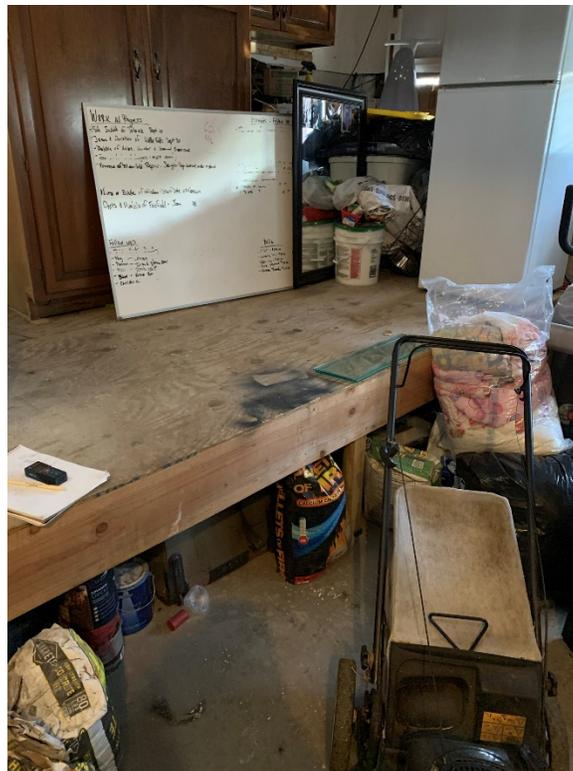
A timber platform was observed within the garage spanning the full length of the room along the west wall. This platform was built to match the elevation of the residence's first floor. The timber joists of the platform connect to perpendicular timber girders at each end using metal hangers. The east girder is supported by timber posts and the west girder is connected to the concrete foundation wall of the garage.

**Photo 6. Timber Platform in Garage (Northwest Corner)**

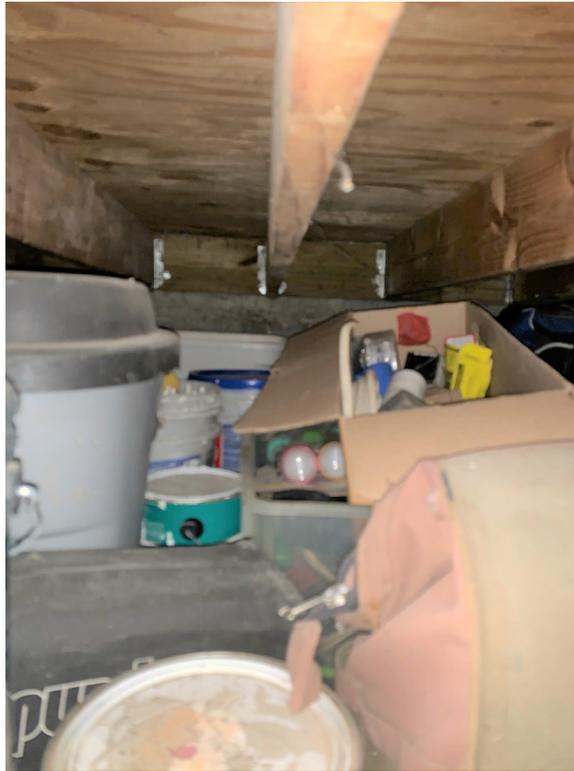
**Photo 7. Subfloor of Timber Platform (Looking West)**

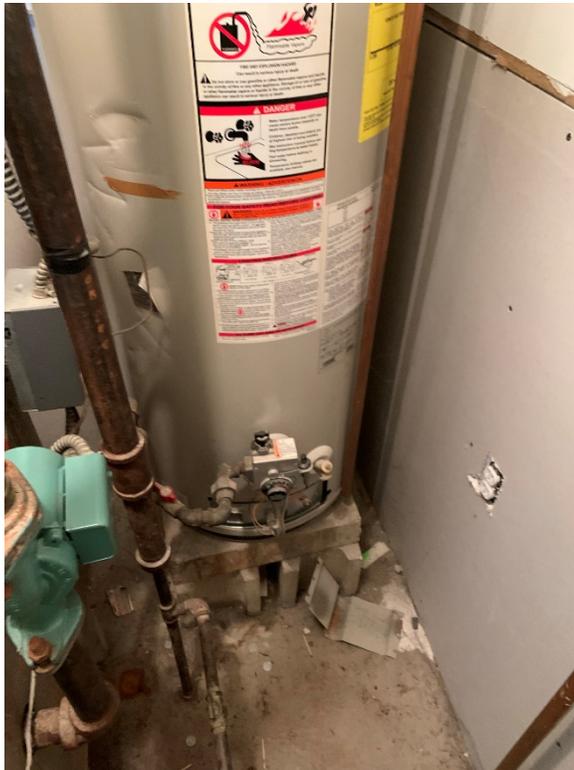
The first floor of the house contained two utility closets adjacent to the garage area. The first utility closet included a boiler and water heater. The boiler was situated on the floor of the room, while the water heater was elevated 11” atop CMU blocks. A CMU exhaust chimney was also observed in this closet, extending up and out of the building’s roof. The second utility closet, located in the southeast corner of the first floor, contained a stacked washer/dryer unit located on the floor.

In the water heater/boiler closet, a piece of the ceiling was removed, exposing the timber floor joists above. One joist exhibited significant section loss – about 2” of the bottom of the joist were missing. It is unclear if this was done intentionally for piping purposes or was the result of accidental construction damage.

**Photo 8. Water Heater & Boiler in First-Floor Closet**

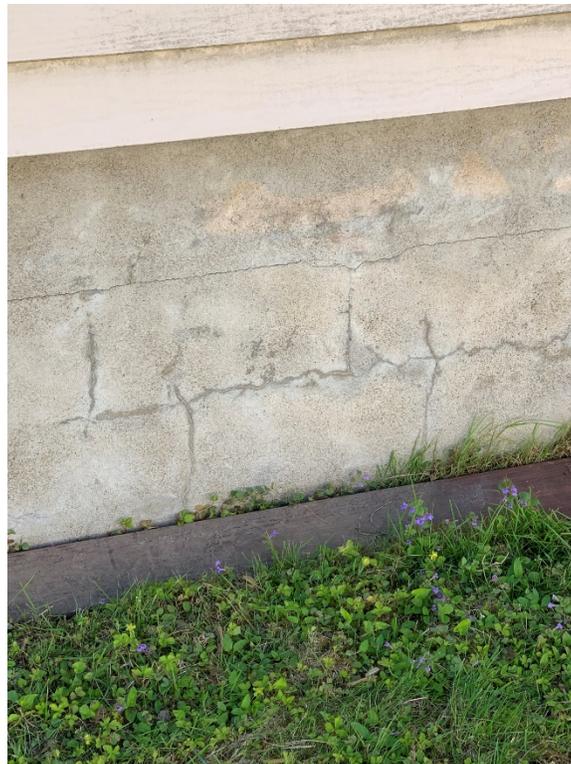
Cracks in the stucco veneer throughout the east foundation wall of the building appeared to follow the joints of a typical CMU wall. For this reason, it is believed that the foundation walls throughout the first floor of the building were constructed with CMU block.

**Photo 10. Stucco Cracks in West Exterior Wall**

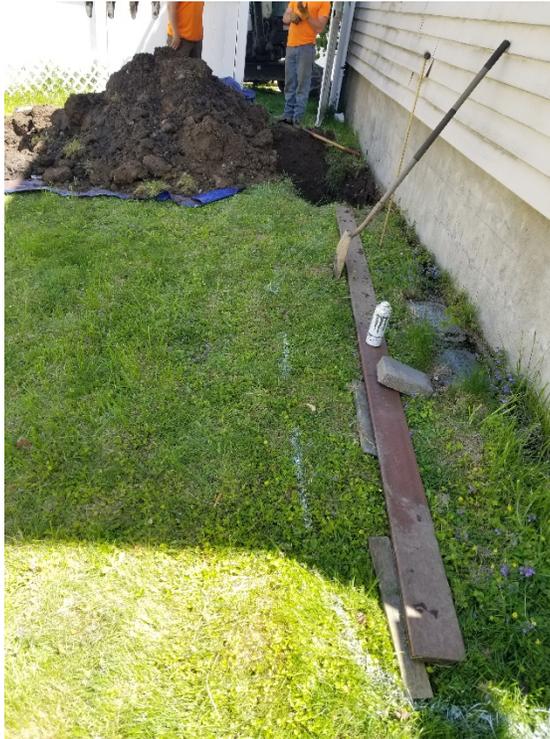
**Photo 11. Test Pit TP-1 Location (West Wall of Building)**

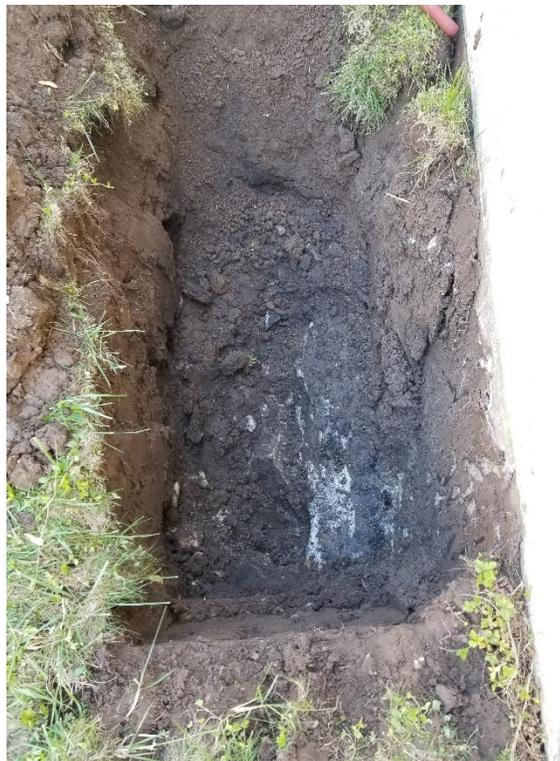
Below the foundation walls in the west edge of the house, an approximately 28" wide concrete spread footing was revealed during the test pit excavation program, with a bottom approximately 44" below exterior grade. Based on our findings within the test pits and from conventional foundation construction, Matrix utilized a 16" wide footing as a minimum value for analysis, but believes the actual footings for the building to likely range from 16" to 28" in width. Prior to raising the house, Matrix recommends that the contractor confirm the foundation size and bearing adequacy with multiple test pits around the building perimeter.

**Photo 12. Test Pit TP-1 Foundation Conditions**

Brown SILT and mf Sand, some fine Gravel, dry-moist (ML)	
39-44		39-44		Top of concrete encountered at 39" bgs, protrudes 10" from the face of the wall and extends 5" downward.	
				Bottom of Test pit @ 44 in. Test Pit Backfilled.

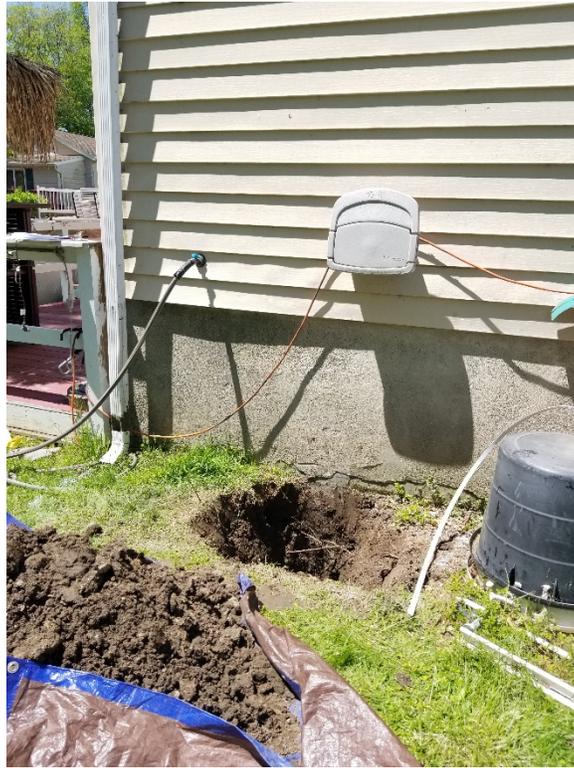
In TP-2 (Southeast corner of building), the top of a septic tank was encountered at 20” bgs. It was determined in the field that the crew could not safely advance the test pit further at this location without potential damage to the tank, and the test pit was abandoned at this location.

**Photo 13. Test Pit TP-2 Location (East Wall of Building – Garage)**

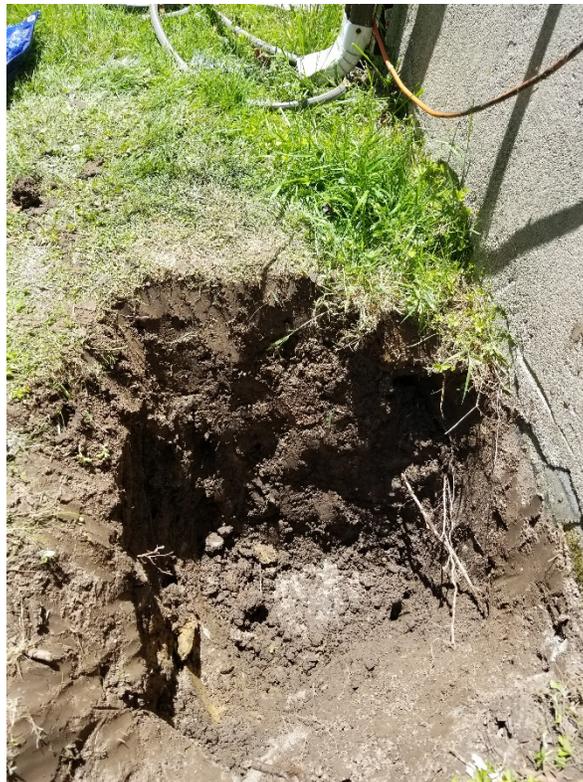
**Photo 14. Test Pit TP-2 Foundation Conditions**

Depth Inches (Elev)	No.	Depth Inches	Graphic Symbol	Description Of Material	Laboratory Tests
		0-20		Brown SILT and mf Sand, some fine Gravel, moist (ML)	
				Encountered top of septic bank at 20" bgs, could not advance test pit further to confirm foundation at this location. Bottom of Test pit @ 20 in. Test Pit Backfilled.
