**ENGINEERING INVESTIGATION & ANALYSIS
GEOTECHNICAL & STRUCTURAL
ASSESSMENT REPORT**

**59 CLINTON ROAD
FAIRFIELD, NEW JERSEY 07004**

Matrix No. 20-1052

September 2021

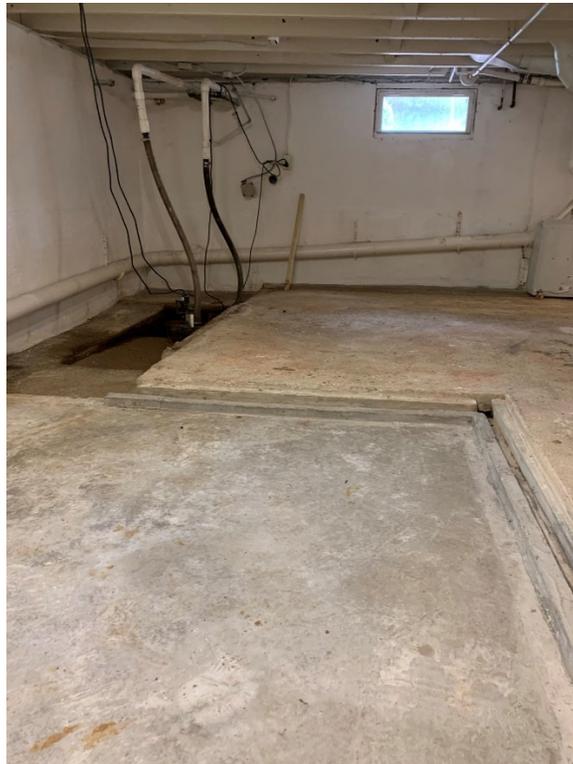
along with much of the southwest corner of the area. The floor in the southeast corner of the basement is 4" lower than the main floor, and the southwest edge (approximately 3' wide) is 7" lower than the main floor. This southwest edge also ramps down along the south wall to a sump pit in the southwest corner, which is an open hole containing two pumps that convey water out of the pit and into the south yard of the property. No girders were observed in the basement on the north side; nominal 2x10 timber floor joists, spaced 16" on center, span the full length of the basement (front to rear) in this area, and are supported at either end by the concrete foundation walls. On the south side, spanning the width of the extended portion of the L-shaped basement, the joists change direction and run north to south (side to side of building). These joists are supported on the south edge by the concrete foundation wall and on the north edge by a timber girder consisting of (2) nominal 2x10 members. The girder is supported at its ends by the concrete foundation walls, and a 2.5" diameter steel jack post has been installed at midspan, bearing on a 5" high concrete pedestal, to provide additional support.

Photo 4. Basement Concrete Floors with Differing Elevations

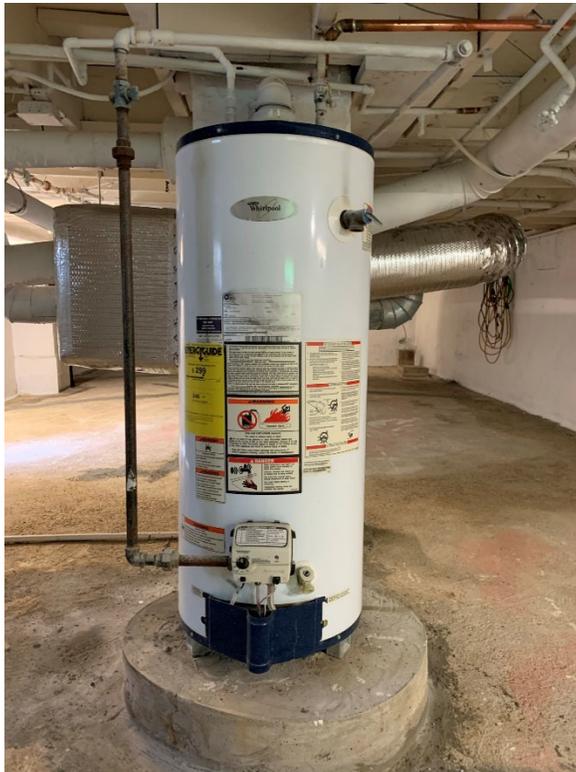
Photo 6. Water Heater on Concrete Platform (Center of Basement)

Additionally, any service equipment, whether outside or in the basement/crawl spaces, such as air conditioning, heat pump compressors, gas meters, electric meters, and hot water heaters, must be elevated at least 3 feet above the BFE. For interior elements, this may include relocation to an upper floor and thus less usable living space. For this residence, the hot water heater, gas meter, water flow meter, internal air conditioner unit, electrical panel and security panel in the basement would require elevating 3 feet above the BFE. The exterior air conditioning units will also need to be raised 3 feet above the BFE on new, raised platforms.

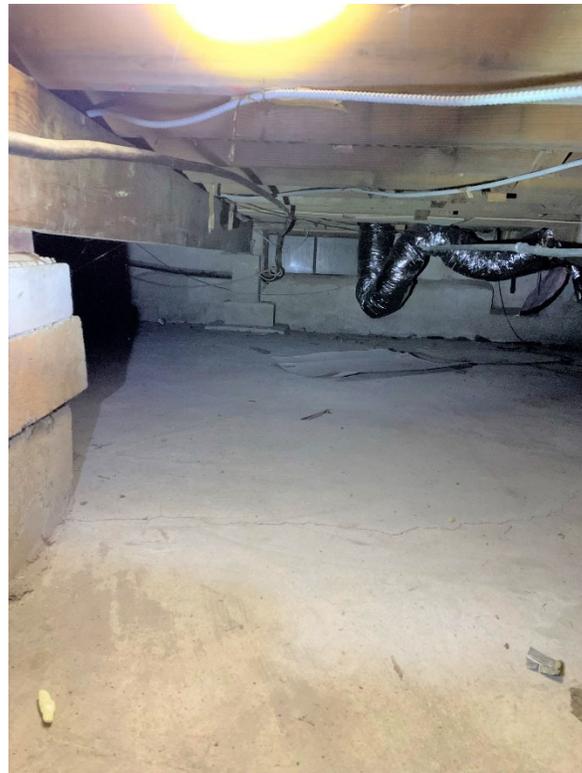
In the central crawl space, the pedestal supported for the main girder and additional 4x4 beam appeared to be unstable. They consisted of different types and sizes of CMU block, brick, and even wood studs stacked together to support the building’s structural members. Regardless, no damage to the building’s foundation walls or subfloor was noted within this central crawl space area at the time of the inspection.

Photo 8. Central Crawl Space Concrete Walls & Timber First-Floor Subfloor (Looking West)

Additionally, the existing steel posts or brick/concrete block pedestals intermittently supporting the existing building's girders must be removed and replaced by new steel, concrete, or masonry block columns. These new columns will need to include a spread footing beneath to sufficiently support the building loads. The existing concrete chimney along the north wall of the house, and the two exhaust chimneys in the basement, will also require extending during raising of the house to keep the tops of the chimneys above the roof level.

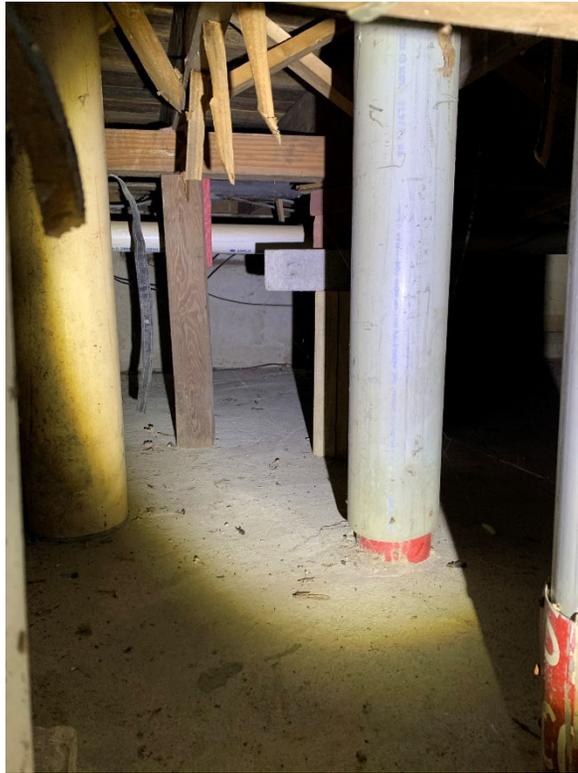
Adjacent to the basement, along the northwest wall, a crawl space comprises the central area of the residential building. This area also appears to contain cast-in-place concrete walls, though the concrete floor is approximately 33" higher than the basement floor. The central crawl space could not be accessed at the time of the inspection, as the only opening was a small hatch within the basement's west wall. From the basement hatch opening, it was observed that the concrete walls of this crawl space were not uniform in thickness. Throughout the visible portions of the walls, protrusions and depressions were noted at multiple locations and at multiple heights within the walls. The subfloor above the foundation walls consisted of nominal 2x10 timber floor joists, spaced 16" on center, running side to side of the building (north to south). These joists are supported at either end by the concrete foundation walls and at midspan by a timber girder consisting of (2) nominal 2x10 members. The girder is situated atop (3) pedestals made up of CMU and brick. An additional girder or support beam for the floor joists was observed in the southeast corner of the central crawl space, consisting of an estimated 4x4 timber beam supported by a combination of timber studs, CMU blocks, and bricks. It could not be confirmed at the time of the inspection, but this girder does not appear to span the full length of the crawl space, and its purpose is not explicitly known.

Photo 9. Additional Timber Beam in Central Crawl Space (Looking South)

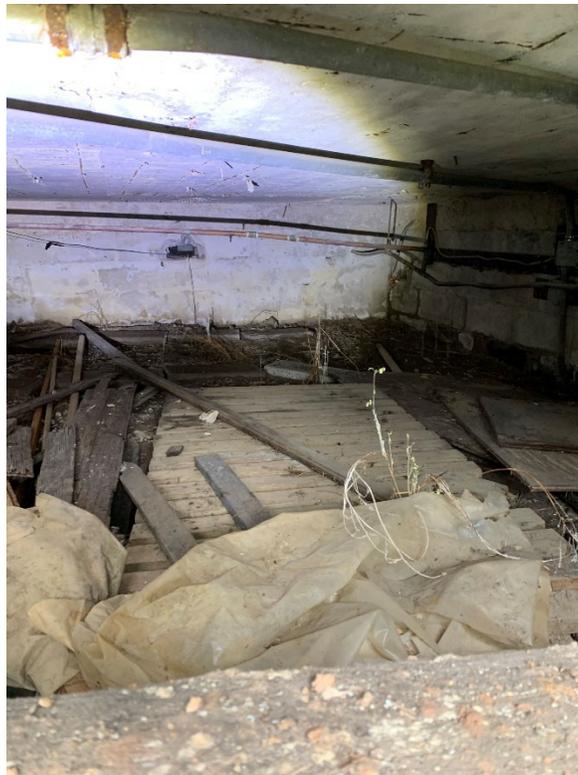
In the rear crawl space, two large holes were observed in the south CMU wall and in the west turndown of the concrete first-floor slab. These holes could only be observed from a distance, but the hole in the south wall was seen to span the full thickness of the wall. The hole in the south wall appeared to be about 12” wide and 4” deep, while the turndown hole was significantly smaller (estimated 3” wide x 2” deep).

Photo 10. Rear Crawl Space CMU Walls & First-Floor Concrete Slab (Looking South)

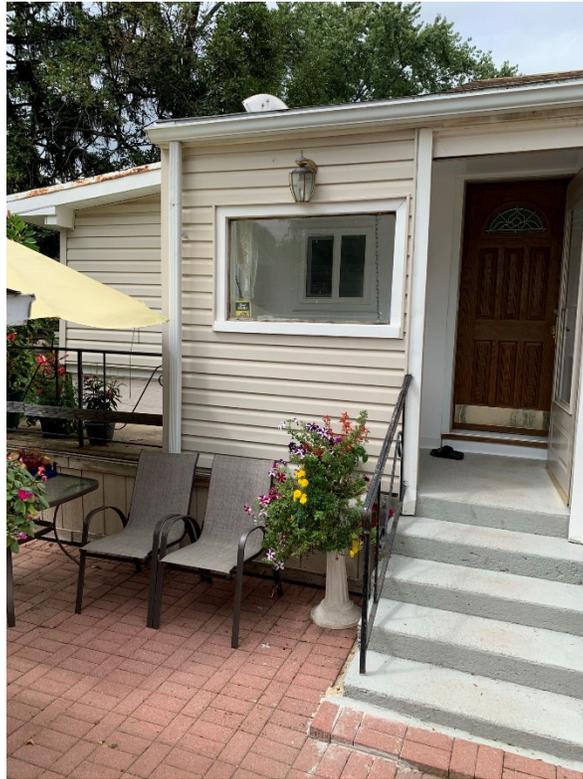
foundation walls. This vestibule is supported by timber posts embedded in concrete that extends into the ground. These posts are assumed to support timber floor joists which run front to rear and bear on the west basement wall of the building.

Photo 11. Rear Southwest Entrance Vestibule (Looking North)

It is also recommended that new concrete or CMU walls be built, or additional height added to the existing walls, to support the newly raised rear entrance vestibules and rear concrete patio. The groundwater table was observed at approximately 6 feet bgs during the subsurface investigation, and no groundwater was encountered during the test pit excavation completed along the front basement wall. For these reasons, dewatering is not expected to be a concern for this project but may be required during construction of the new foundation walls within the vestibule and rear patio areas if new walls are necessary. As previously noted, the groundwater table can be impacted by seasonal variations, precipitation, and other climatic factors. Presence of groundwater at foundation depths may severely impede the constructability of footings due to possible inflow of groundwater into the open excavation. The appropriate measures to be taken for groundwater control during construction should be determined in the field at the time of excavation and are the responsibility of the Contractor.

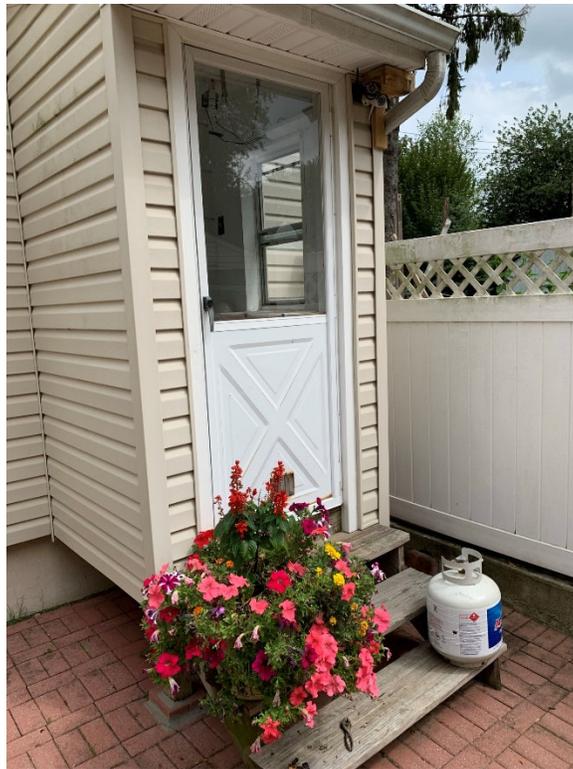
Photo 12. Rear South Entrance Vestibule (Looking Southeast)

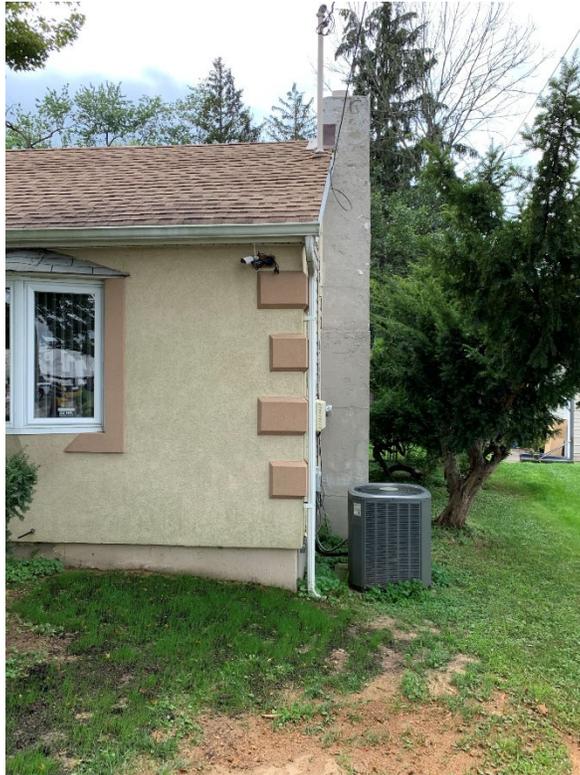
A concrete chimney was observed along the north wall of the building. Its base measured approximately 61" wide x 24" deep, but changed to a narrower column near mid-height of the structure.

Photo 13. Concrete Chimney Along North Wall (Looking West)

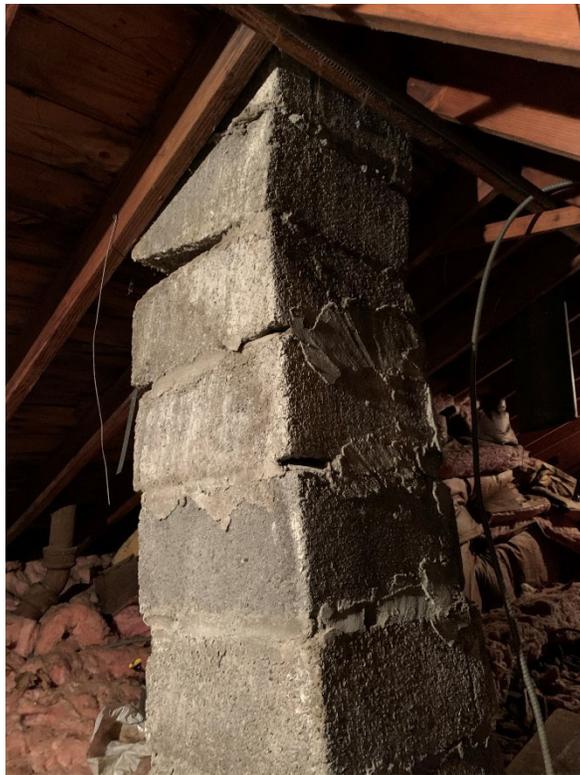
Observed from the attic, the CMU exhaust chimney located along the west wall of the front basement was leaning significantly as it extended through the attic and out to the roof. The displacement of the chimney has resulted in loss of mortar between joints, dislocation between adjacent CMU blocks, and creation of large openings in the chimney.

Photo 14. Damaged Exhaust Chimney Extending Through Attic (Looking Northwest)

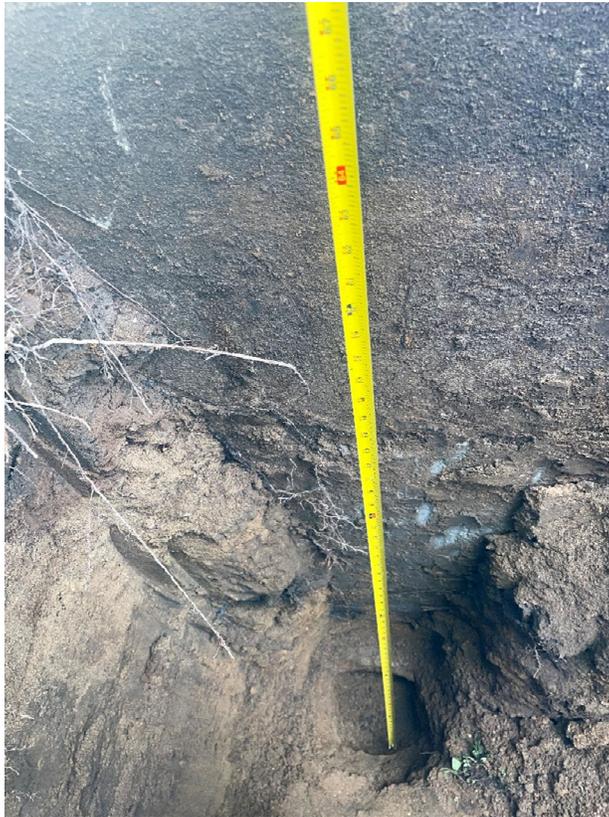
A test pit excavation was performed in the northeast corner of the basement to determine the type and size of the building’s wall footings. The test pit revealed a concrete footing approximately 4” thick and with a bottom approximately 67” bgs. Based on our findings within the test pit and from conventional foundation construction, Matrix assumed a 16” wide footing as a minimum value for analysis, but expects the footings for the building to range between 16” and 24” in width. Prior to raising the house, Matrix recommends that the contractor confirm the foundation size and bearing adequacy with multiple test pits around the building perimeter.

Photo 16. Test Pit TP-1 Foundation Conditions
