**ENGINEERING INVESTIGATION & ANALYSIS
GEOTECHNICAL & STRUCTURAL
ASSESSMENT REPORT**

**6 SYLVAN ROAD
FAIRFIELD, NEW JERSEY 08203**

Matrix No. 20-1052

August 2021

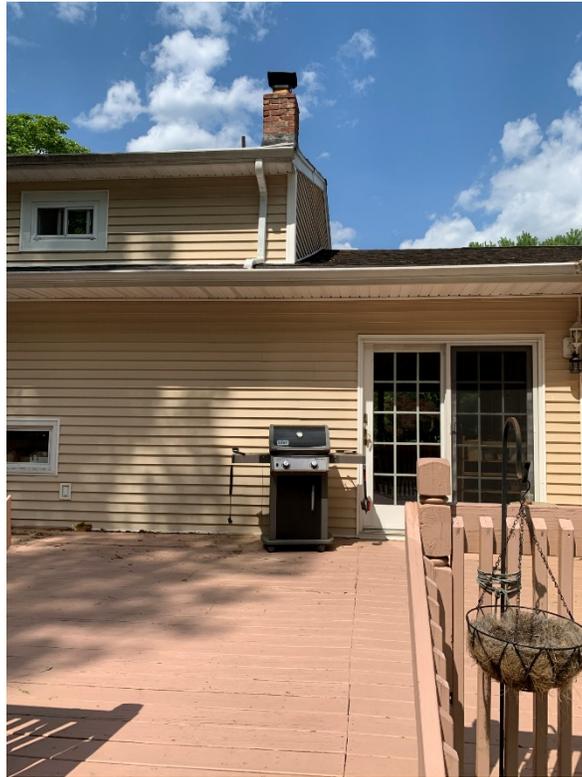
Two timber decks were observed at the Site, each connected to the main building. Both decks are comprised of timber decking, beams, and girders. The rear deck's girders are supported intermittently by CMU block pedestals extending into the ground surface. The west deck – which is attached to the half story level – is supported on its west side by two 4x4 timber posts atop concrete Sonotube footings.

Photo 3. Rear of Building with Timber Deck

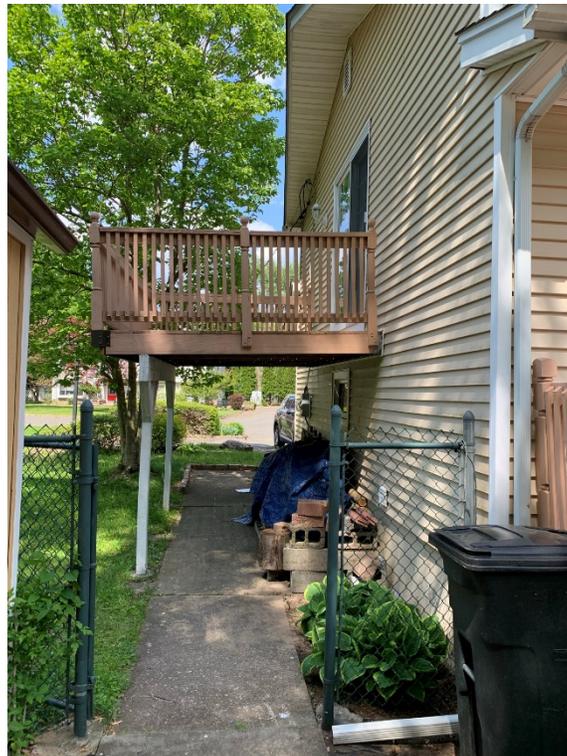
Photo 4. Timber Deck Along West Wall of Building

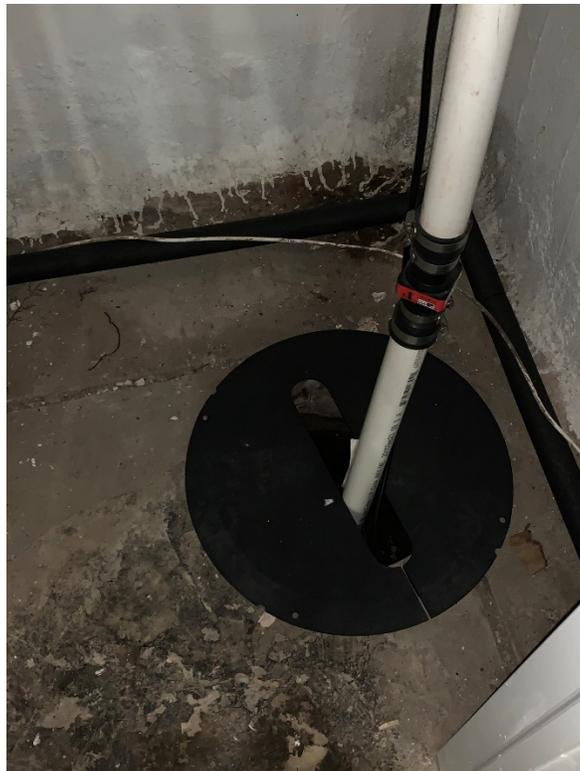
The only machinery observed within the rear basement area were two sump pits – one in each of the northern corners, and both in the unfinished portion of the basement. PVC piping and electrical wires were also observed running below the floor joists in the unfinished portion of the basement.

Photo 6. Sump Pump in Unfinished Portion of Basement (Typ.)

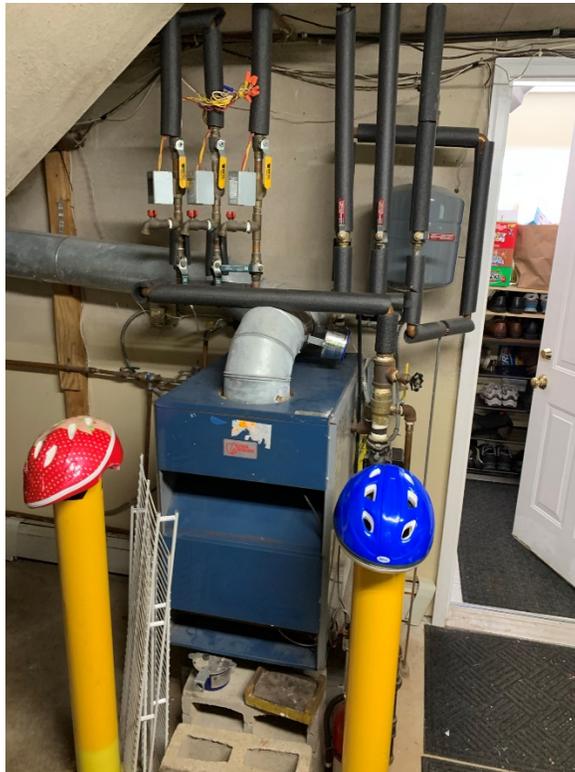
A boiler was observed in the garage (along the rear wall) situated atop CMU block pedestals. The blocks raised the boiler approximately 15.5” above the garage floor. An electrical panel was also seen on the garage’s west wall, with the bottom approximately 35” above the floor surface.

Photo 10. Boiler in Garage (Rear Wall)

Additionally, any service equipment, whether outside or in the basement/crawl space/garage, such as air conditioning, heat pump compressors, gas meters, electric meters, and hot water heaters, must be elevated 3 feet above the BFE. For interior elements, this may include relocation to an upper floor and thus less usable living space. For this residence, the hot water heater, boiler, electrical panel, and water pump in the building interior would require elevating 3 feet above the BFE onto the raised first floor. The exterior air conditioning unit would also require elevating 3 feet above the BFE on a new or extended exterior platform.

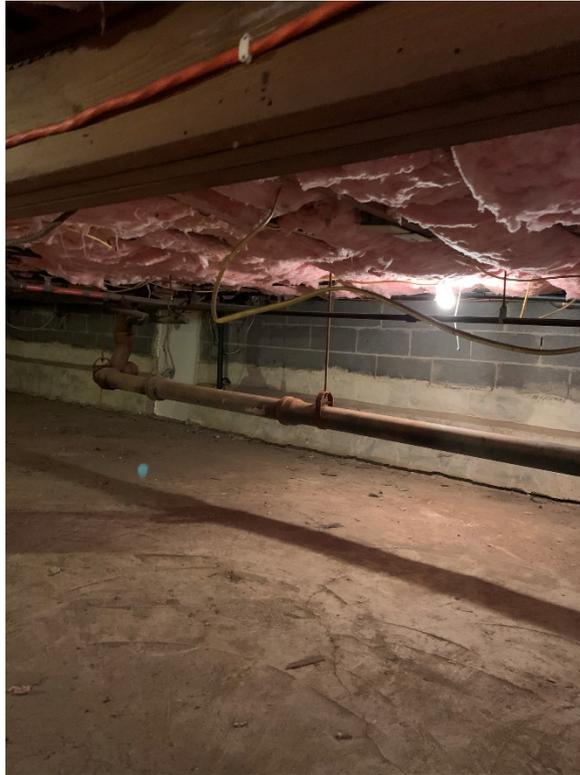
Photo 11. Crawl Space South CMU Wall (Typ.)

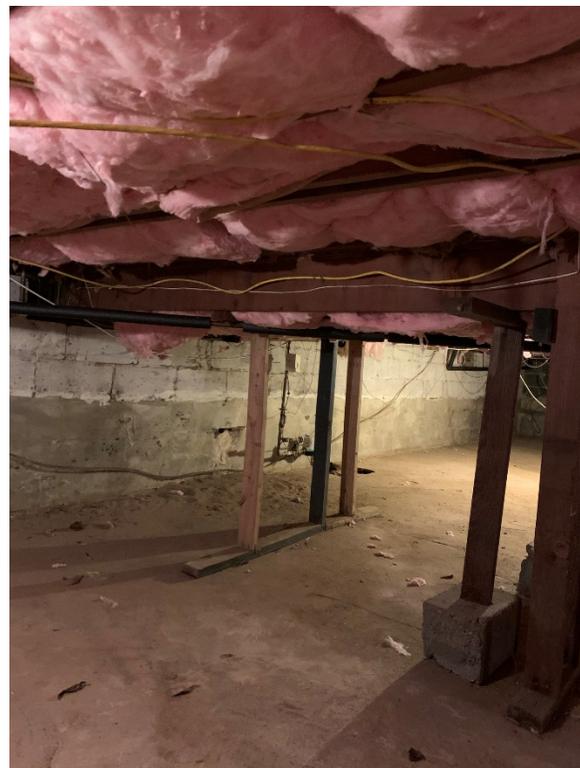
Within the crawl space, an area of lower floor joists was observed to support the first-floor entrance vestibule, which is approximately 6" below the rest of the first floor. Still nominal 2x8 joists, these beams were supported by the north CMU wall of the crawl space as well as two rows of timber nominal 2x4 studs bearing on either nominal 2x4 flat timber planks or CMU block pedestals. Above the north CMU wall of the crawl space, blocks had been removed to accommodate the lower elevation of these floor joists.

Photo 12. Lowered Vestibule Subfloor in Crawl Space

The existing concrete block pedestals intermittently supporting the building's girders, as well as the timber studs supporting the lower entrance vestibule floor, must be removed and replaced by new concrete or masonry block columns. These new columns will need to include a spread footing beneath to sufficiently support the building loads. Additionally, the balcony and deck are anticipated to require raising to match the current ingress/egress heights of the main structure. This would require replacement or extension of the timber support posts.

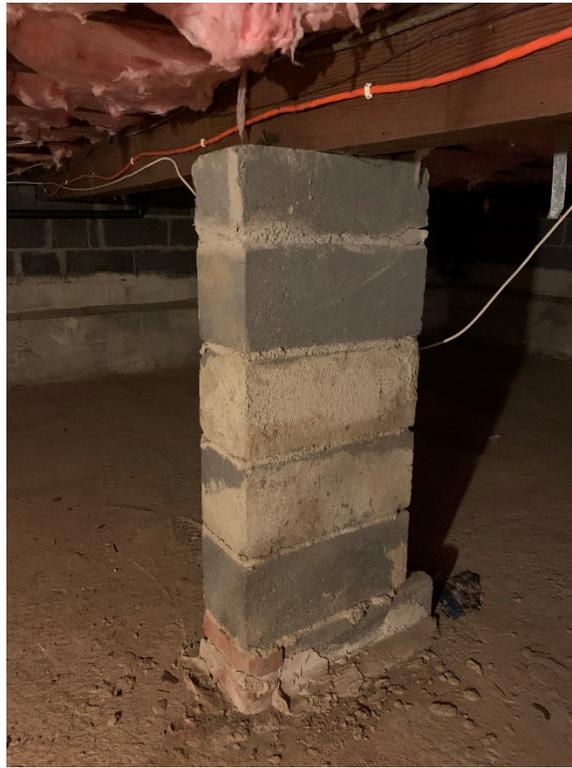
Photo 13. Crawl Space Central Girder and CMU Pedestal (Typ.)

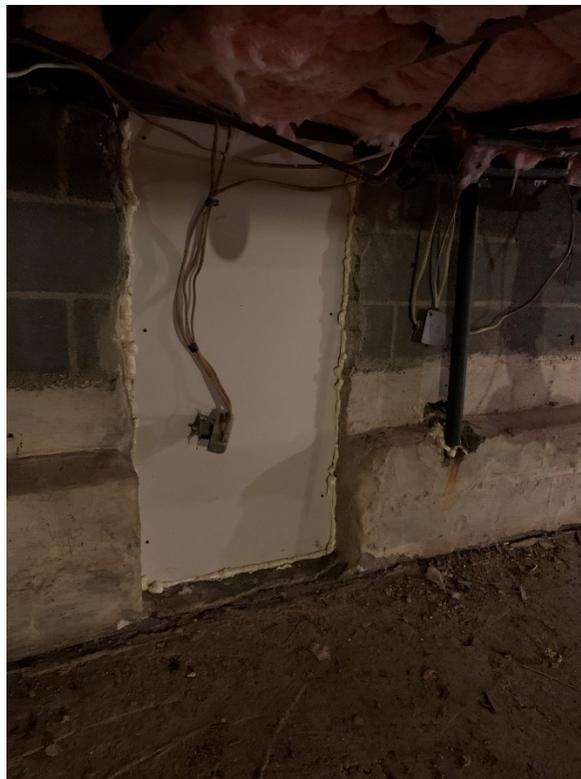
Photo 14. Boarded Up Opening in Crawl Space South Wall

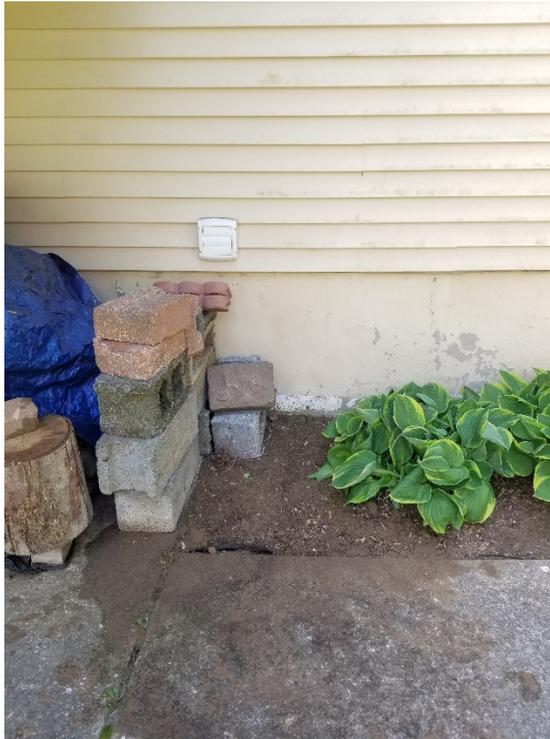
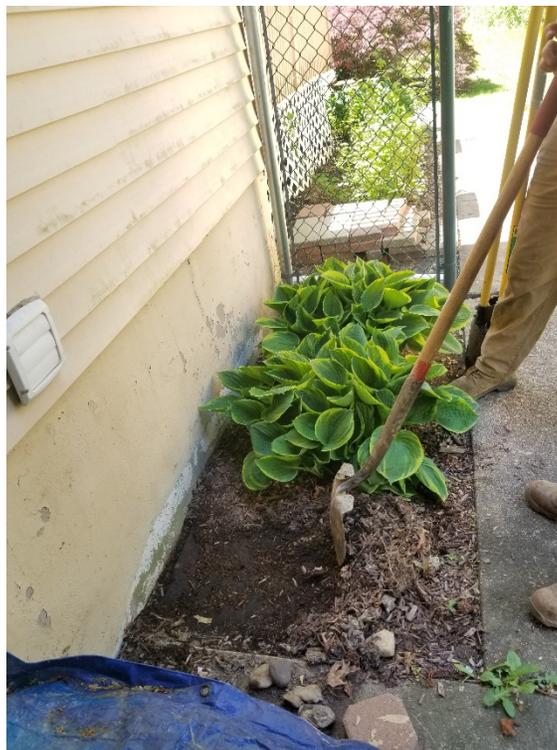
A test pit excavation along the west wall of the garage revealed an approximately 32" wide concrete spread footing with a bottom approximately 53" below the exterior grade. The water table was observed to be about level with the bottom of the footing at the time of the test pit excavation. Based on our findings within the test pit and from conventional foundation construction, Matrix utilized a 16" wide footing as a minimum value for analysis, but believes the actual footings for the building to likely range from 16" to 24" in width. Prior to raising the house, Matrix recommends that the contractor confirm the foundation size and bearing adequacy with multiple test pits around the building perimeter.

Photo 15. Test Pit TP-1 Location (West Wall of Building – Garage)

Top of concrete encountered at 47" bgs, protrudes 12" from the face of the wall and extends 6" downward. Water found beneath the footing.	
				Bottom of Test pit @ 53 in. Test Pit Backfilled.
