**ENGINEERING INVESTIGATION & ANALYSIS  
GEOTECHNICAL & STRUCTURAL  
ASSESSMENT REPORT**

**93 GLENROY ROAD EAST  
FAIRFIELD, NEW JERSEY 07004**

Matrix No. 20-1052

September 2021

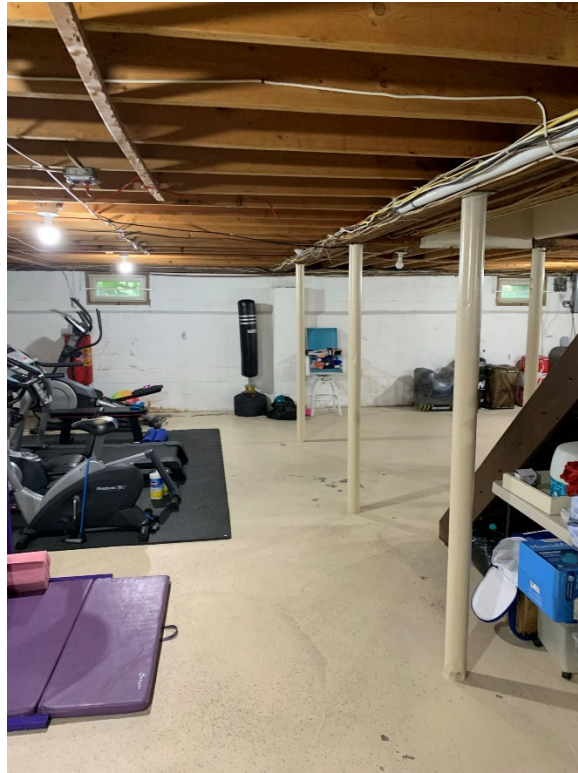
The basement/garage walls and visible first-floor floor joists were in good condition at the time of the inspection. No notable damages or abnormalities were observed.

**Photo 5. Basement CMU Walls and First Floor Subfloor (Looking Southeast)**

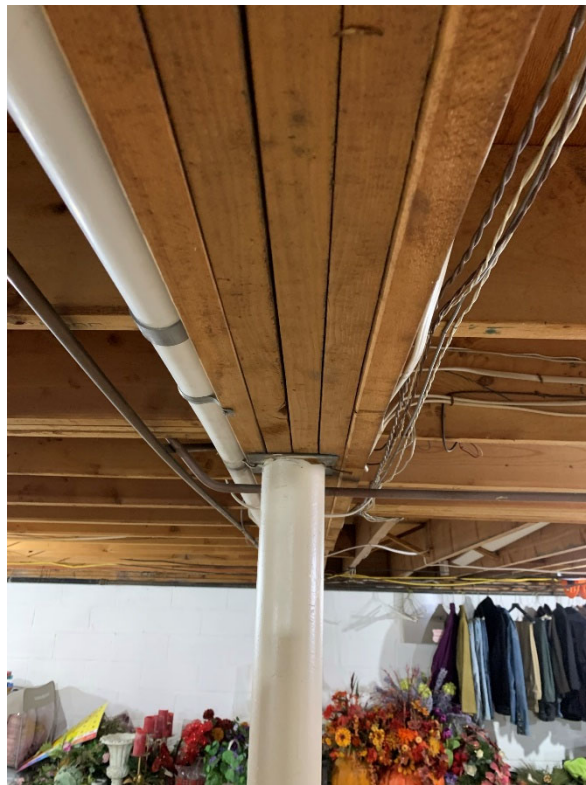
**Photo 6. Timber Girder with Steel Post Column (Typical)**

the building's girders must be removed and replaced by new steel, concrete or masonry block columns. These new columns will need to include a spread footing beneath to sufficiently support the building loads.

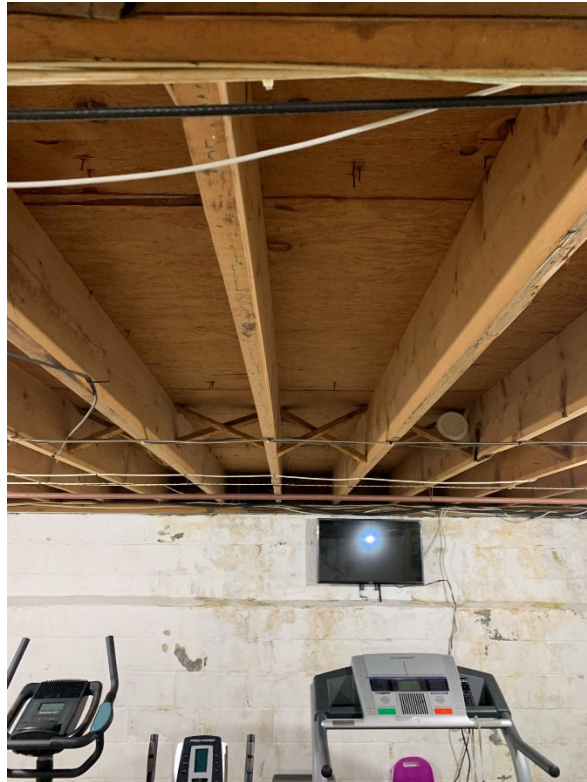
above, which consists of nominal 2x10 timber floor joists, spaced 16" on center. The floor joists vary in span direction, as the rear half, southwest corner, and southeast corner joists run north to south (front to rear), while the rest of the joists run east to west. The floor joists are connected to the sides of timber girders, which consist of (4) nominal 2x12 timber members. A total of 5 girders were observed supporting the first floor, and three of these girders were further supported along their length by 4" diameter steel post columns. The longest clear span of a girder, located in the southeast corner of the house, was measured at 15'-4" long.

**Photo 7. First Floor Timber Floor Joists (Typical)**

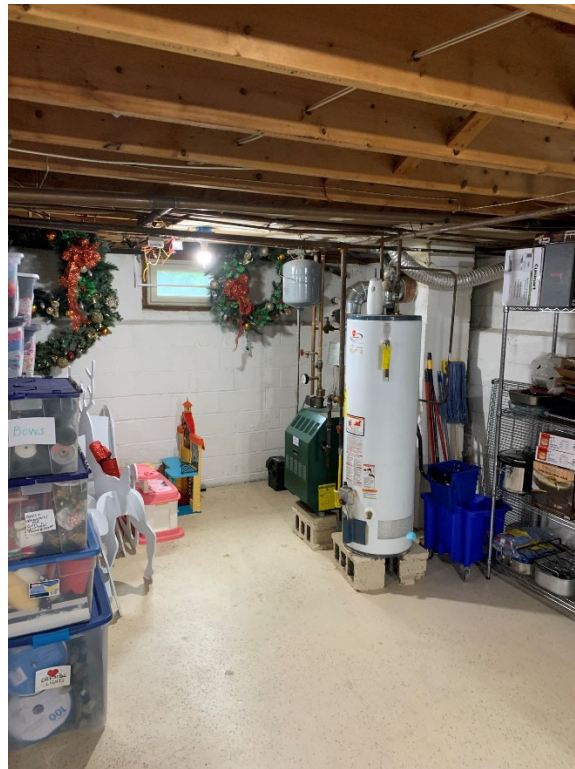
Various pieces of equipment and machinery were observed within the basement at the time of the inspection. The northwest corner of the basement contained a boiler unit and hot water heater, both raised atop CMU blocks (11" and 8" above the floor surface, respectively). Also in this corner, a sump pit was observed within the ground and a central vacuum cleaner was elevated 39" above the floor surface. The southeast corner of the basement contained a gas meter (54" above the floor), electrical panel (60" above the floor), and a water meter (27.5" above the floor). Also, along the front wall near the southwest corner, a security system panel was observed approximately 66.5" above the floor surface. Various metal and PVC conduits, as well as electrical cables, were also observed running along the timber members of the first-floor joists and girders.

**Photo 8. Boiler & Hot Water Heater in Basement (Looking North)**

BFE. For interior elements, this may include relocation to an upper floor and thus less usable living space. For this residence, the hot water heater, boiler, gas meter, water meter, electrical panel, central vacuum cleaner, and security panel in the basement would require elevating 3 feet above the BFE. The exterior air conditioner unit and generator will also need to be elevated 3 feet above the BFE on new, elevated platforms.

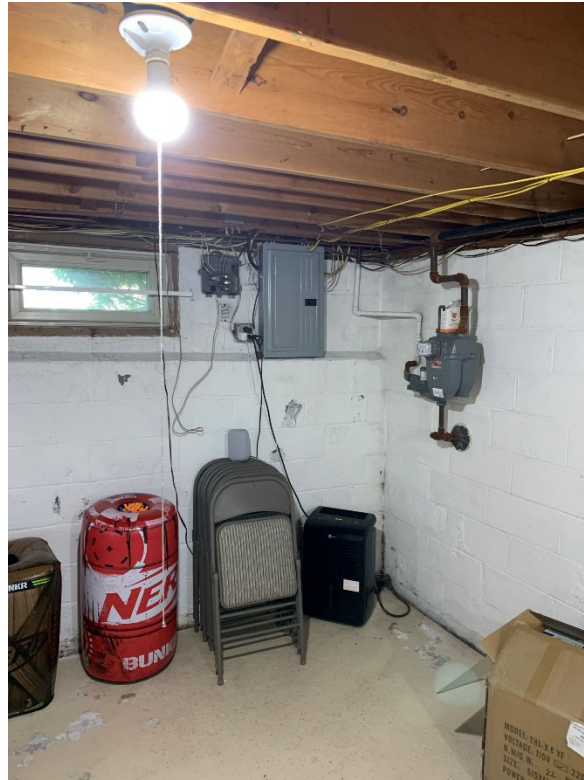
**Photo 9. Gas Meter & Electrical Panel in Basement (Looking South)**

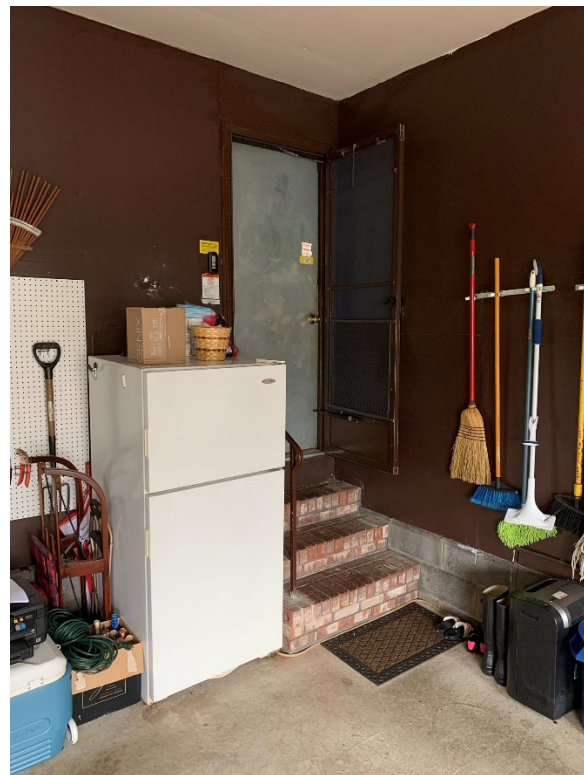
The garage area, adjacent to and west of the basement, is located at ground level (approximately 65" above basement floor) with brick stairs leading up to the first floor in the northwest corner of the garage. The CMU foundation walls continue around the perimeter of the garage to support the timber building frame, and extend 18" to 19.5" above the garage floor surface (top of wall consistent in elevation throughout building footprint). The garage is about 10'-8" in height measured from the concrete slab floor surface, and the first floor of the house is approximately 33" above the garage floor.

**Photo 10. Garage Walls with Stairs to First Floor of Building (Looking East)**

The garage door located in the front of the house will need to be removed prior to raising, and the opening replaced with a new timber-framed wall to match the rest of the building. The garage door will then be replaced at the ground level once the house is elevated. The existing brick exhaust chimney will also require extending during raising of the house to keep the top of the chimney above the roof level.

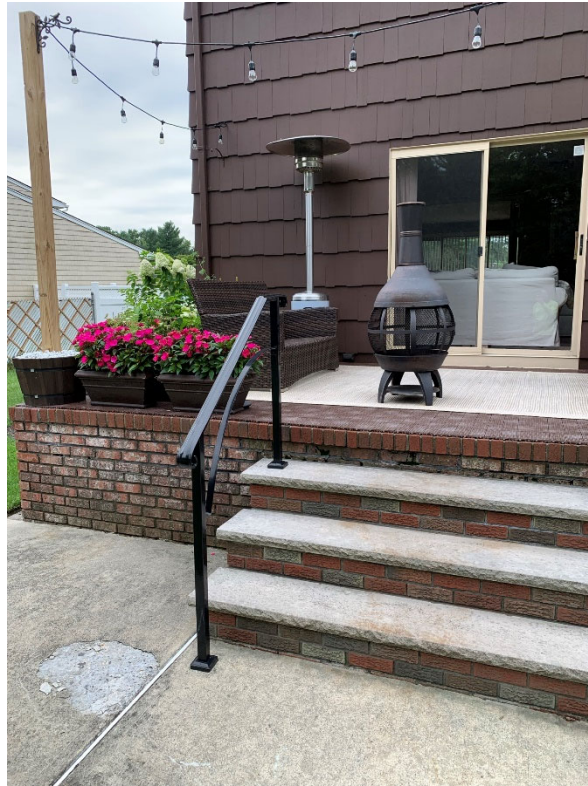
**Photo 11. Rear Brick Patio**

The rear brick patio is anticipated to require raising to match the proposed ingress/egress heights of the main structure. This would require reconstruction of the brick patio to raise the walls of the structure to the new first floor elevation. If additional brick is deemed infeasible, the existing stationary brick patio can be removed and replaced with an elevated timber deck, or the brick patio can be left in place and a new timber deck of equivalent square footage built around and above it to create a new exterior deck level with the first-floor elevation.

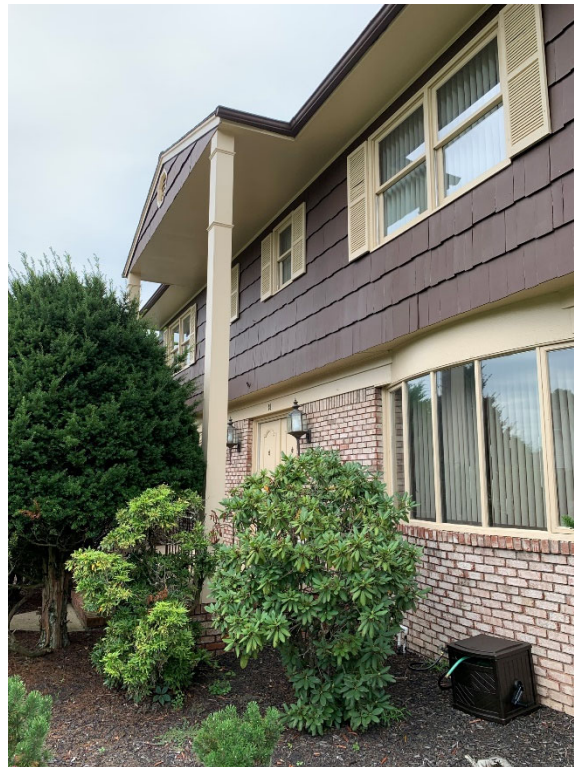
**Photo 12. Roof Overhang with Column Supports on Front Porch**

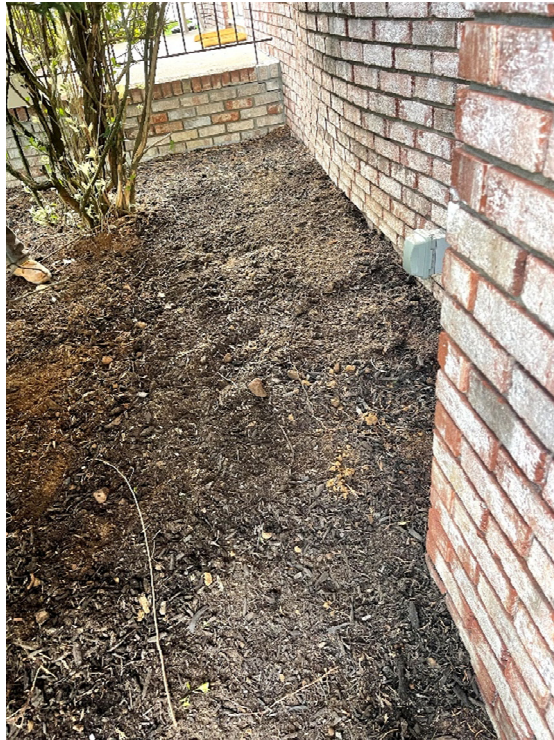
Test pit TP-1 was completed along the front basement wall, in the southwest corner of the building. Due to limited access, the concrete footing could not be reached during test pit excavation. The excavation was terminated along the length of the foundation wall at 48” bgs.

**Photo 13. Test Pit TP-1 Location (Front of Building – Basement, Southwest Corner)**

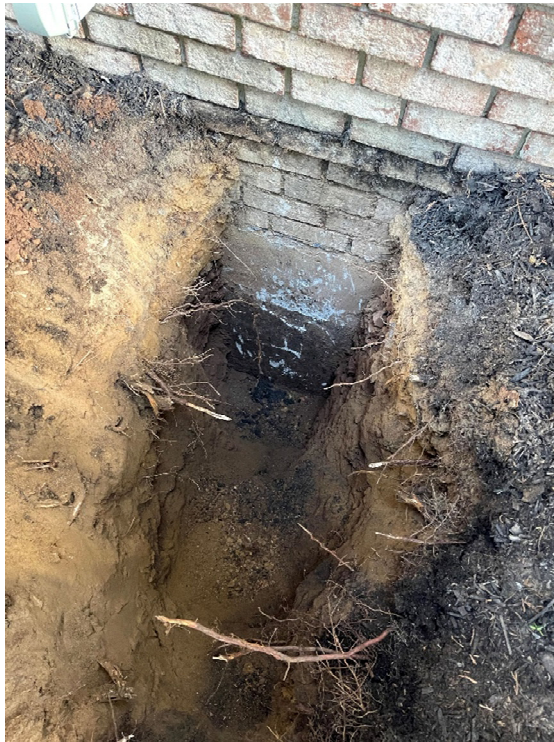
A test pit excavation was performed at the southwest corner of the basement to determine the type and size of the building's wall footings. However, due to site constraints, the foundation wall footings could not be reached to determine the structural dimensions. Based on conventional foundation construction, Matrix assumed a 16" wide concrete spread footing as a minimum value for analysis, but expects the building footings to be within 16" to 24" wide. Prior to raising the house, Matrix recommends that the contractor confirm the foundation size and bearing adequacy with multiple test pits around the building perimeter.

**Photo 14. Test Pit TP-1 Foundation Wall Conditions**
