Conrail Freight Train Derailment with
Vinyl Chloride Release
Paulsboro, New Jersey
November 30, 2012

NTSB/RAR-14/01
PB2014-108820
Notation 8475A
Adopted July 29, 2014

Railroad Accident Report

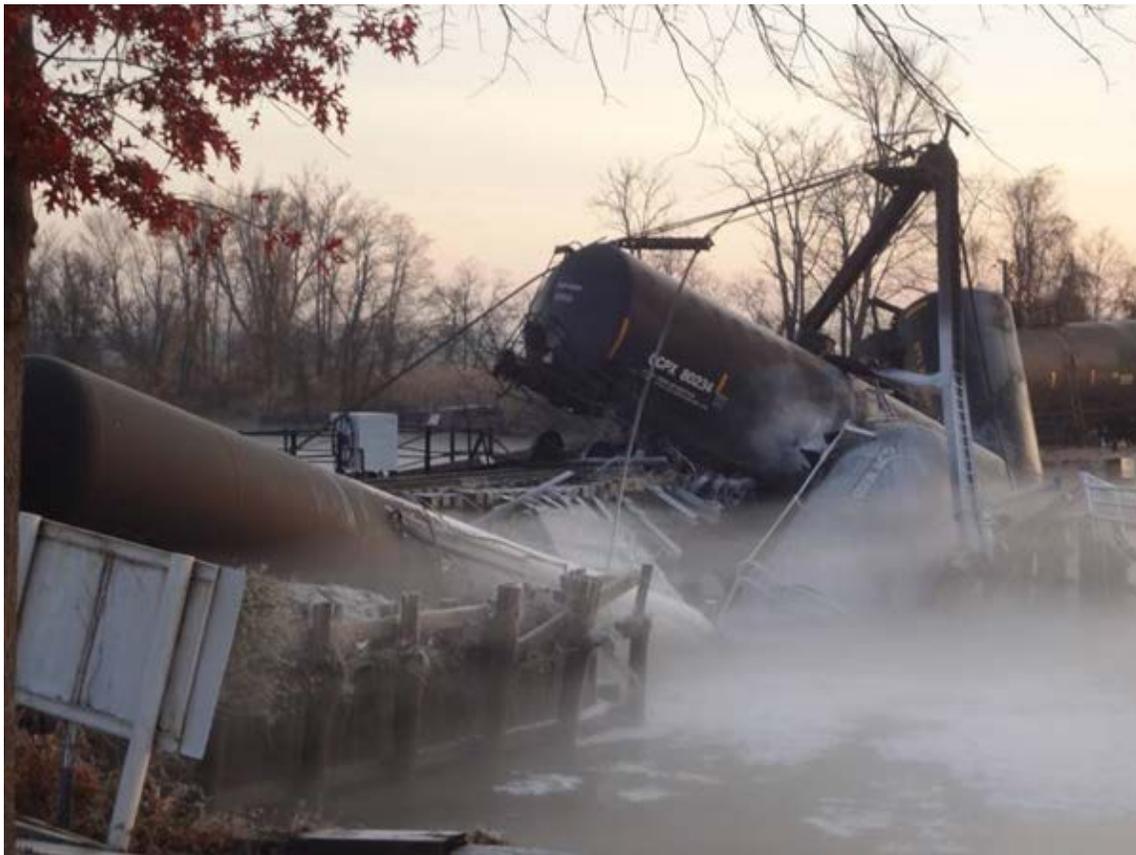
The deputy fire chief established the initial incident command post (ICP) at his residence, which was only about 50 yards from the ruptured vinyl chloride tank car. He radioed the communications center with additional information and requested Paulsboro Fire Department and Conrail officials to respond. Figure 10 shows the deputy fire chief's view of the accident scene. About 7:17 a.m., the fire chief arrived on scene and assumed the role of incident commander. Arriving support agencies were directed to the ICP and the incident command staff congregated within several feet of the accident scene during the response.

Figure 10. The breached tank car leaning off the bridge and the vinyl chloride vapor cloud. (Photograph provided by a private citizen)
