FIREFIGHTER INJURY REPORT
ATLANTIC CITY FIRE DEPARTMENT
ATLANTIC CITY, NEW JERSEY

NOVEMBER 18, 1993

REPORT ISSUED SEPTEMBER 15, 1995

**REPORT OF THE
METALLURGICAL EVALUATION
PERFORMED BY
FAILURE ANALYSIS ASSOCIATES, INC.**

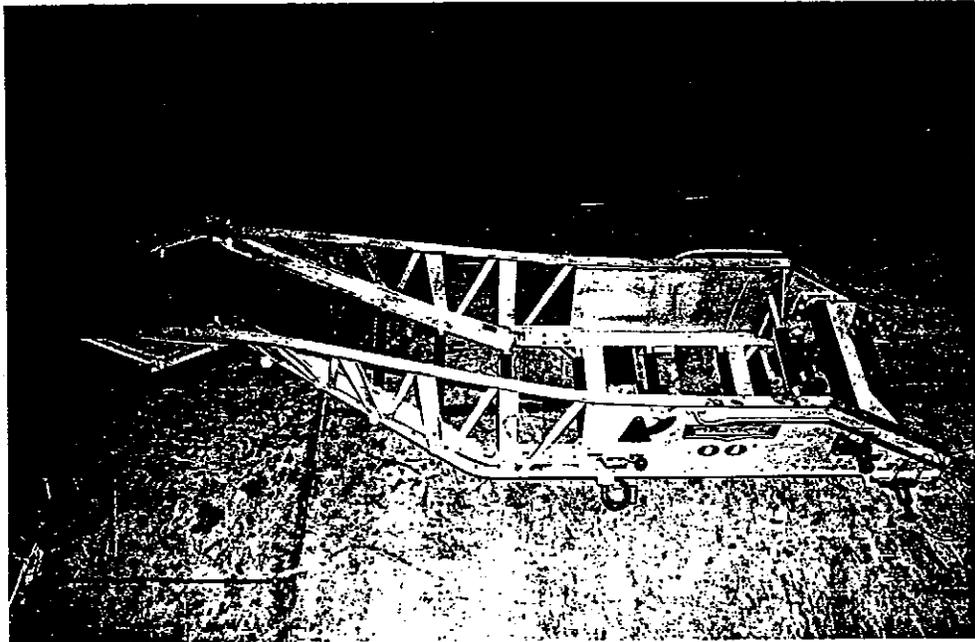
Figures 1 and 2 show overall views of the failed segment of the ladder. Figure 3 shows the underside of the failed segment, including the fracture of the T-section rail (right hand side). To obtain specimens for metallurgical evaluation, the T-section rail was cut and sectioned as shown in Figures 4 and 5. Figure 4 shows the locations of sections 1A-1 and 1A-2 on the right side T-section rail, close to, and away from, the fracture surface, respectively. Figure 5 shows the location of section 1A-3 on the left side T-section rail.

Figure 1. Overall view of failed ladder segment
Photo Id: DC17800-R1E1

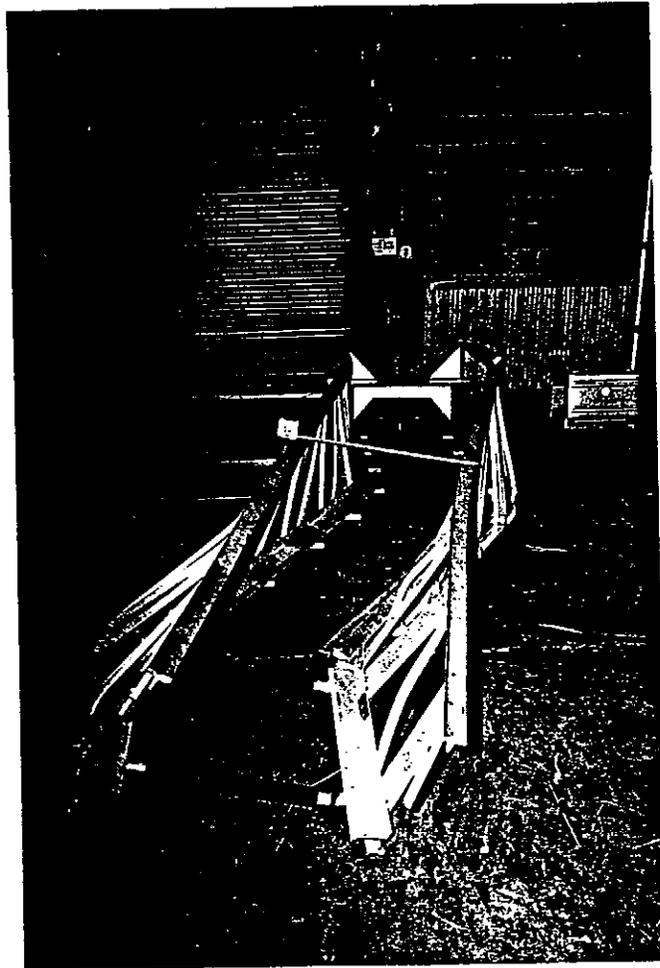
Figure 2. Overall view of failed ladder segment
Photo Id: DC17800-R1E6

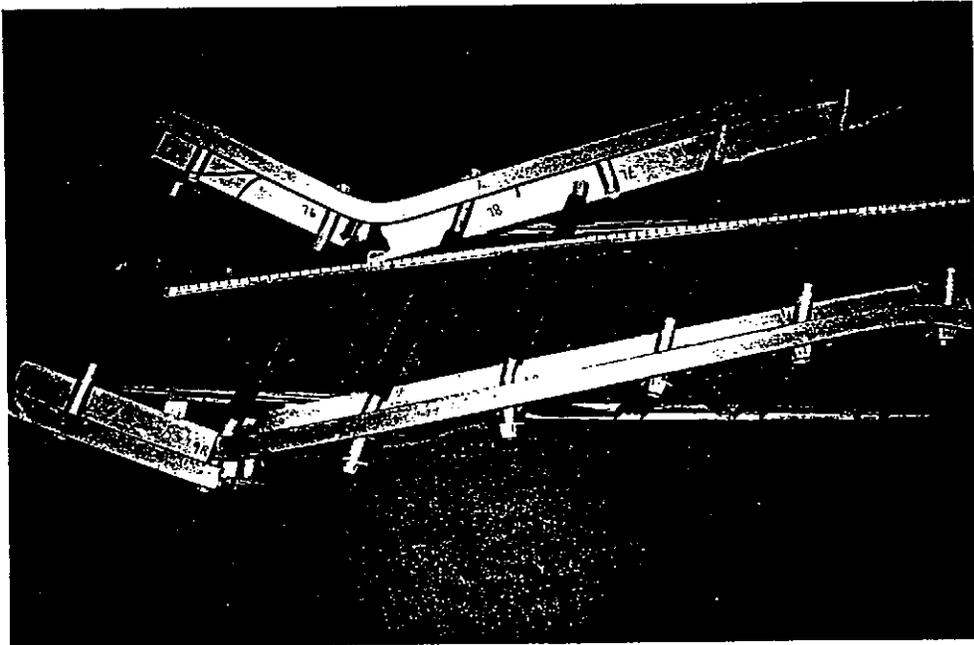
Figure 3. Underside of failed ladder segment
Photo Id: DC17800-R3E3

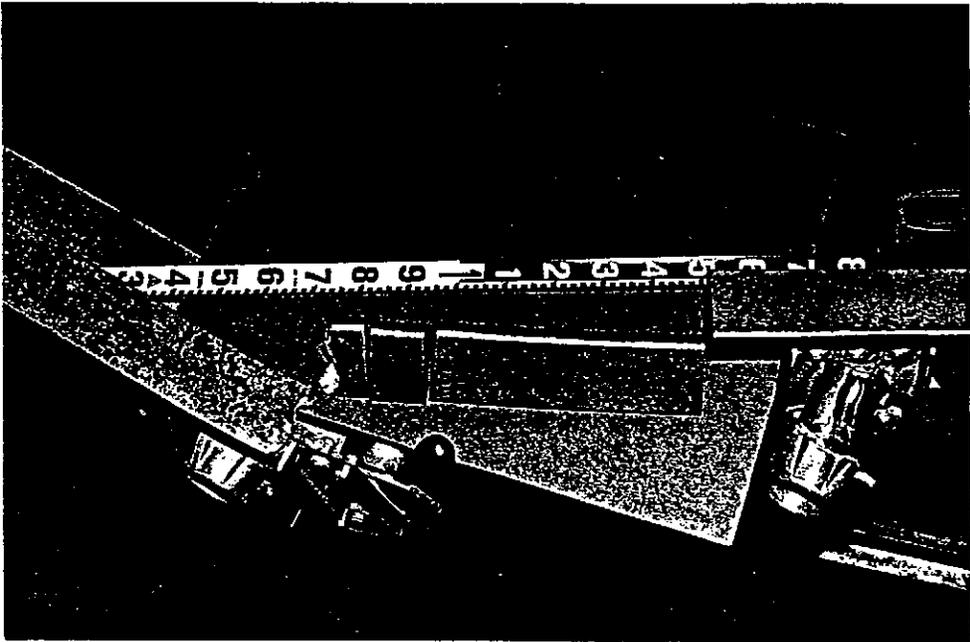
Figure 4. Fracture surface and sections 1A-1 and 1A-2 locations
Photo Id: DC17800-R4E1

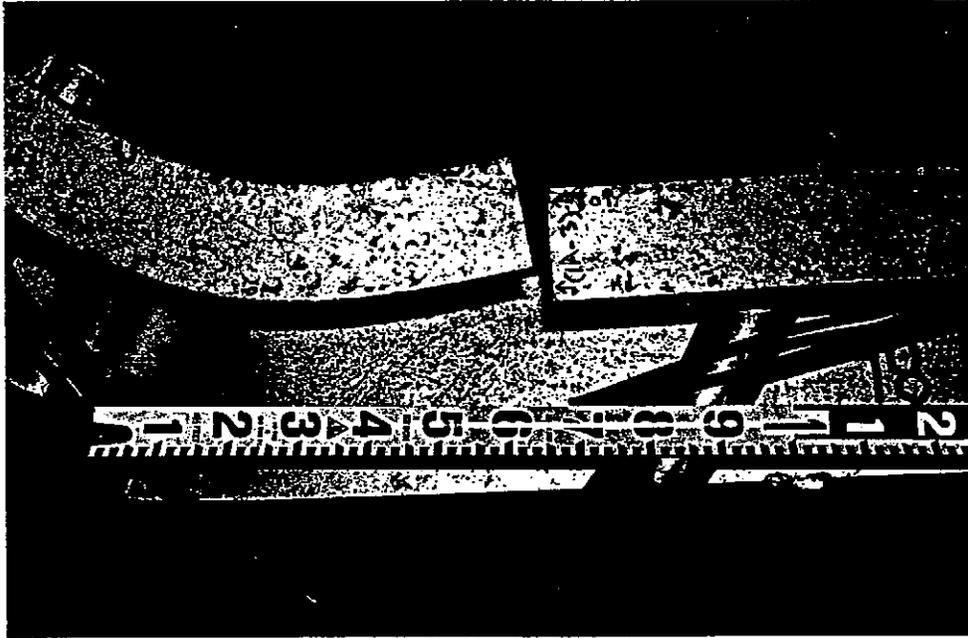
Figure 5. Section 1A-3 location
Photo Id: DC17800-R1E2

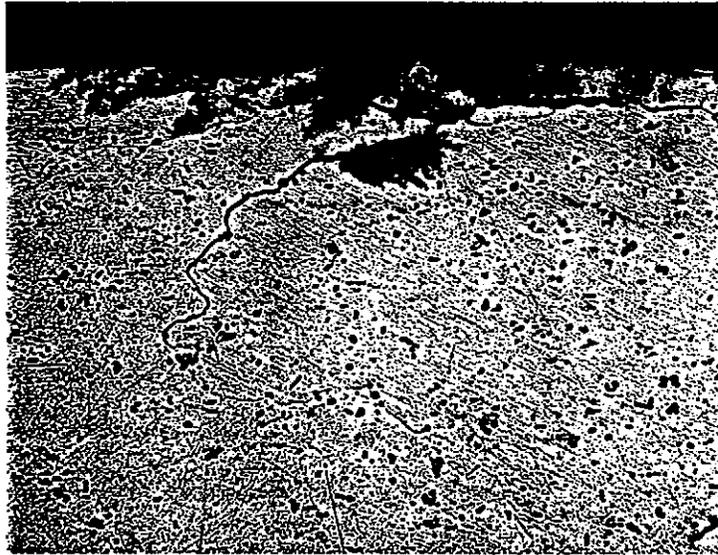
Evidence of grain boundary corrosion attack was found, as shown in Figure 7. This attack is localized corrosion along grain boundaries from a free surface, leading to grain separation¹. High strength 2014-T6 aluminum alloy is particularly susceptible to this type of corrosion cracking if the material is underaged following quenching².

Figure 7. Intergranular corrosion crack
200 X Kellar's reagent
Photo Id: DC17800-PAL-3-3/24/95

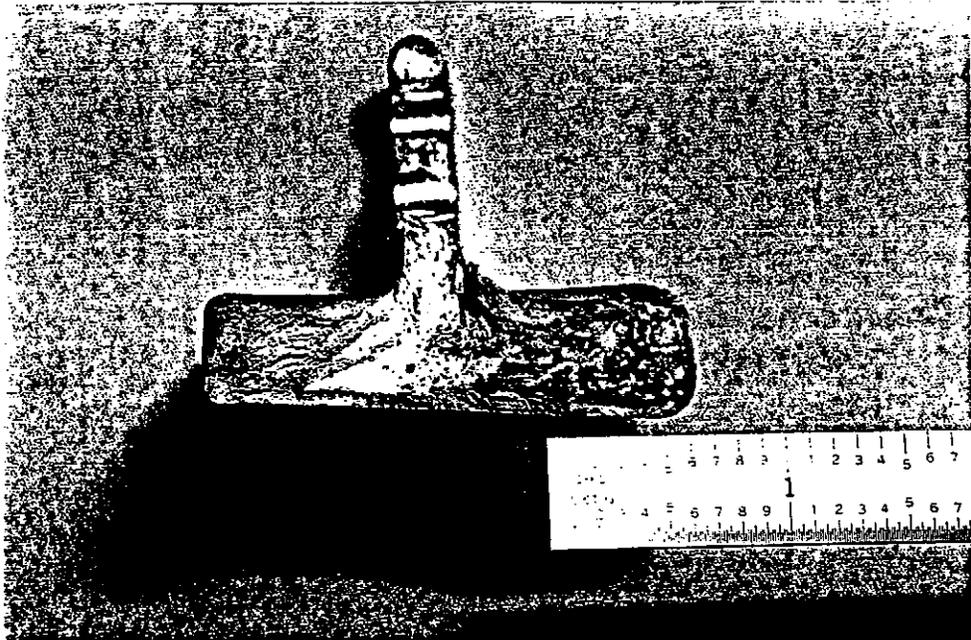
Fractography was performed on the fracture surface from the right side T-section rail in the scanning electron microscope (SEM). Figure 8 shows a photograph of the fracture surface. Figure 9 shows an SEM micrograph that reveals the surface detail. All regions of the fracture surface showed ductile dimpled rupture, consistent with tensile overload. Although surface cracks exist elsewhere on the rail (e.g., Figure 7), no evidence of cracking was found at the fracture surface. No cracks found were deep enough to cause failure of the rail by fast fracture.

Figure 8. Photograph of the fracture surface
Photo Id: DC17800-R4E4

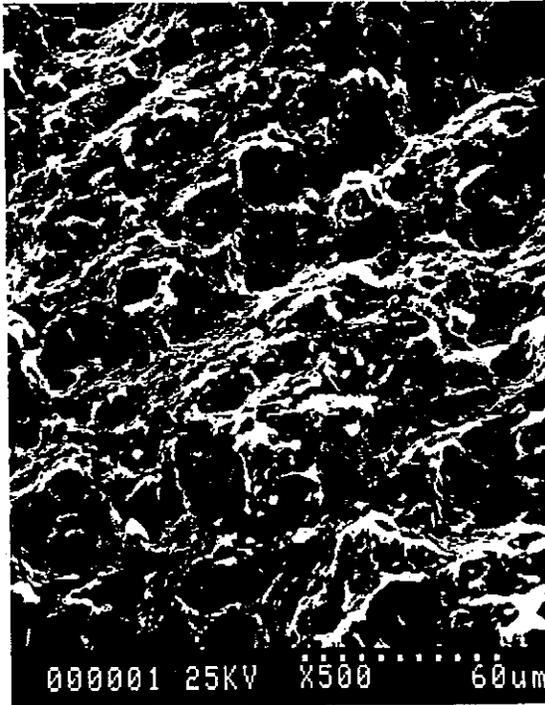
Figure 9. SEM micrograph showing detail of the fracture surface.
Failure mode is ductile dimpled rupture.
Photo Id: DC17800-PAL-1-2/7/95

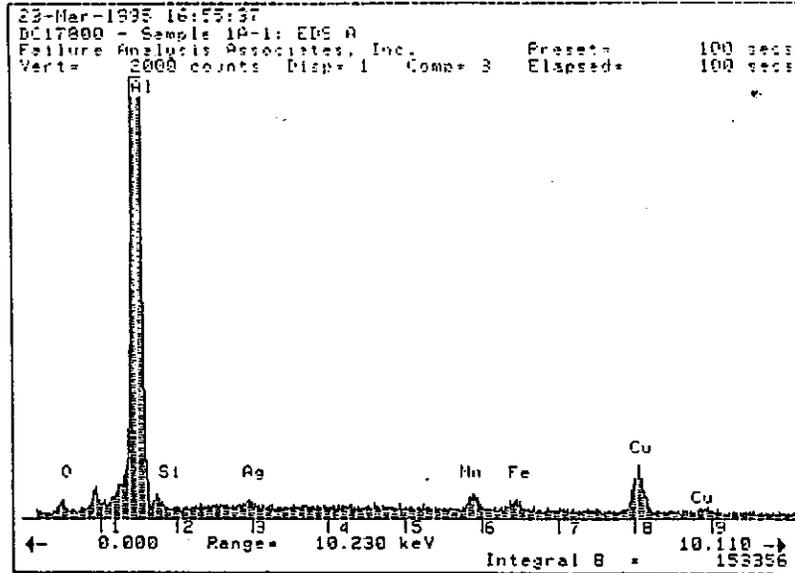
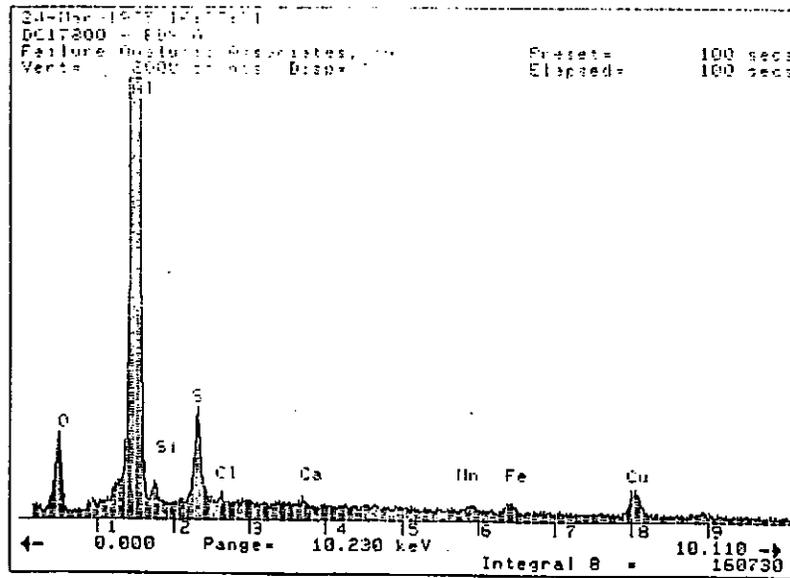
The chemistry of the fracture surface was probed using energy dispersive spectrometry (EDS) and the results are shown in Figure 10. For comparison, the exterior surface of the rail was probed to determine the EDS signature of the surface corrosion, also shown in Figure 10. No evidence of extensive corrosion of any region of the fracture surface was found, supporting the conclusion that surface cracks did not contribute significantly to the rail failure.

Figure 10. EDS spectra showing surface chemistry
a) fracture surface
b) corrosion scale
