**FIREFIGHTER
FATALITY / INJURY REPORT**

RUTHERFORD FIRE DEPARTMENT

RUTHERFORD, NEW JERSEY

JANUARY 4, 1994

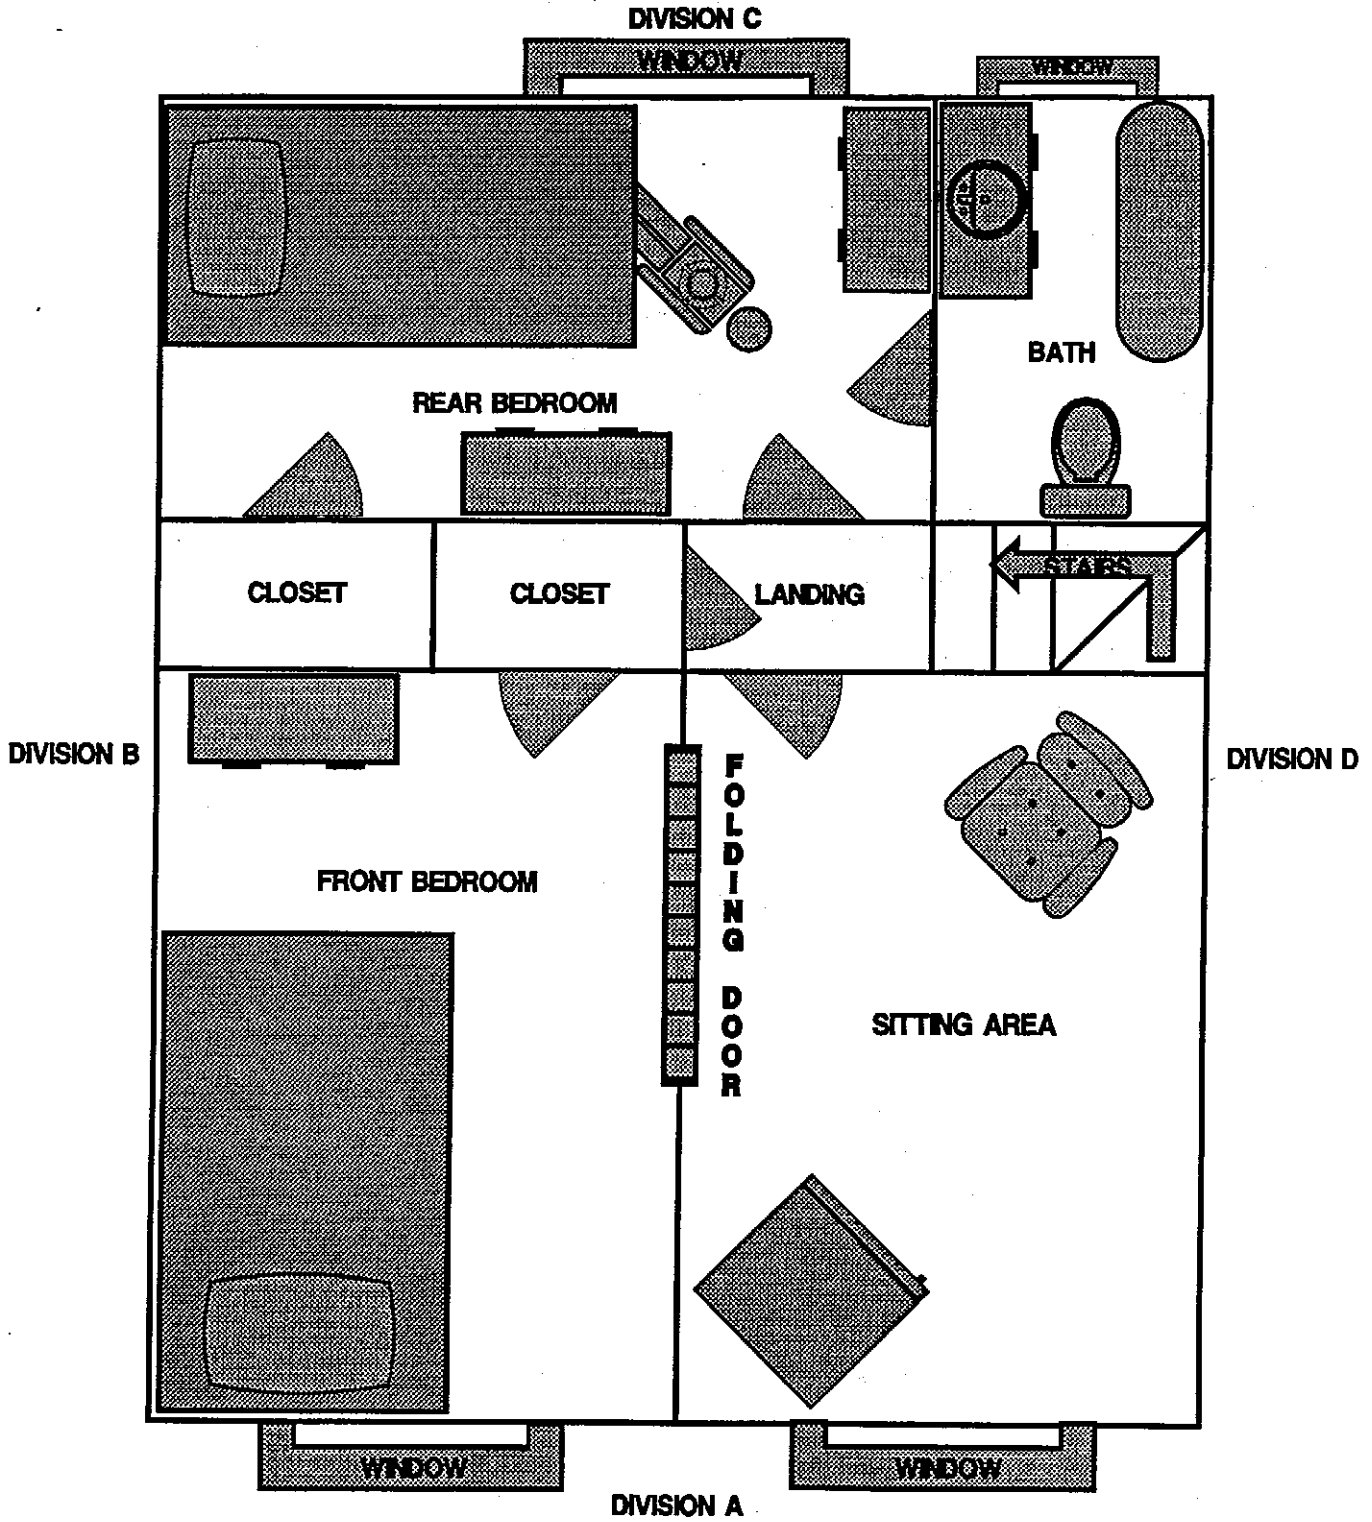
SECOND LEVEL FLOOR PLAN

During the course of the incident, FFs Dunn and Jacobs ascended to the second floor to search for possible trapped occupants, perform horizontal ventilation in the area and search for fire extension. The conditions on the second floor were tenable. There was little heat. Visibility was good, with only a light haze of smoke at the ceiling level. They first proceeded to the front bedroom located at Division A of the structure. As they were leaving the bedroom and re-entering the hallway, conditions changed dramatically. Extreme heat and pressurized smoke came up the stairway at about the time they were passing by the top of the stairs. Both firefighters immediately dropped to a prone position and then were obscured from each other by dense smoke that filled the entire space between the ceiling and the floor. During this time the two were communicating, calling to each other by name and trying to locate one another. Jacobs yelled that they must find a window. They continued through the hallway into the bedroom at the rear of the second floor. This room had now become untenable. Jacobs was able to reach the rear exterior wall of the room and subsequently a window. He exited through the window and onto the sun porch roof, which was coated with ice and snow. Jacobs slid off the edge of the roof and impacted the ground.

When FF Dunn entered the rear bedroom, he apparently did not realize where the window was located and rather than traveling in a straight line, turned to his left and encountered a bed frame. His feet became entangled in the bed and he was unable to escape. When he was found by his comrades, his facepiece was removed. The firefighters who found him reported during interviews conducted after the incident that his facepiece was found nearby and was not entangled. After locating Dunn, the firefighters removed him through the bedroom window, onto the porch roof and down the ladder to the ground.

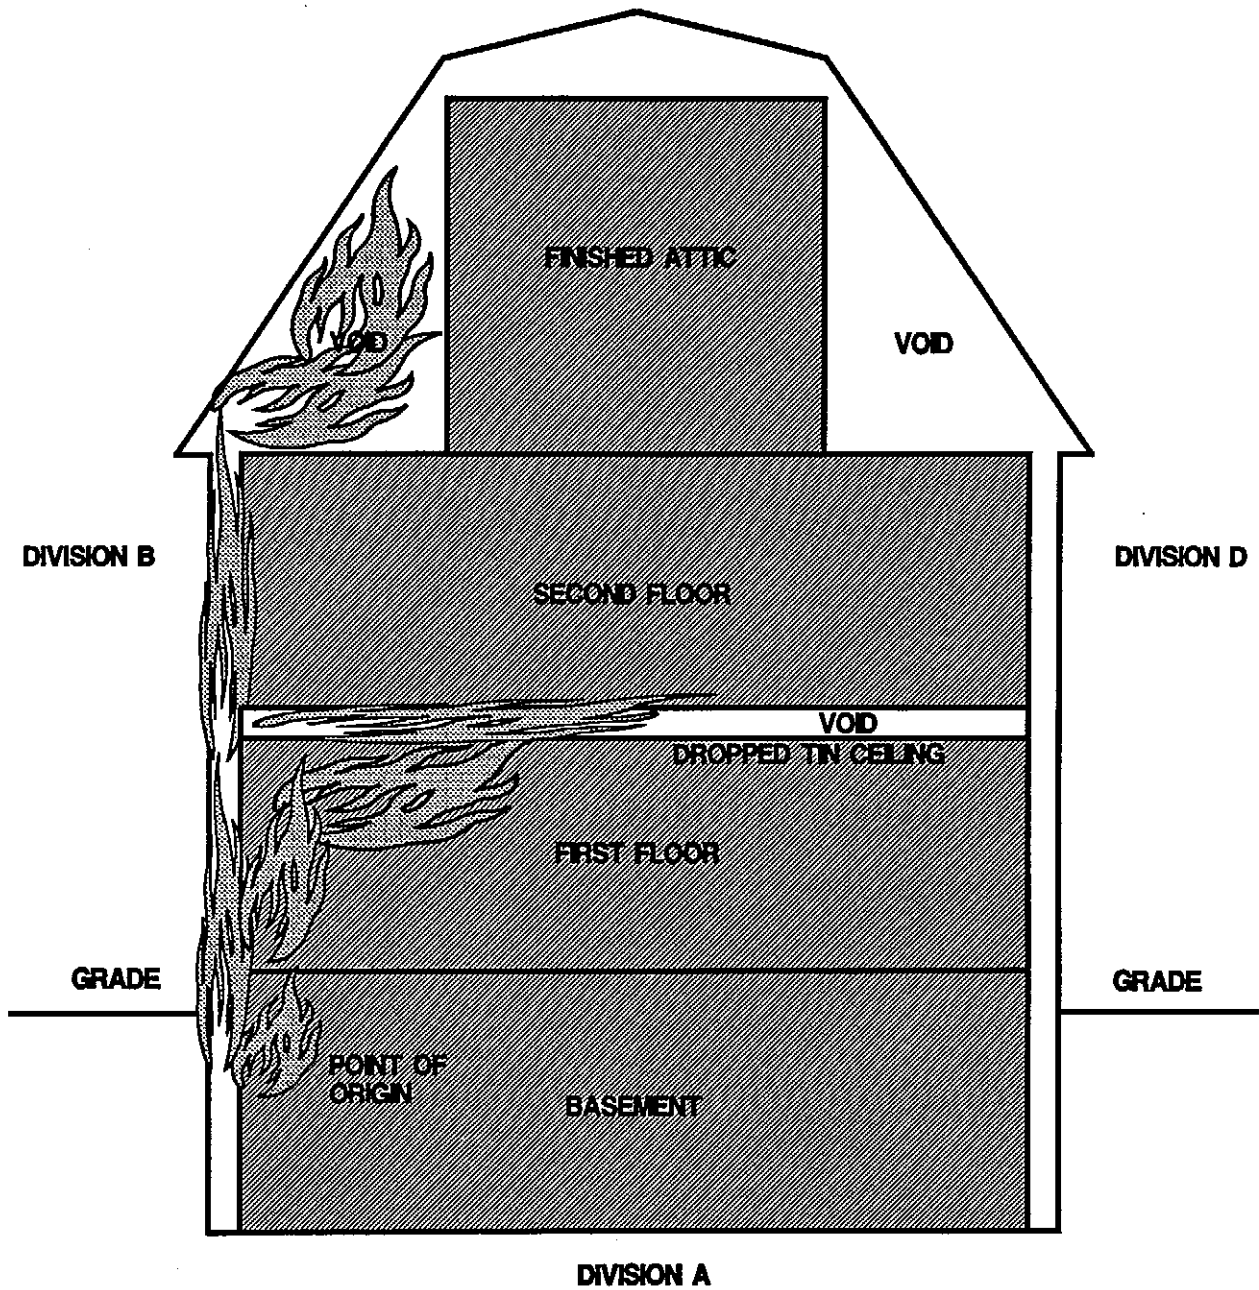
CROSS SECTION OF STRUCTURE AND ROUTE OF FIRE TRAVEL

The involved structure was constructed of wood framing in what is commonly known as "balloon style". Unlike "platform style" wood frame construction, which is a wood stud framing system in which studs are story height and floors provide some inherent firestopping, balloon style utilizes studs that are continuous for the full, two-story building height and inherent firestopping is not provided between floors. This characteristic allows for fire spread from lower levels in the structure to all areas above the fire floor, often into the attic space. Fire spreading in this manner is usually concealed until it burns through a wall or the roof. The fire in the Rutherford building burned in this fashion, spreading from the area of origin in the basement through the Division B wall and, ultimately, into the attic.

It is possible for flashover to occur in a confined space or void. If a fire breaks through to an uninvolved space, the products of combustion may fill that previously uninvolved space rapidly, under elevated temperatures and pressure. Although not conclusive, a more likely explanation of the events that transpired may be that fire in concealed spaces in the Division B wall, and above a false tin ceiling in the living room broke through into the living room. This would be consistent with the reports of the crew working in the doorway of the Division C side, who witnessed fire on the Division B wall of the living room. It is conceivable that fire may have broken through on the second floor from the walls and from the attic above. It was noted that the attic contained a small room in the center, surrounded by a considerable concealed space. Examination of the space between the interior and exterior walls of the Division B side of the building revealed that fire had traveled from the area of origin in the basement directly into the concealed space in the attic. The sudden introduction of heavy fire and large amounts of superheated gases into a previously uninvolved space could very well account for the rapid build-up of heat and smoke. The intensity of the fire was most likely increased by a chimney effect created by the ventilation that had been undertaken below and above the level of the fire. Additionally, a hoseline in a fog pattern was being operated in the area of the living room at the time. It is conceivable that the operation of this hoseline could have produced considerable steam expansion. This would most likely have upset the thermal balance in the space and also contributed to the pressurization and the extreme heat the firefighters on the second floor experienced.

Occasionally, firefighters may vent at locations they believe to be above the fire, not realizing that fire has traveled in concealed spaces into areas above the vent level. This is particularly true with balloon construction. The effect of the fire intensifying can be equated with a wood-burning stove. When air is introduced below the fire level, the fire intensifies greatly. This can place firefighters above the fire in extreme jeopardy.

The Division of Fire Safety recommends that all fire departments review their standard operating procedures and training regarding ventilation, especially concerning coordination of ventilation and fire attack and search and rescue operations at and above the level of ventilation.
