## WASTE EFFLUENT SURVEY

Plant Name: Atlas Refinery, Inc.  
Address: 142 Lockwood Street, Newark, N. J. Zip 07105  
Person and Title to whom any further inquiries should be directed: J. Bihun, Technical Director  
Phone No.: (201) 589-2002  
Number of Employees: 36  
Number of Working Days Per Week: 5  
Number of Shifts Per Day: 1  
Area of Property: 1.78 Acres, or Sq. Ft.  
Type of Industry and 4 digit U. S. Standard Industrial Classification No.: 2843  
Surface Active Agents, Finishing Agents, Sulfonated Oils and Assistants  
Finished Product(s): Oils for Leather, Textile and Paper Industry  
Average Production: 12,000,000 Lbs/Year  
Raw Materials Used: Animal, Vegetable, and Marine Oils, Mineral Oils  
Brief Description of Operations: Refining of Animal Oils, Sulfation and Sulfonation of  
Animal, Vegetable, and Marine Oils; Compounded Oils; Sulfation and Sulfonation  
of Straight Chain Unsaturated Hydrocarbons.

Violation and Elimination - Atlas Refinery, Inc., 142  
Lockwood Street, Newark, N.J.  
June 6- August 4, 1972 ( J. Mc Laughlin)

# POLLUTION ABATEMENT PROGRAM

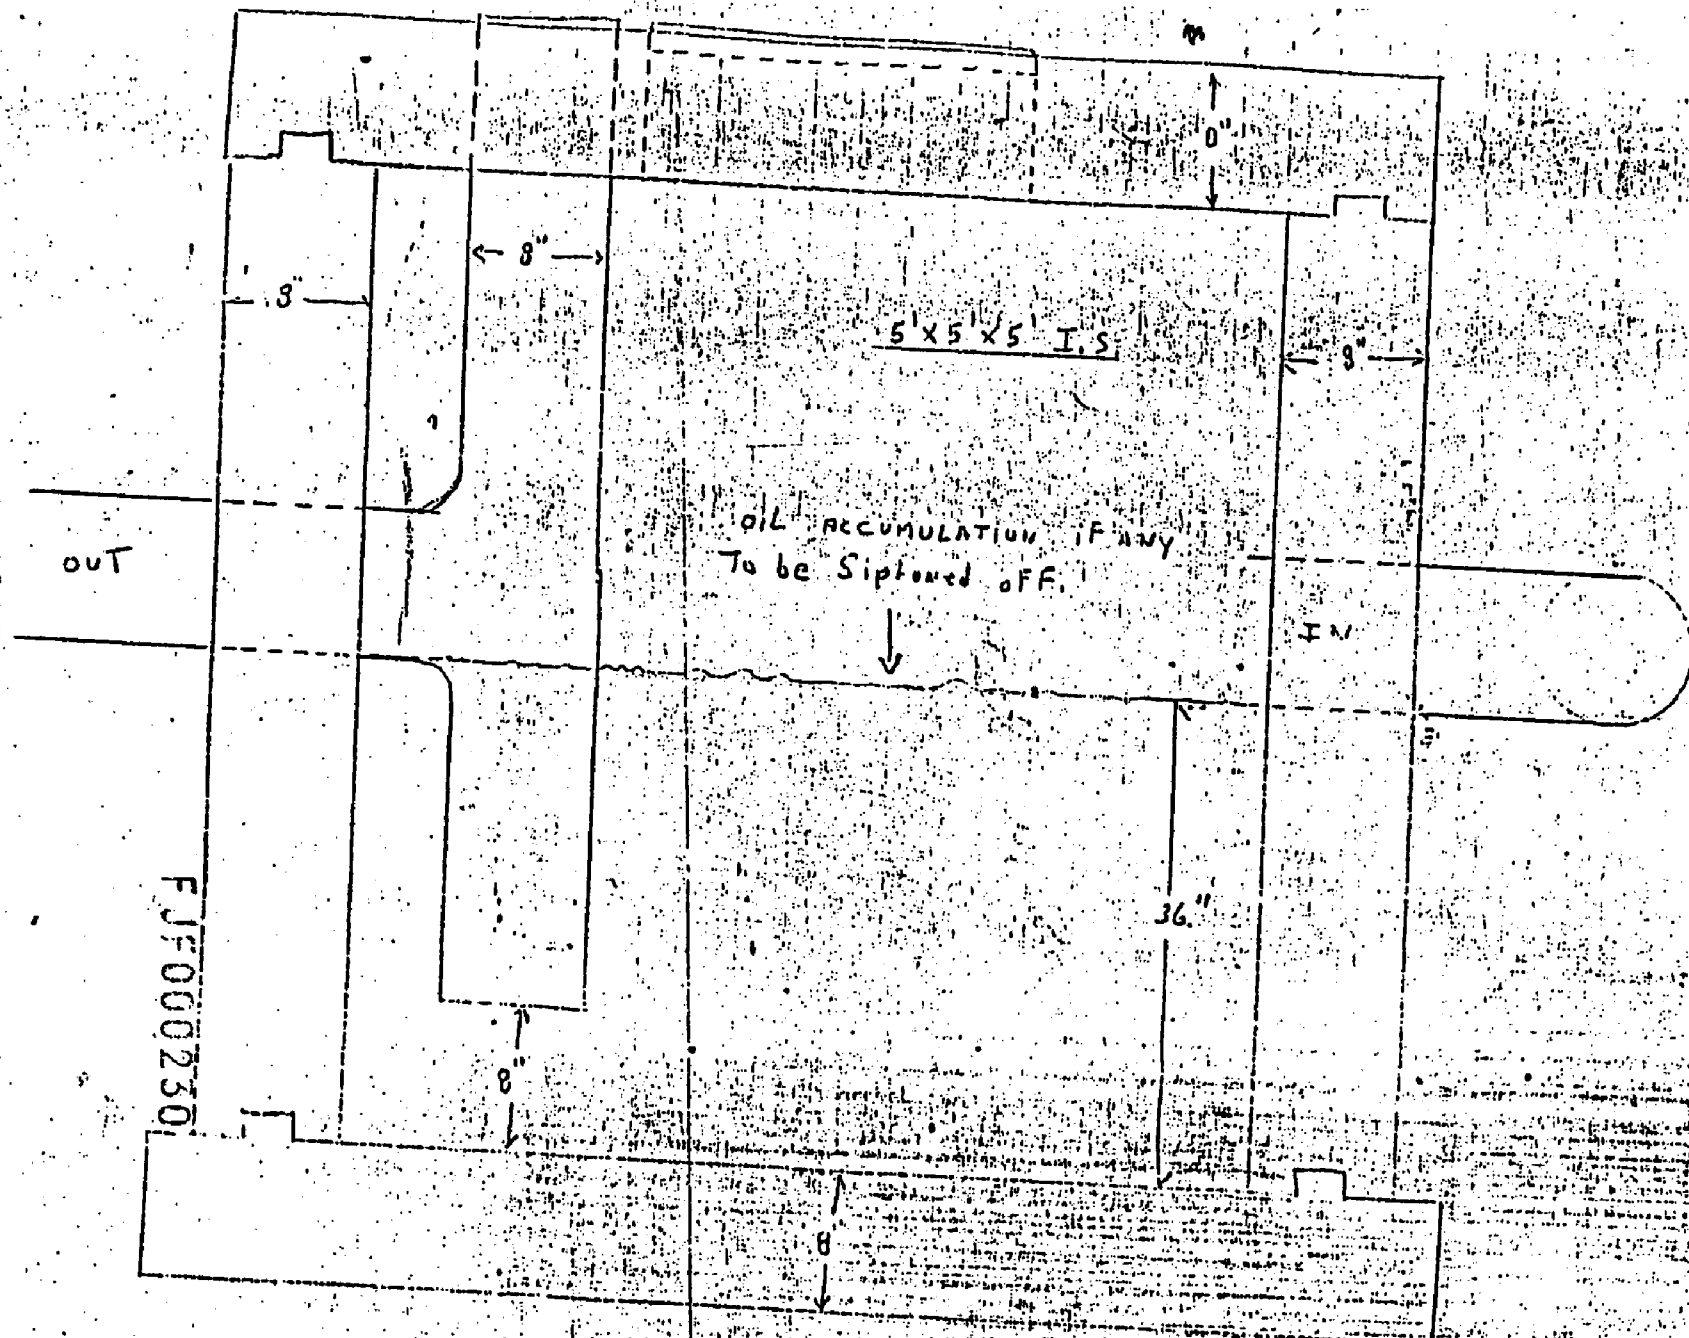
SHEET NO. 1 OF 1  
 JOB NO. 142 LOCKWOOD NE  
 NEWARK, N.J.

OIL Separator  
(PROPOSED BASIN)

SUBJECT SHOW R.R. TRACKS + CURB
