City of Newark, New Jersey
Feasibility Study

POLLUTION ABATEMENT PROGRAM

**NEWARK POLLUTION ABATEMENT
FEASIBILITY STUDY**

**SOURCES OF POLLUTION IN STORM
SEWER SYSTEMS ON BLANCHARD,
LOCKWOOD AND BROWN STREETS**

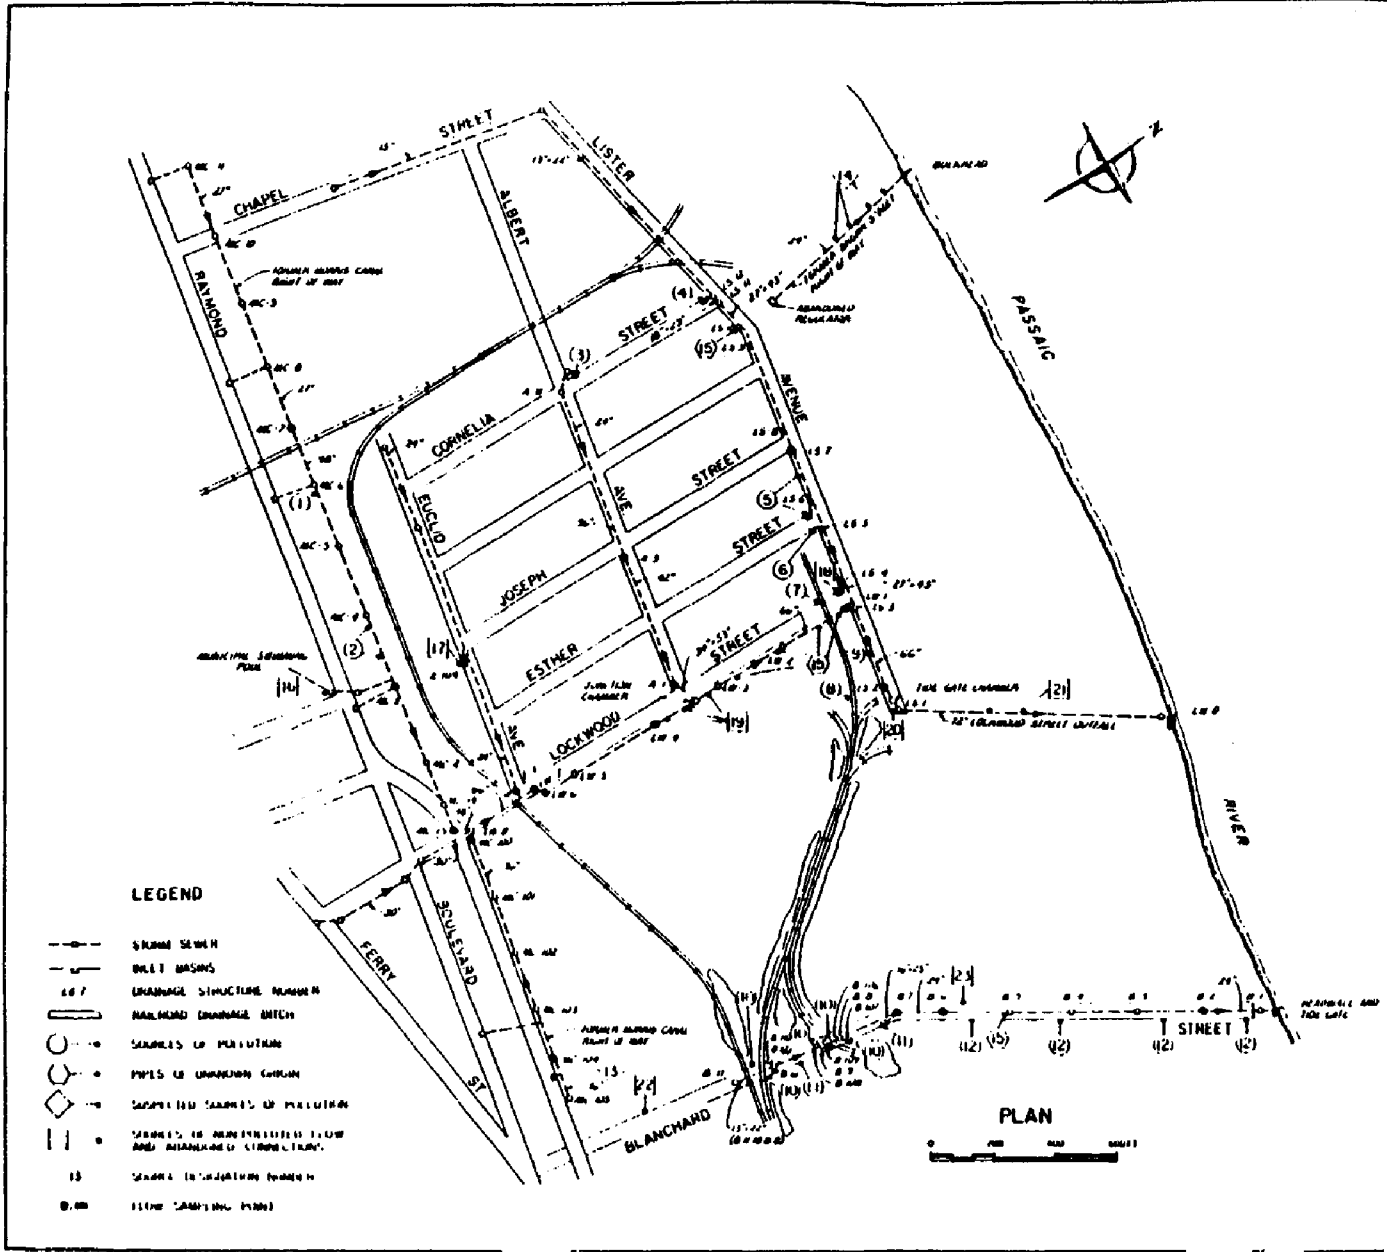
INTERMITTENT DUMPING OF PAINT INTO SEWER AT ASSOCIATED AUTO BODY AND TRUCKS INC.

CAR WASH DRAINS AT SERVICE STATION CONNECTED TO STORM SEWER

INTERMITTENT LOW VOLUME DISCHARGE OF OIL AND WATER ENTERING INLET FROM COLLIERIES CORP.

CONTINUOUS FLOW OF THICK VISCOUS CHEMICALS ENTERING INLET FROM COLLIERIES CORP.

CONTINUOUS FLOW OF BLACK OILY CHEMICALS ENTERING INLETS FROM S-LINE TRUCKING COMPANY.

RAILROAD DRAINS AND OIL SEPARATOR AT ATLAS REFINERY INC. CONNECTED TO STORM SEWER

FALL-OFF OVERFLOW OF SEWAGE FROM SANITARY MANHOLE ENTERING INLETS
