New Jersey Department of Environmental Protection
COMMUNICATIONS CENTER NOTIFICATION REPORT

Avionics Division

HAZARDOUS SUBSTANCE DISCHARGE REPORT

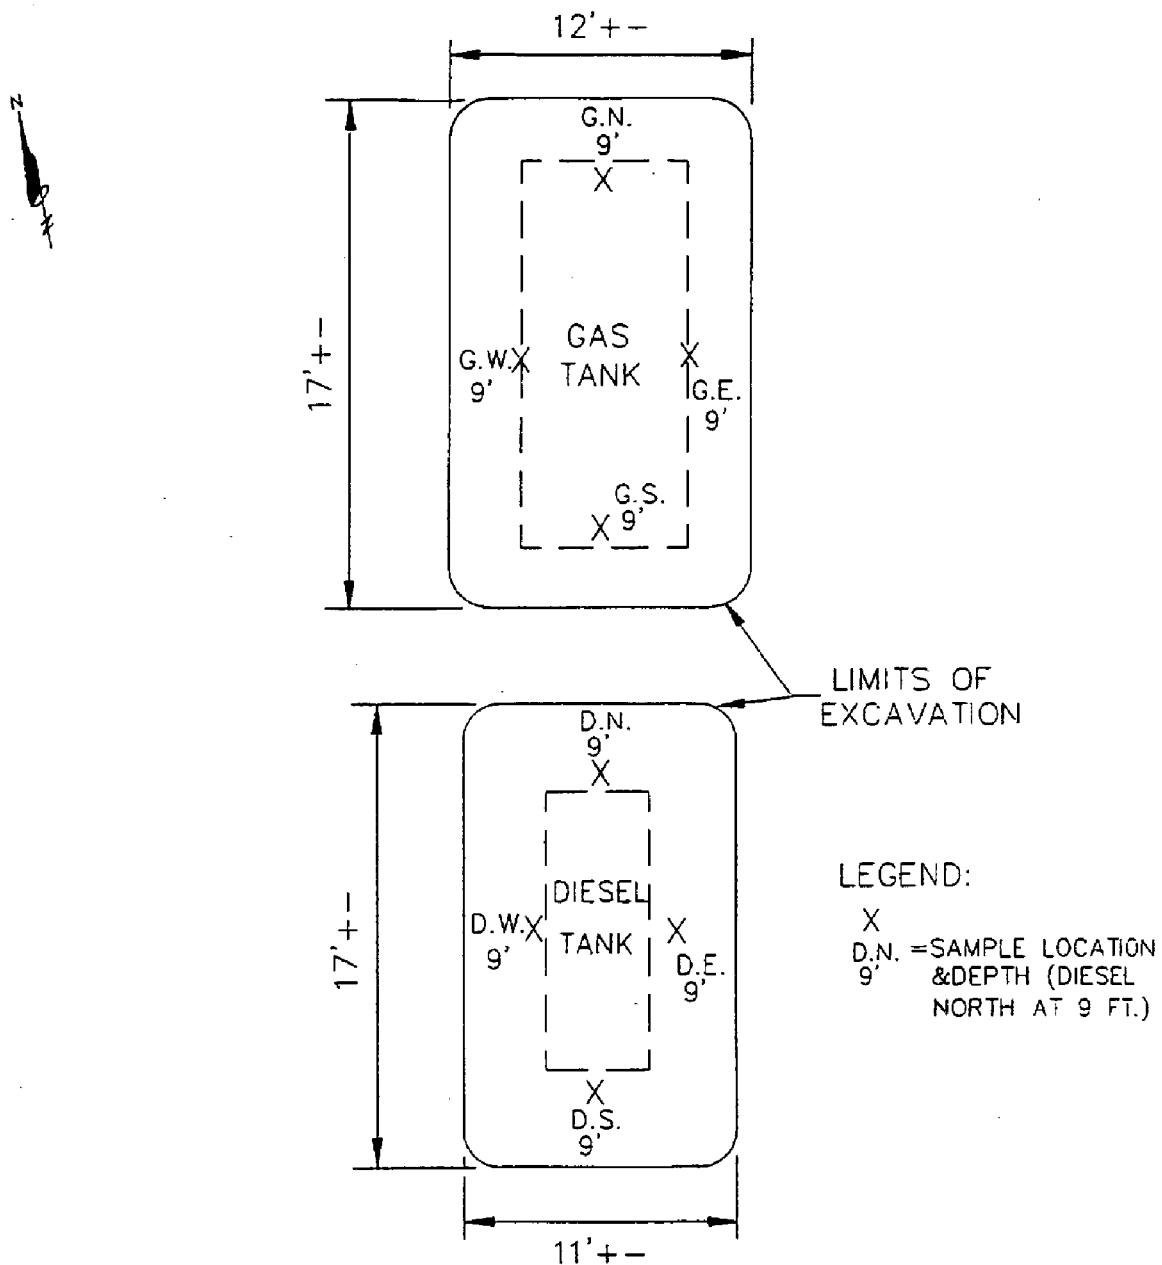
FIGURE 2-15

On September 15, 1989, two (2) additional USTs were pressure tested by FMI. The results indicated that a 1,000 gallon diesel fuel UST (UST system E-10) failed the test and a 4,000 gallon leaded gasoline UST (UST system E-9) tested inconclusively. On December 19 and 20, 1989, the two USTs (BUST Case No. 89-09-15-1420) and all appurtenances were excavated and removed from the site under the field oversight of an H2M representative and a NJDEP Northern Bureau of Regional Enforcement representative. Product from within the tanks was transported to S&W Waste (EPA I.D. No. NJD991291105) under manifest No. NJA0633829. Four post-excavation confirmatory soil samples were collected from each excavation and analyzed for VOCs and total petroleum hydrocarbons (TPHC).

POST-EXCAVATION CONFIRMATORY SOIL SAMPLE LOCATIONS
FORMER GASOLINE AND DIESEL FUEL TANKS
ITT AVIONICS DIVISION
CLIFTON, NEW JERSEY

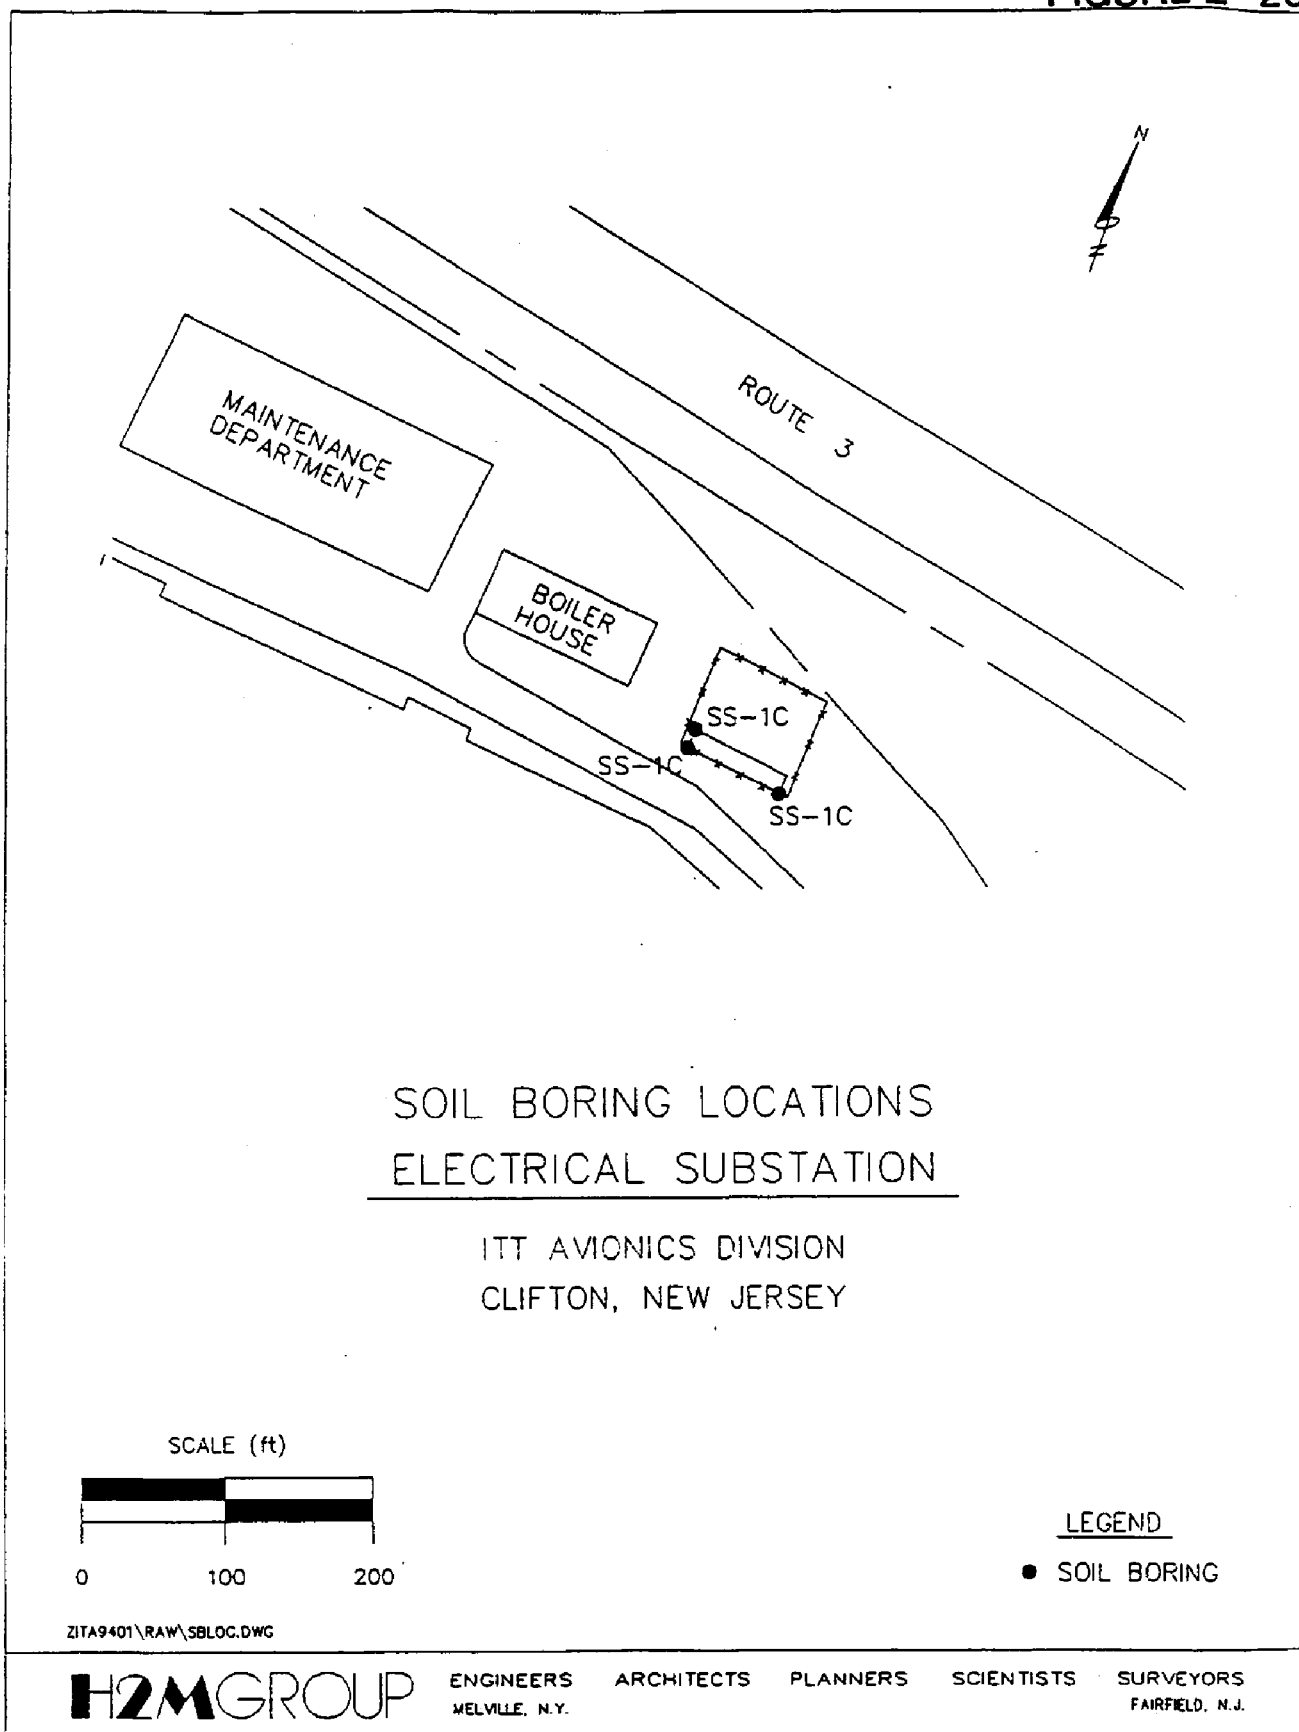
FIGURE 2-20

The area in the vicinity of the electrical substation located north of the main building (see Figure 2-20) was identified because of the presence of a transformer which historically contained oil that had leaked onto the concrete pad. Three transformers are located on the concrete pad, with each having been sampled and analyzed for PCBs by General Electric on April 17, 1989. Sampling results indicated that PCBs are not present in the transformer oil. This AOC was investigated under ITT's corporate environmental survey program.

To evaluate the oil which had caused a stain on the concrete pad, three (3) shallow soil borings were advanced around the electrical substation as part of an ITT Corporate site assessment program conducted in 1992. Soil samples were collected from each borehole at a depth of 0.5' to 1.0' below grade. These soil samples were composited and analyzed for TPHC and PCBs.

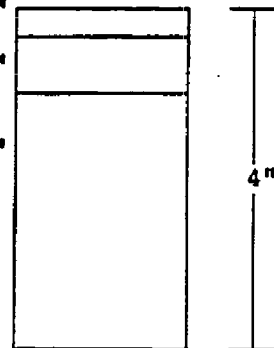
Sample ID: C-1 1/8"
Date: 8/27/90
Time: 1000 1/4"
Parameters: EP TOX Metals, Reactivity,
Corrosivity
Description: 1/8" Tarazzo & Paint 3 5/8"
1/4" Dark Gray
3 5/8" White, Gray,
MF Gravel

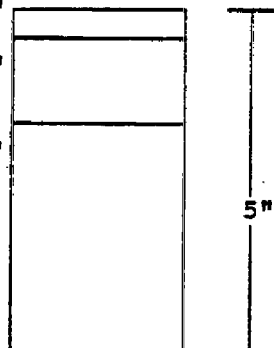
Sample ID: C-2 1/8"
Date: 8/27/90
Time: 1015 1/2"
Parameters: EP TOX Metals, Reactivity,
Corrosivity
Description: 1/8" Tarazzo & Paint 4 3/8"
1/2" Dark Gray, Black
4 3/8" White, Gray,
MF Gravel

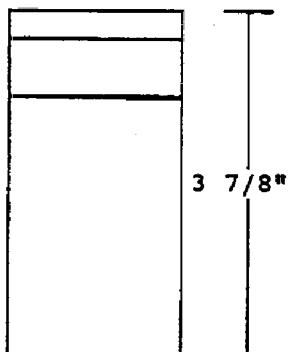
Sample ID: C-3 1/8"
Date: 8/27/90
Time: 1030 1/4"
Parameters: EP TOX Metals, Reactivity,
Corrosivity
Description: 1/8" Tarazzo & Paint 3 7/8"
1/4" Dark Gray, Black
3 1/2" White, Lt Gray,
MF Gravel 3 1/2"

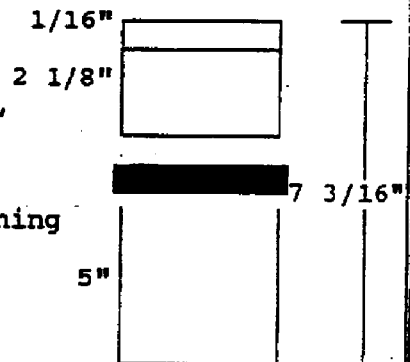
Sample ID: C-19
Date: 8/28/90
Time: 1025
Parameters: EP TOX Metals, Reactivity, Corrosivity
Description: 1/16" Tarazzo, Paint
2 1/8" Lt Tan, MF Gravel
5" White, Gray, Some Staining
Top 1" Of This Section
