Prioritization of Potential Streambank Stabilization and Habitat Restoration Projects in the Rancocas Creek Watershed

A scenic view of the South Branch Rancocas Creek.

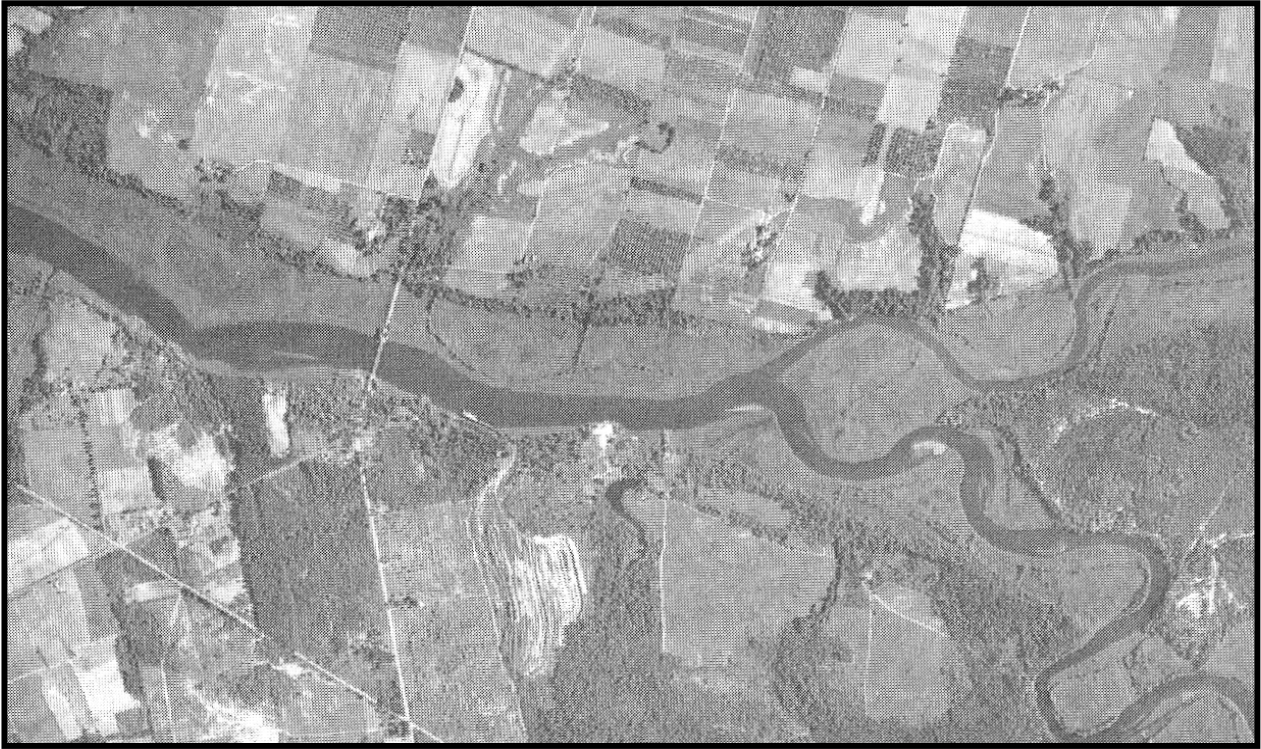
Map #1: 1940 Aerial photograph of the Rancocas Creek.

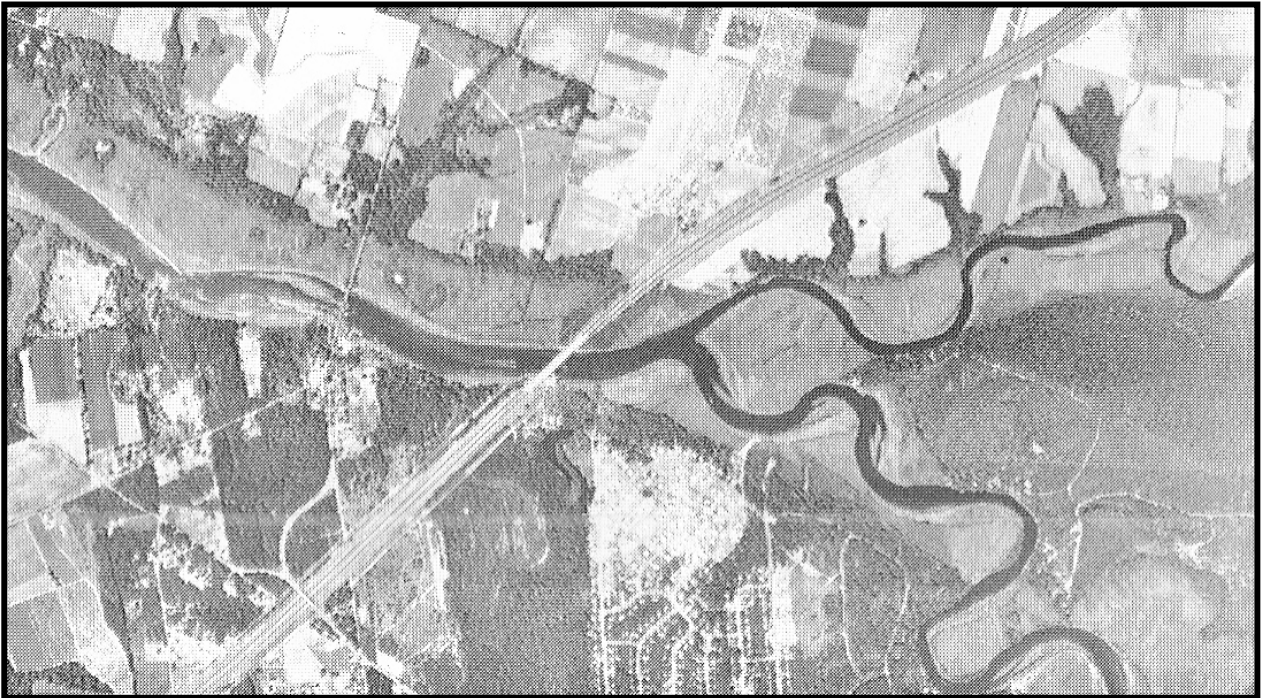
Map #2: 1963 Aerial photograph of the Rancocas Creek. Note the increased sediment levels in the Main Stem as well as the additional infrastructure.

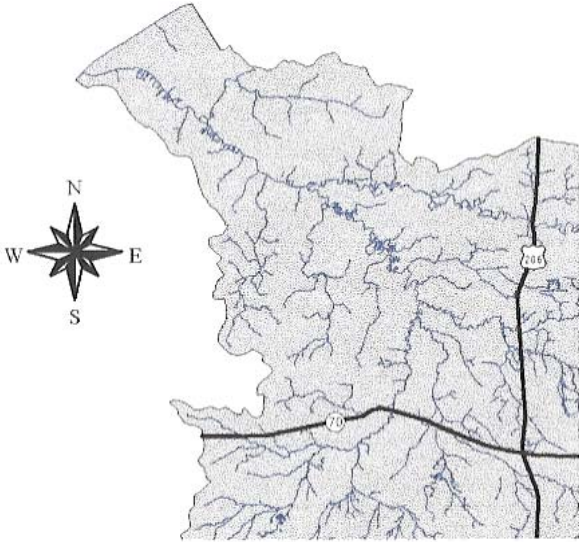
The purpose of this grant proposal was to survey the Rancocas Creek and its tributaries in order to locate and prioritize potential sites for streambank stabilization and habitat restoration projects. The Burlington County Soil Conservation District utilized the New Jersey Department of Environmental Protection's 1994 State Water Quality Inventory Report as a guide in determining the project area. As a result, the project focused on the portion of the Rancocas Creek

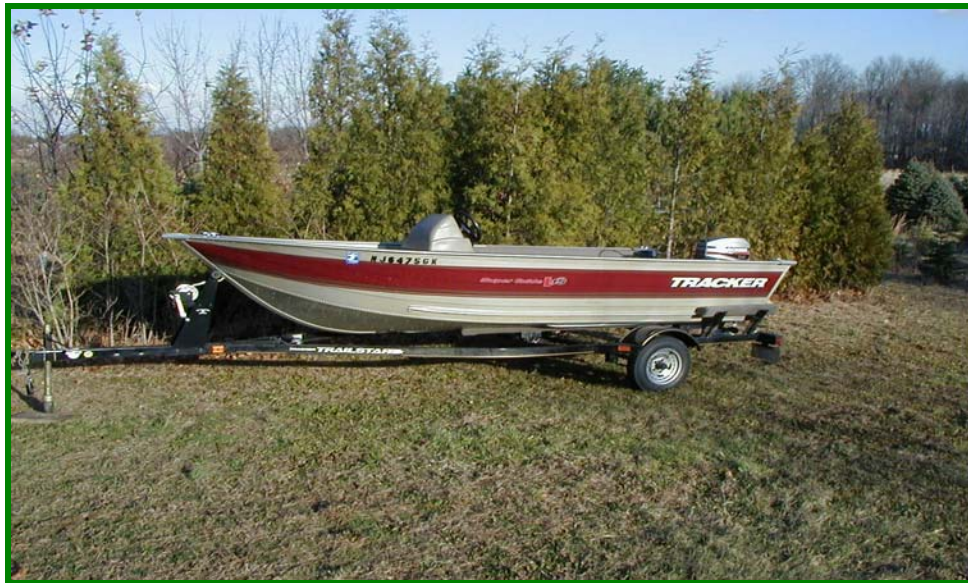
This Tracker boat was used to navigate the Rancocas Creek during the course of this project.

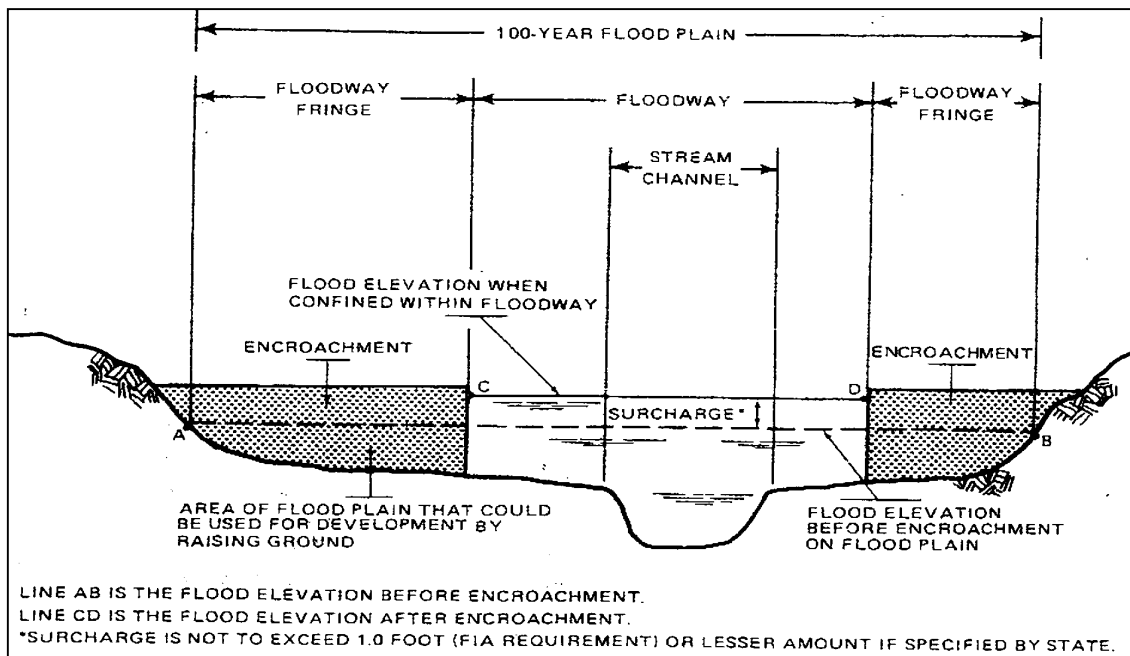
This diagram, which was published in a FEMA Flood Insurance Study demonstrates the theory of encroachment on a 100-year flood plain.

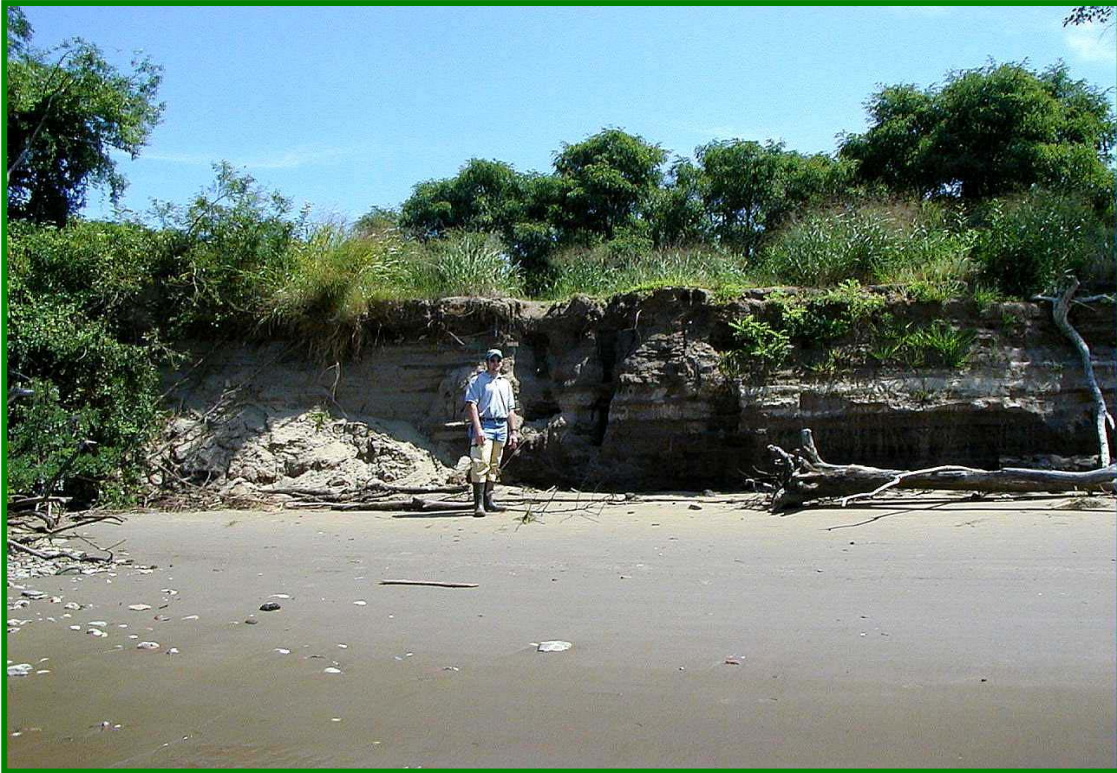
The height of the cliffs at Hawk Island are greater than six feet tall.

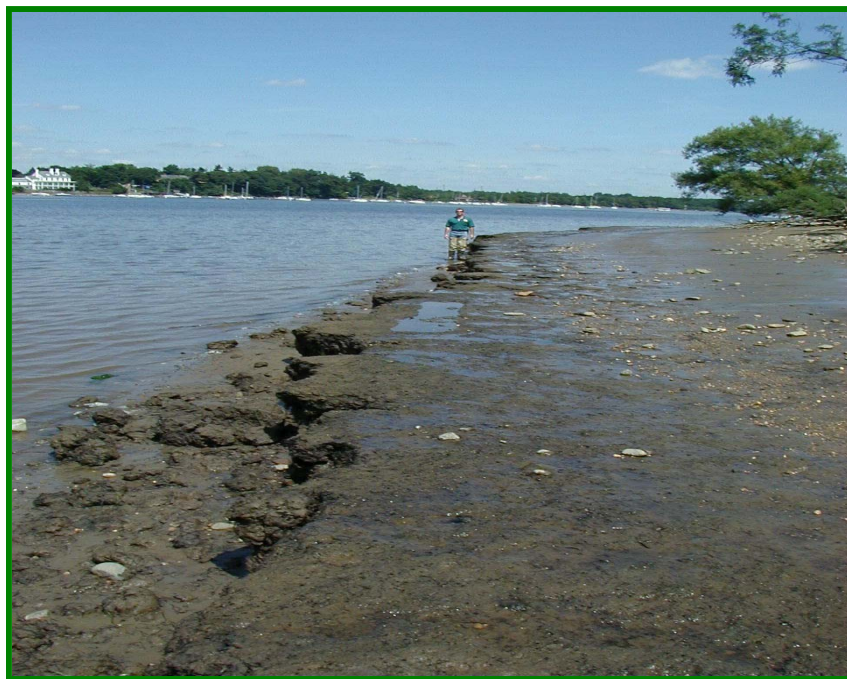
This particular section of shoreline that faces Pennsylvania illustrates the shoreline erosion existing around Hawk Island.

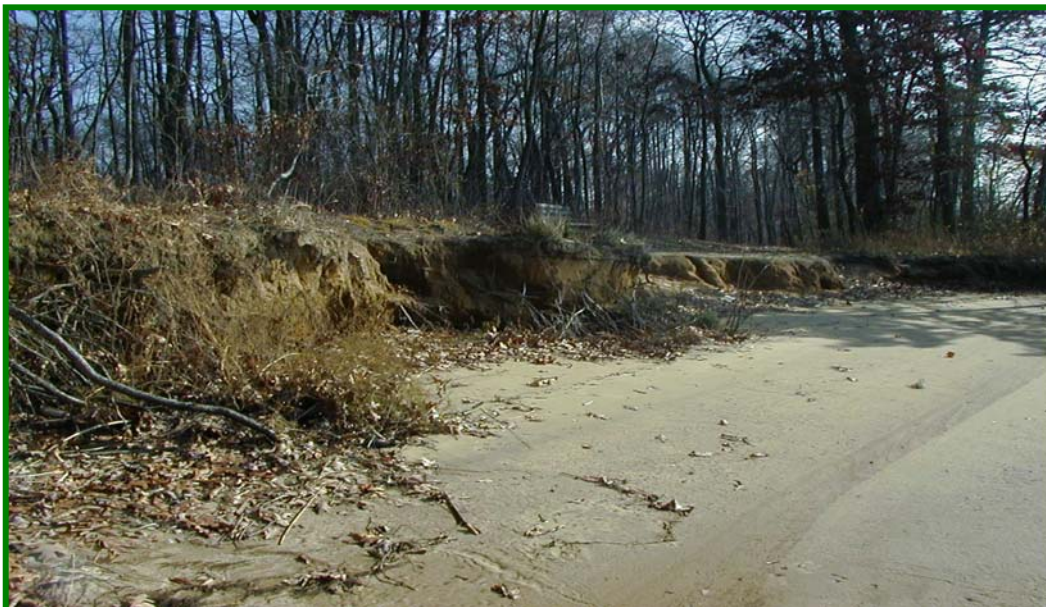
Poorly vegetated slopes in conjunction with foot traffic, tidal effects, and overland runoff contribute to the eroded nature of this site.

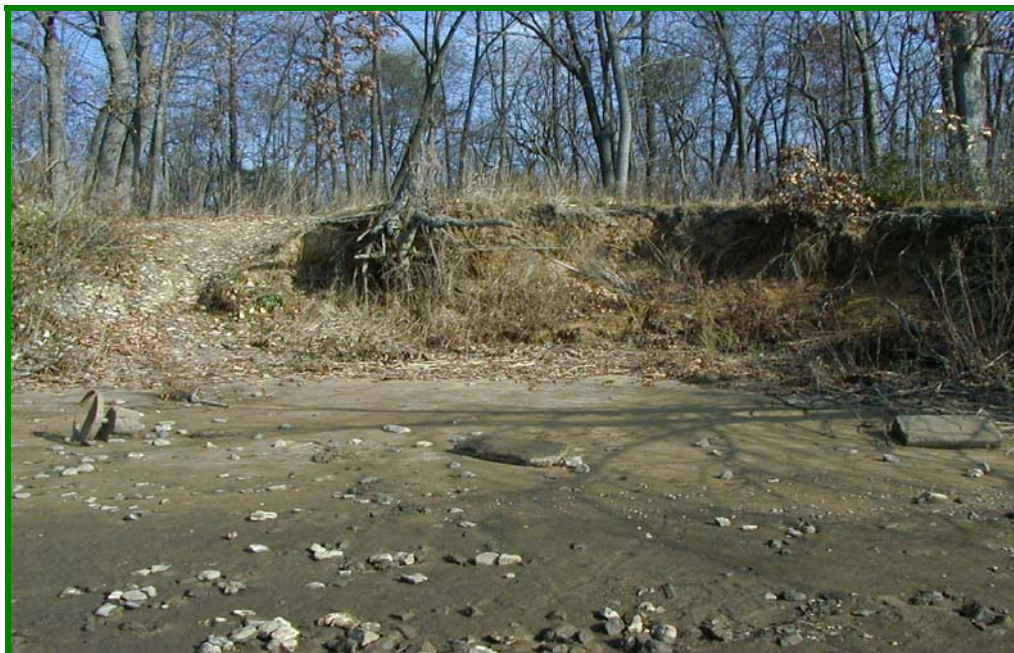
Implementing stabilization methods on this slope would prevent additional erosion.

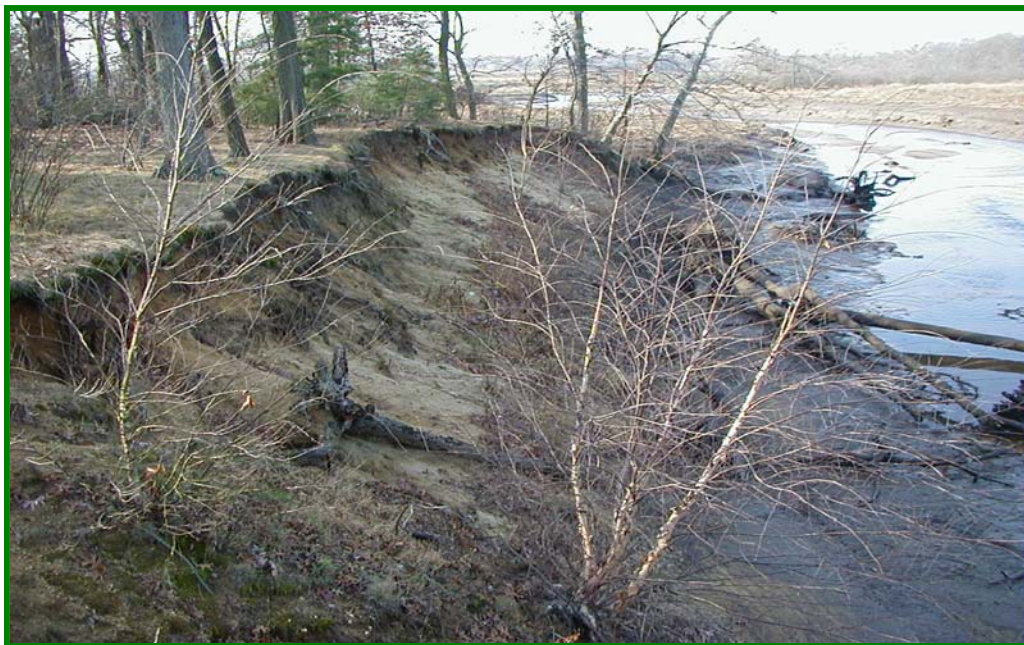
Sandy soils, poor vegetation, and upper bank failure has resulted in a significant eroded area at this location.

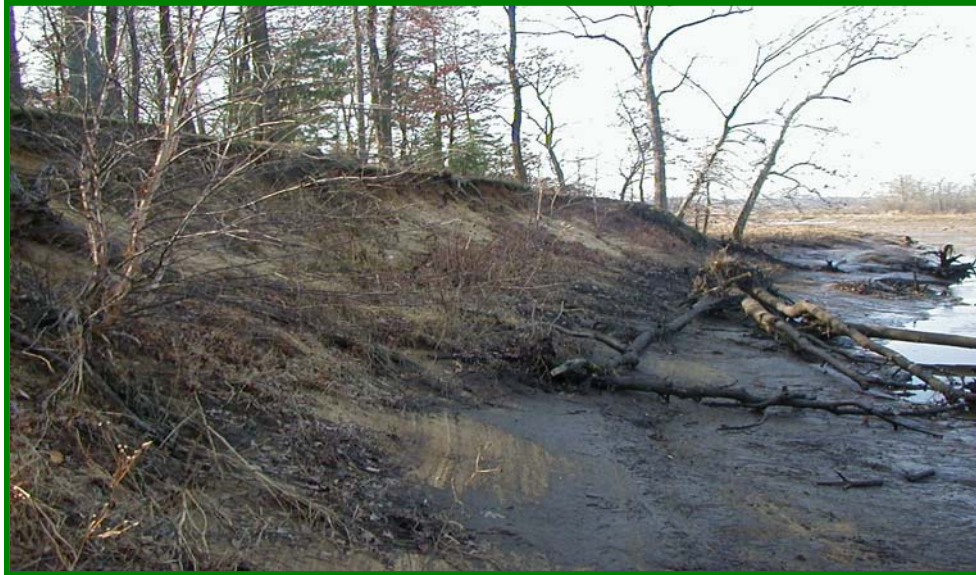
Many trees litter the shoreline at this site.

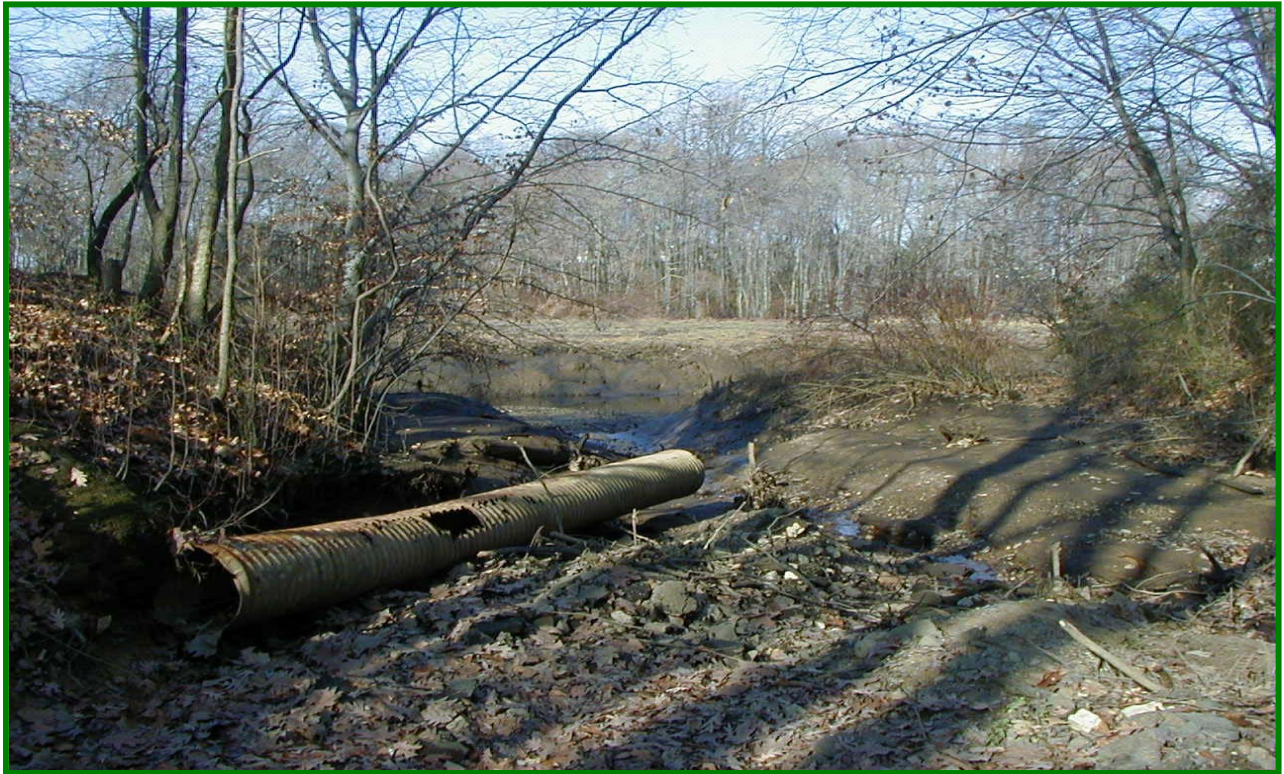
This pipe first drew the attention of staff to investigate this location further.

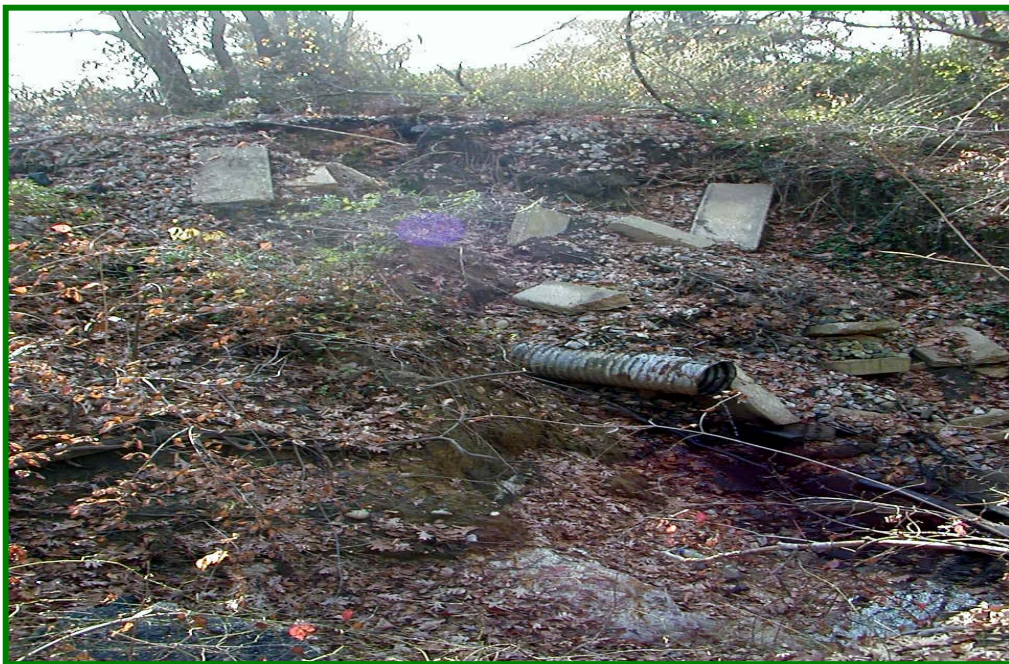
This exposed pipe has contributed to a severely eroded condition in a nearby wooded area.

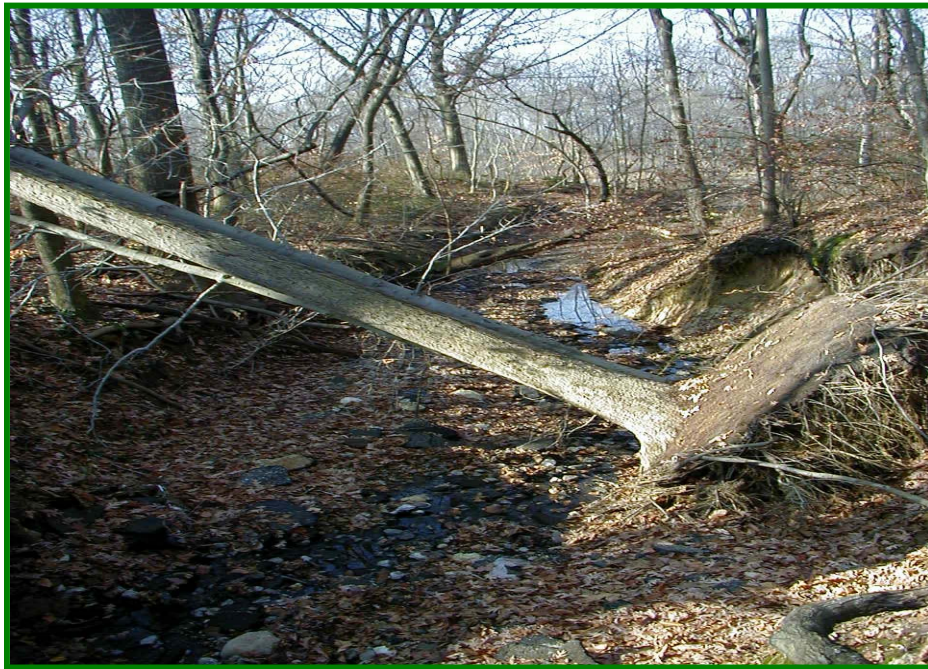
Severe erosion in the gully has compromised several trees in this wooded area.

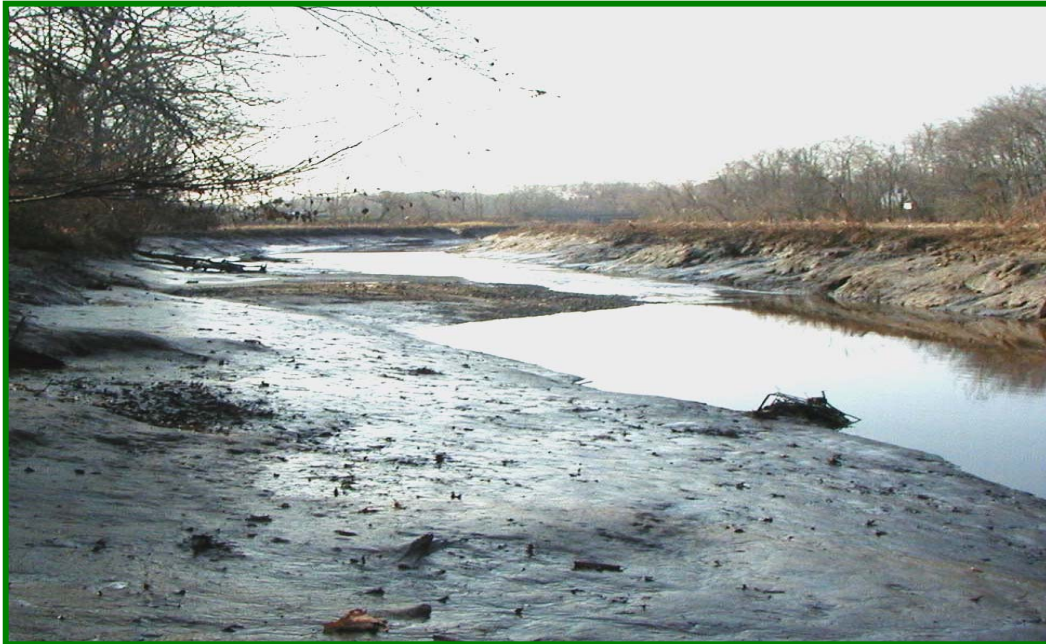
Increased sediment in the waterway in conjunction with low tide, makes this section of Mill Creek extremely difficult to navigate.

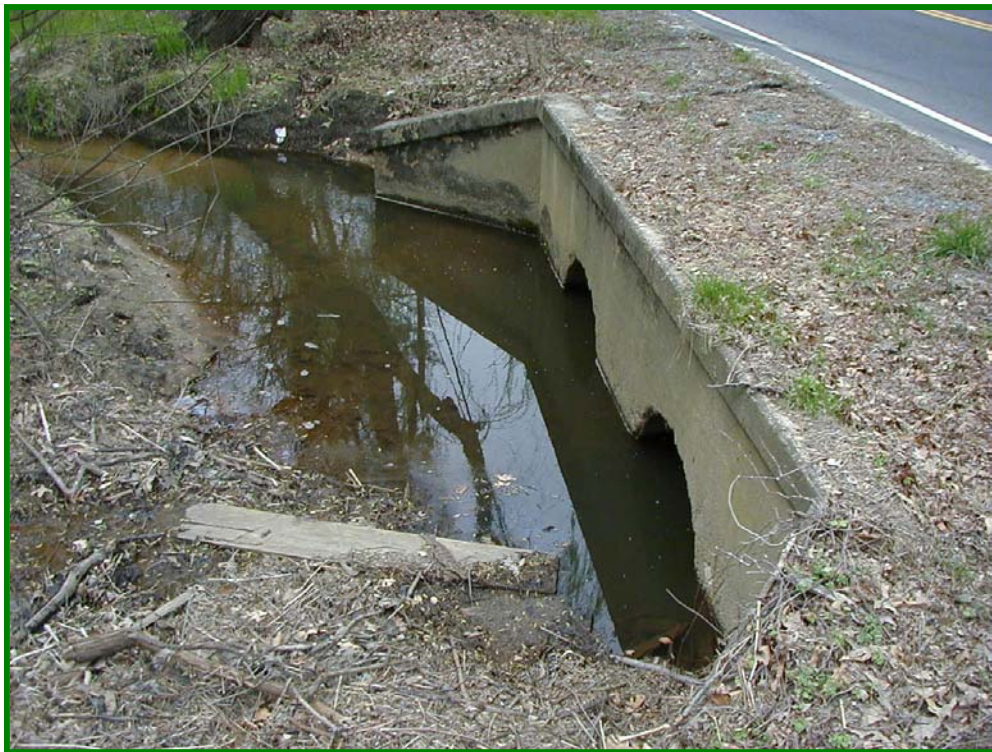
This culvert is blocked with sediment and other debris creating a flooding problem during times of heavy rainfall.

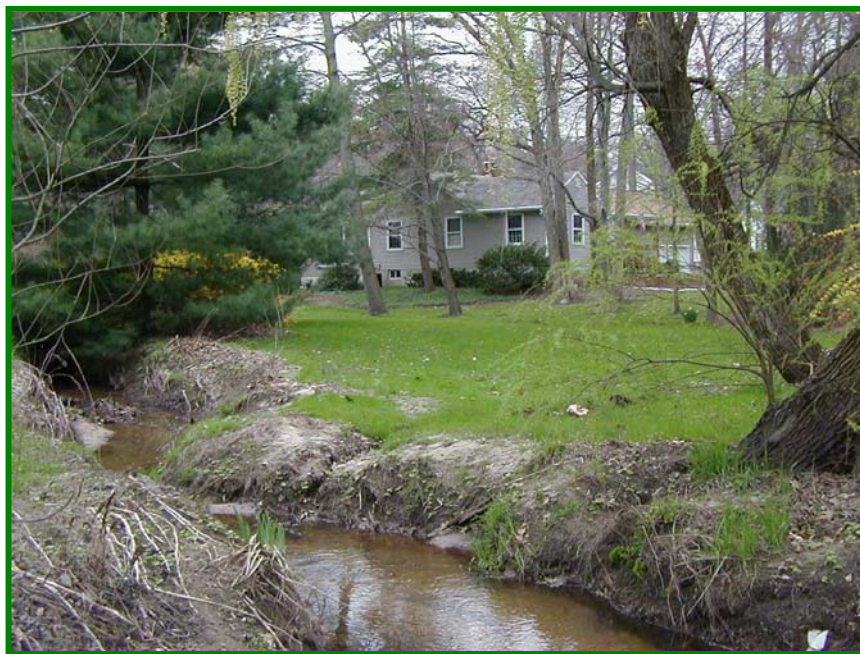
The bare condition of the adjacent streambank is clearly seen.

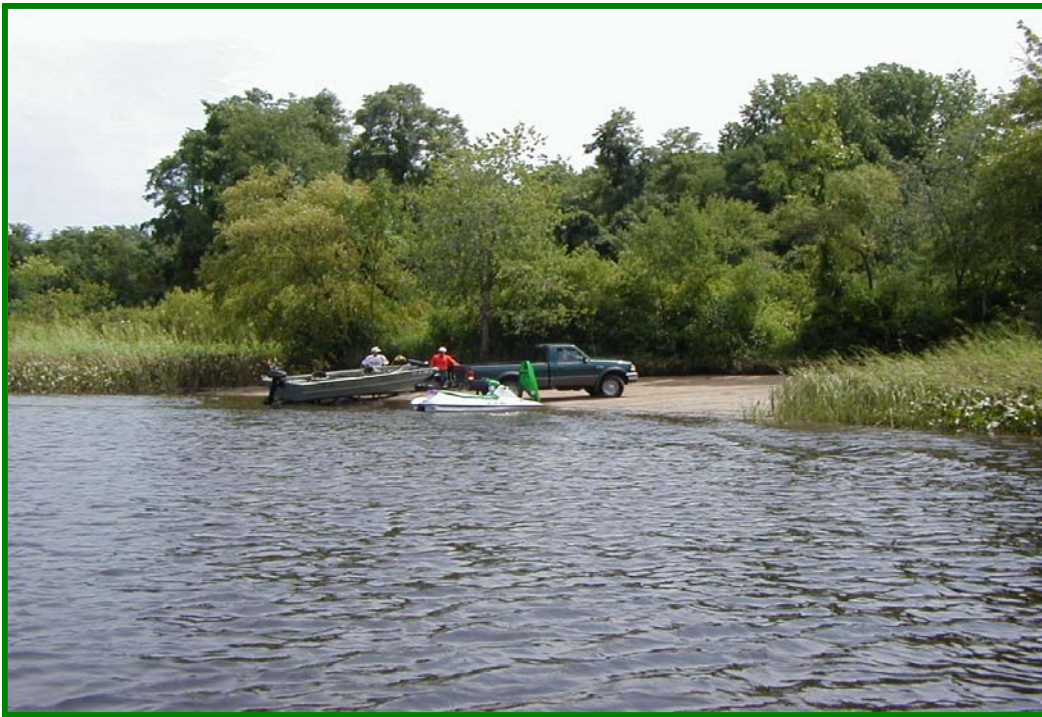
This site is a popular location for the launching and removal of recreational watercraft from Rancocas Creek.

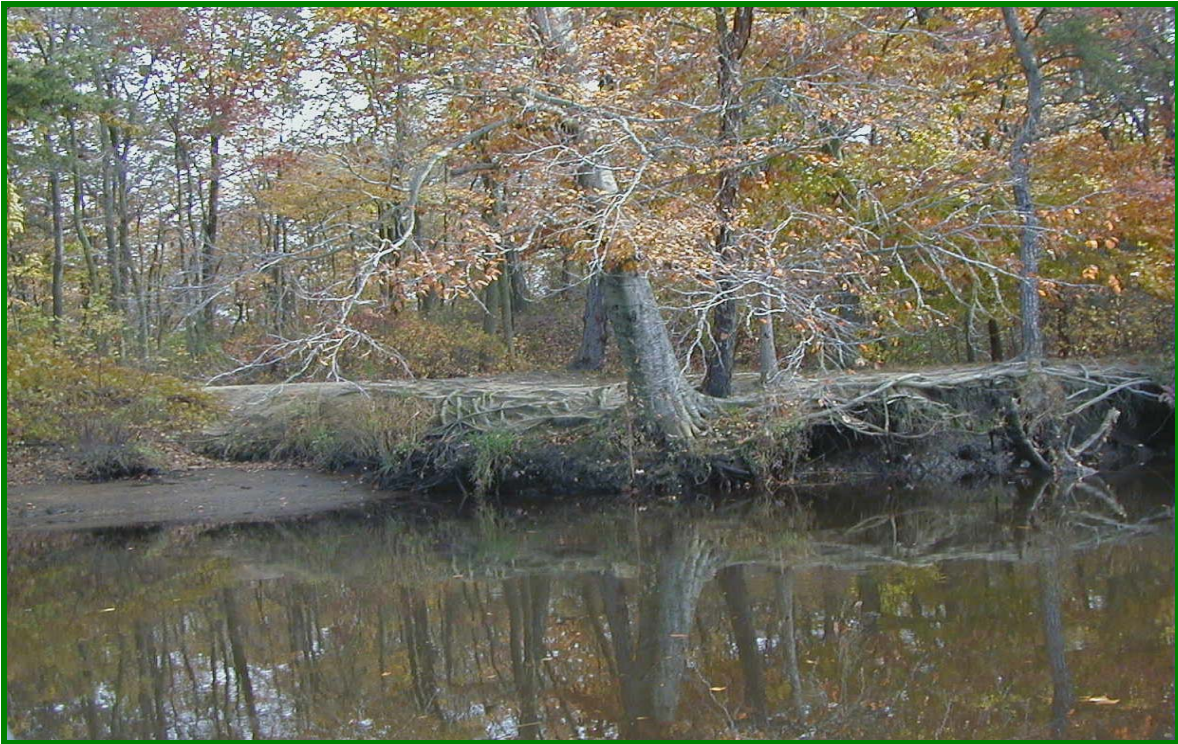
Tidal effects has caused moderate undercutting of the streambank and has compromised the stability of nearby trees.

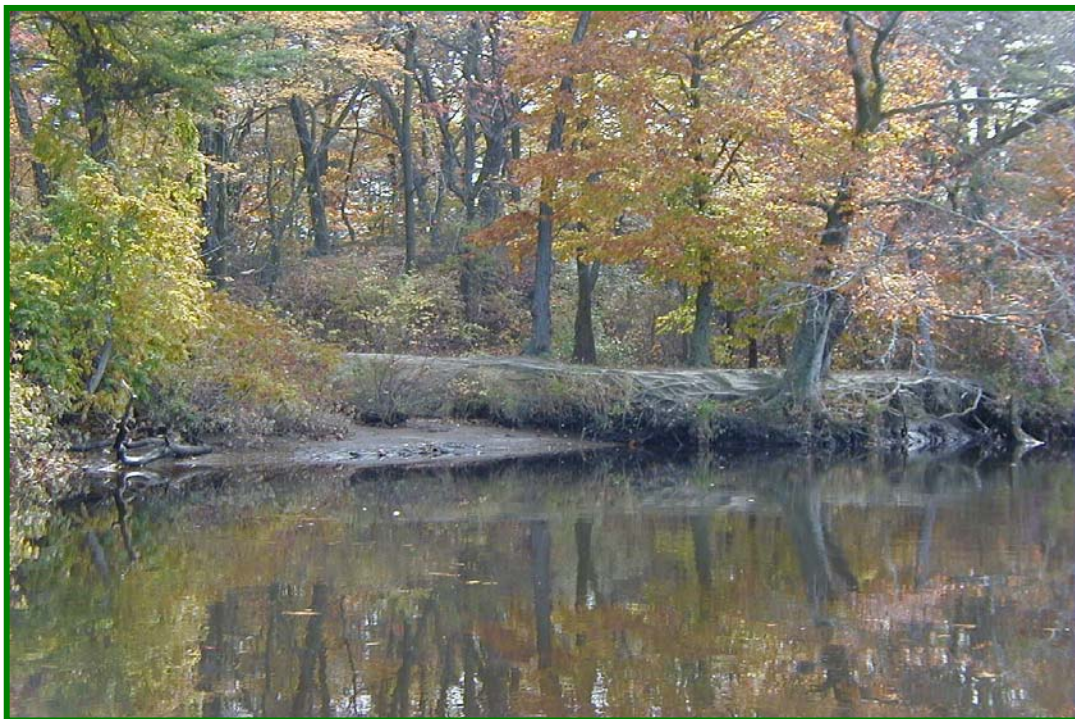
Heavy foot traffic and poor vegetation of the area contributes to enhance the effects of erosion at this site.

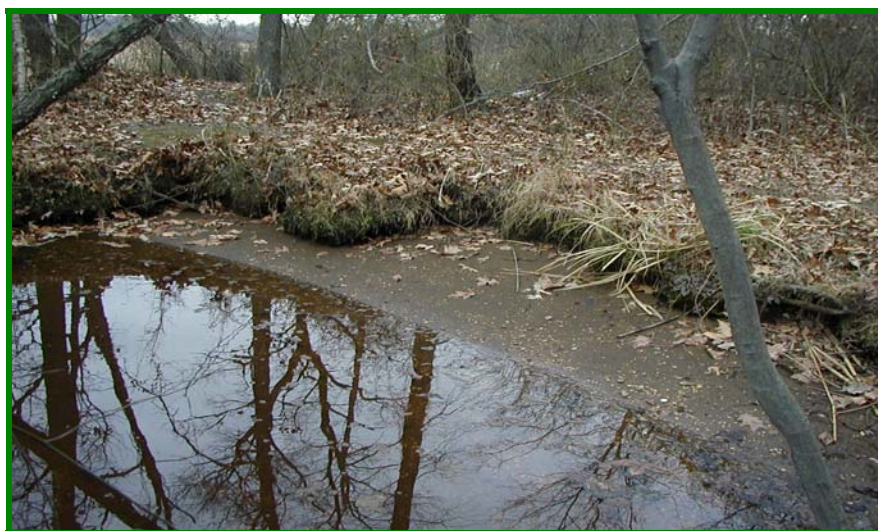
Tidal effects and the current have contributed to the erosion occurring along shoreline.

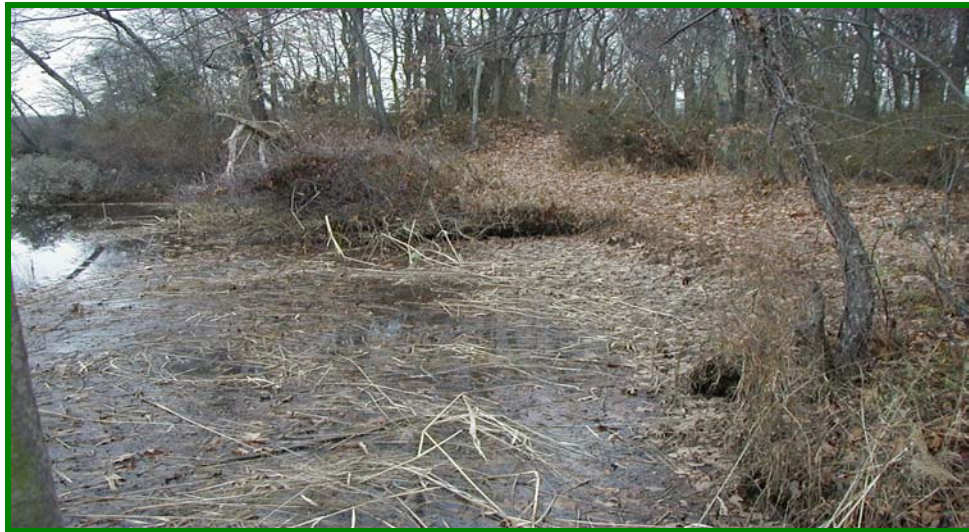
Overland runoff also contributes to the erosive conditions.

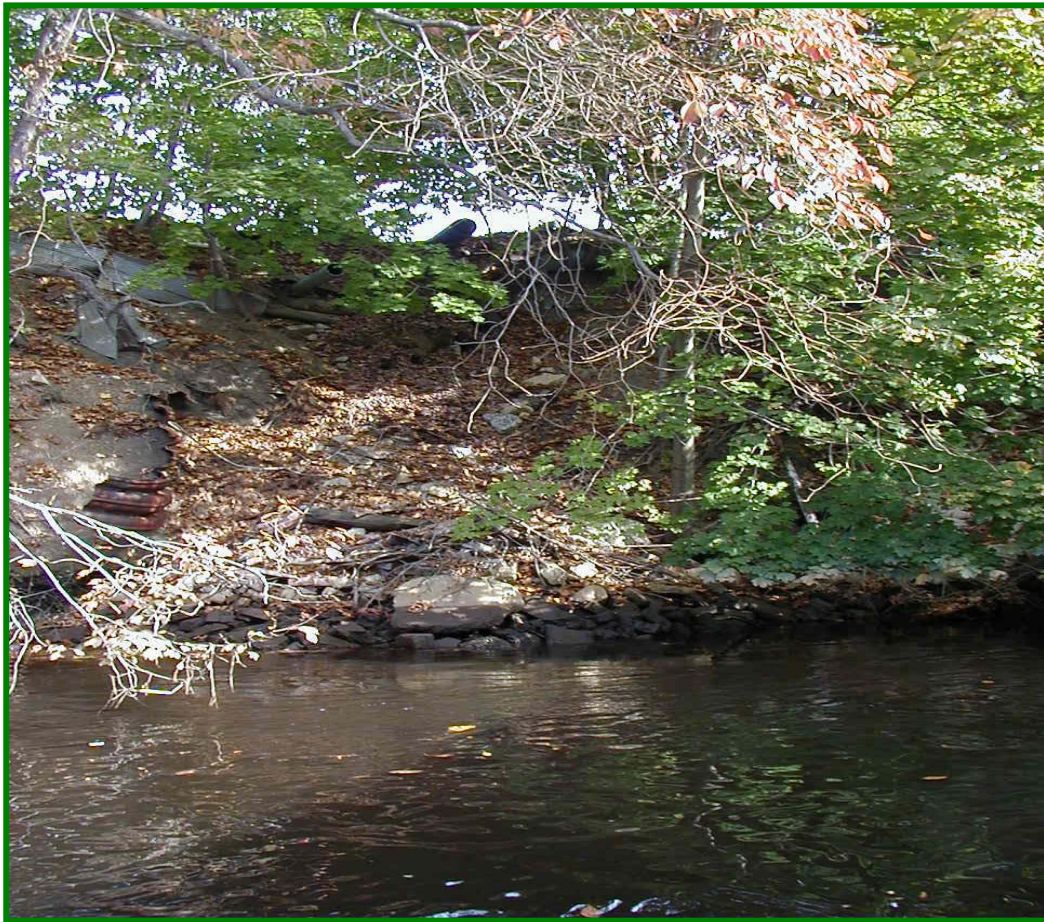
Improper installation of outfall pipes has resulted in the undermining of this slope.

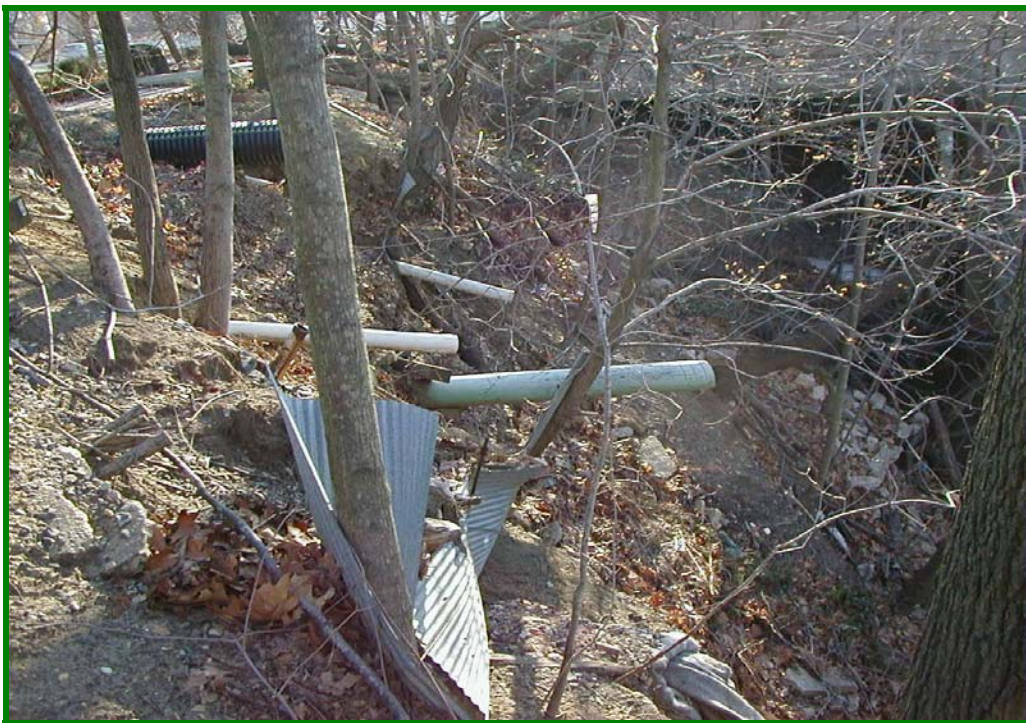
A multitude of protruding pipes and the failing condition of the slope can be easily seen in this photo.

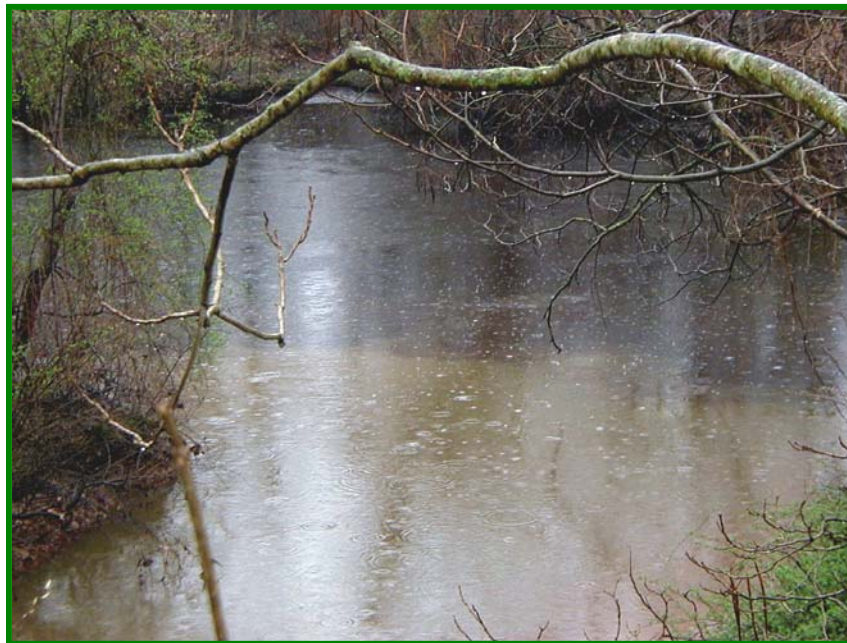
The meeting of these two bodies of water can be clearly seen.

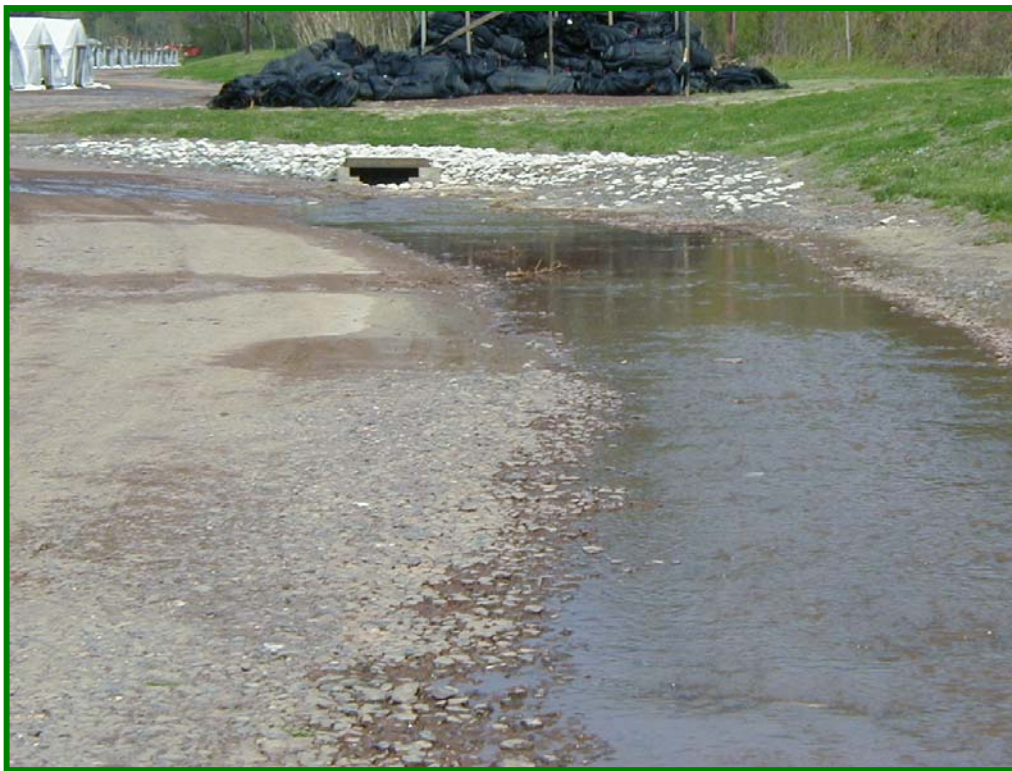
This agricultural operation is designed to channel excess water to specific, low-lying areas.

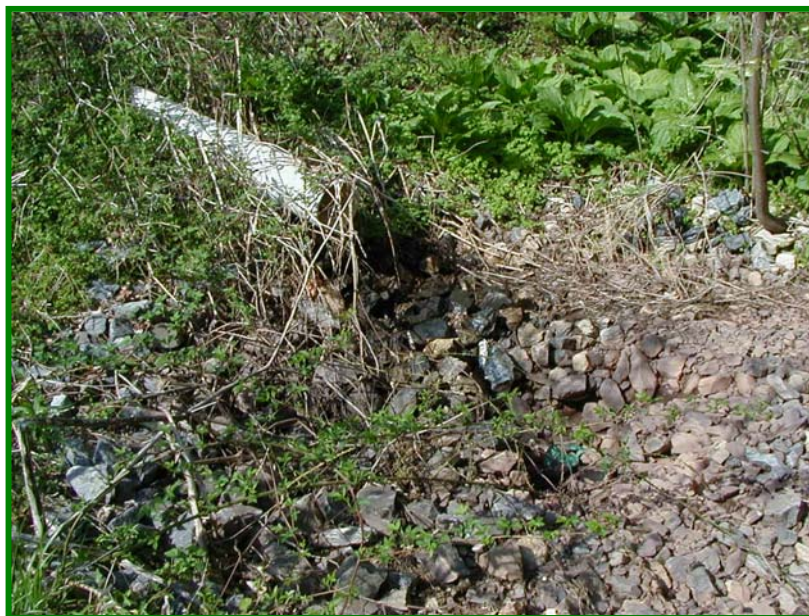
This outlet discharges to an inadequately stabilized area at the top of a slope.

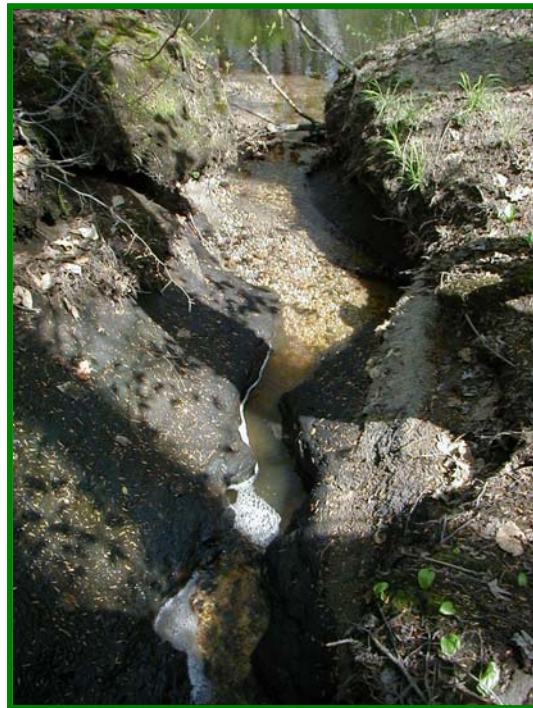
This is the end of one of the gullies.

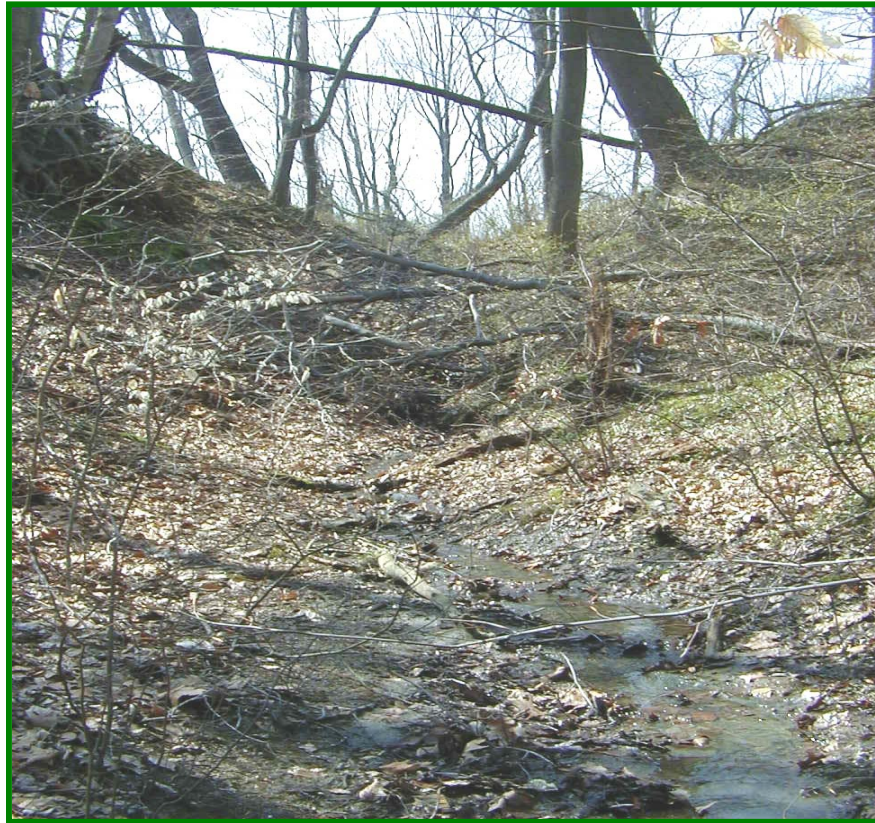
This gully has been formed as a result of overland runoff from an adjacent farm field.

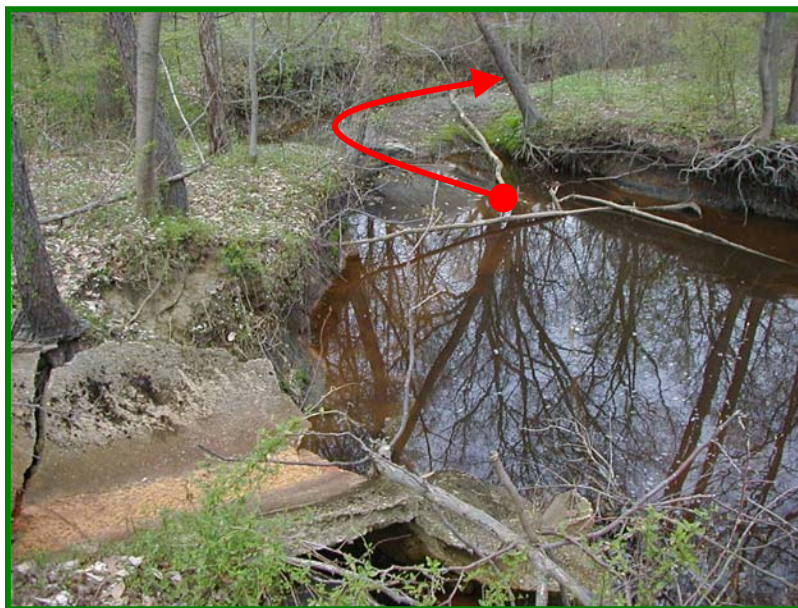
The eroded nature of the feeder stream can be easily seen in this photo.

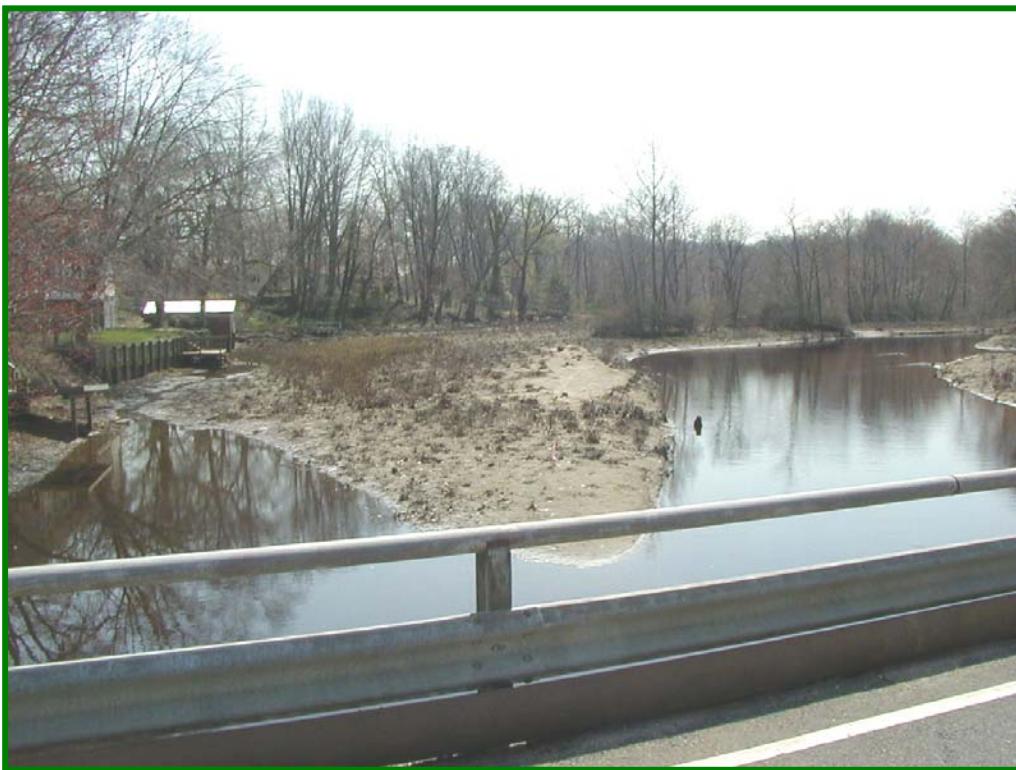
A sediment pad can be easily observed from Church Road in Medford Township.

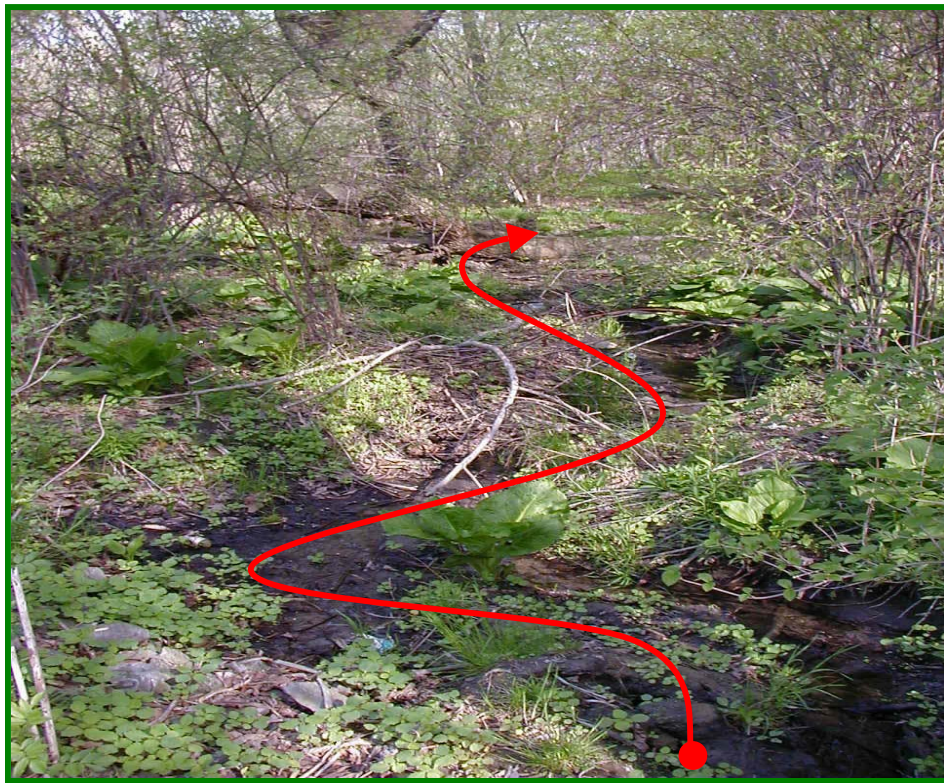
A feeder stream such as this can facilitate the transportation of silt to a large water body, as well as cause eroding conditions in other parts of the watershed.
