Prioritization of Potential Streambank Stabilization and Habitat Restoration Projects in the Rancocas Creek Watershed

A scenic view of the South Branch Rancocas Creek.

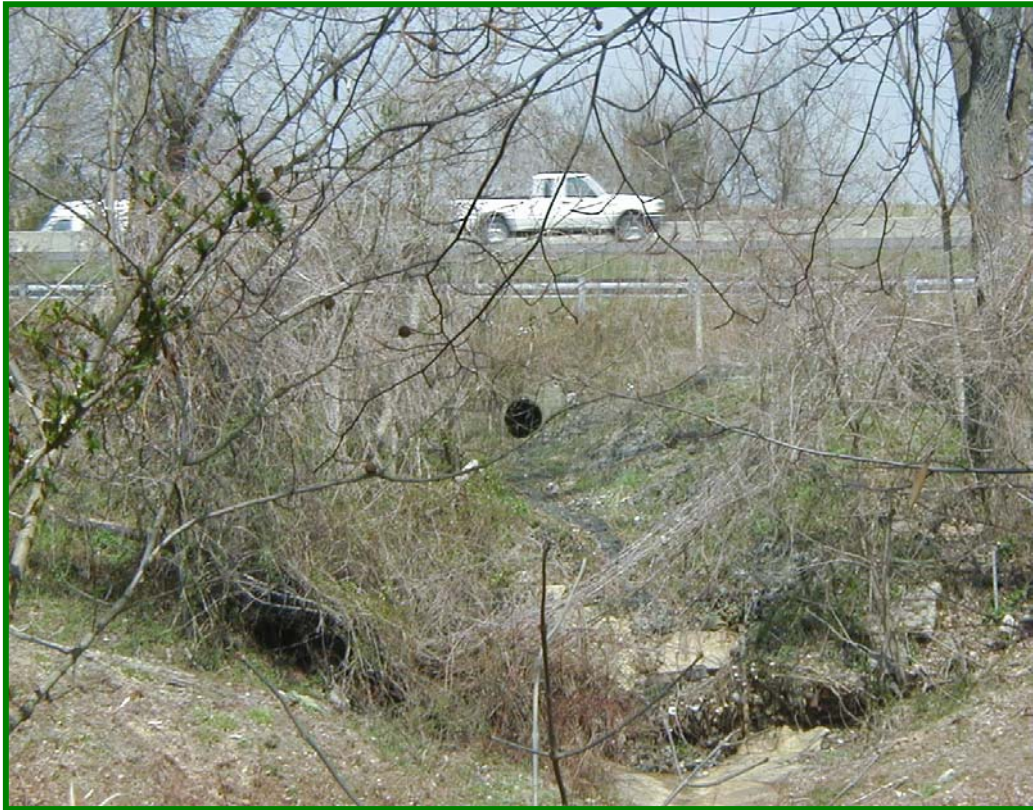
This drainage pipe allows concentrated stormwater flows to leave the New Jersey Turnpike and create offsite erosive conditions.

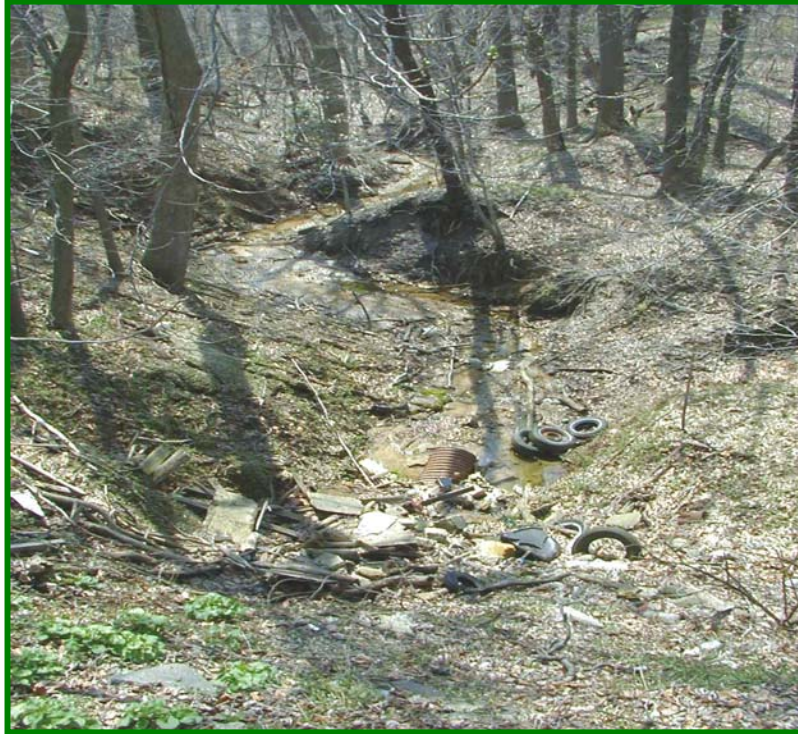
Due to the site's proximity to the Turnpike, this ravine plays host to a great deal of litter and debris such as car tires.

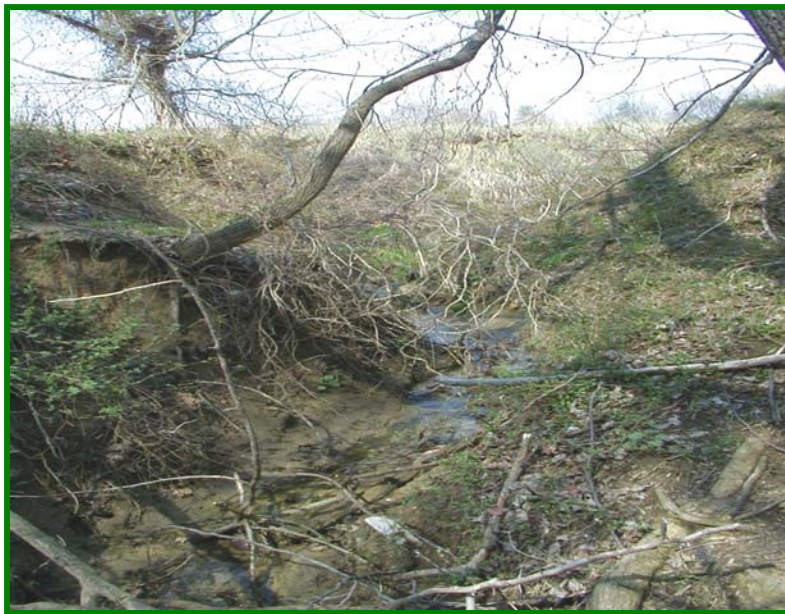
This is the beginning of the larger gully after the emergence of the two upland gullies.

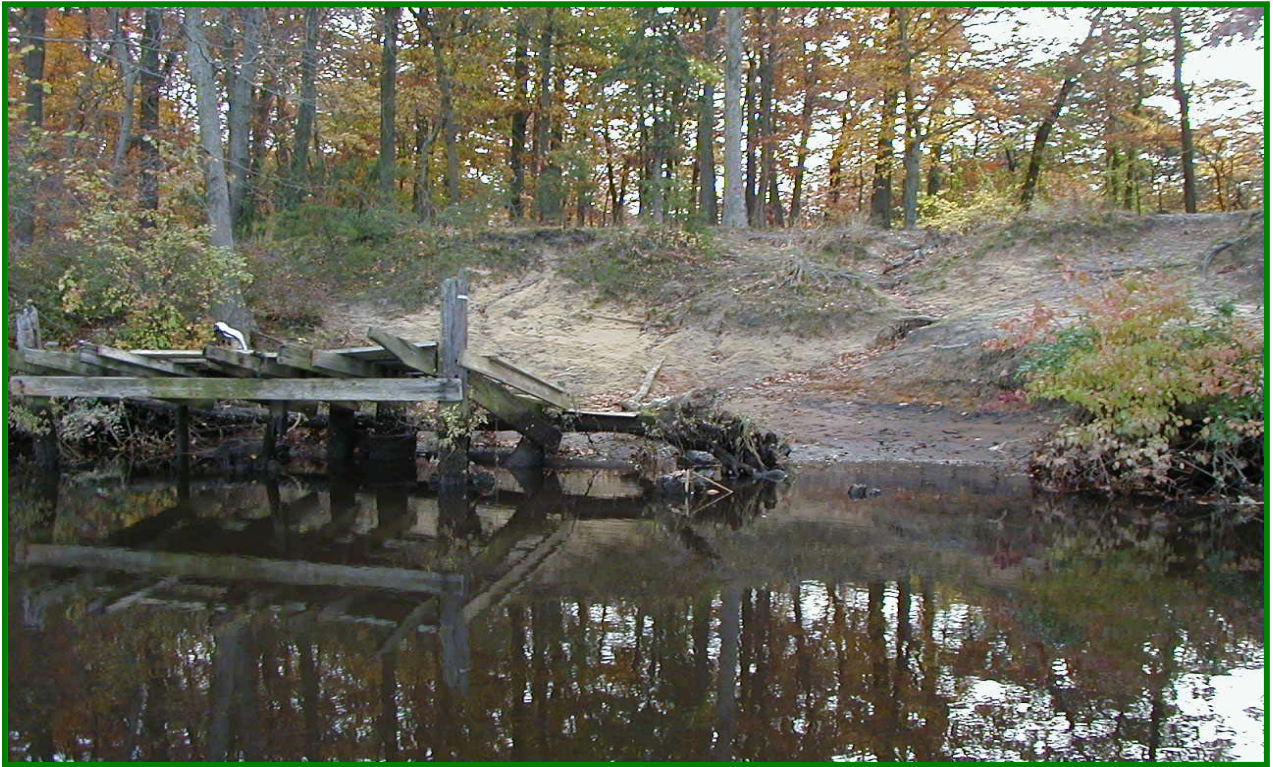
This old, decrepit dock indicates that this site used to be a very popular recreation area.

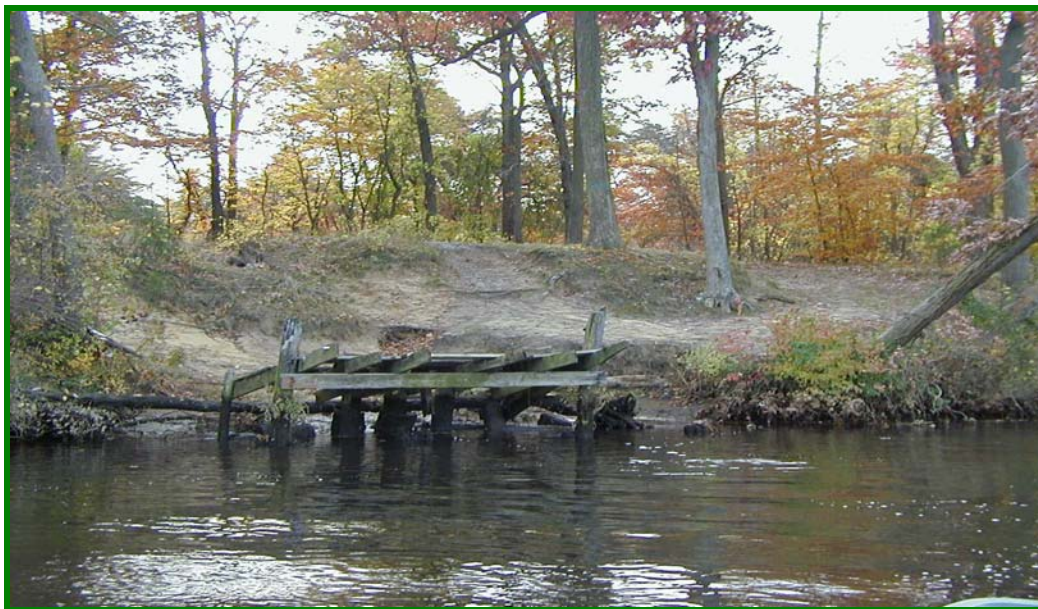
The fluctuating tide, exposed slopes and high usage all contribute to the erosive conditions that exist at this site.

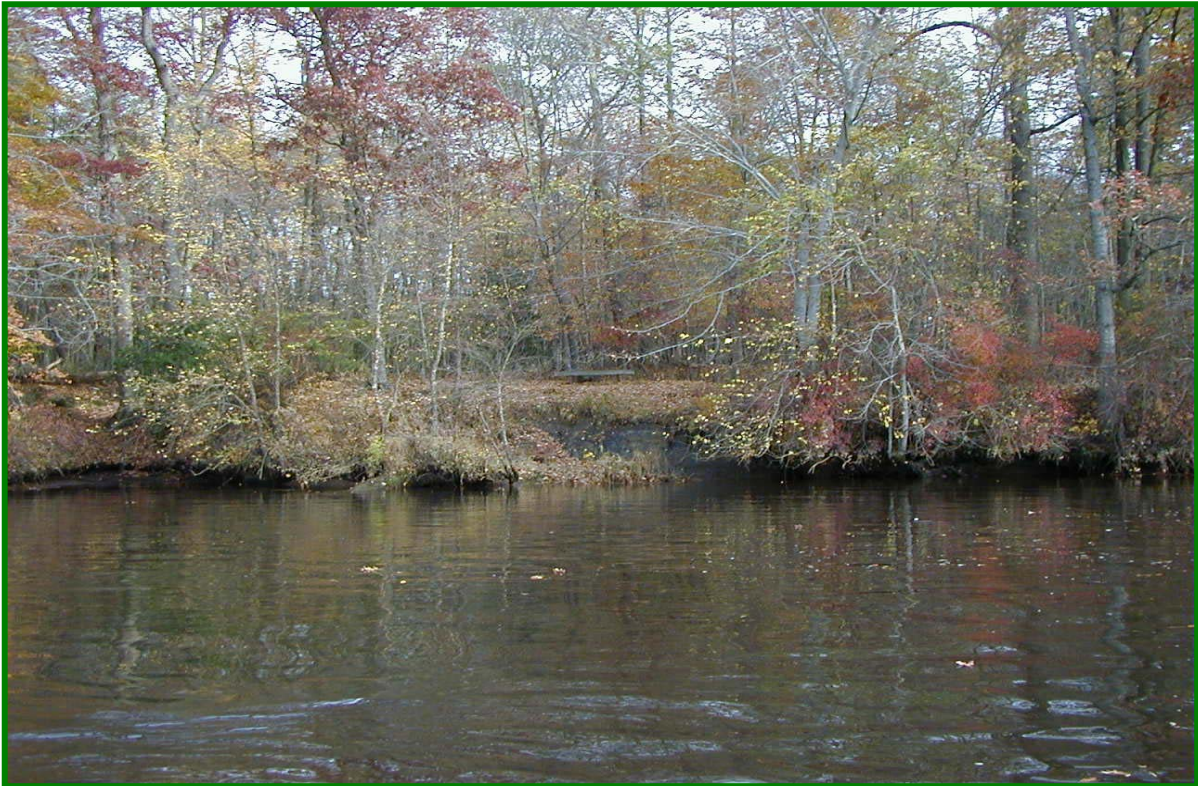
Along the shorelines of the Rankokus Indian Reservation eroded slopes can be easily seen.

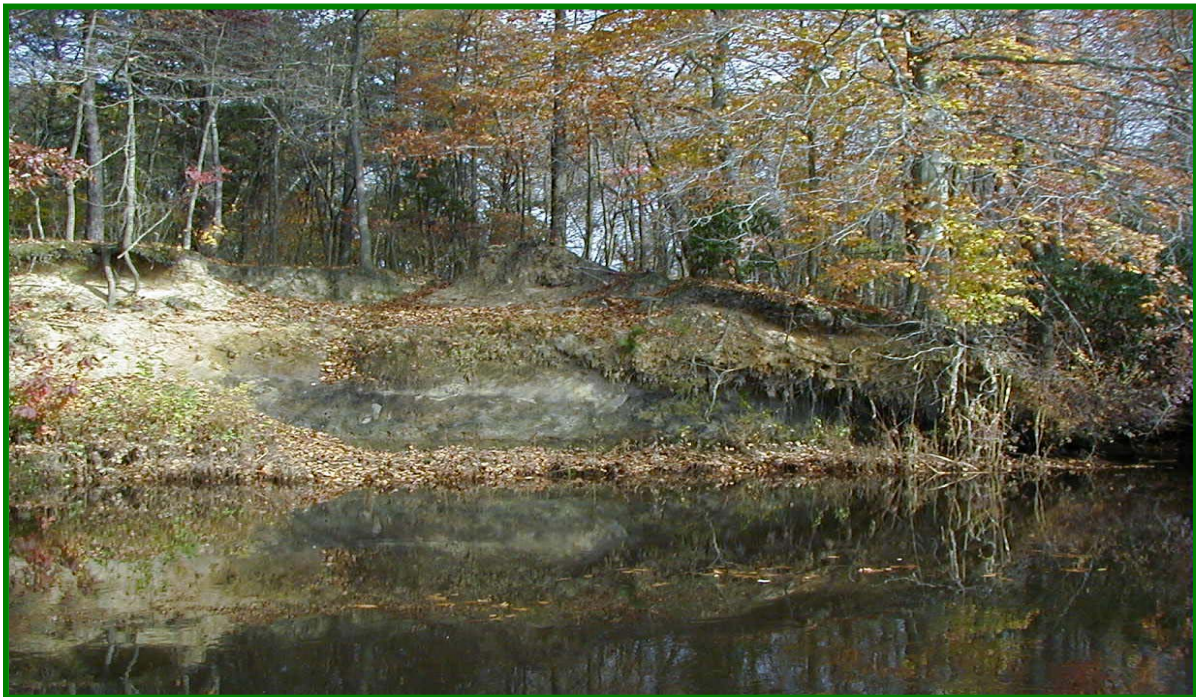
The nature trails, as well as, the sheer cliffs and exposed tree roots that are present at this site can be easily seen in this photograph.

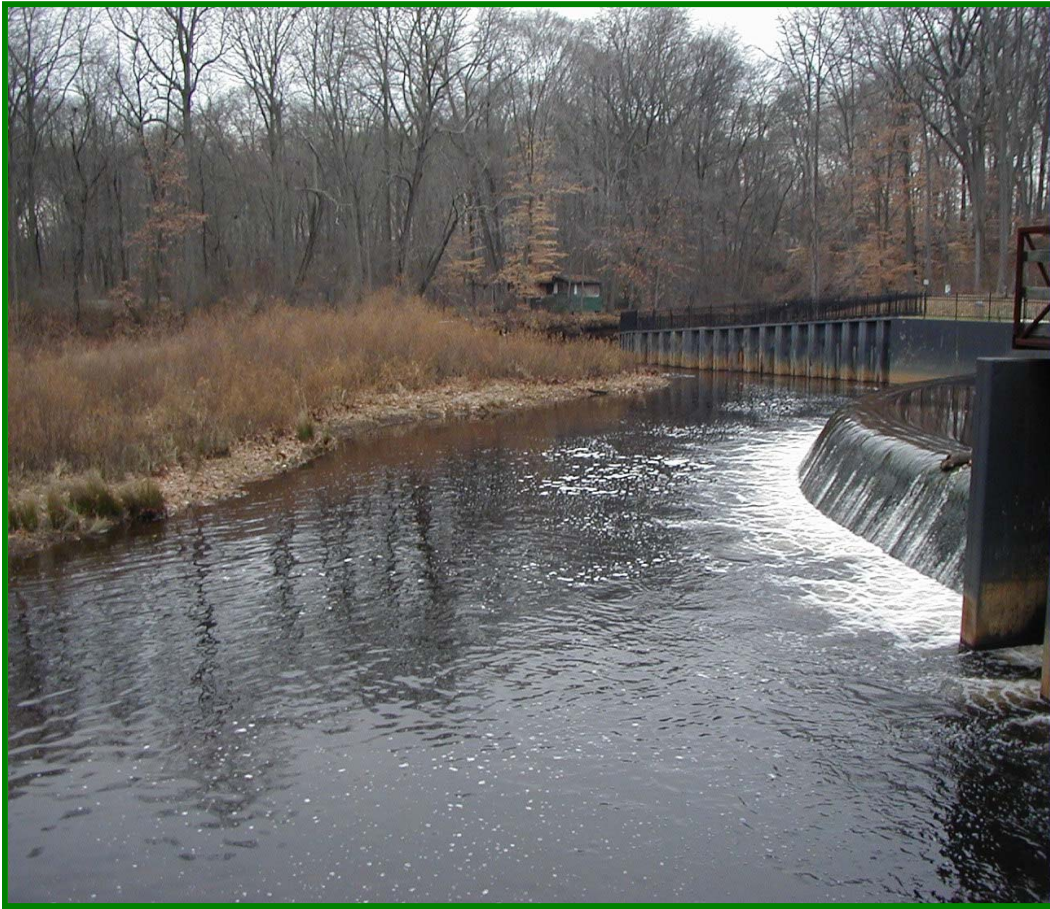
The Smithville Dam is nestled within a diverse and historical environment.

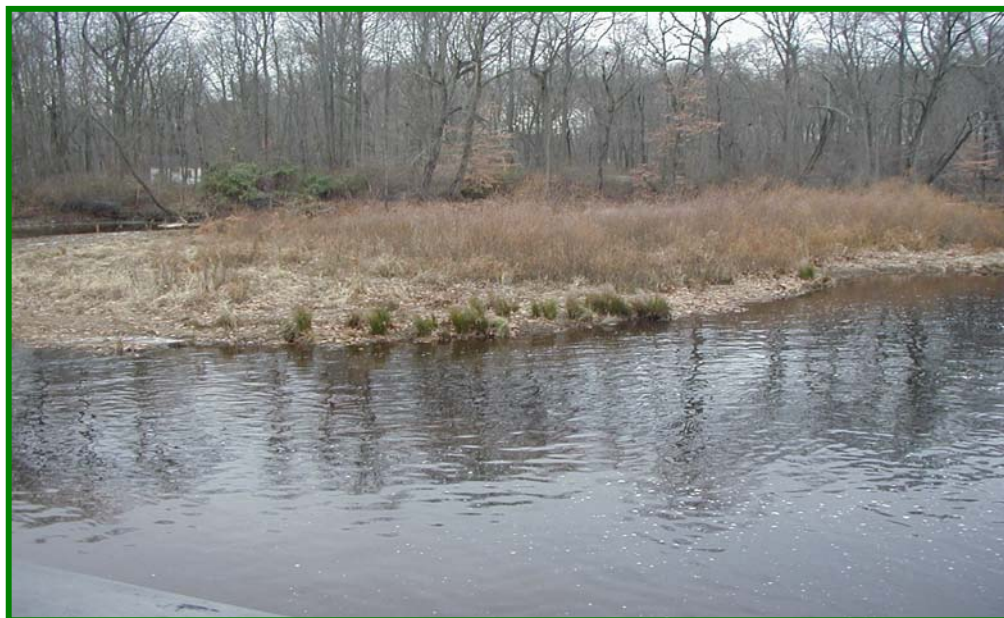
This sediment bar, although well vegetated with a variety of native plant species, has altered the stream flow on the North Branch.

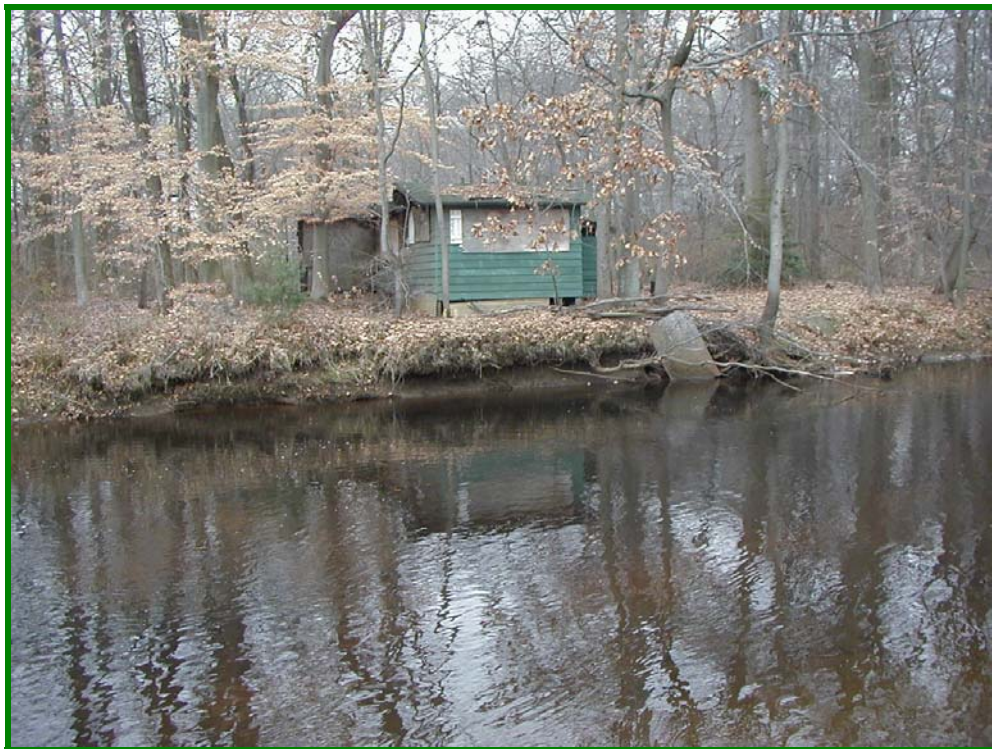
Sections of shoreline at this location have been undercut as a result of stream flow and the gradually changing course of the creek.

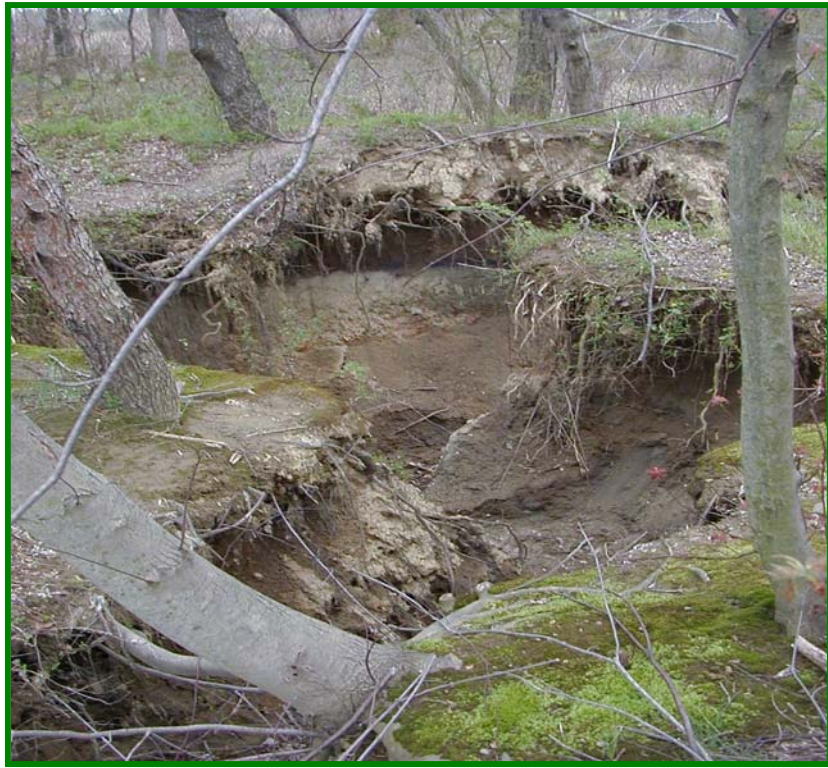
This ravine is compromising trees and affecting the overall habitat of the area.

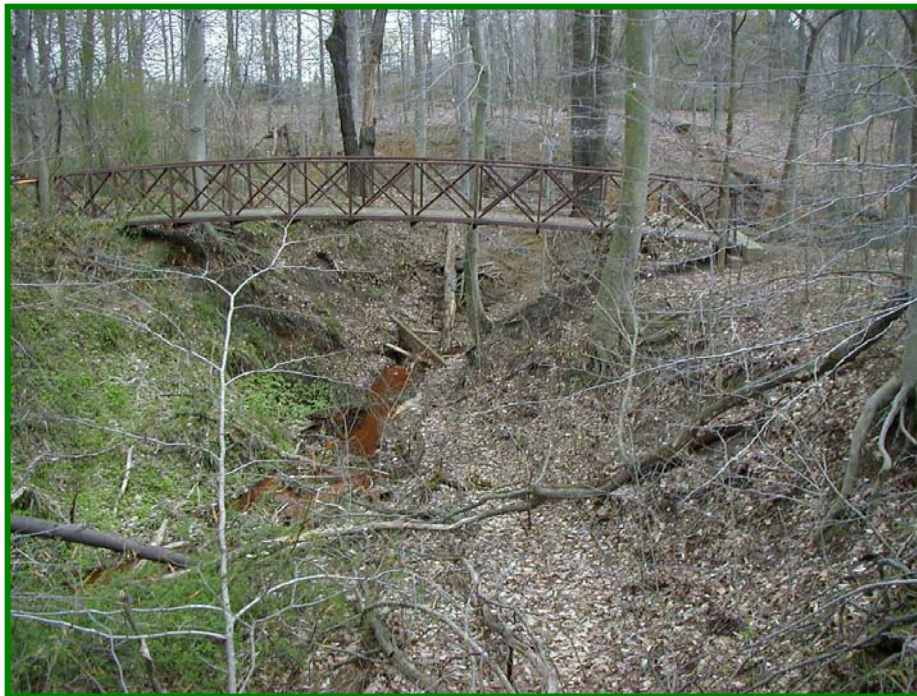
The stability of this footbridge has been compromised as the underlying ravine worsens due to the ongoing erosion.

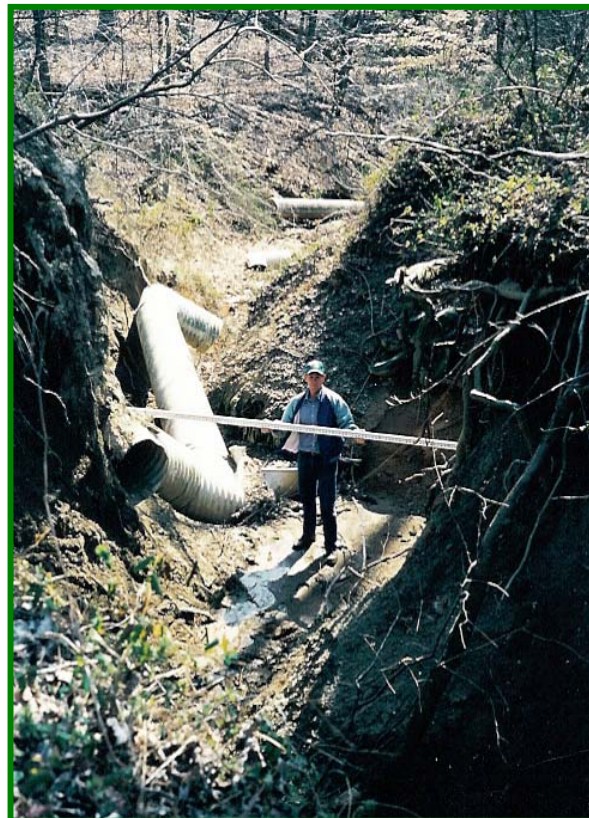
The severity of the ravine can be clearly evidenced in this photograph.

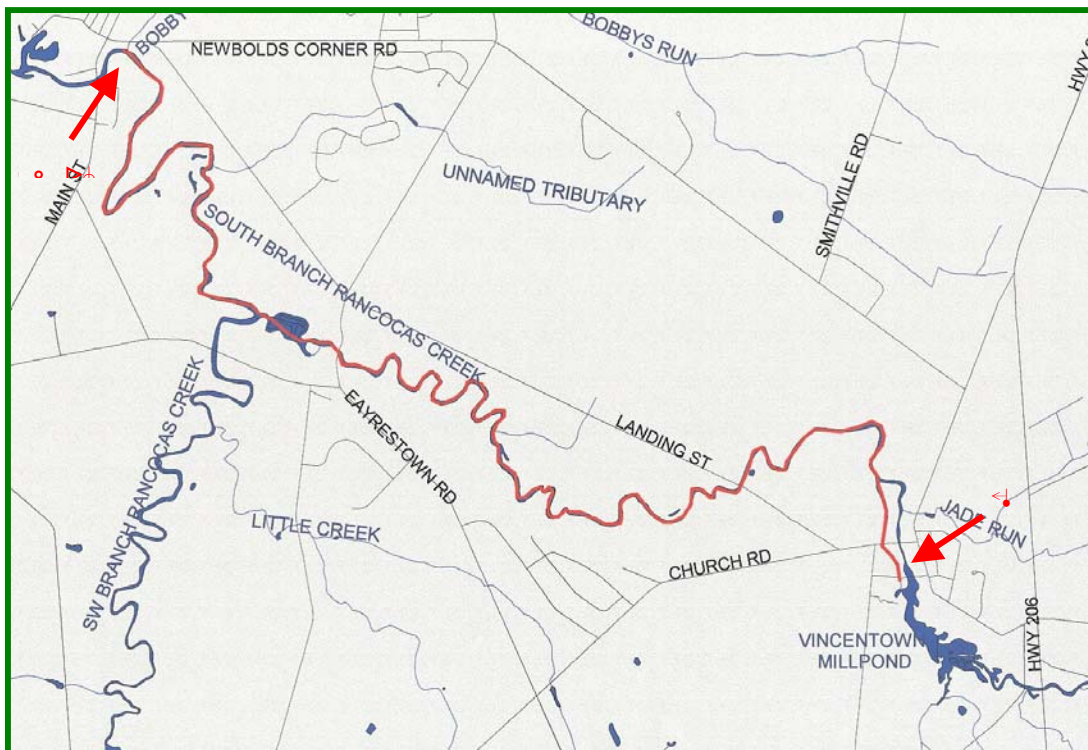
The banks of the South Branch suffered the same damage from agricultural tile drains that the North Branch had. One agricultural operation in particular was noted as having an outfall that discharged water from the top of a steep, once vegetated slope. The velocity of the water leaving

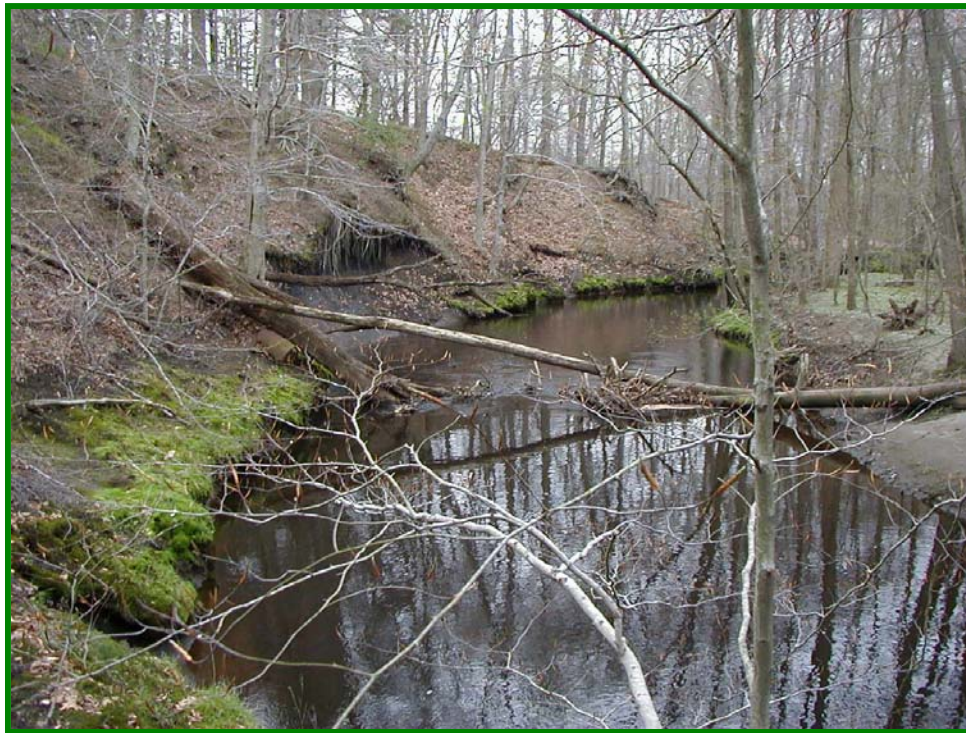
This photograph depicts only one of the many obstructions that can be found along the South Branch Rancocas Creek.

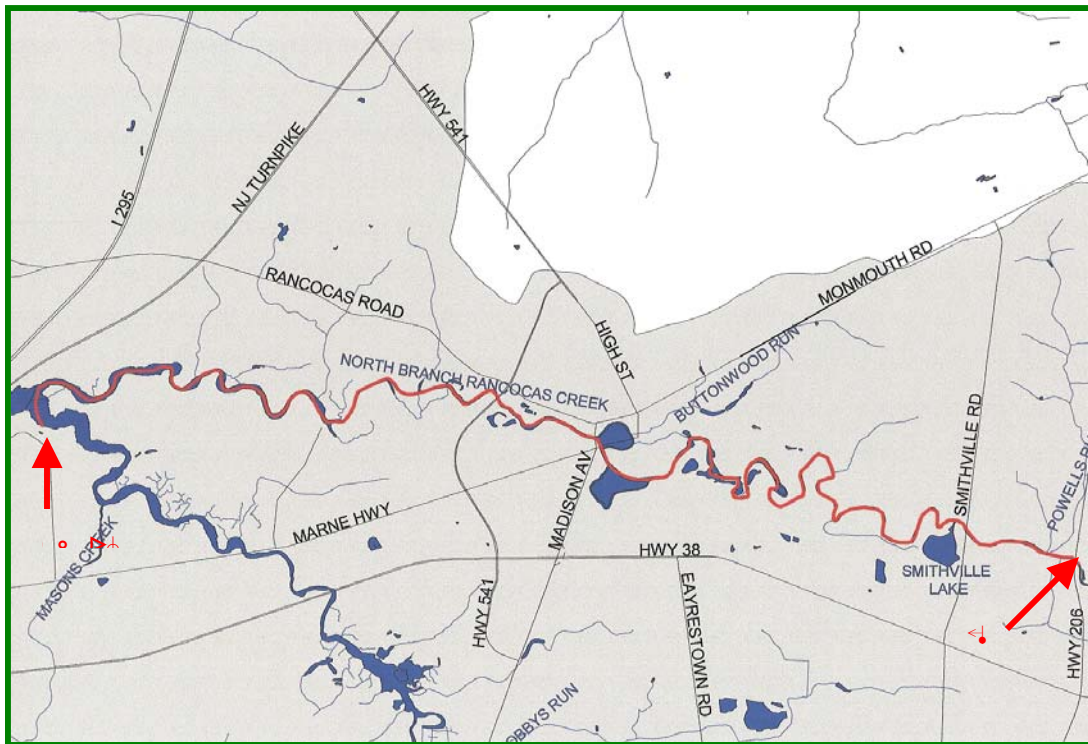
As it winds through Eastampton, there are numerous places that were noted to have erosion problems as a result of improperly installed agricultural drainage. Many outfalls from tile drains discharge at the top of the slope allowing occasional high velocities of water to concentrate over existing vegetation and soil, washing them away and creating gullies and bare slopes. In addition, many other tile drains are in a state of general disrepair that also creates eroded conditions within the watershed. Unfortunately, the District decided that there were too many instances along this section to inventory or GPS and would suggest that these issues be pursued with residents and farmers in an agricultural education outreach effort. Policy changes with

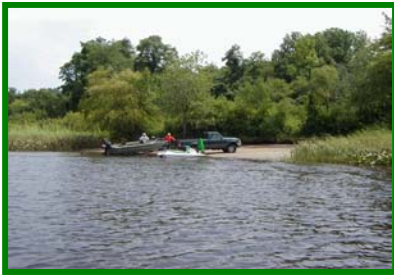
Site # 7: Rancocas Woods Public Boat Launch

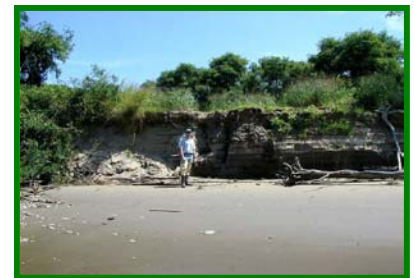
The Burlington County Office of Land Use Planning identified the island as an environmentally sensitive area, recommending that it be acquired and preserved for passive recreational uses. This site has not been used as a disposal area since 1988, and since that time, Hawk Island has developed a rich and diverse habitat, colonized by a wide variety of plants and animals.

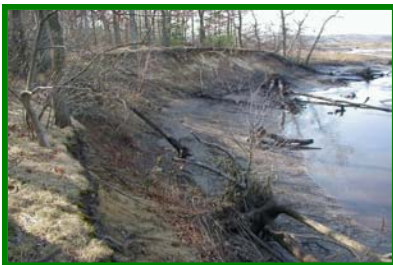
Site # 3: Mill Creek Park (Mill Creek side)

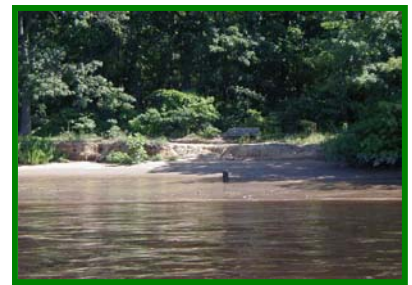
Benefits to remediating this site are numerous. First, the general public actively uses this site for a variety of recreational activities, making it highly visible from land as well as from the creek. Any proposed improvements would correct any hazardous issues that affect park visitors. This site also is an ideal location for the installation of a fishing pier or observation deck. This may draw in more visitors to the park and it could be worked in nicely if the adjoining nature trails were redesigned to become an eco-trail that would provide general information about the surrounding environment. Educational seminars could be performed to address environmental and watershed issues that would serve to increase the public's awareness of them. These general

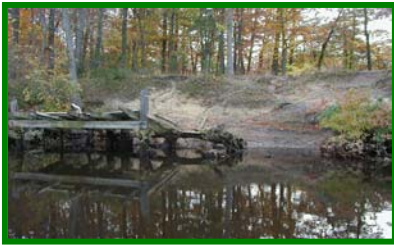
Site # 19: Rancocas State Park (old pier)

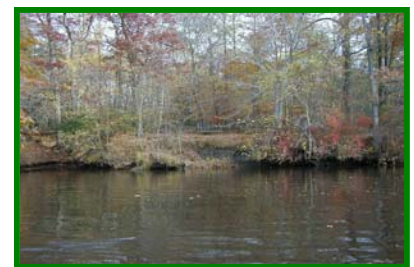
This location is a favorite spot for many recreation seekers because of the area's beauty and because of the diverse waterfowl and wildlife that inhabit the region. Easily noticed from the waterway in part because it can be found at a 90-degree bend in the

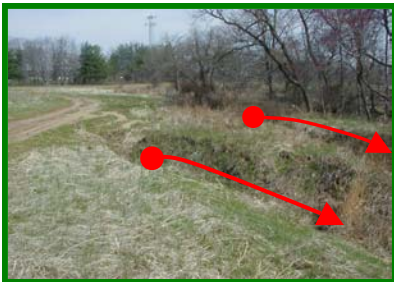
Site # 18: Rancocas State Park Farm Fields

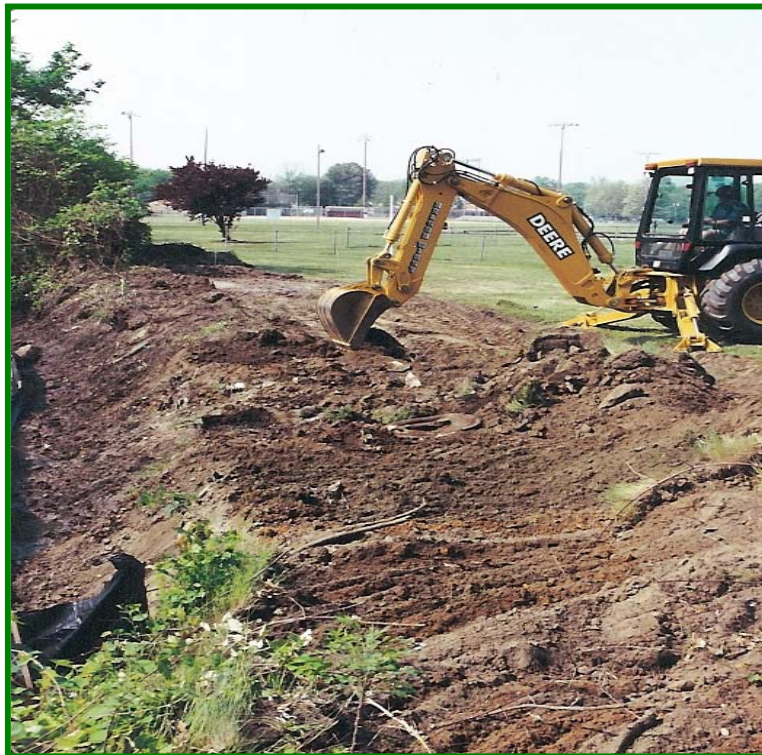
The excavation and re-shaping of the shoreline begins.

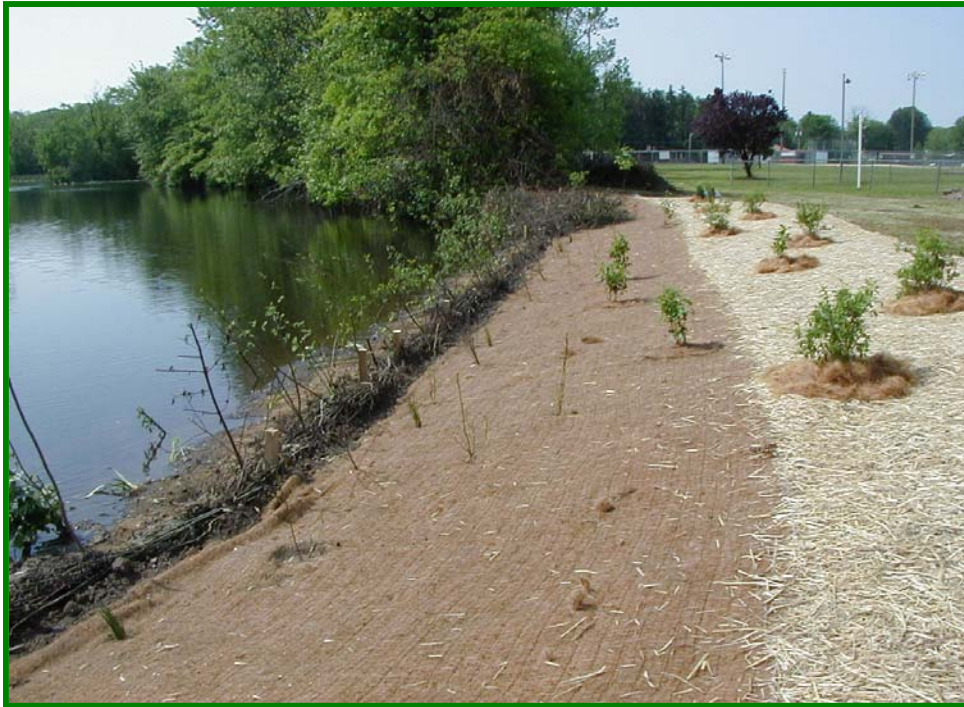
*The bioengineering methods have been installed, the site has been stabilized,
and all native vegetation has been planted.*

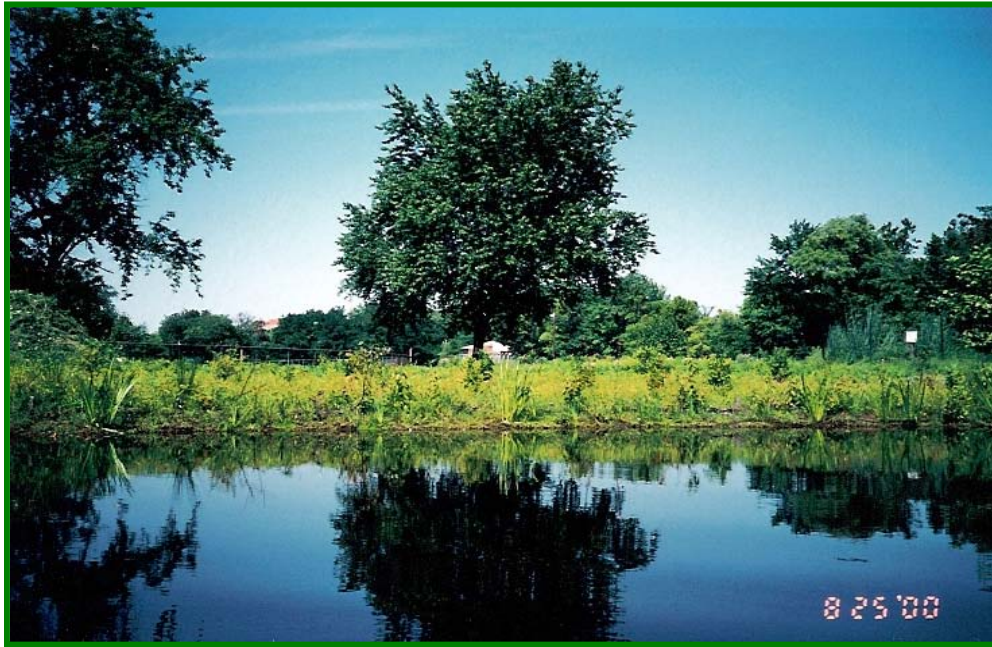
The project area can now be seen as a flourishing, well -vegetated area.
