### LACEY TOWNSHIP PARKS TREE INVENTORY AND EVALUATION

Project No. 92-172-09

September 1992

Revised December 1992

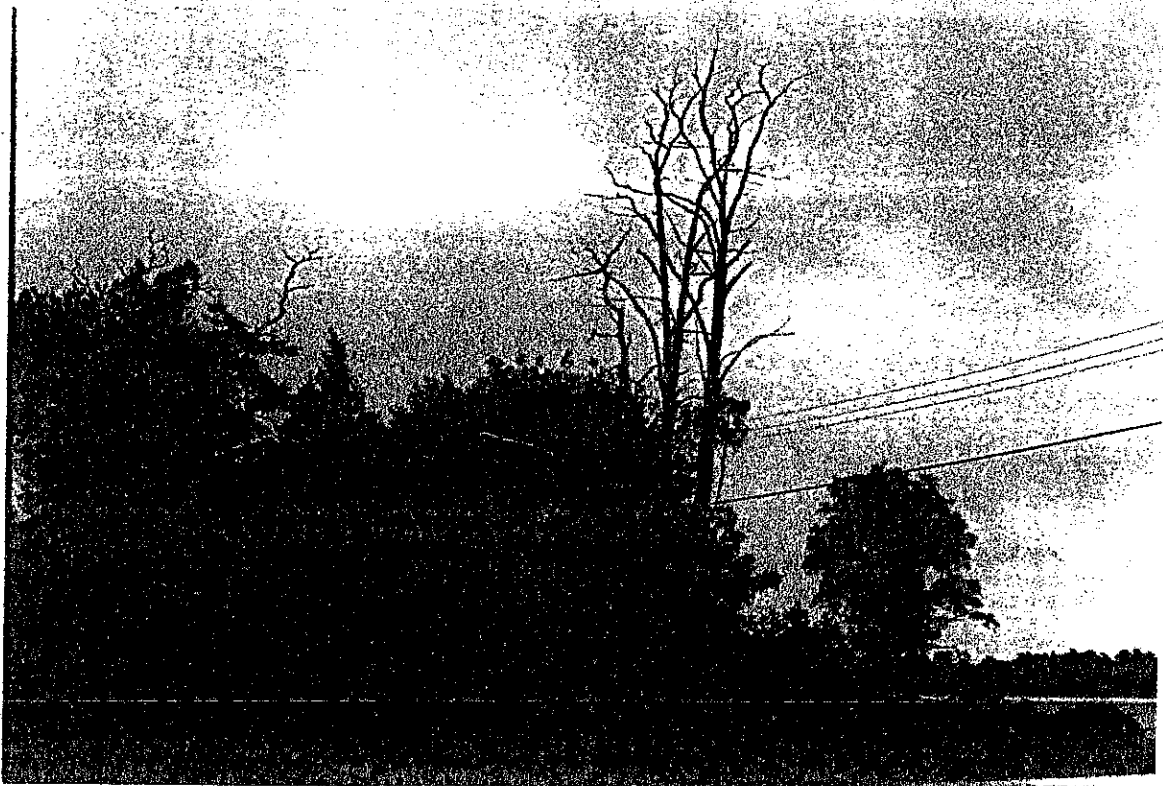
**Photograph #2. Two hazard trees located at corner of Bamber Lake parking lot**

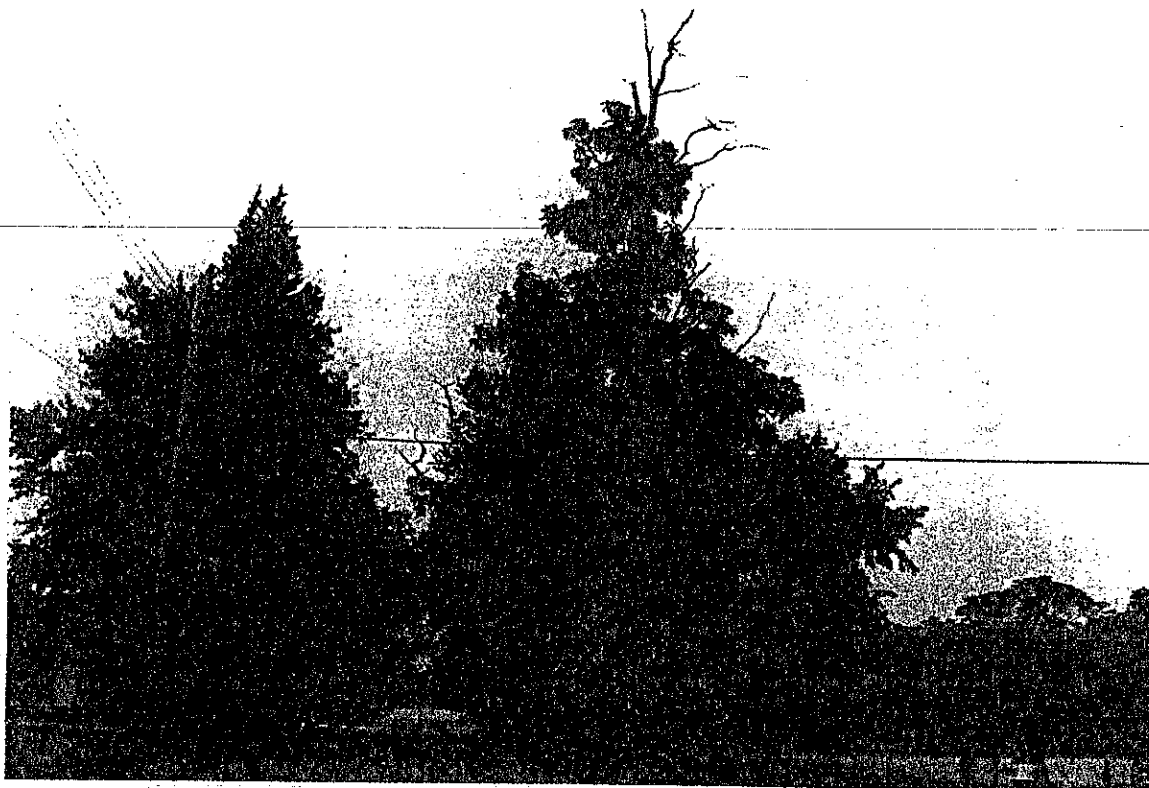
**Photograph #3. Hazard tree located at corner of ballfield marked for removal**

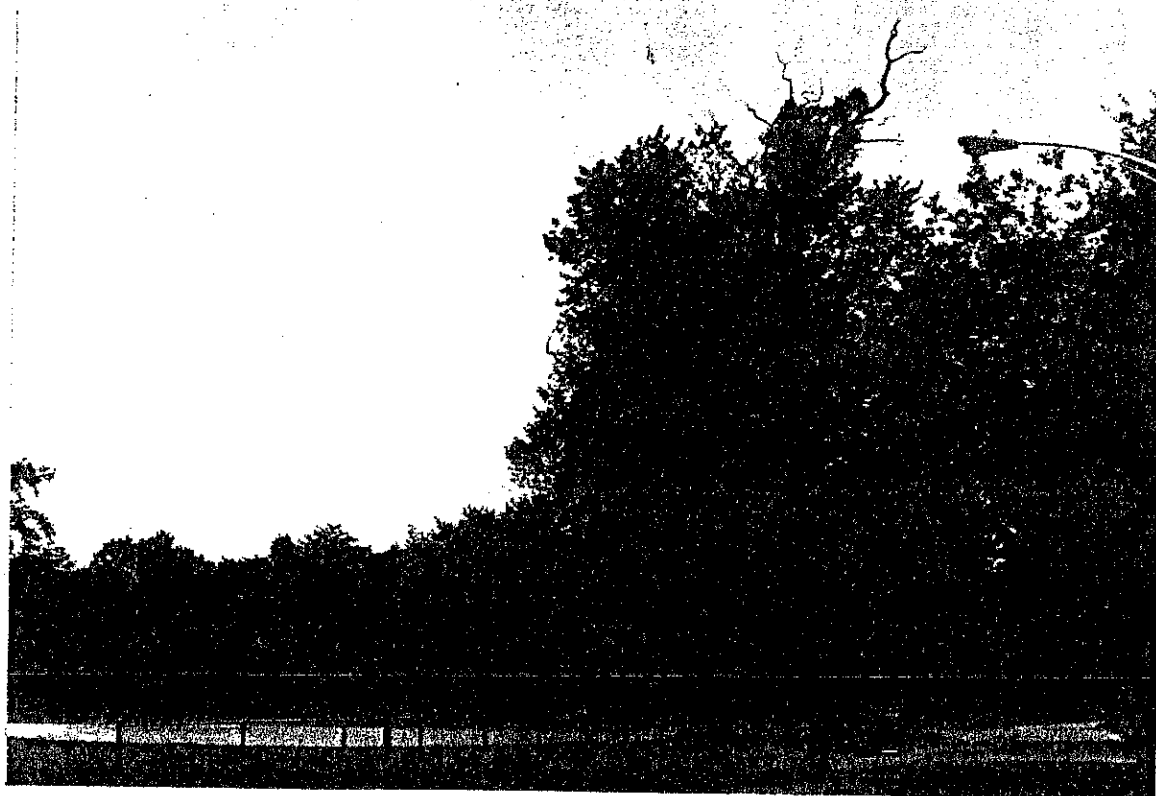
**Photograph #4. Top prune BL #9 to reduce hazard potential**

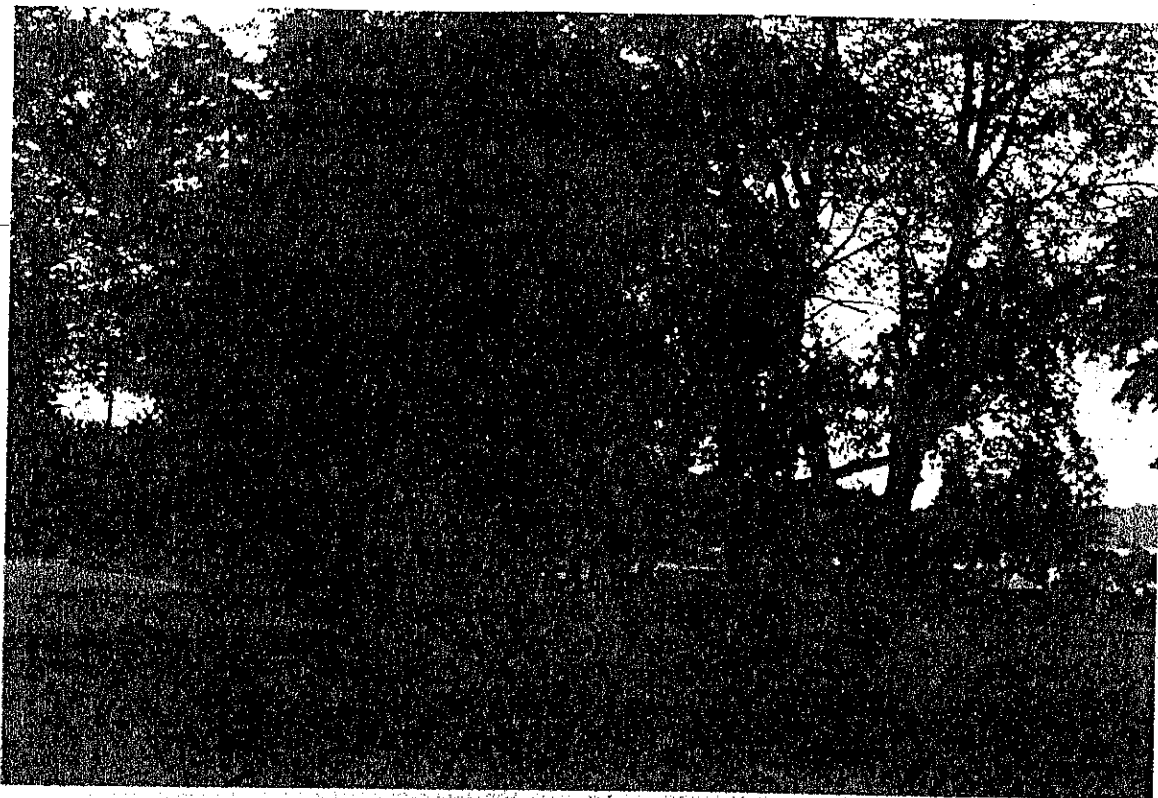
**Photograph #5. Black cherry trees along Good Luck Road**

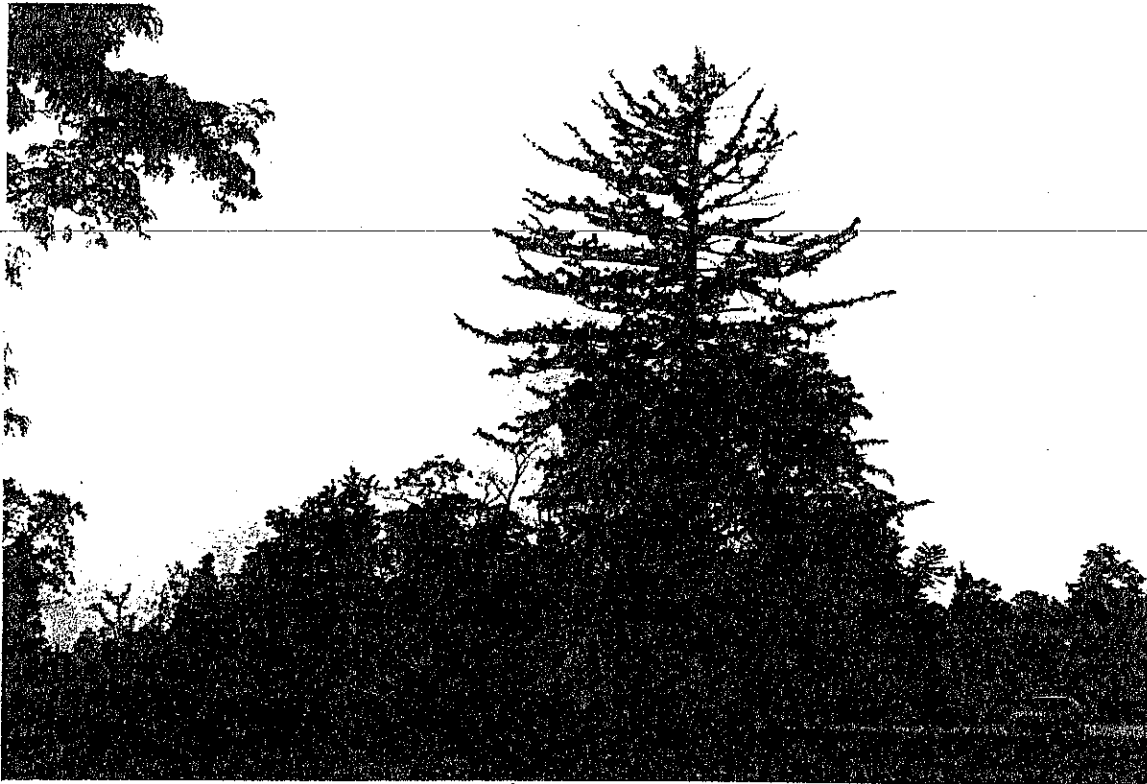
The large Norway spruce (*Abies picea*) [BL 33] located in the center of the main park area (Photograph #7) has been struck by lightning and presently exhibits evidence of decay associated with this injury (Photograph #8). This tree should be lightly thinned and pruned and closely monitored for further evidence of this decay. Regular fertilizer application should be provided in order to improve the vitality of this tree and to promote healing. A discussion of fertilization techniques is included in section III.

**Photograph #7. Norway spruce BL #33**

**Photograph #8. Basal rot on Norway spruce BL #33**

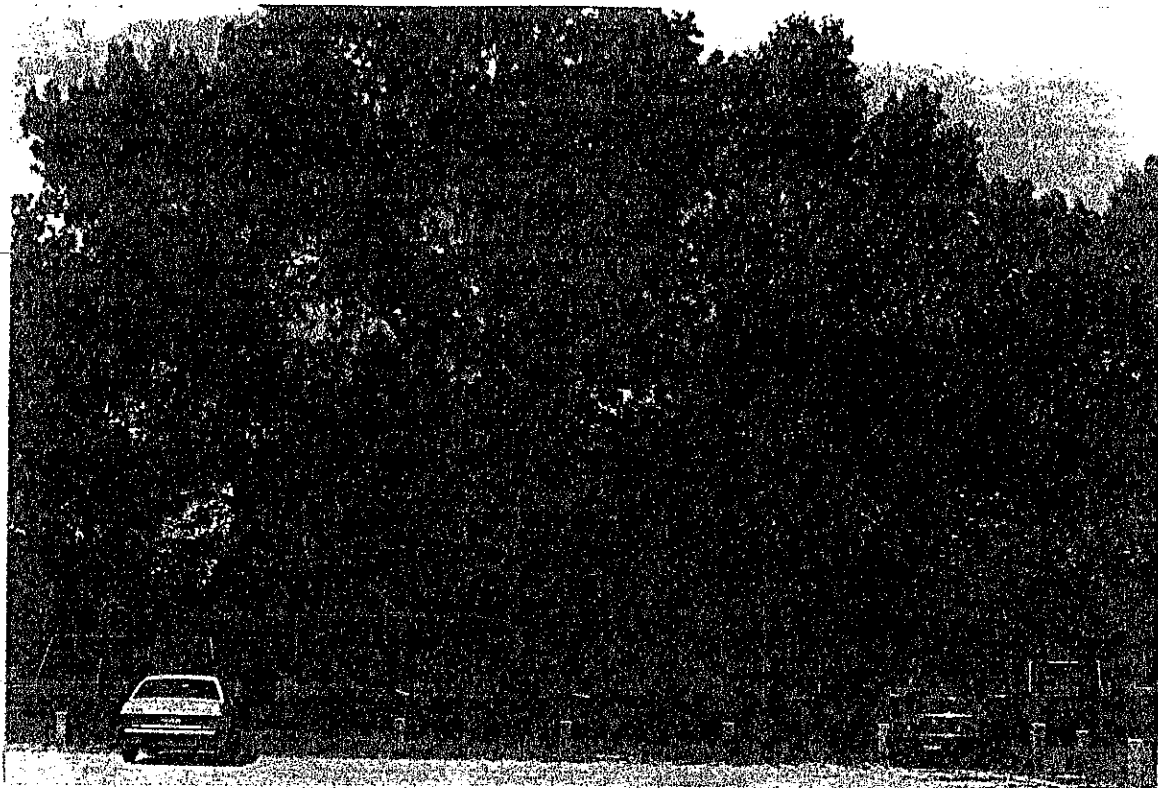
The most immediate recommendation involves the maintenance of the grove of black oak (*Quercus velutina*) trees located between the tennis court and the parking lot (Photograph #11). The damage that these trees exhibit is consistent with fire scorch from approximately 15-20 years ago. These trees [WH 41, WH 42, WH 43, and WH 44] all have severe trunk damage which runs the entire length of the stem (Photograph #12). WH 41 also has severe basal rot (Photograph #13). These trees are structurally unsafe and should all receive a Class IV crown reduction pruning of approximately 10 feet in order to reduce their hazard potential. Ideally these trees should be removed altogether and replaced; however, they do provide shade for passive recreation. An exception to this is the Black oak located four feet southwest of tree WH 43, which should be removed as it is extremely top heavy and is structurally not amenable to crown reduction.

**Photograph #11. Black oaks, WH #41 through WH #46, require top pruning to reduce hazard**

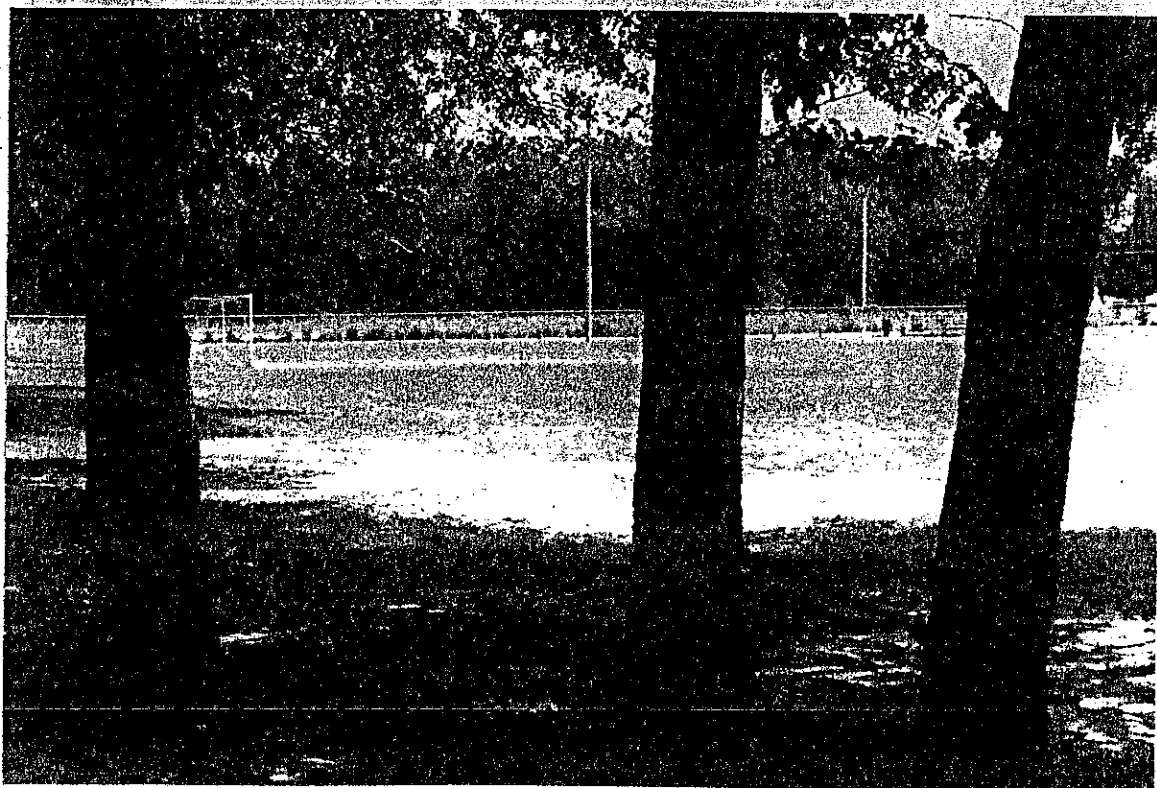
**Photograph #12. Trunk damage on WH #43 and WH #44 due to past fire scorch**

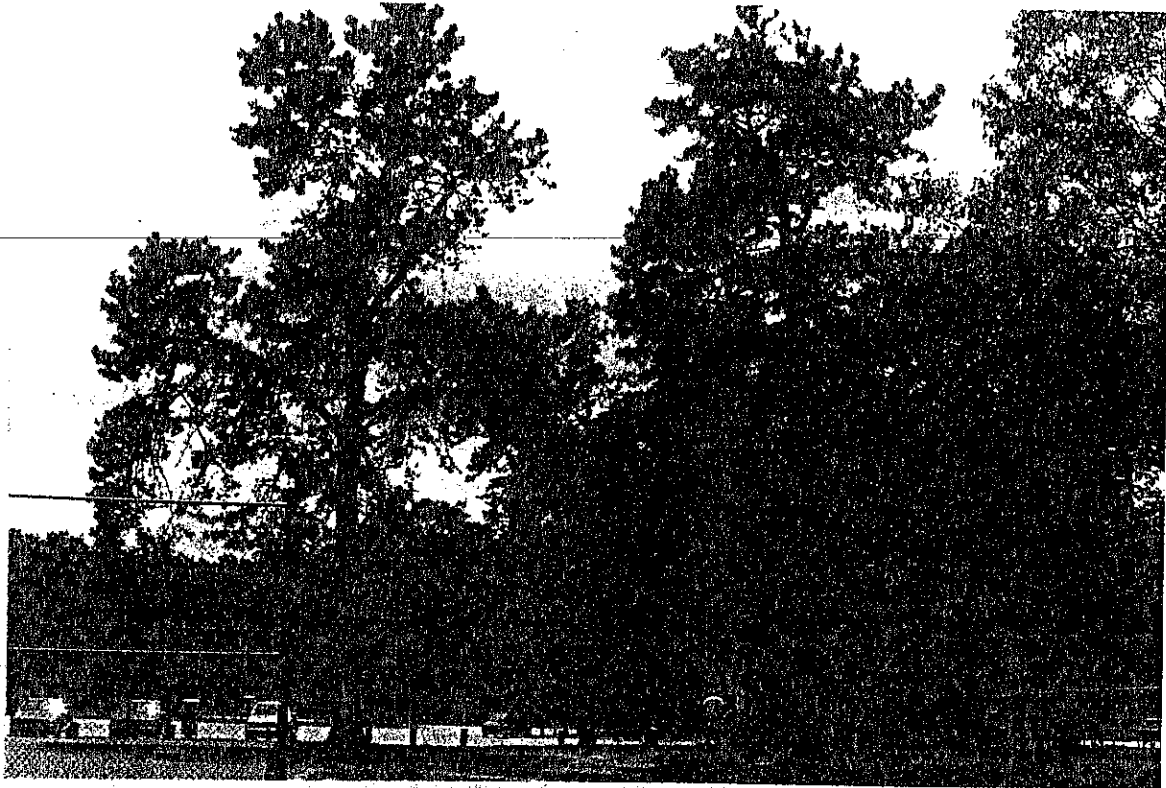
**Photograph #17. Pitch pine, WH #32, should have limb reduced over tennis court**

Black oak [WH 26] (Photograph #14), white oak (*Quercus alba*) [WH 28] (Photograph #15), and pin oak (*Quercus palustris*) [WH 29] (Photograph #16), are all located in prominent positions within WHP and are extremely valuable specimen trees. These trees should receive priority pruning. They each require a light pruning to remove obvious deadwood and correct structural problems and should have "stubs," the short dead branches that occur as a result of improper pruning techniques, properly pruned from the lower trunk. In addition, WH 29 should have its lower canopy raised four to six feet above the roof of the storage building. The other trees within this area (WH 31 through WH 38) should also receive some light pruning as this area is heavily utilized. Pitch pine (*Pinus rigida*) [WH 32] should be pruned to reduce the weight on the limb that hangs over the tennis court (Photograph #17).

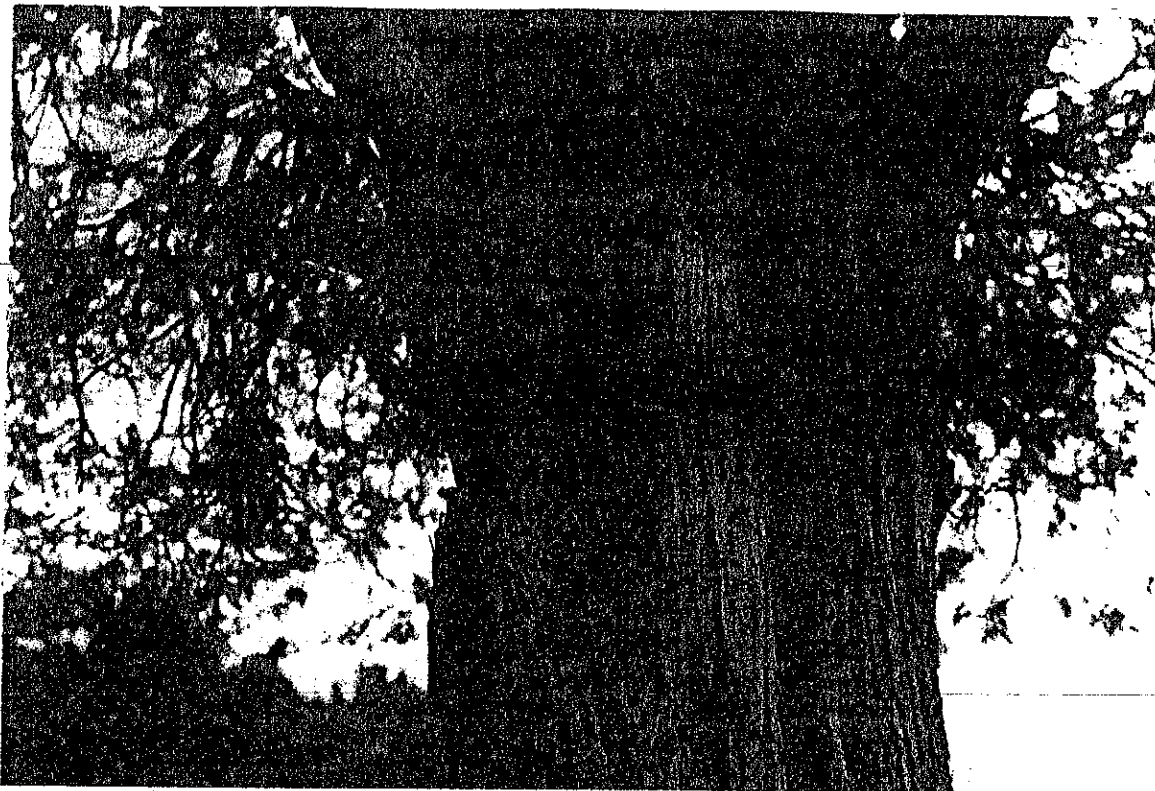
**Photograph #19. Girdling wire in WH #9. Should be removed and tree should be cabled**

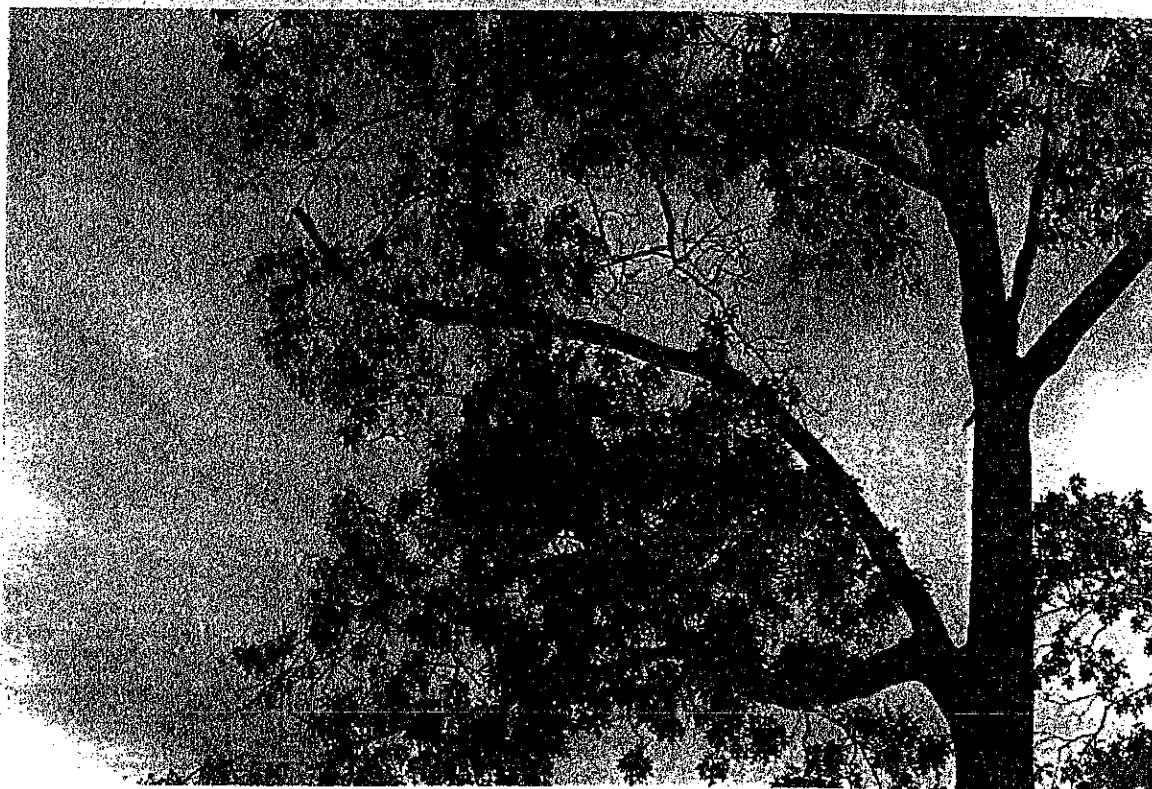
**Photograph #20. Large deadwood in row of trees between eastern soccer fields**

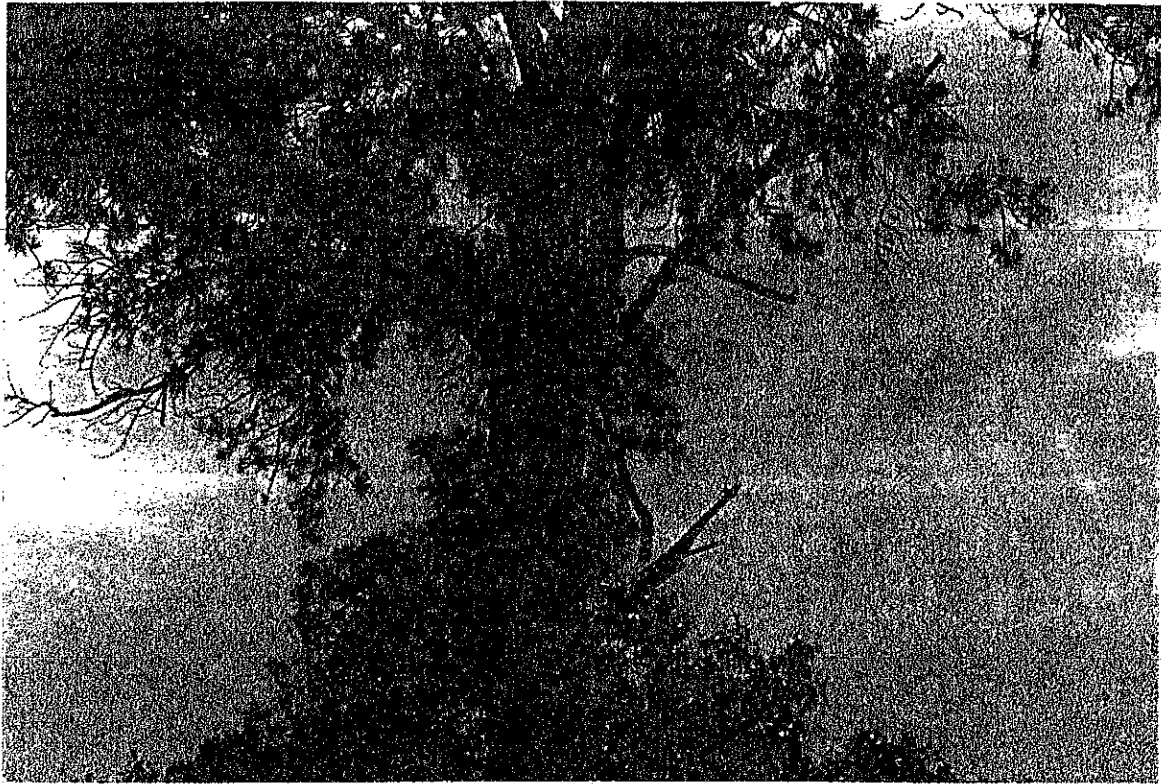
**Photograph #23. Typical lower deadwood and "stubs" on large pitch pines**

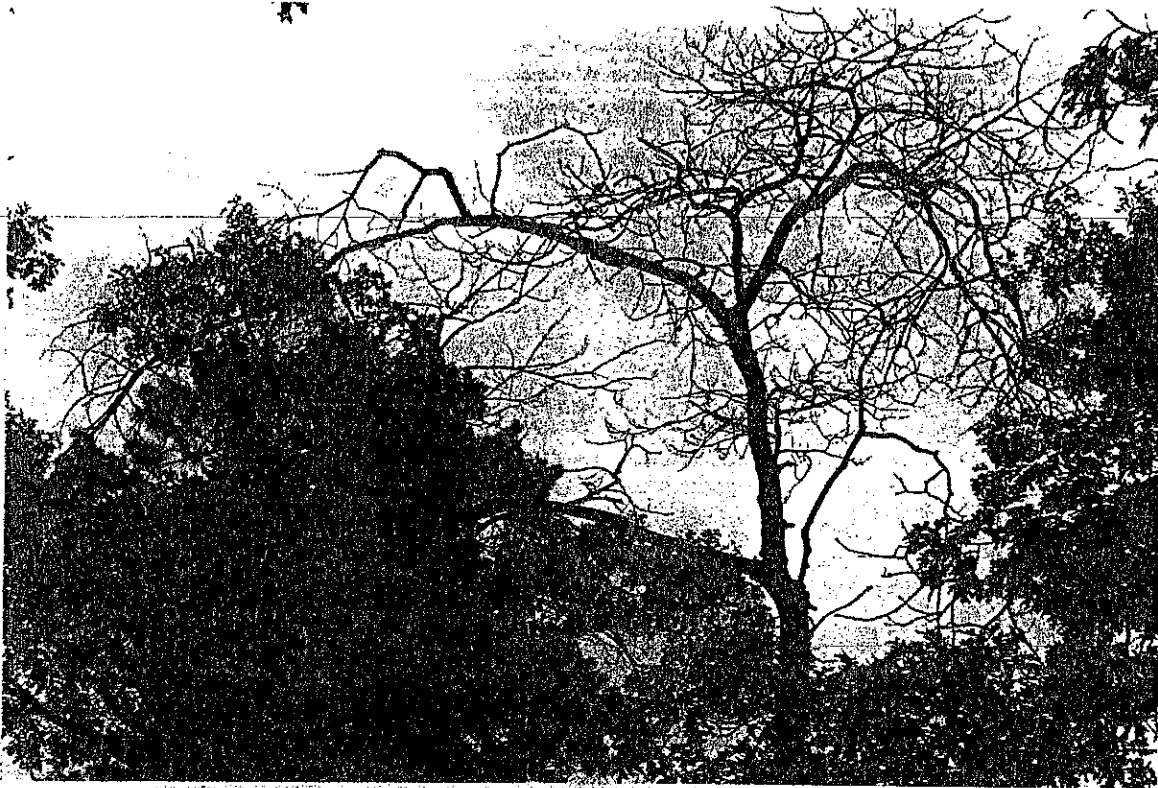
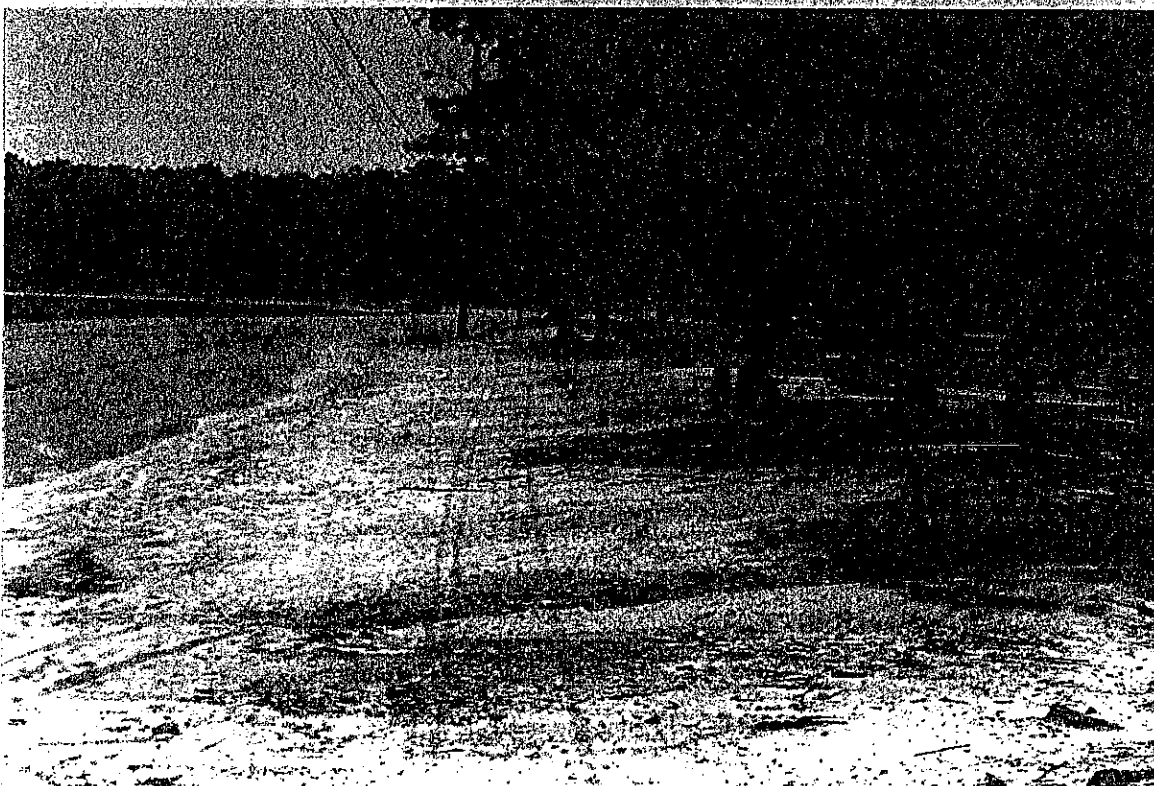
In general, the trees within this park (especially the oaks) are suffering from top dieback (Photograph #27), a typical response to general root zone damage. Vehicular traffic traverses the entire site (Photograph #28), resulting in the erosion of the surface layer and exposed portions of the tree root systems (Photograph #29). The pitch pines, a deeply rooted tree, do not appear as damaged as the other trees.

**Photograph #27. Top dieback, typical response to root environment damage, Vincent Clune Park**

**Photograph #28. Vincent Clune Park, vehicles can access entire site**

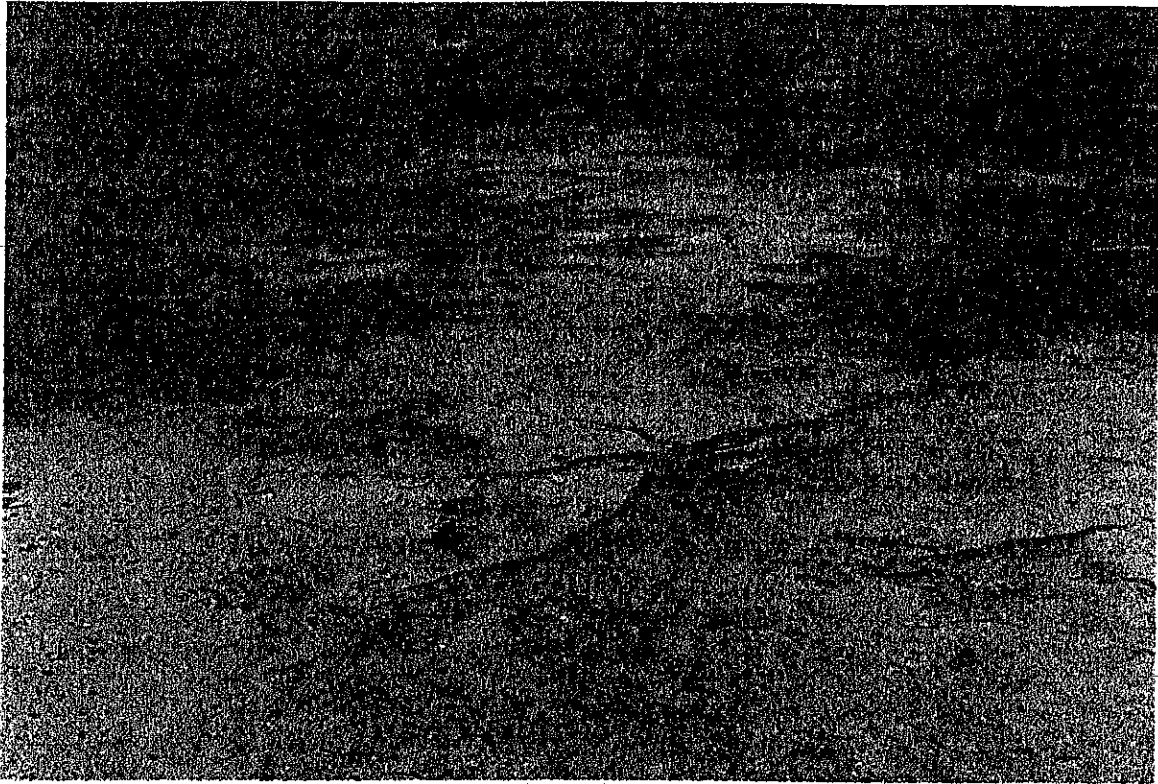
**Photograph #29. Vincent Clune Park, traffic and erosion has removed organic layer and exposed roots**

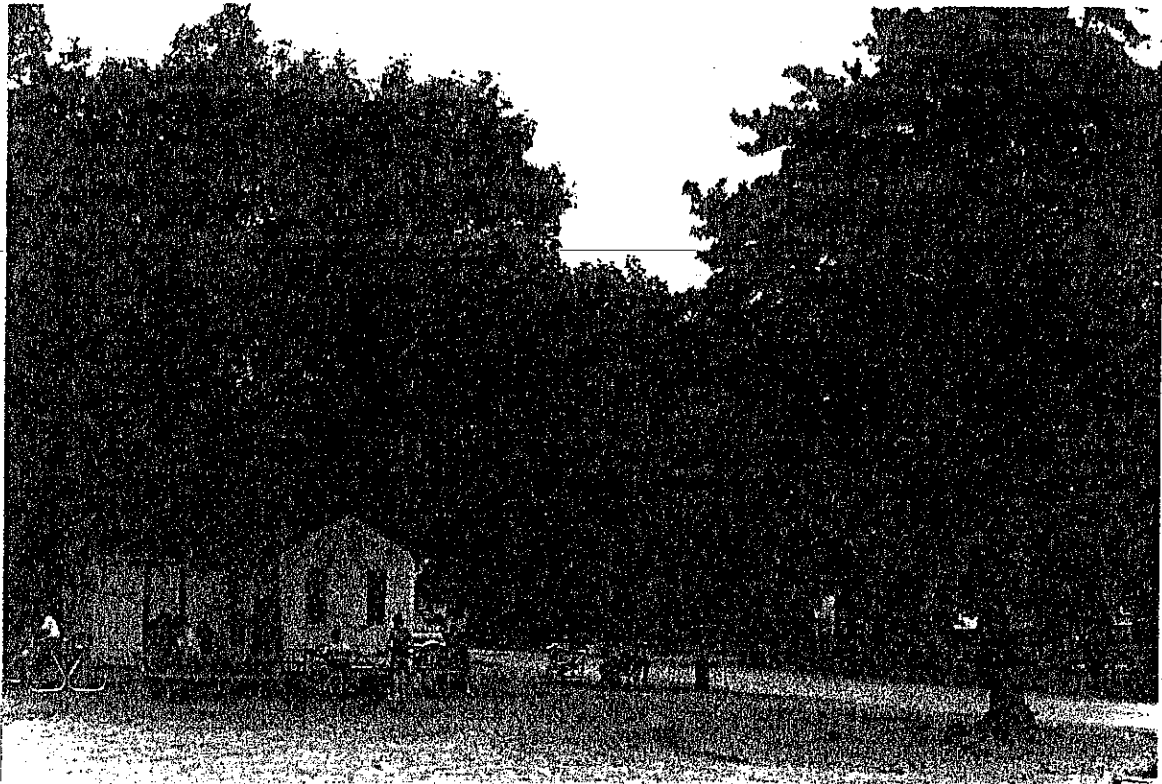
Trees HW 6 and HW 7 (Photograph #31) both contain large amounts of deadwood hanging directly over the picnic area. Lacey Township Municipal employees have been alerted to this imminent hazard. Trees HW 9, HW 10, HW 11 and HW 12 all require light pruning and should have their root zone protected. The area beneath these trees is presently used for parking (Photograph #32) which has led to soil compaction and the loss of the organic layer. This area should be protected from vehicular access and leaf mold or mulch may be distributed throughout. This area would also benefit from an annual fertilizer application.

**Photograph #31. HW #6 and HW #7 each contain large deadwood over picnic area**

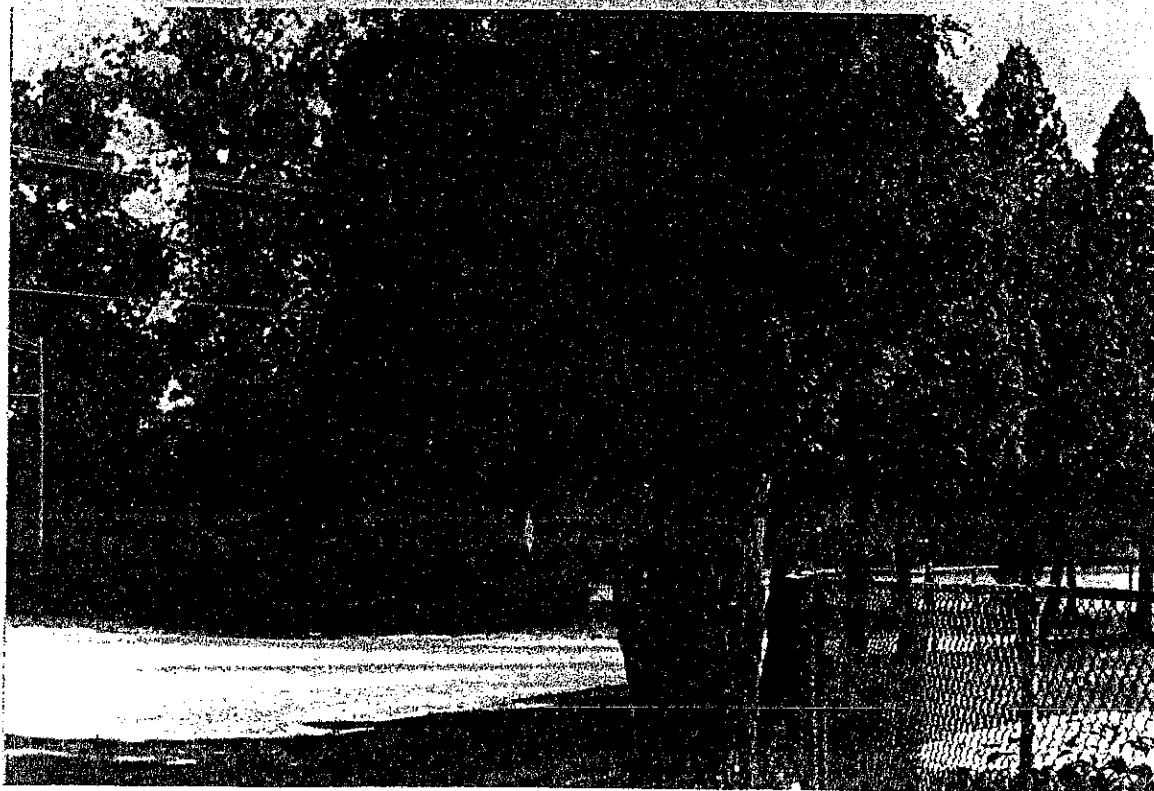
The black locust [DL 3] has a large limb growing out over the small children's play area. Basal rot is present which leads up to the crotch of this tree and has reduced the structural soundness of this limb (Photograph #34). This large limb should be cut back by approximately 20 feet in order to reduce its weight. A cable may also be installed.

**Photograph #34. Basal rot leading to crotch on DL #3**

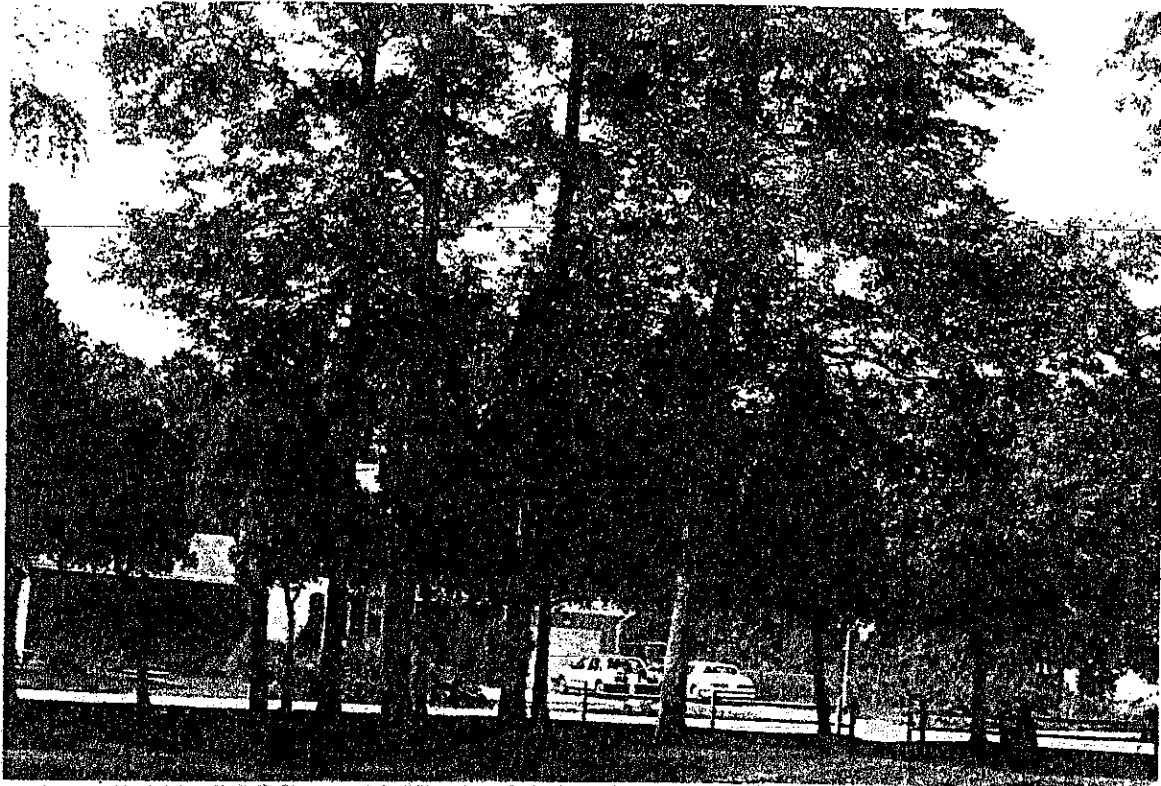
The grove of four persimmon (*Diospyros virginiana*) trees located in the northern end of the park are beautiful specimen trees and rather unique (Photograph #35). These trees have suffered some mower/weed trimmer damage and would benefit from the construction of a mulch bed. One smaller persimmon tree, located in the small

**Photograph #35. 4 Persimmons at Deerhead Lake Park, should receive a mulch bed**
