ROCKFALL HAZARD MITIGATION REPORT

ROUTE 29
ROCKFALL MITIGATION
MP 27.31 TO MP 30.43

TOWNSHIP OF KINGWOOD
HUNTERDON COUNTY

April 24, 2015

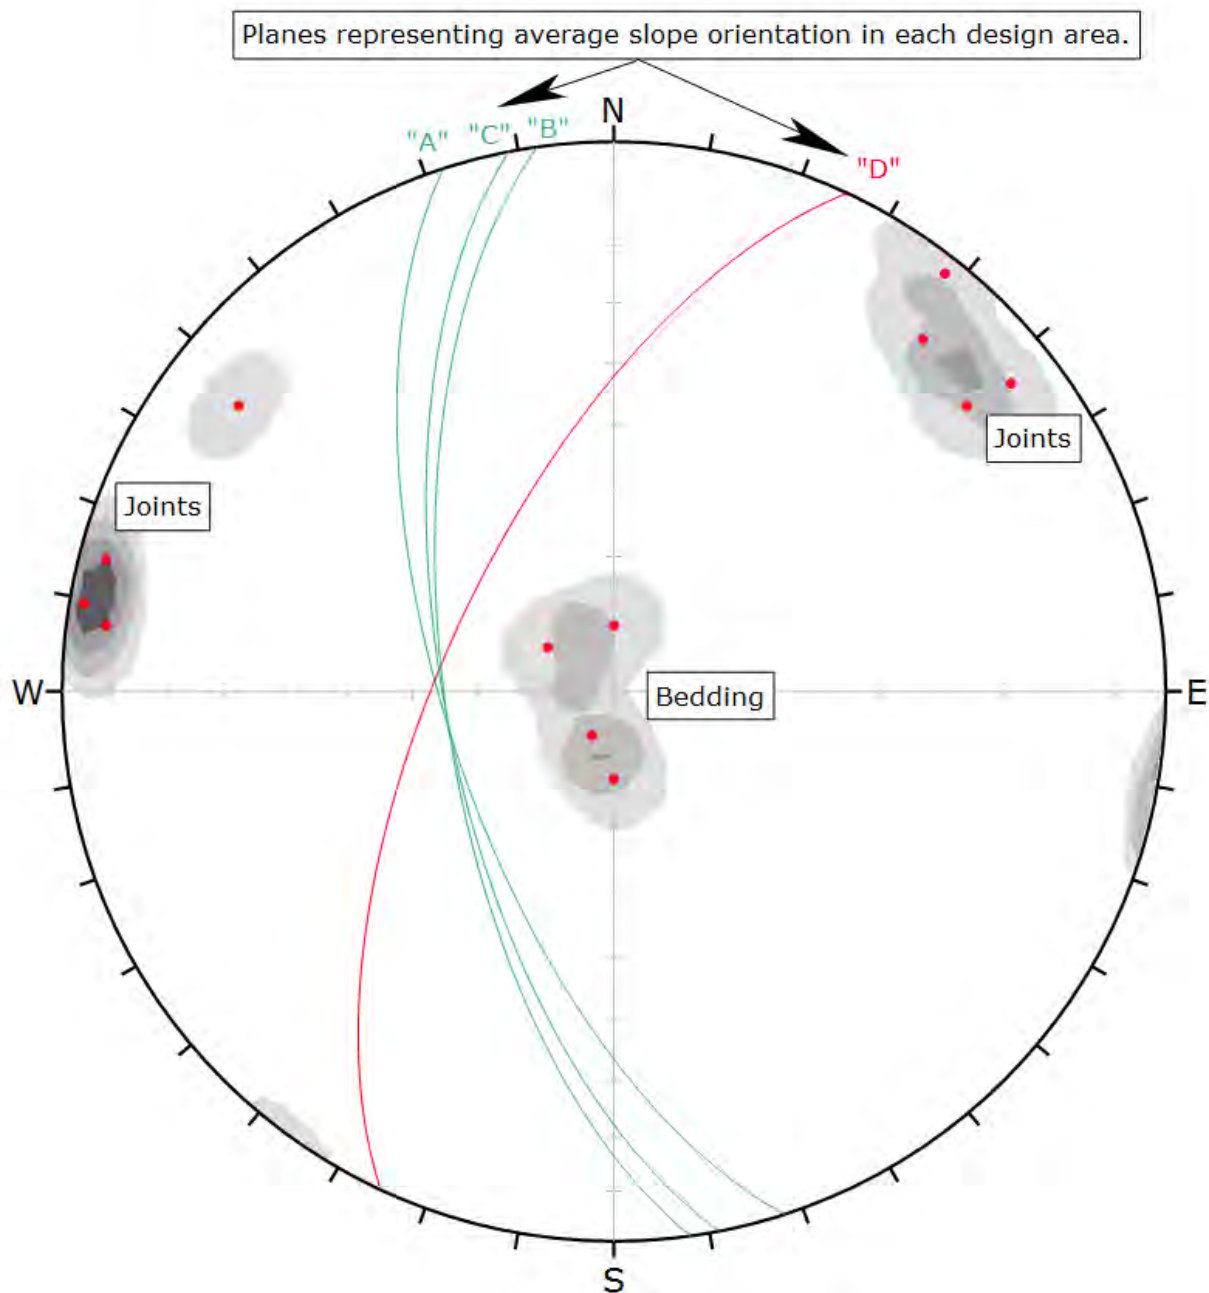
A stereonet analysis of the limited-scale structural data set indicates the presence of two steep dipping joint sets along with northerly-dipping bedding (Figure 5-1). No features were found with

intermediate dips toward the highway. This structural model is favorable for current global stability and indicates that steeper cut slopes could be achieved. Overall slope failure through the rock mass (non-structurally controlled) is improbable due to the strength of the rock and the limited slope heights.

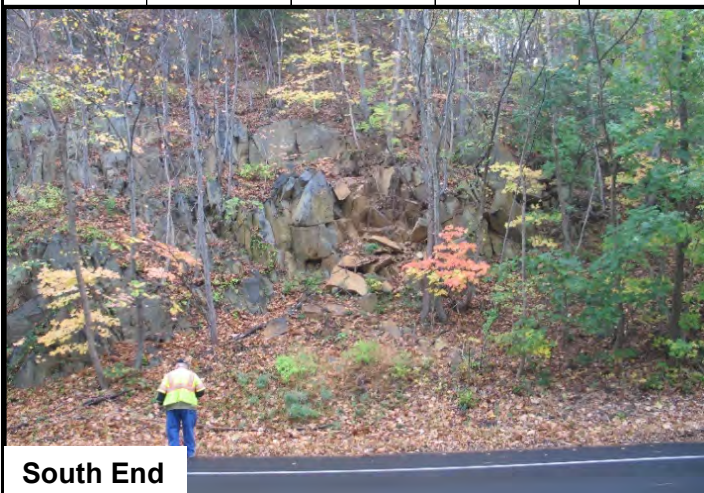
South End

1. Loose rockmass with evidence of root and frost jacking.
2. Localized block toppling.

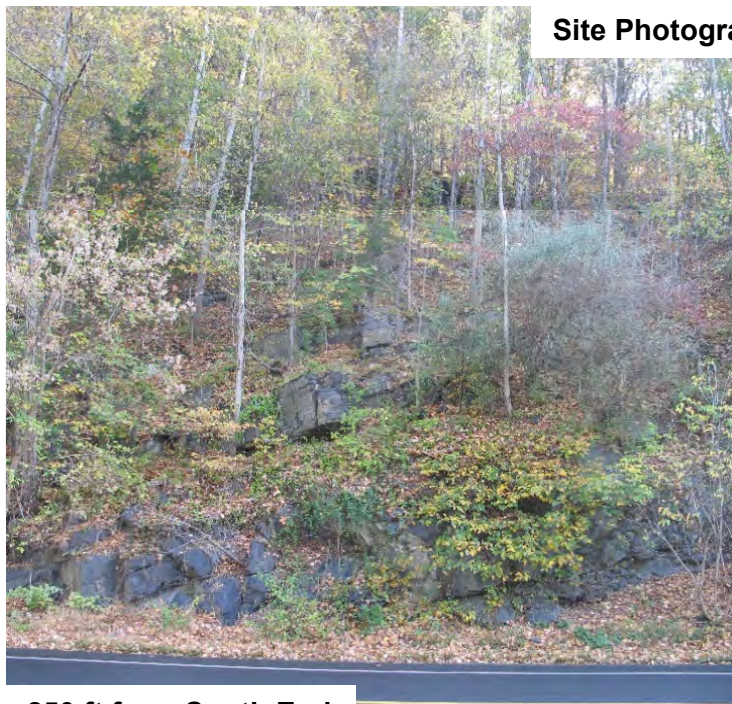
250 ft from South End

1. Loose detached blocks with evidence of root and frost jacking.
2. Localized block toppling.

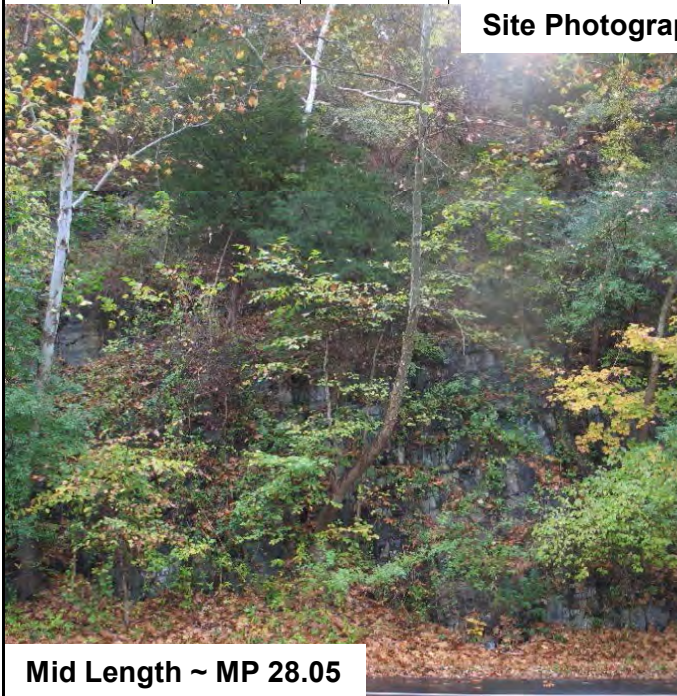
Mid Length ~ MP 28.05

1. Loose rockmass with evidence of root and frost jacking.
2. Localized block toppling.
3. Differential erosion of siltstone.

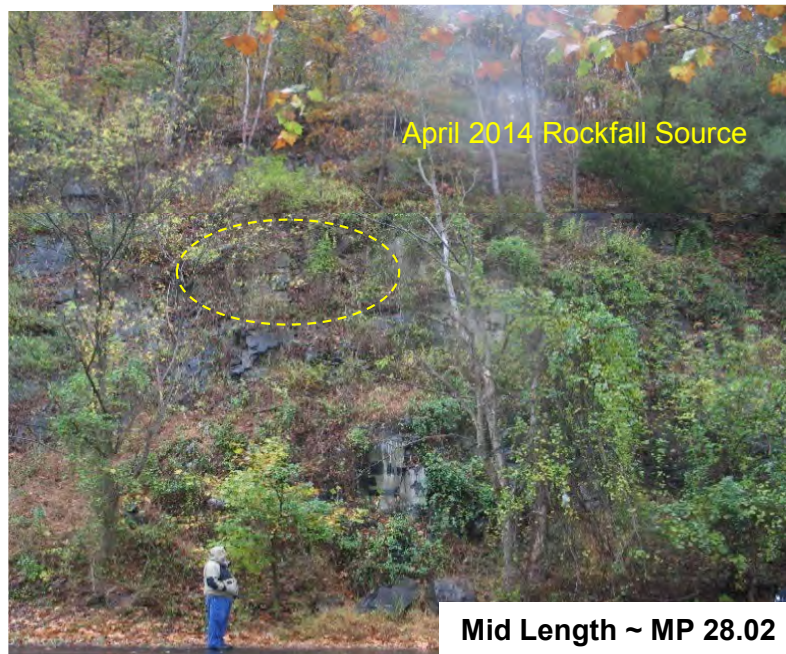
Mid Length ~ MP 28.02

April 2014 Rockfall Source

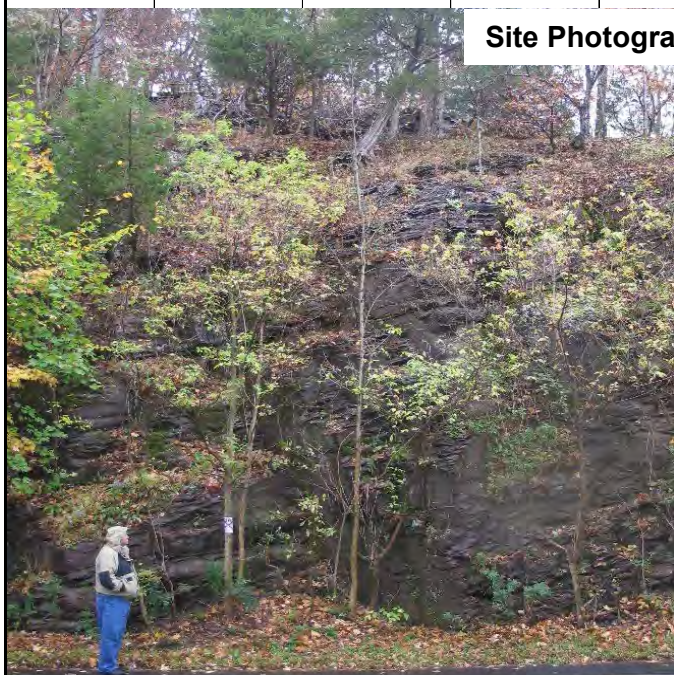
South end ~ MP 29.90

1. Loose rockmass with evidence of root and frost jacking.
2. Localized block toppling.
3. Differential erosion of siltstone.

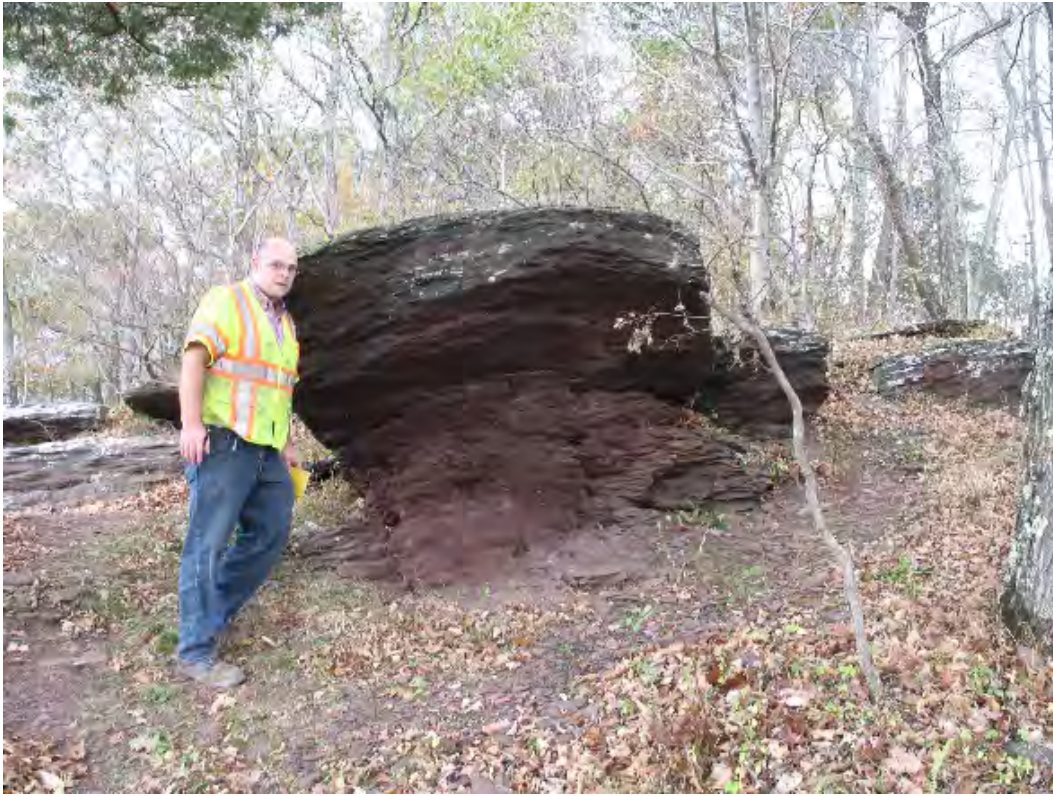
PHOTO 1 - Differential weathering above Devil's Tea Table (Top of Slope, Area D, Looking Northeast)

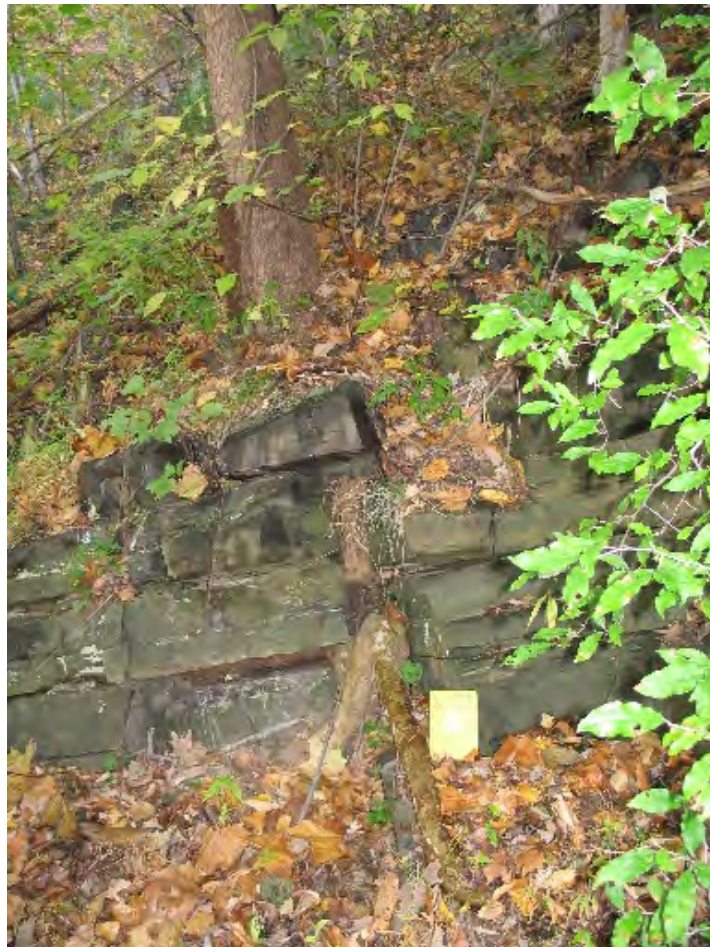
PHOTO 2 – Example of Root Wedging (Toe of Slope, Area D, Looking Northeast)

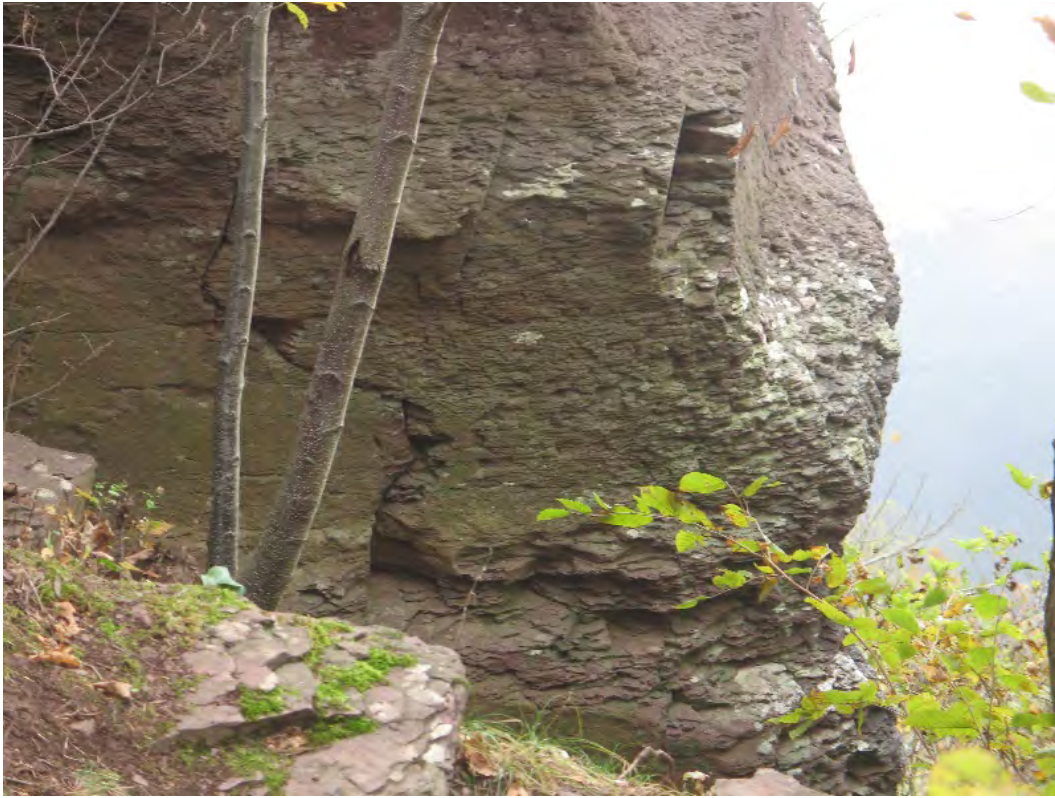
PHOTO 3 - S Shaped Crack in North Side of Block above Devil's Tea Table (Area D)
