BREAKAWAY CABLE TERMINAL EVALUATION

FINAL REPORT

ROBERT F. BAKER

MAY 1980

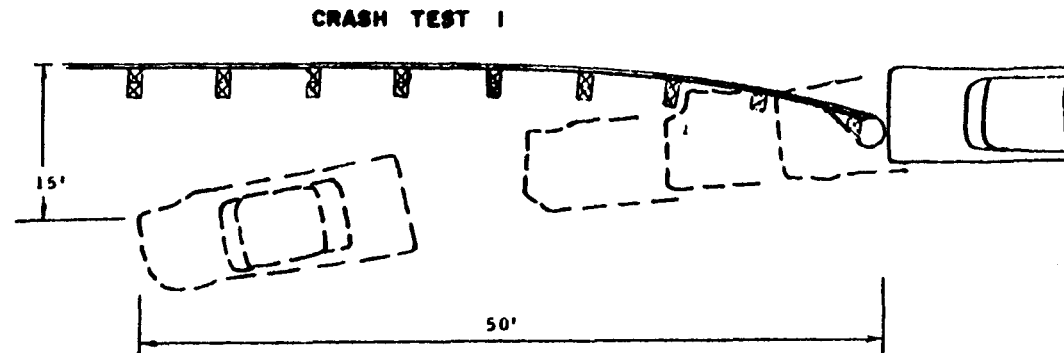
Figure 2

Test Installation ... Flared Terminal*
Posts 8 x 8 Timber
Post Spacing 6.25 ft
Rail Standard 12ga. W beam
Length of Installation 87.5 ft
Ground Condition Dry

Test No. 130
Date 6-11-71
Vehicle 1965 Ford
Vehicle Weight .. 4138 lbs
Impact Speed 61 mph
Impact Angle 0 deg**

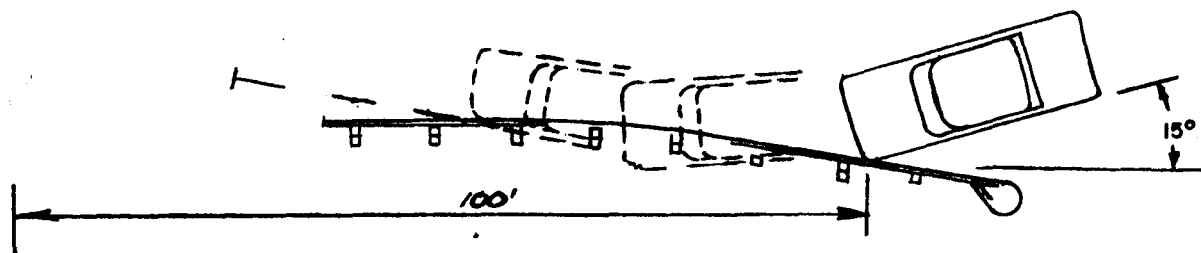
CRASH TEST 2

Test Installation ... Flared Terminal*
Posts 8 x 8 Timber
Post Spacing 6.25 ft
Rail Standard 12ga. W beam
Length of Installation 87.5 ft
Ground Condition Dry

Test No. 131
Date 7-17-71
Vehicle 1963 Ford
Vehicle Weight .. 4000 lbs
Impact Speed ... 59.4 mph
Impact Angle 15 deg

stop 108 feet from the initial point of impact. The cable anchor system, end posts, and foundation were not damaged in the test.

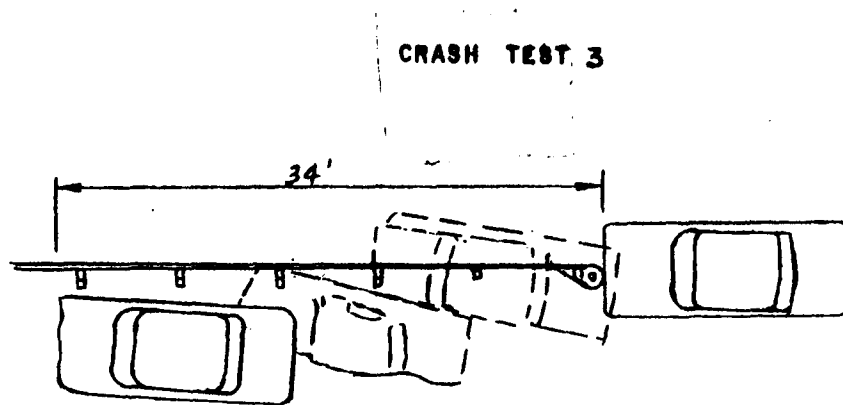
Figure 4.

The installation for the third test (Figure 4) was similar to the previous tests with the exception that steel diaphragms replaced the vermiculite concrete for stabilizing the terminal nose and the flat plate washers were eliminated from the first 6 posts to achieve rail separation from the post. The horizontal flare was eliminated; essentially, the BCT and guiderail installation were parallel to the roadway and column loaded.

Test installation ... Straight Terminal*
Posts 8 x 8 Timber
Post Spacing 6.25 ft
Rail Standard 12ga. W beam
Length of Installation 87.5 ft
Ground Condition Wet

Test No. 132
Date 8-16-71
Vehicle 1964 Ford
Vehicle Weight .. 4100 lbs
Impact Speed ... 58.5 mph
Impact Angle 0 deg

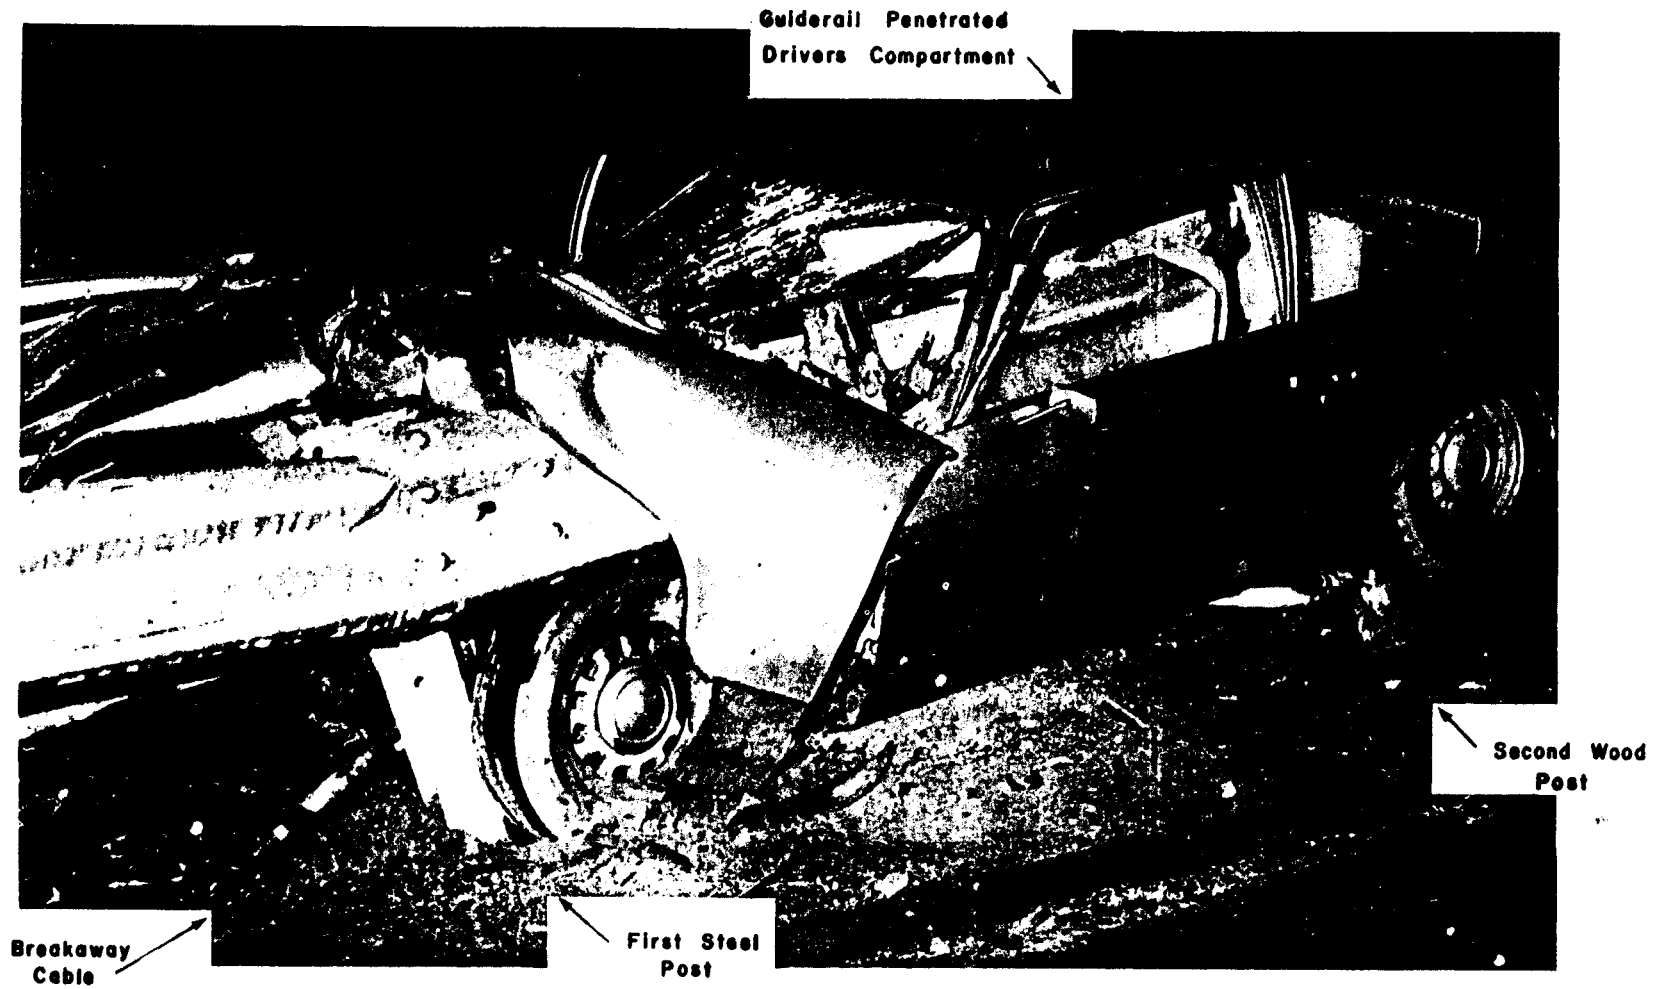
Case #10: A 1972 Chevrolet Vega impacted an undiaphragmed BCT. The BCT was located at the edge of the roadway on a straight guiderail section, i.e., without horizontal flare. The vehicle broke the first and second wood posts at ground level. The guiderail speared the vehicle into the driver's seat pushing the driver's seat backward. Picture #1 shows the speared Vega: Note position of guiderail. The vehicle was severely damaged. The rail remained straight and did not separate from the washerless retainer bolts on the steel posts. The driver was injured seriously.

PICTURE I
SPEARED CHEVROLET VEGA

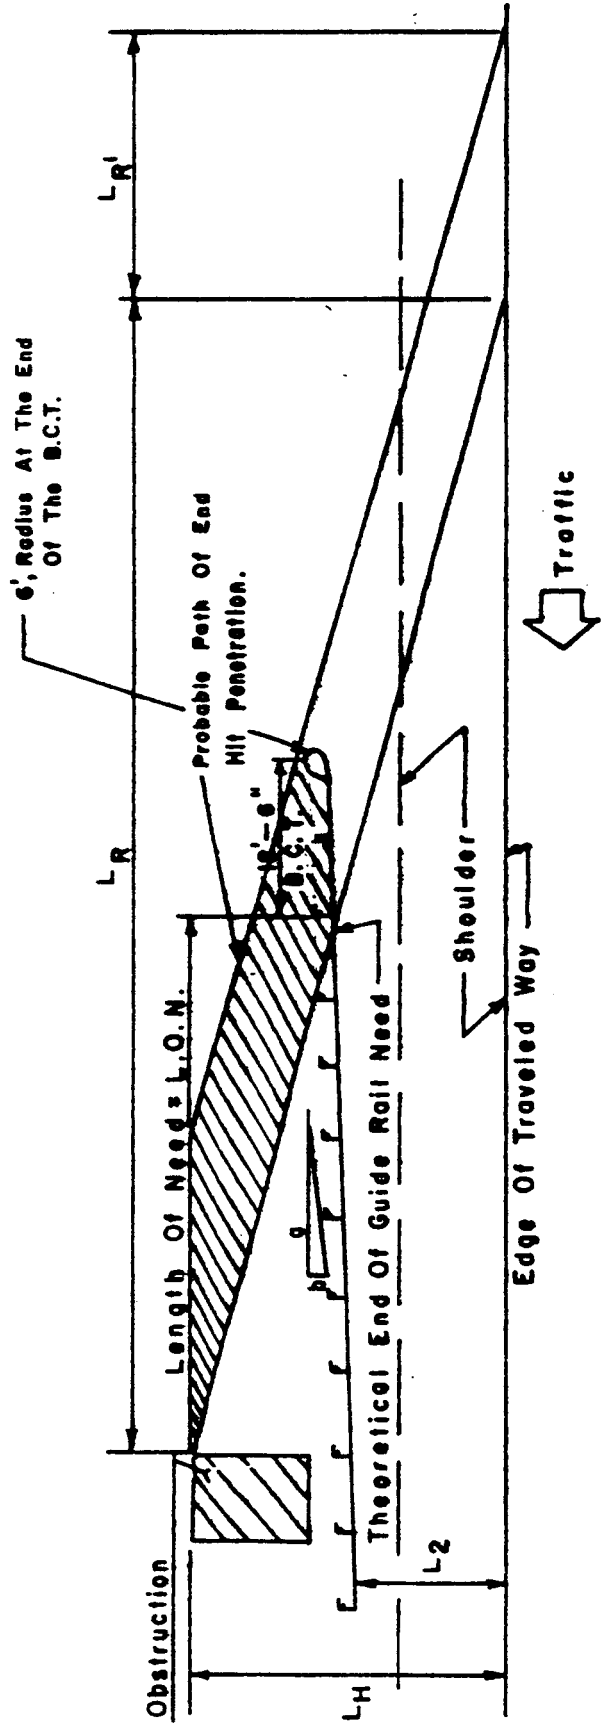
Figure 6 Recovery Area
Probable Path Of End Hit Penetration

The probable vehicle path closely approximates the clear distance defined by the length of need as determined by the Department's guiderail guidelines. The determination of the Department's length of need and probable vehicle path are shown in Figure 6. The probable path and recovery area are shown by the cross-hatched area and are defined by the diagonal line from the edge of the traveled way through the theoretical end of guiderail need to the obstruction and the line parallel to the above line running tangent to a six foot radius from the end of the BCT to the depth of the obstruction.

2. Recovery areas immediately behind the BCT and along the probable vehicle path for expected end hit penetration should be free of obstructions. The minimum recovery area and probable area of vehicle penetration are defined from this study and Southwest Research Institute's research by the diagonal line from the edge of the traveled way through the point of theoretical end of guiderail need to the obstruction, and a line parallel to that line running six feet from the end of the BCT to the line of the obstruction. (See Figure 6 in text.) Engineering judgment should be exercised where sufficient recovery areas are not possible. Such solutions as extension of the length of need, clearing and regrading the site, removing and installing protective barriers should be considered.

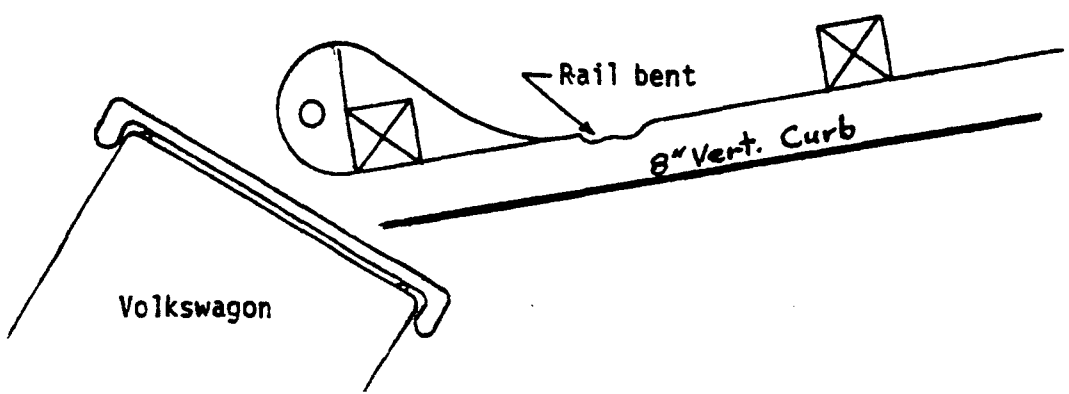
Case #1: A 1969 Volkswagon beetle impacted a BCT at a point immediately behind the buffer nose connection at the first post. The BCT was installed in a gore area behind an 8-inch vertical curb which probably ramped the vehicle causing it to impact the buffer nose connection at bumper height. The vehicle bent the rail between the first and second post, and broke the first post at ground level below the breakaway hole. The vehicle passed behind the guiderail and sustained substantial front and undercarriage damage. The driver was injured seriously.

DAMAGE first post, rail, anchor cable in place, buffer not damaged

COMMENTS: The vehicle impacted the terminal at the buffer-end rail connection point striking the first post which broke away on a diagonal below and above the breakaway hole. The cable remained in place. This BCT is located behind a curb which probably caused the vehicle to vault impacting the BCT at the bumper level of the vehicle.

Vehicle was inoperative. Extensive damage to the undercarriage and front and right side occurred as the vehicle was contained by the bent rail.

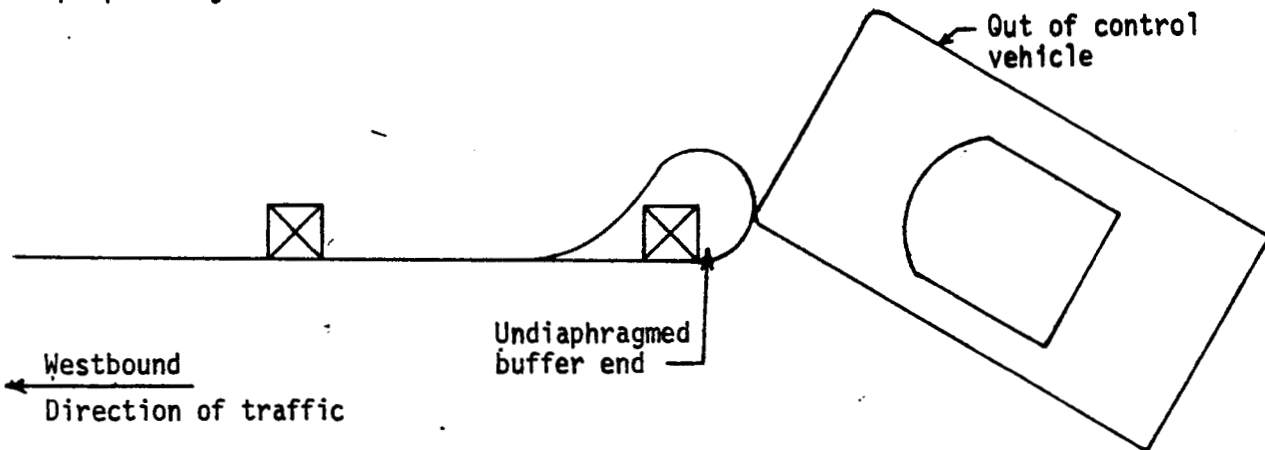
Probable Impact of BCT

Case #2: A 1971 Chevrolet struck a BCT at the buffer end. The BCT was installed on a shoulder berm and horizontally flared. The vehicle compressed the undiaphragmed buffer end and split the post vertically through the center. The vehicle sustained slight damage and passed behind the guiderail. No injuries were reported.

DAMAGE buffer end, broke first post but did not release cable

COMMENTS: Minor accident - The vehicle's left front impacted the BCT and glanced off as shown below. The berm was not graded and caused the vehicle to ride over the buffer end. County was notified to grade berm to obtain proper height for BCT.

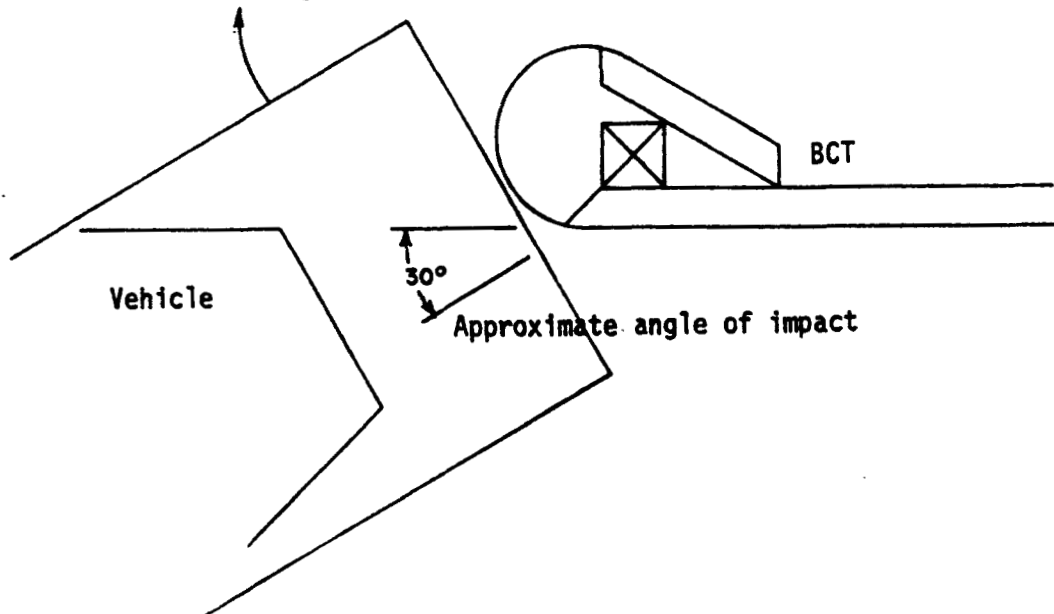
Case #3: A 1975 Pontiac impacted a BCT at the buffer end. The BCT was installed on a horizontally flared guiderail in the median. The vehicle compressed the undiaphragmed buffer end and broke the first post at ground level below the breakaway hole and fractured the top of the post. Although retaining washers were eliminated, the rail remained attached to the second wood post and the steel posts. The vehicle sustained front damage to the radiator and engine. After the impact, the vehicle rebounded into the opposite roadway. No injuries were reported.

DAMAGE Buffer end was flattened and post was broken below breakaway
hole and at top of post

COMMENTS: (pictures of vehicle are not available)
Vehicle swung in this direction after impact

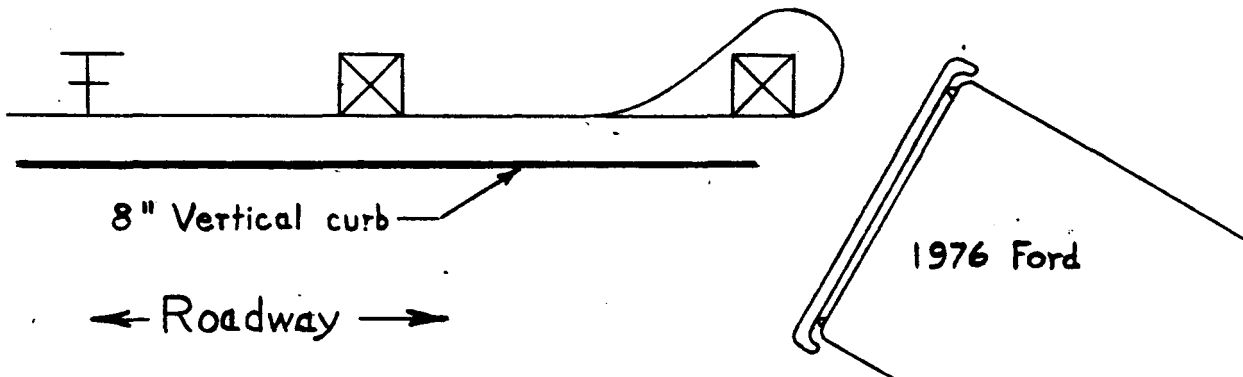
Case #4: A 1976 Ford impacted a BCT at the buffer end. The BCT was installed behind an 8-inch vertical curb on a guiderail section parallel to the roadway. The slow moving vehicle broke the first post at ground level and bent the guiderail between the first and second post. The rail separated from the second wood post but did not separate from the steel posts. The vehicle was damaged moderately in the front and right front fender. No injuries were reported.

DAMAGE Broke first post. Crushed buffer. Bend rail between first and second wood post. Rail separated from second wood post but did not separate from steel posts.

COMMENTS: BCT and guiderail are installed behind 8" vertical curb and parallel to roadway.

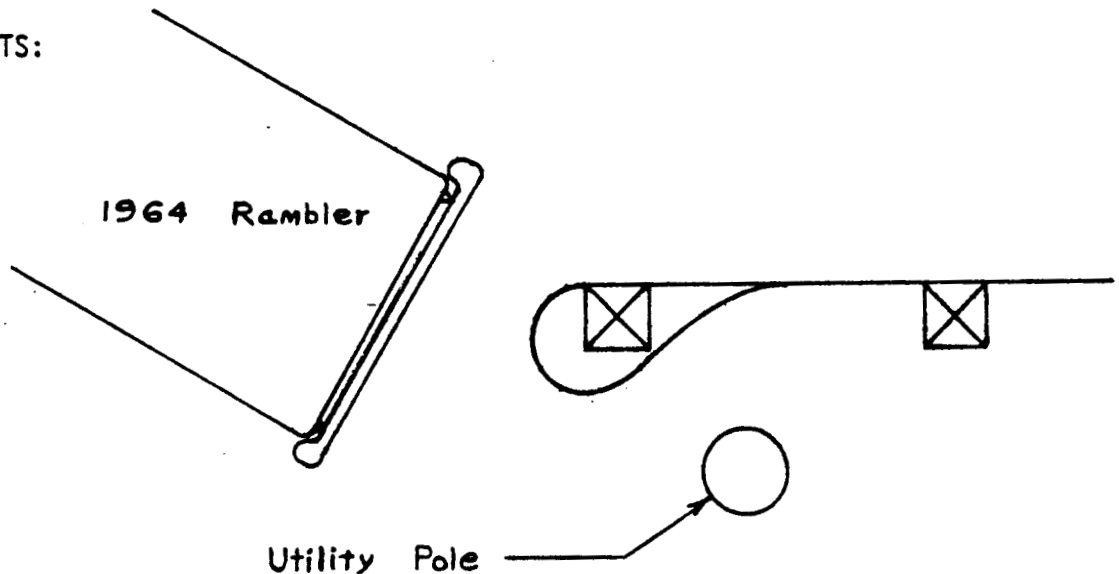
DAMAGE Broke first post, dislodged footing, crushed buffer end.

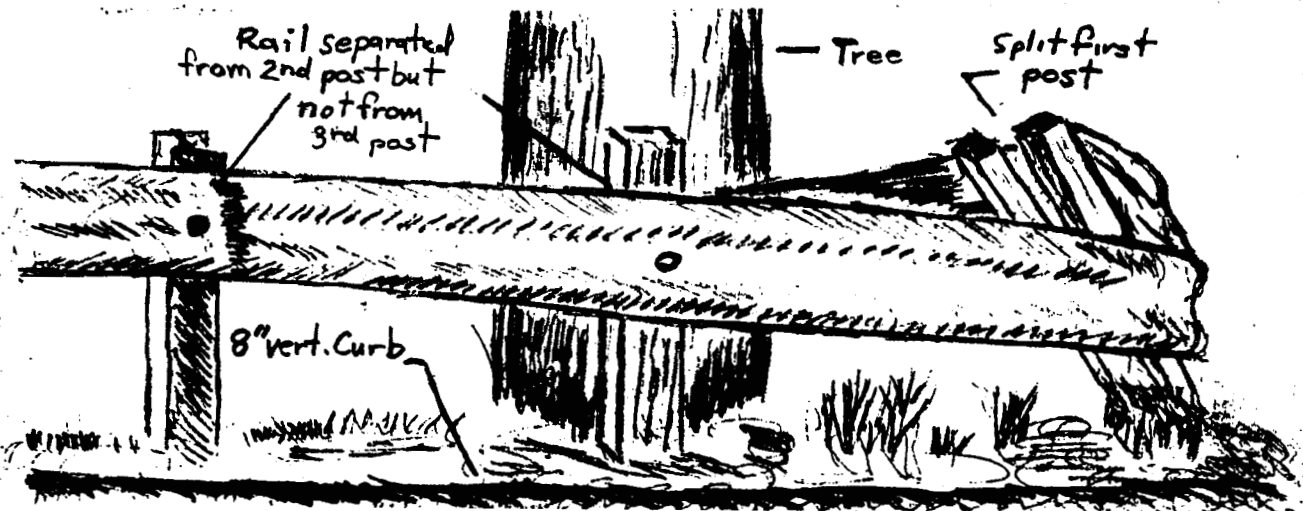
Case #6: A 1972 Chevrolet impacted the diaphragm buffer nose as described above. The BCT was located at the edge of the roadway behind an 8-inch vertical curb. The vehicle split vertically the first post through the retainer bolt and pushed the buffer nose behind the broken post. The vehicle sustained front end damage to the radiator and engine. After the impact, the vehicle rebounded across the two-lane road into a front yard. The road was snow covered. No injuries were reported.

DAMAGE First post split down the center, guard rail pulled away from second post.

COMMENTS: Vehicle going eastbound impacted BCT on southside of road and swung across road onto private property on north side of road. (Foreman repaired BCT before Research personnel could take photos. Foreman pulled post out of concrete footing and replaced new post in old footing.)

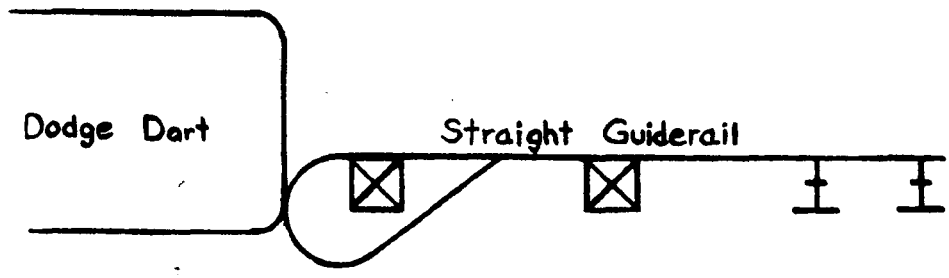
DAMAGE Broke off first two posts, crushed buffer end.

VEHICLE TYPE Dodge Dart DAMAGE Vehicle speared

COMMENTS: There is a high probability that anyone in the passenger's seat would have been killed. Vehicle went under guiderail and BCT.

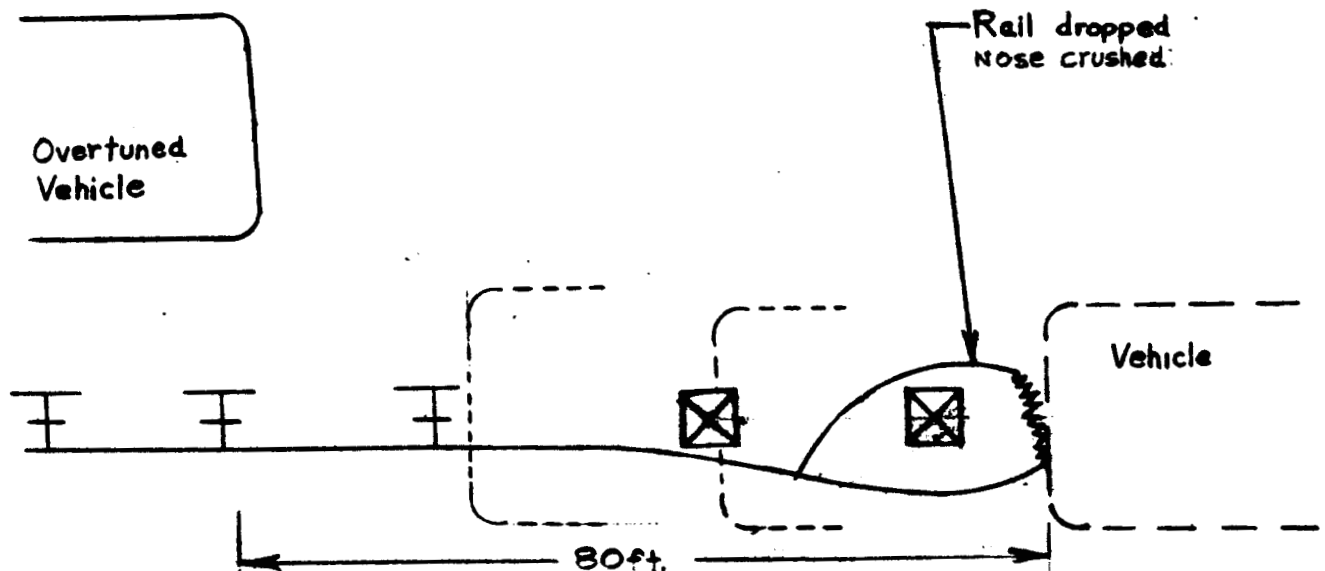
Case #9: A 1970 Chrysler impacted an undiaphragmed BCT. The BCT was located on the road berm. The vehicle broke the first post above the bearing plate (the bearing plate remained in place after the accident). The second post was broken at ground level. The third, fourth and fifth steel posts were pushed over. The concrete footing of the first post was cracked vertically. The rail was pushed down and separated from the washerless retainer bolts. The buffer end was torn off. It was reported by the investigating officer that the "vehicle rode on top of the guiderail for 80 feet" before overturning down an embankment. The vehicle was severely damaged. The driver was injured seriously.

DAMAGE Broke both wood posts, bent over three steel posts, broke footing on first post.

COMMENTS: The vehicle hit the BCT and rode 80 ft. on top. Vehicle overturned and came to rest on the four wheels.

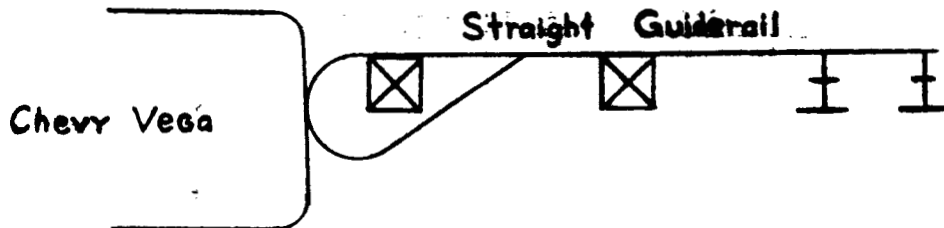
DAMAGE Impact broke off the first two posts. Buffer end was crushed and

COMMENTS: (The investigators did not pursue an inquiry into the driver's precise condition. However, the driver was not killed.) The BCT speared the vehicle and penetrated the driver's compartment to the front seat back. Guiderail was installed parallel to roadway.

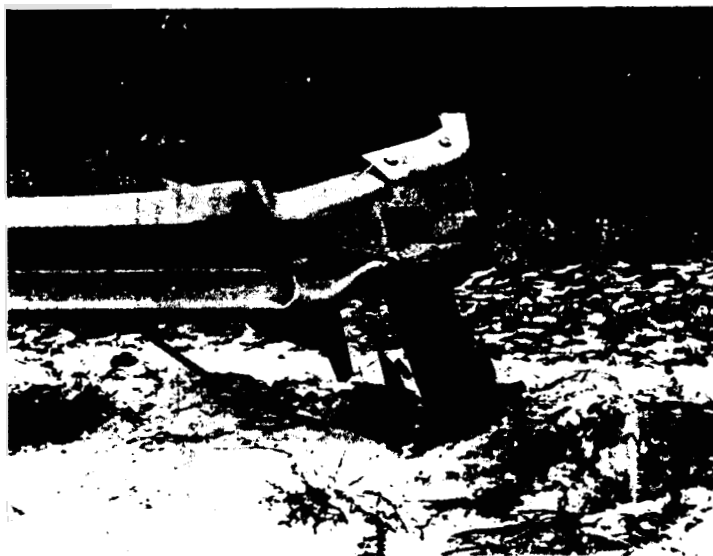
Pushed over
footing

Case #11: A 1977 Chevrolet impacted an undiaphragmed BCT. The BCT was located behind an 8" vertical curb. The vehicle pushed over the first wood post and concrete footing and compressed the buffer end. The vehicle damage was confined to the engine compartment. The driver and a passenger were injured moderately.

DAMAGE Did not break first post but pushed over post and footing and loosened second post footing.

The concrete footing in the first post is essential for guiderail post anchorage in downstream impact conditions. Loose soil around the concrete footings should be adequately compacted to insure post anchorage.

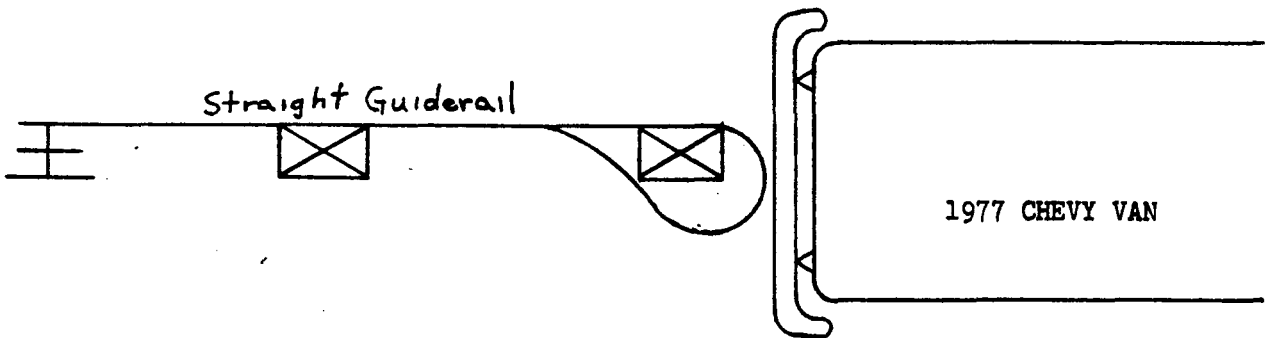
Case #12: A 1977 Chevrolet Van impacted an undiaphragmed BCT. The BCT was located behind an 8-inch vertical curb. The vehicle broke the first and second wood posts at ground level. The guiderail was bent at the buffer end connection to the guiderail. The vehicle sustained extensive front end damage. Guiderail penetration into the vehicle was prevented by a large V-8 engine, an air-conditioning unit and radiator. The driver was injured moderately.

DAMAGE First post split (did not break at breakaway hole) and broke away.
Second post also broke. Rail bent behind buffer end.

COMMENTS: The bulk of the vehicle (air conditioning unit, radiator and V-8 engine) prevented guiderail penetration of the vehicle.

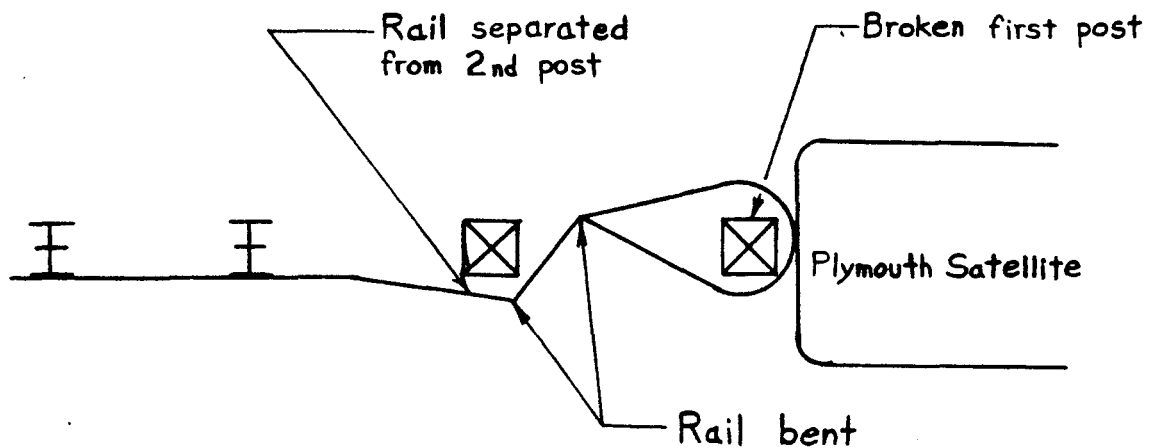
Case #13: A 1972 Plymouth Satellite impacted an undiaphragmed BCT. The BCT was located at the edge of the roadway. The vehicle fractured the first wood post and dislodged the concrete footing. The second concrete footing was also dislodged. The guiderail was bent at the buffer end connection to the guiderail. The vehicle was damaged extensively in the front and right side. The driver hit the windshield and was injured seriously.

DAMAGE Broke first post, moved concrete footing (1st & 2nd post),
rail bent at junction of terminal connector & rail.

VEHICLE TYPE Plymouth Satellite DAMAGE Right front-penetration to firewall
