Safety Audit of Fatalities and Injuries Involving Guide Rail

**Final Report
December 2006**

H. Clay Gabler, Ph.D.
Douglas J. Gabauer

New Jersey
Department of Transportation
Bureau of Research
And
U. S. Department of Transportation
Federal Highway Administration

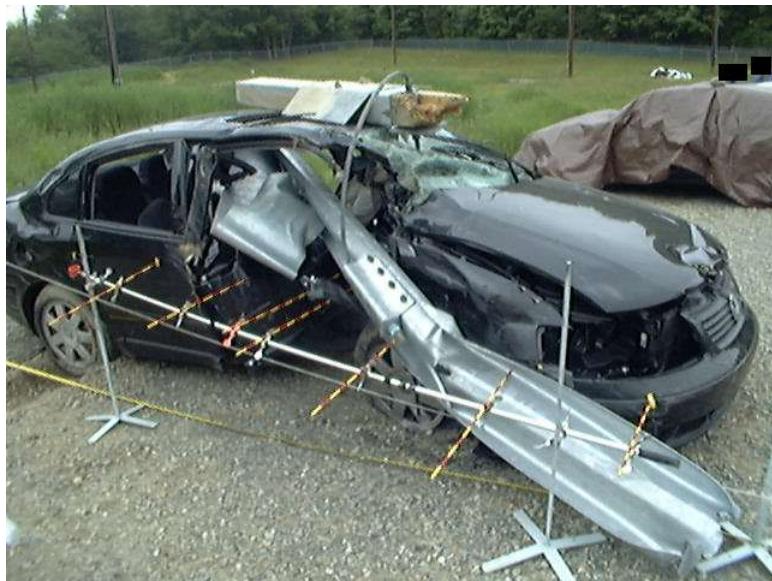
Figure 1. Collisions with Guide rail are not always forgiving. [NASS/CDS Case 2001-81-036 - Fatal Side Impact of 1999 VW Passat into Guide Rail End Treatment]

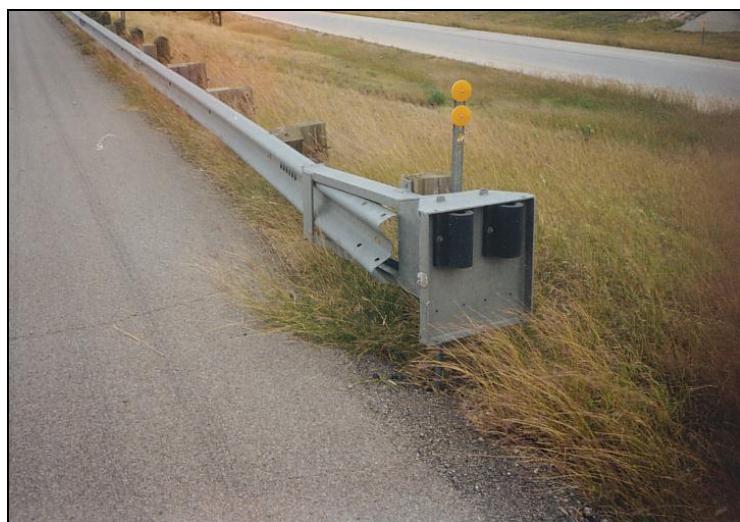
As evident in the full-scale crash tests with roadside hardware, barrier performance can be sensitive to seemingly minor changes in barrier details. Different contractors may install longitudinal barriers across a particular state making quality control difficult. Often times, the result is a barrier installed in the field that does not match the detailed specifications of the crashworthy design. For instance, the rail element in the end terminal (shown in Figure 2) is not properly aligned in the extruder terminal. In the event of a head-on impact with this system, the misalignment will not allow the rail to be deformed as originally intended and may result in adverse performance.

Figure 2. Improper Rail Installation for an Extruder End Terminal

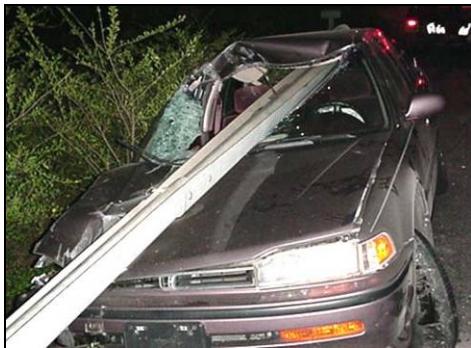
Figure 3. Poor End Terminal Performance: Vehicle Spearing

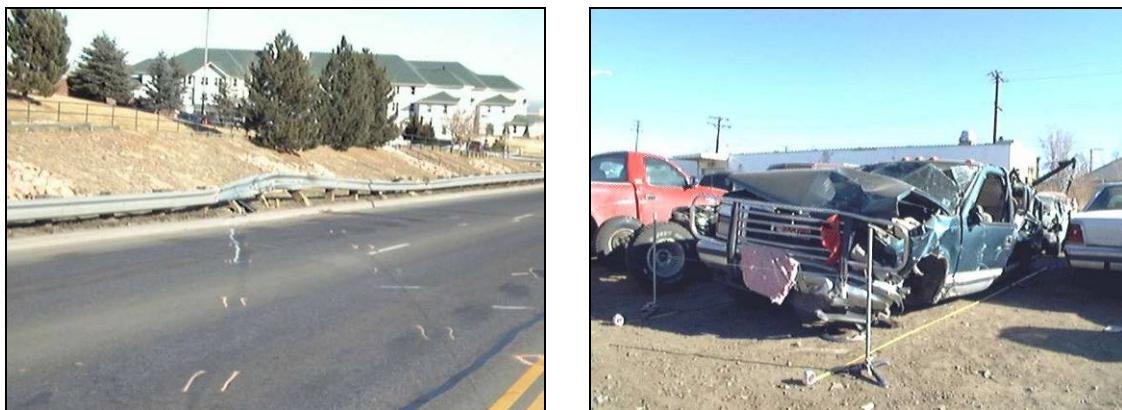
Figure 10 shows that 14% of all fatal guide rail collisions result in a rollover. One concern raised in the national literature is the possibility that a guide rail could act as a rollover trip hazard. In today's fleet, many light trucks have a center of gravity which is higher than the guide rail. When light trucks collide with guide rail there is a significantly greater chance of guide rail "vaulting" and roll-over [Stephens, 1996; Eskandarian, 2003]. Figure 11 presents an example of a sport utility vehicle (SUV) which vaulted over a guide-rail and then overturned.

Figure 11. Higher Center-of-Gravity SUVs can "vault" a guide rail system. In this 2001 case, a 1992 GMC Suburban became airborne on impact with a W-beam guide rail, overturned, and injured the driver. (Ref: NASS/CDS 2001-75-001)

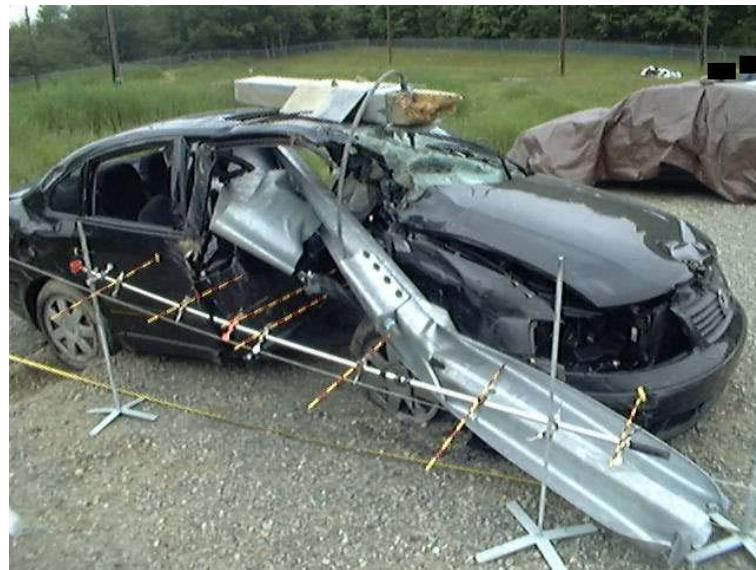
Figure 15 shows the outcome of a side impact of a car into a guide rail end treatment. In this case, extracted from the NHTSA National Automotive Sampling System / Crash Data System (NASS/CDS), a w-beam barrier end treatment speared through the passenger door of a 1999 VW Passat. The right front passenger was seriously injured but survived. The driver was fatally injured.

Figure 15. Guide Rail End treatments are not designed for Side Impact [NASS/CDS Case 2001-81-036]

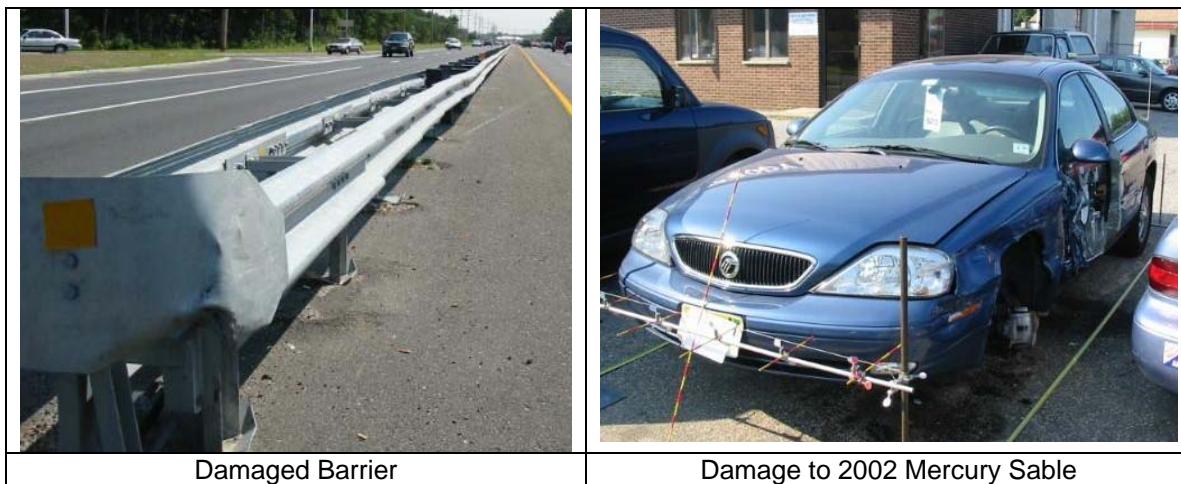
Case NASS-1: A 2002 Mercury Sable was eastbound on New Jersey State Highway 70 in Brick Township, New Jersey proceeding straight through an intersection. The vehicle drifted toward the median as it was exiting the intersection. The front left of the vehicle struck a w-beam (steel block-outs) guide rail end treatment in the median. The guide rail end treatment redirected the vehicle to continue in the eastbound direction. There was subsequent sideswipe damage to the vehicle on the driver's side. Neither the driver, a 78 year old male, nor the passenger, a 74 year old female had reported injuries. Both occupants were restrained with lap and shoulder belts and there was no airbag deployment. Figure 8 provides images of the vehicle damage and guide rail.

Figure 8. Barrier and Vehicle Damage in 2002 Mercury Sable – End Treatment Collision

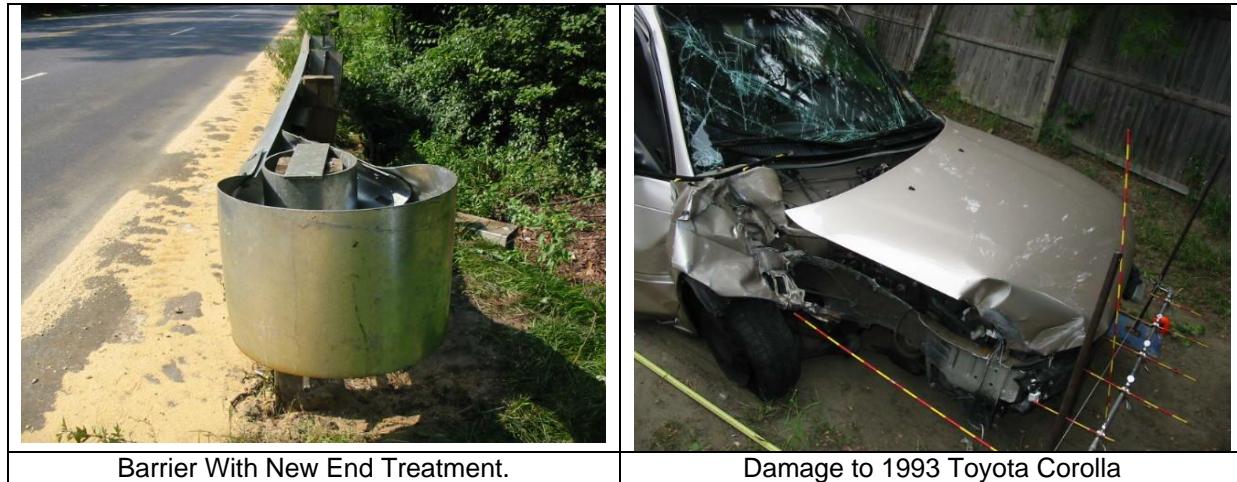
replaced before NASS investigators reached the crash site. Figure 9 provides the images of the vehicle and the replacement guide rail end treatment.

Figure 9. Replaced Guide Rail End Treatment and Damage to 1993 Toyota Corolla

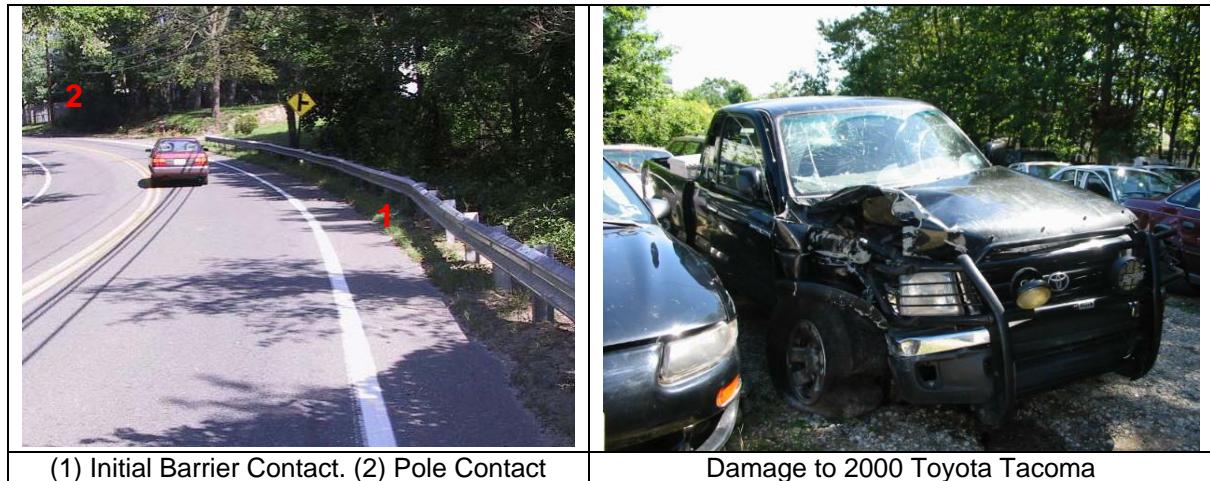
Case NASS-3: A 2000 Toyota Tacoma was traveling on Ocean County Road 636, a county road in Jackson Township, New Jersey. The vehicle exited the two-lane roadway to the right as it was negotiating a left curve. The vehicle contacted the w-beam guide rail (no block outs) then began following a path along the guide rail. The vehicle also struck a mailbox and continued on its path to climb a curb and strike a utility pole just off the roadway. The vehicle came to rest against the pole. The driver, a 21 year old male, had no reported injuries. He was restrained by the lap and shoulder belts as well as the deployed airbag. The pole was determined to be the most harmful event. The guide rail had succeeded in returning the vehicle to the roadway, but the driver was unable to negotiate the vehicle away from the roadside following the guide rail contact resulting in the subsequent collisions. Figure 10 provides the images of the barrier and the vehicle damage.

Figure 10. Barrier Damage and Utility Pole Contact (left) and Damage to Vehicle (right).

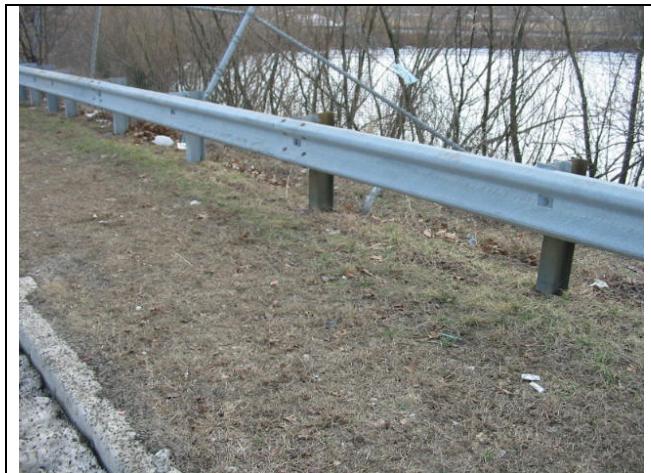
Case NASS-4: A 1994 Honda Civic was sitting at a red light on State Highway 37 in Dover Township, New Jersey, waiting to continue straight through the intersection. A 1993 Ford Tempo struck the Civic in the rear and both vehicles were forced into the intersection. The Honda Civic came to rest in the center of the intersection and the Tempo continued on through the intersection and exiting to the right side where the vehicle came to rest against a w-beam guide rail (steel block outs). The driver of the Tempo, a 79 year old male, sustained massive injuries to the chest resulting in 3 rib fractures on each side as well as hemothorax and pneumothorax (AIS 5). The driver of the Tempo passed away two days after the crash as a result of his injuries. A determination of which event caused the fatal injuries was not reported. The photographs taken from the scene show no damage to the guide rail at the point of contact and only show minimal paint transfer. We conclude that the injuries were the result of the initial impact with the Honda Civic, and not the guide rail. The guide rail was able to prevent the vehicle from continuing on down the embankment. Figure 11 shows the contact point on the guide rail for the Tempo. No photographs were available for the Ford Tempo.

Figure 11. Barrier which contained 1993 Ford Tempo after striking another vehicle.

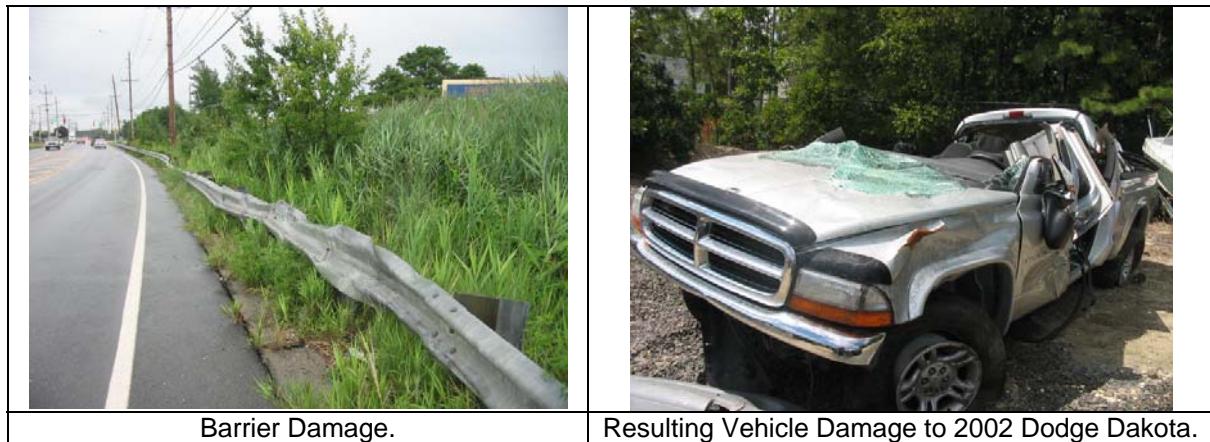
Case NASS-5: A 2002 Dodge Dakota was traveling on US 9, a State Highway in Lacey Township, New Jersey. The Dakota was negotiating a left curve and drifted off the roadway to the right. The vehicle struck a w-beam guide rail (wood block-outs) and began to rotate clockwise. The vehicle climbed the guide rail and began to rollover, leading with its left side. The vehicle completed one full rotation and landed on its wheels in a water hazard of approximately four feet in depth. It was not noted whether the driver, a 44 year old male was wearing a seat belt or if the air bags deployed. The driver suffered an open humerus fracture (AIS 3). The guide rail was determined to be the most harmful object. It was determined that the guide rail was unable to contain the vehicle and resulted in the vehicle vaulting the guide rail and causing the vehicle to rollover. Figure 12 shows the guide rail damage and the vehicle damage.

Figure 12. Barrier and Vehicle Damage in 2002 Dodge Dakota – Guide Rail Collision

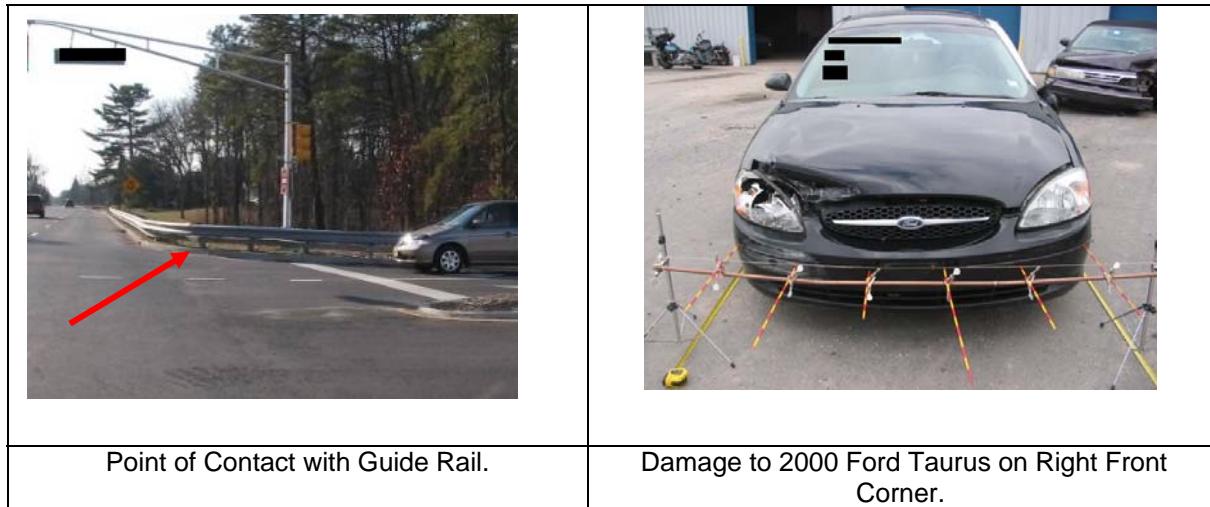
Case NASS-6: A 2000 Ford Taurus was passing through an intersection controlled by a traffic light on Ocean County Road 638 in Jackson Township, New Jersey. A 2004 Toyota Corolla was traveling in the opposite direction and made a left turn at the intersection striking the Taurus in the driver's side. The Corolla struck the Taurus in the left front quarter panel. The Corolla came to rest at the site of impact.

Figure 13. Barrier and Vehicle Damage in 2000 Ford Taurus – Guide Rail Collision

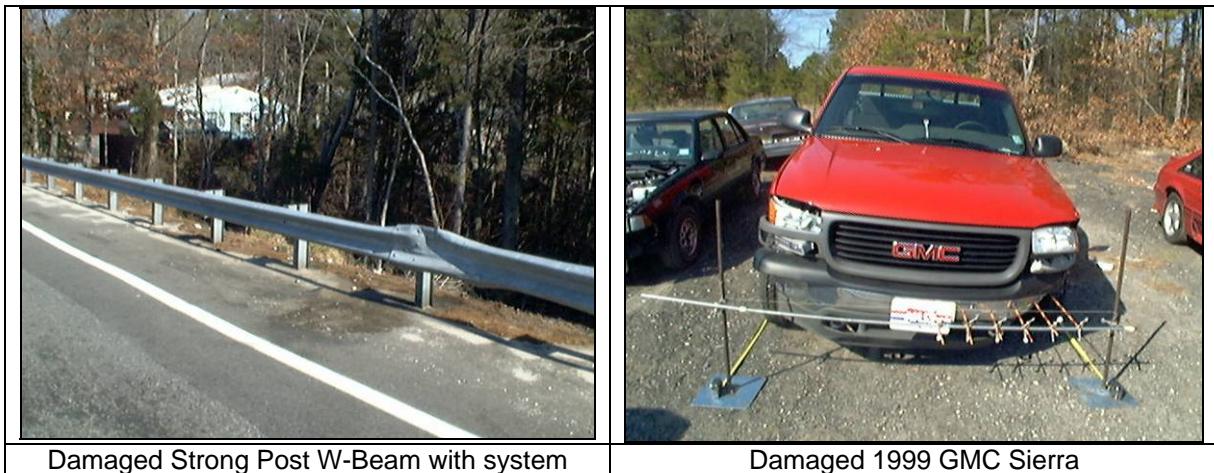
Case NASS-7: A 1999 GMC Sierra was struck by a 1992 Honda Civic which lost control while entering a curve on a two-lane roadway. As a result, the Sierra spun counterclockwise coming to a stop after hitting the strong post w-beam guide rail (steel block outs) on the east side of the road. The belted driver of the Sierra sustained only a minor leg injury (AIS 1). Note that the barrier prevented the vehicle from traversing a steep slope despite being impacted at a splice location. Figure 16 provides images of the vehicle and barrier damage.

Figure 16. Barrier and Vehicle Damage in 1999 GMC Sierra – Guide Rail Collision

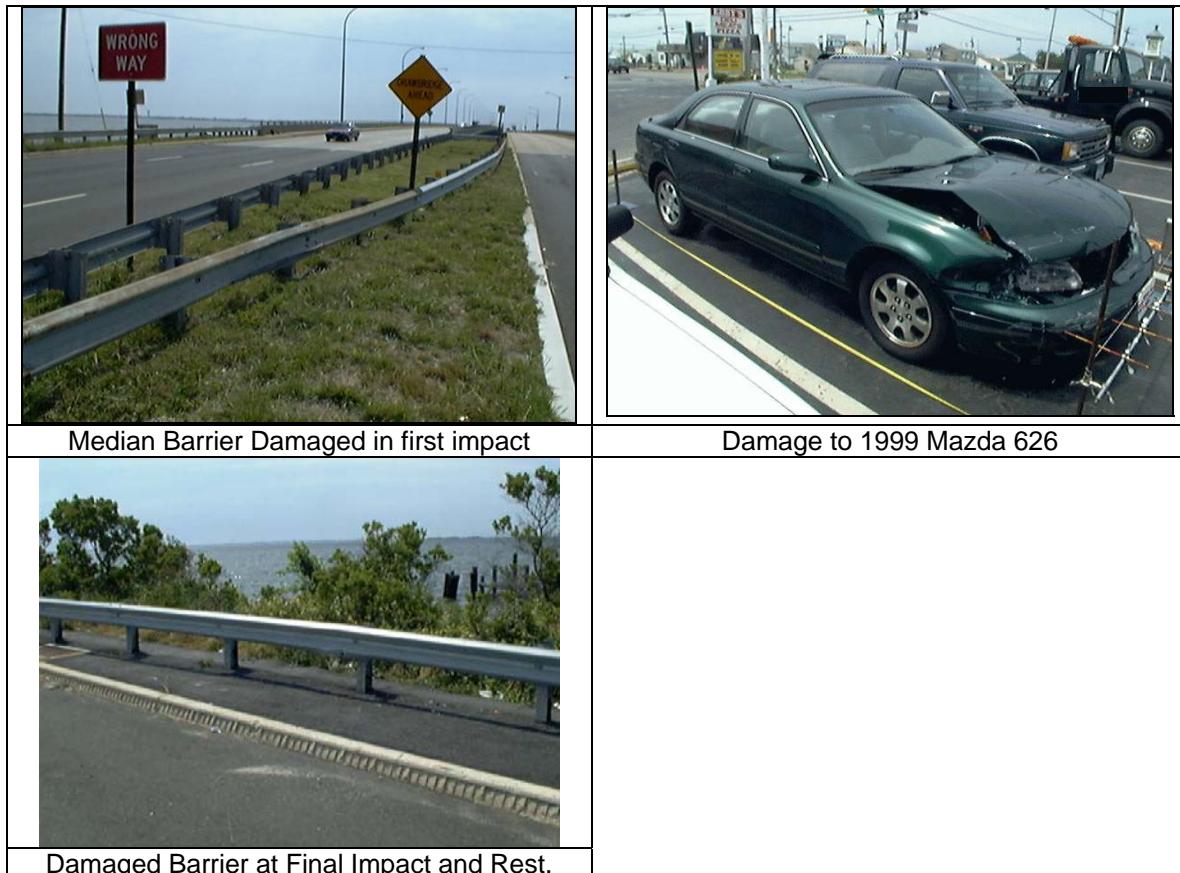
Case NASS-8: A 1999 Mazda 626 vaulted the median curb and the vehicle front engaged the guide rail located behind the curbing. The guide rail redirected the vehicle across three eastbound lanes of traffic and the vehicle became wedged under the guide rail off the right shoulder of the road. Belted but not subjected to an airbag deployment, the 55 year old driver sustained a concussion (AIS 2). It appears that some conditions may have been pre-existing as the driver blacked out just prior to the crash. Note that both guide rail prevented penetration but the post-impact vehicle trajectory from the first impact was not desirable. Figure 17 provides images of the initially impacted barrier and the resulting vehicle damage.

Figure 17. Barrier and Vehicle Damage in 1999 Mazda 626 – Guide Rail Collision

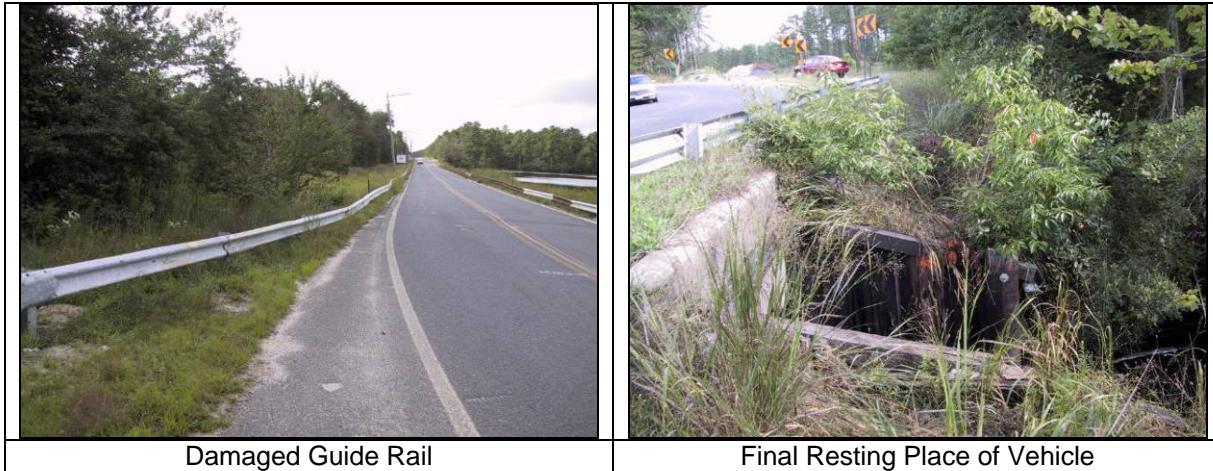
Case NASS-9: The driver of a 1992 Subaru Legacy failed to negotiate a 90-degree right hand curve on a two-lane road. Exiting the road to the left, the vehicle impacted and overrode the guide rail ultimately coming to rest suspended over a spillway of a nearby lake. No airbag was available in the vehicle and investigators could not determine belt usage by either occupant. The 83 year-old male driver suffered AIS 2 level injuries to the face while the 80 year-old female passenger suffered major head trauma (AIS 4). The combination of injuries resulted in fatality for both occupants. Note that there were no block outs present in the guide rail. Figure 18 provides images of the impacted guide rail and final resting place of the vehicle. There were no photos of the vehicle as the vehicle was not inspected.

Figure 18. Guide Rail at the Crash Location of 1992 Subaru Legacy

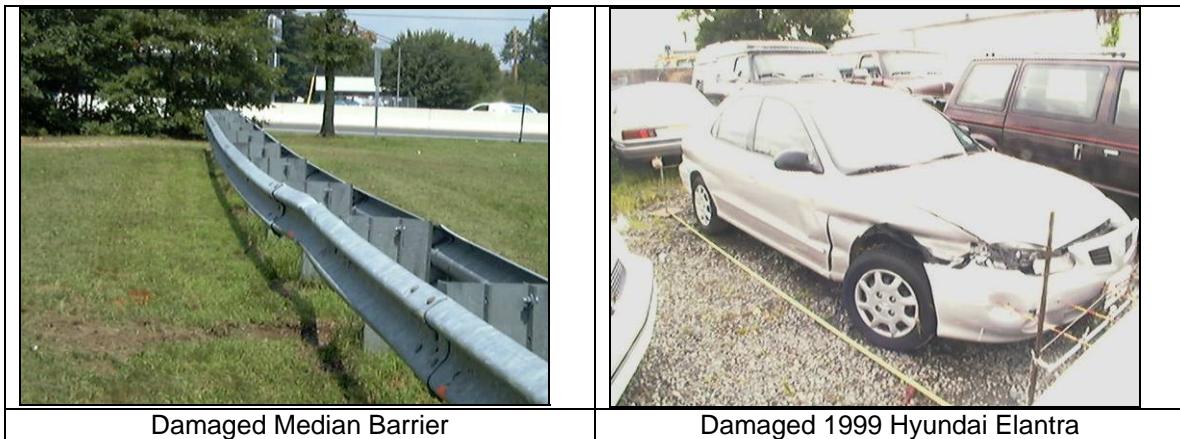
Case NASS-10: A 1999 Hyundai Elantra lost control while negotiating a U-turn exit. Leaving the roadway to the left, the Hyundai spun and the right side of the vehicle impacted a strong post w-beam median barrier (steel block outs). The 18 year-old belted female driver sustained minor injuries to the head (AIS 1) and minor cuts to the upper and lower extremities. Note that the airbag did not deploy in this collision and that the barrier properly contained the vehicle. Figure 19 provides images of the barrier and vehicle damage.

Figure 19. Barrier and Vehicle Damage in 1999 Hyundai Elantra – Median Barrier Collision

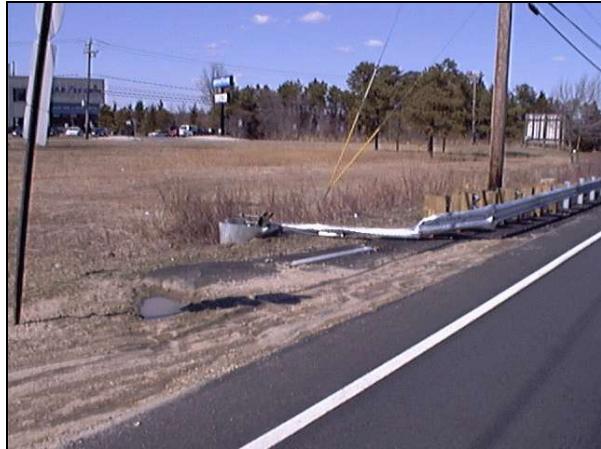
Case NASS-11: A 1987 Chevrolet Suburban lost control, skidded across an intersection, and struck the right front of a 1993 Buick Skylark traveling in the opposite direction. The Suburban then spun clockwise, and its left side impacted a guide rail end treatment situated on the roadway shoulder. The Suburban was not the subject vehicle and was not inspected by investigators. No information was collected regarding the Suburban or injuries to its occupants. The SRT 350 end terminal performed satisfactorily even though the impacting vehicle most likely was struck on the side. Figure 20 shows the damaged end terminal.

Figure 20. Barrier End Treatment Damage after collision with 1987 Chevrolet Suburban

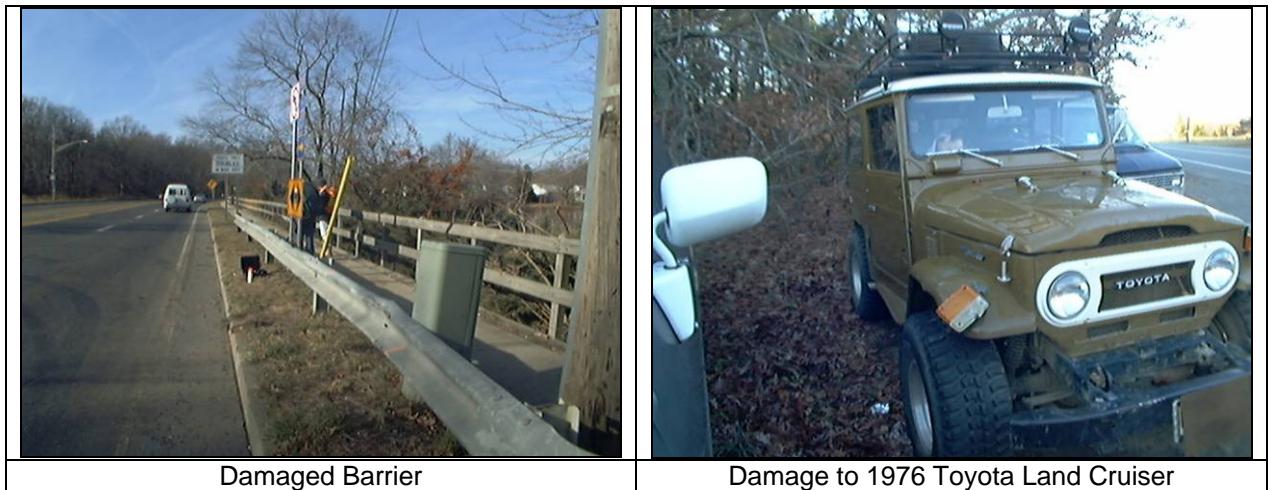
Case NASS-12: A 1976 Toyota Land Cruiser struck the rear of a stopped 2001 Volkswagen Jetta near an intersection. The Land Cruiser then departed the north side of the roadway impacting a strong post w-beam guide rail (no block outs) installed behind a curb. Both occupants of the Land Cruiser were belted (no airbag available) and no injuries were reported. Note that the barrier successfully contained the vehicle. Figure 21 provides images of the vehicle and damaged barrier.

Figure 21. Barrier and Vehicle Damage in 1976 Toyota Land Cruiser – Guide Rail Collision

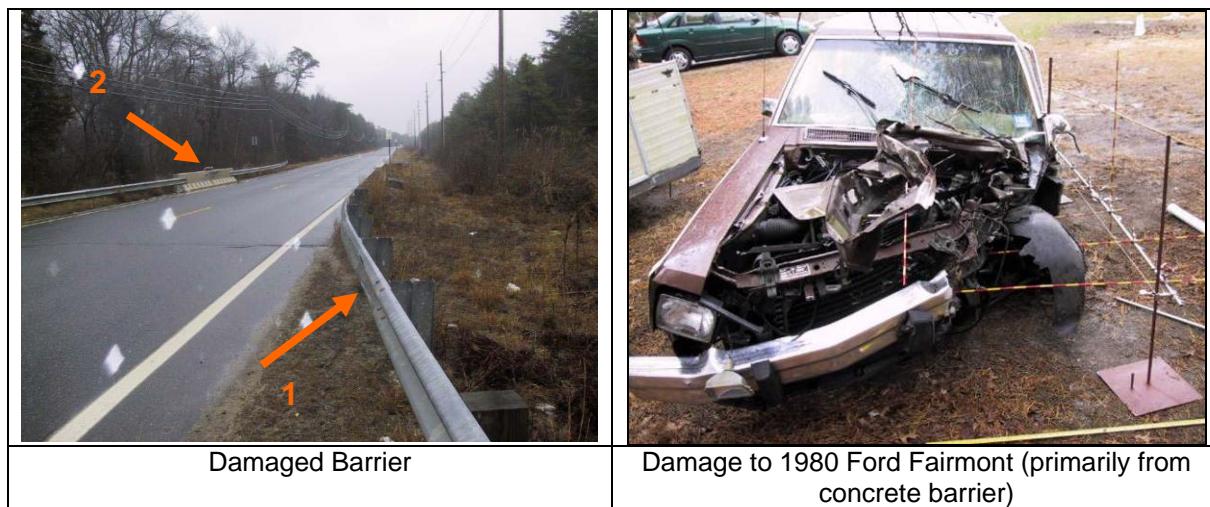
and a minor abrasion to the arm. Although the guide rail produced an undesirable post-impact vehicle trajectory, the vehicle was successfully contained. Figure 22 provides images of the vehicle damage and guide rail.

Figure 22. Barrier and Vehicle Damage in 1980 Ford Fairmont – Guide Rail Collision

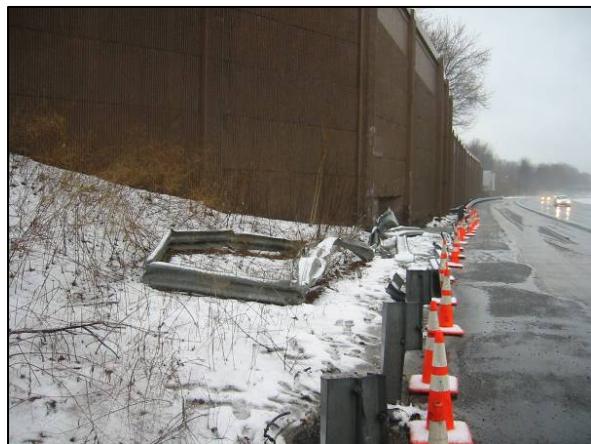
I-295 NB MP 28.3: A tractor trailer traveling on I-295 southbound (SB) crossed the unprotected median and impacted the strong steel post w-beam barrier (steel blockouts) shown in Figure 23. The unidentifiable end terminal (most likely a breakaway cable terminal) and roughly 400 feet of guide rail was damaged; the impacting heavy vehicle penetrated the guide rail and impacted the sound-wall that the guide rail was shielding. As the strong post w-beam barrier is tested to NCHRP test level 3, it is not designed to redirect heavy vehicles such as tractor trailers.

Figure 23. Strong Steel Post Barrier Damage at I-295 NB MP 28.3

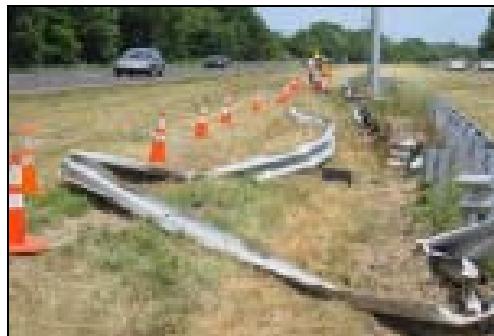
I-95 SB MP 6.3: A tractor trailer heading southbound on I-95 departed the roadway on the left and impacted a strong steel post w-beam barrier (steel blockouts) protecting an overhead sign support in the median. Based on tire ruts left at the scene, the impact angle was determined to be approximately 15 degrees. Although the barrier has not been designed to redirect heavy vehicles, it appears that the tractor trailer was brought to a controlled stop. A total of 150 feet of barrier was damaged.

Figure 24. Barrier Damage at I-95 SB MP 6.3

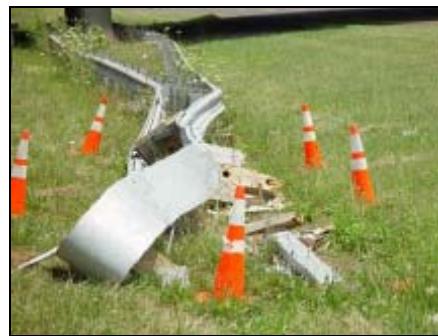
I-95 NB MP 8.1: The driver of a four door passenger sedan traveling northbound on I-95 lost control, departed the roadway on the left, and impacted a CAT 350 end terminal (shown in Figure 25) causing damage to the front of the vehicle. Approximately 32 feet of guide rail was damaged due to the impact. Based on the field investigation, the end terminal appeared to break away as intended with no evidence of vehicle spearing. According to the PAR, both occupants of the vehicle reported no injuries.

Figure 25. CAT 350 End Terminal Damage at I-95 NB MP 8.1

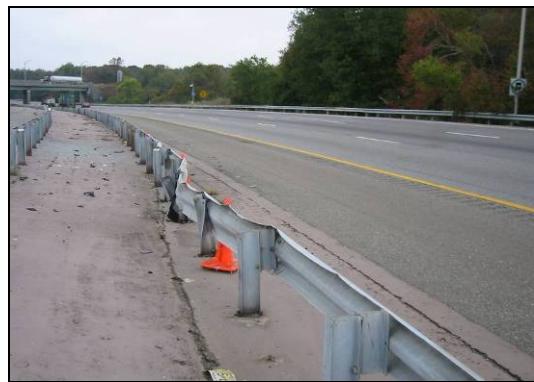
I-295 SB MP 14.3: A steel strong post w-beam roadside barrier (steel block-outs) located in the median (see Figure 26) was struck in two locations by a small passenger vehicle. The median width varies but is approximately 10 feet at the impact location and there is roughly a four foot differential in vertical alignment of the north and southbound lanes resulting in a 3:1 (H:V) slope of the median toward the southbound lanes. Note that the posts of the barrier were anchored in bituminous material. Based on tire marks on the pavement, the vehicle struck the barrier first at a 25 degree angle and then a 40 degree angle. There was no penetration in either case. Maximum barrier deflection was 20 inches for the 32 feet (7 post section) of total barrier damaged.

Figure 26. Barrier Damage at I-295 SB MP 14.3

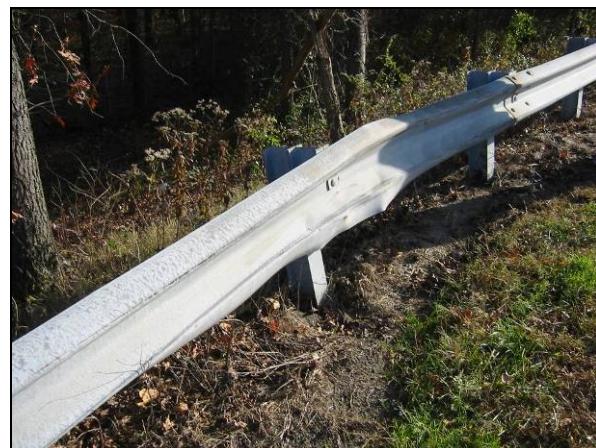
I-295 NB MP 64.5: A passenger vehicle traveling on I-295 NB departed the roadway to the right and impacted a strong steel post w-beam guide rail (steel blockouts) in two locations, first with the front of the vehicle followed by the rear of the vehicle. Barrier damage resulting from the second impact is shown in Figure 27. A total of 27 feet of barrier was damaged with a maximum deflection of 6 inches. Based on the PAR, there were no injuries sustained by the driver of the vehicle.

Figure 27. Secondary Impact Damage at I-295 NB MP 64.5

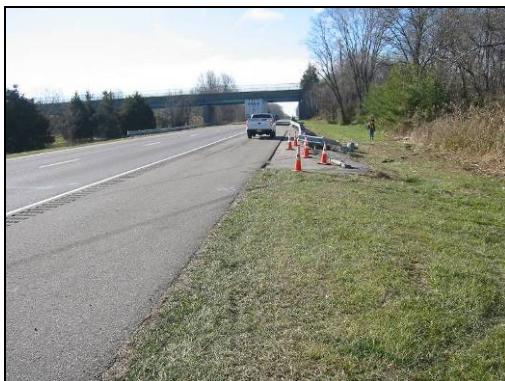
As designed, the posts of the terminal failed allowing penetration of the vehicle without the rail penetrating the occupant compartment. After the barrier impact, however, the vehicle rolled. The location of the tire marks suggest that the strut located between post 1 and 2 of the end terminal may have aided in tripping the vehicle as it was sliding sideways. Approximately 35 feet (9 post section) of barrier was damaged, which comprises essentially the entire end terminal. Note that based on the inspection of the damaged section the end terminal appeared to be installed to standard with the exception of the rail height (25 inches as opposed to 27.5 inches).

Figure 28. SRT 350 Damage Resulting in Vehicle Rollover and Driver Fatality on I-295 SB

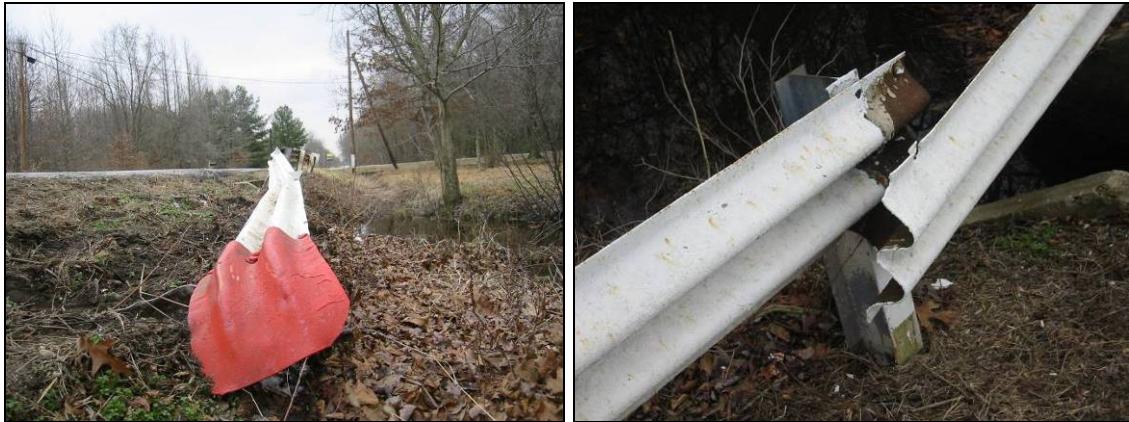
Figure 29. View of Damaged End Terminal (Left) and Failed Splice Location (Right)

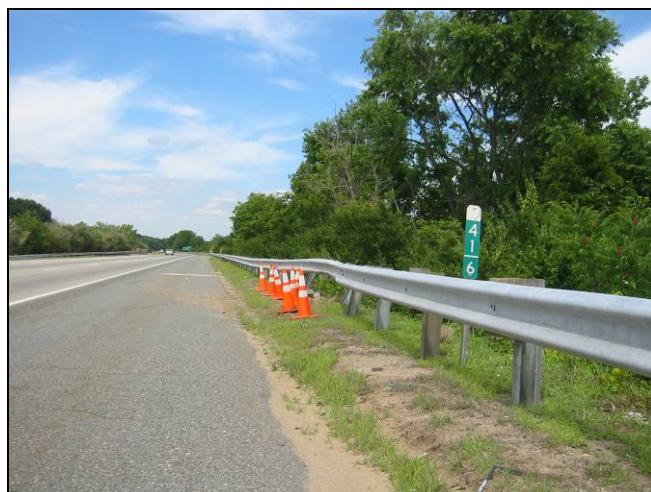
Figure 30. Barrier Damage at I-295 NB MP 41.6: View from South

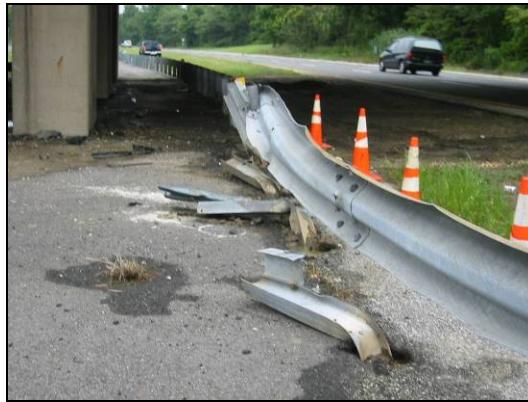
Figure 31. Barrier Damage at I-295 NB MP 25.1

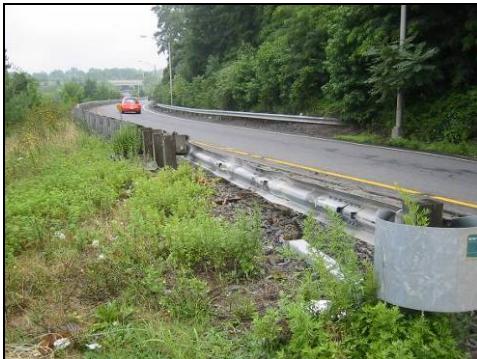
inspection of the damaged section the barrier appeared to be installed to standard specifications.

Figure 32. SRT 350 Damage at I-195 WB MP 0.14

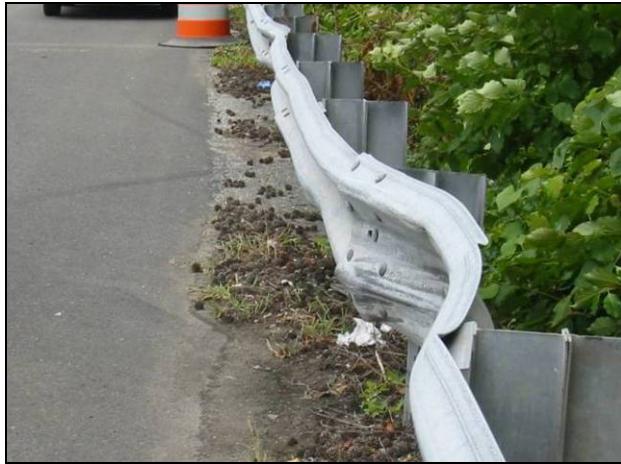
Figure 33. Initial Impact (Foreground) and Second Impact (Background) at State Highway 42 SB MP 12.2

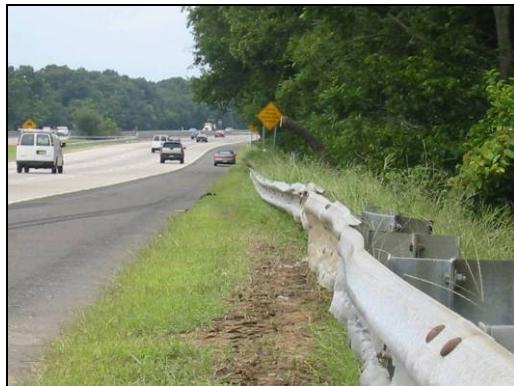
Figure 34. Barrier Damage at I-295 SB MP 43.9

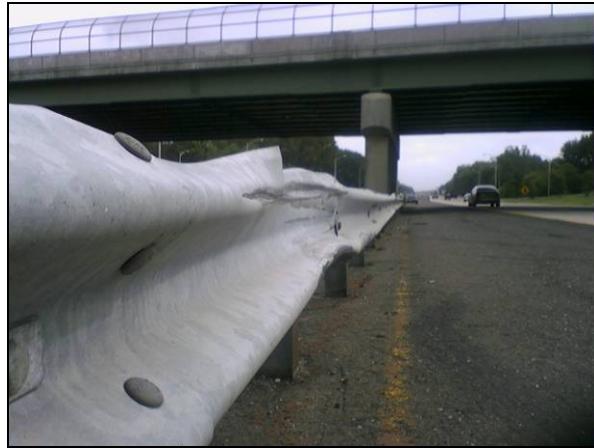
Figure 35. Barrier Damage at I-295 NB MP 19.3

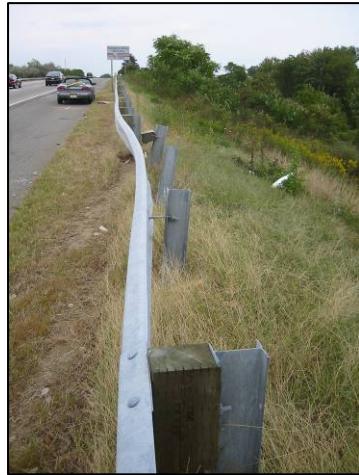
Figure 36. Barrier Damage at I-295 NB MP 41.3

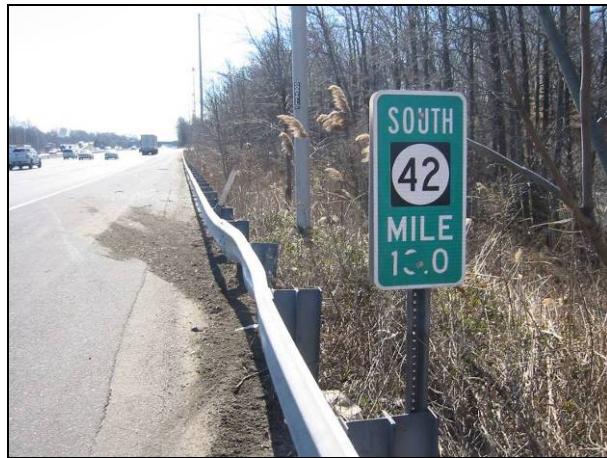
Figure 37. Damage from First Impact at State Highway-42 SB MP 13.0
