**NEW JERSEY DEPARTMENT OF TRANSPORTATION
MEMORANDUM**

SUBJECT: Inspection Priority Alert
Non-Standard Light Pole Cracking

Structure No.: 1222-150 Route: NJ 35 Cycle No.: 14
Name: NJ 35 over Cheesequake Creek and Ramp Insp. Date: 10/19/06

Structure No.: 1511-150 Route: NJ 70 Cycle No.: 14
Name: NJ 70 over Manasquan River Insp. Date: 10/3/06

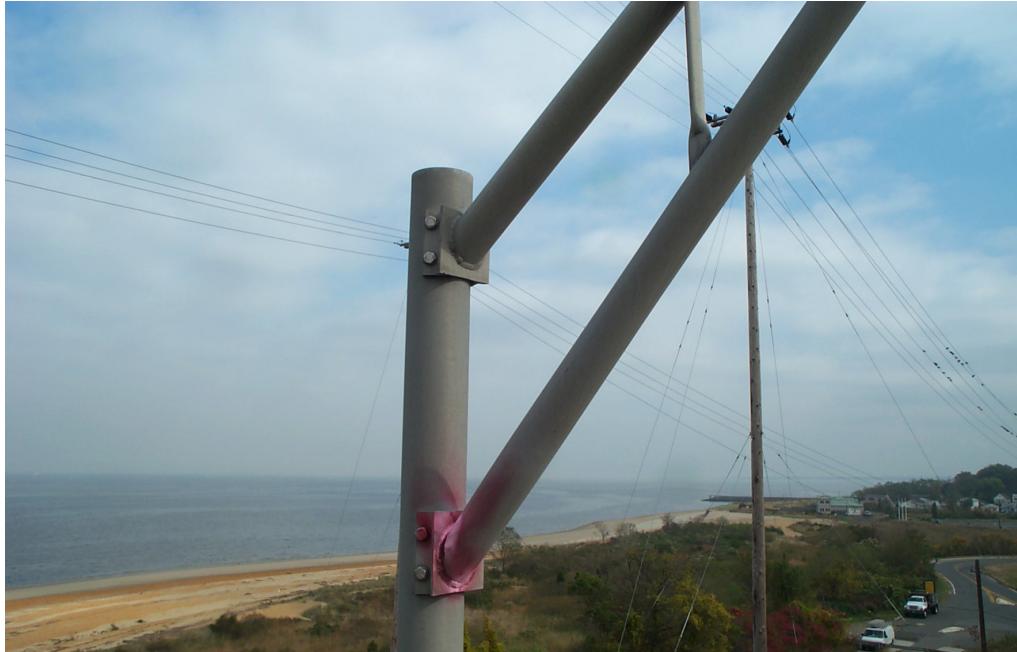
Photo No: 1

Location:	Light standard East Fascia over Pier 6
Description:	General view (Note: cracked lower connection welds tested with dye penetrant)

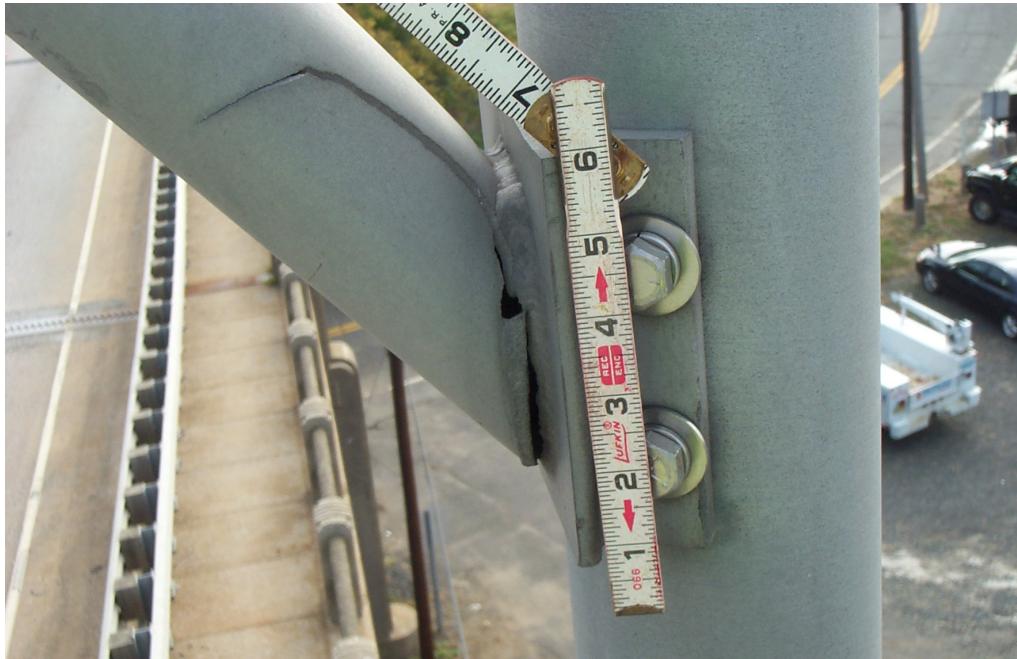
Photo No: 2

Location:	Light standard west fascia over Pier 2 (Pole 5)
Description:	5 $\frac{3}{4}$ " cracked weld extending 4 $\frac{1}{2}$ " into the lower diagonal of the light standard.

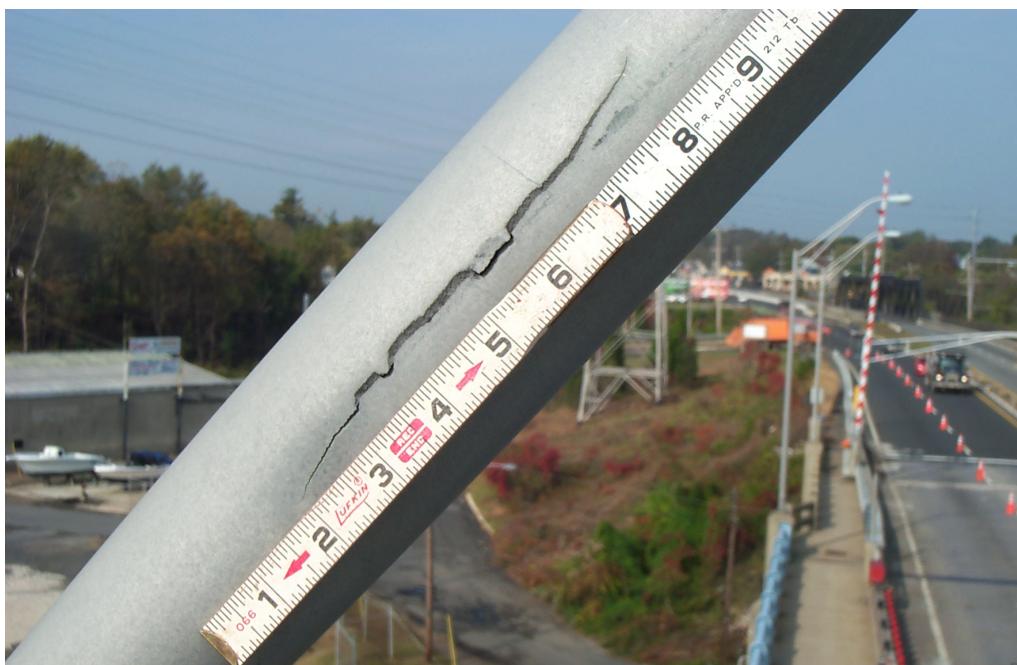
Photo No: 3

Location:	Light standard west fascia over Pier 6 (Pole 3)
Description:	6 1/4" long crack in the lower diagonal (Note: There is also a 6" long crack in the weld connecting the diagonal to the mast).

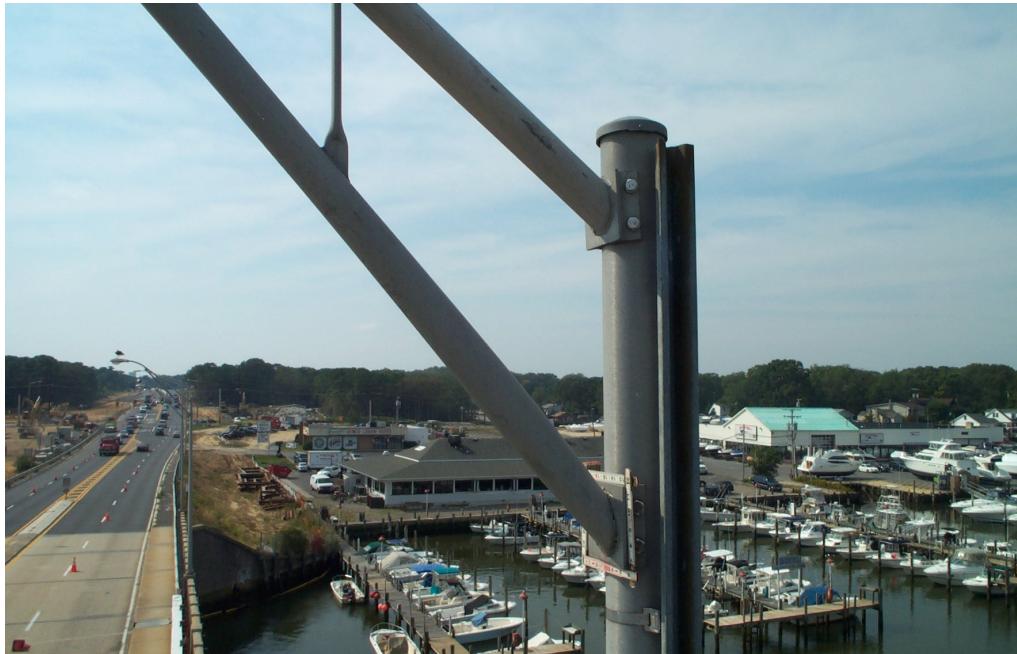
Photo No: 4

Location:	Light standard north fascia Pier 7, looking northwest
Description:	General view (Note: cracked weld lower strut at the mast.)

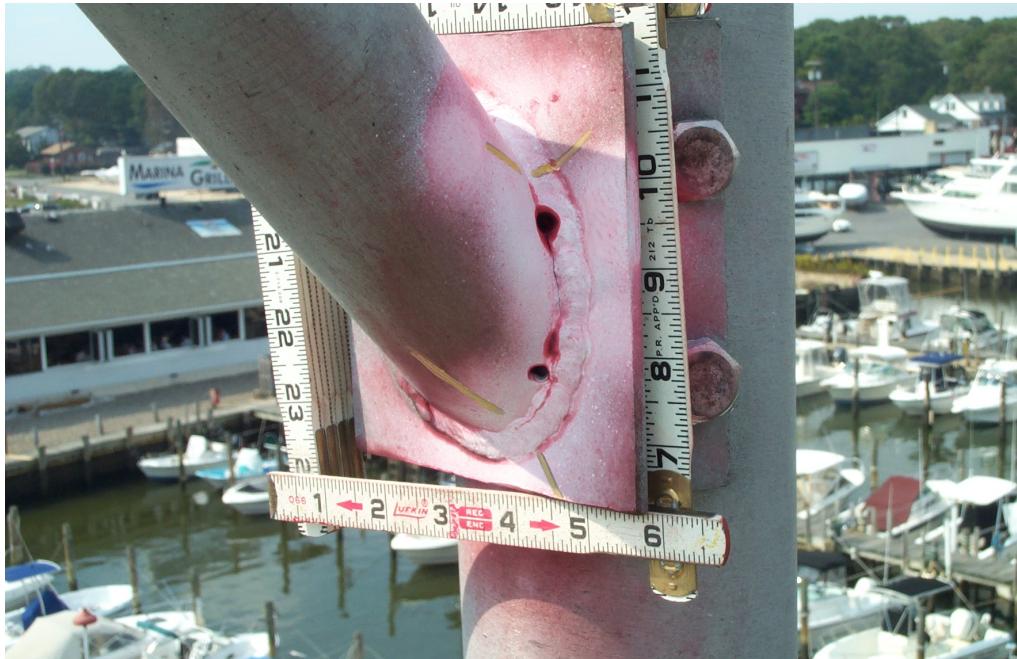
Photo No: 5

Location:	Light standard north fascia Pier 3, looking northwest
Description:	Crack in the weld at the lower strut connection to the mast extends beyond the drilled holes

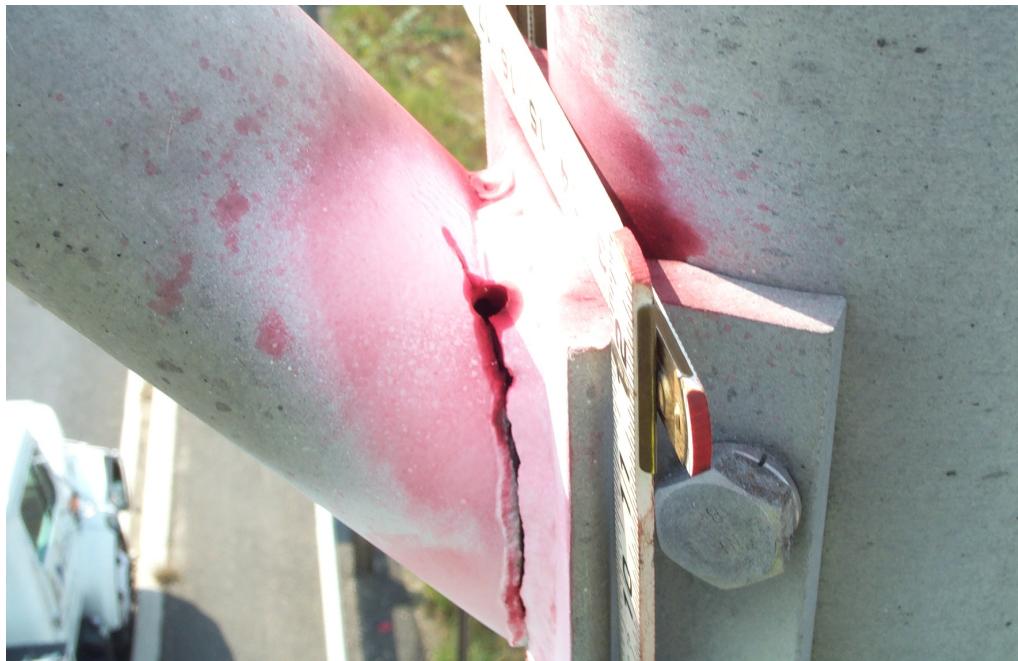
Photo No: 6

Location:	Light standard north fascia at the west abutment, looking west
Description:	Crack in the weld at the lower strut connection to the mast extends beyond the drilled hole and into the lower strut
